Bernalillo River Maintenance Priority Site Bend Migration Monitoring Spring 2005 Report

U.S. Department of the Interior
Bureau of Reclamation
Albuquerque Area Office

August 2005

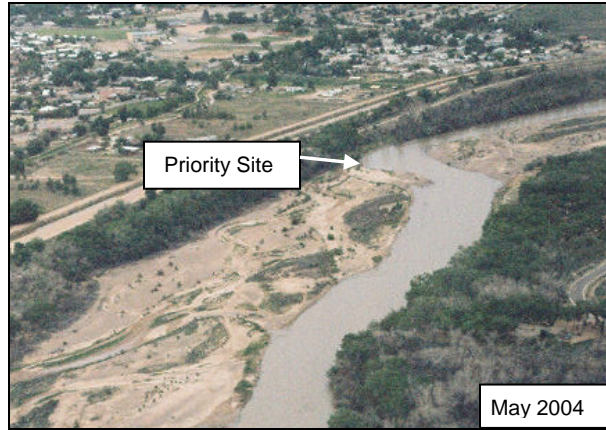
This Rio Grande bend formed in the 1990s and slowly migrated towards the levee toe. As the bankline moved closer to the levee (Figure 1), a short-term ‘fix’ of riprap was emplaced along the edge of the bankline in 2003 (Figure 2). The bankline armouring is a short-term solution until a long-term solution is constructed. At present, a long-term solution is in the planning phase which may include both reinforcing the eastern bank line with a series of ‘bendway’ weirs and splitting the low-moderate flows by partially re-activating the western side channel (Figure 1). This project is estimated to begin construction next year (Fiscal Year 2006).

Figure 1: Aerial view of the Priority Site, May 2004, looking downstream at the east bank with the town of Bernalillo in the distance.

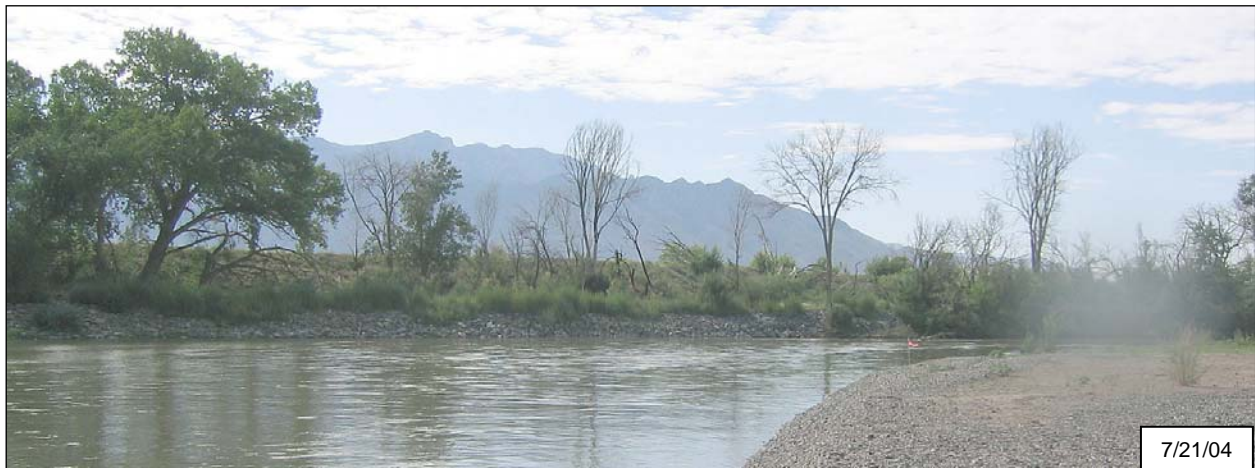
Figure 2: Bernalillo Priority Site; photo taken in July 2004, looking downstream towards the rip-rap lined east bank.

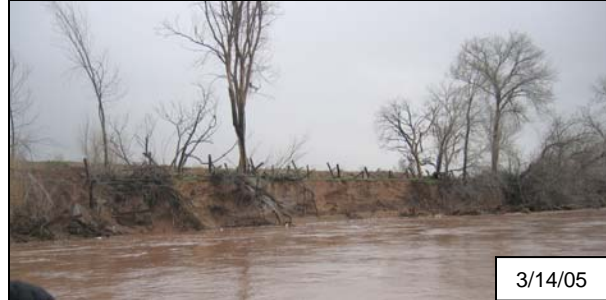
Bank erosion was first noticed on March 14, 2005 (Figure 3), however the initiation of a migrating bend was not observed until late in April 2005 as spring runoff flows began; erosion continued until the end of May. Although the priority site bend is located upstream of the boundaries of the Pueblo of Sandia, once bend migration initiated, the bend rapidly shifted downstream onto the Pueblo's land. At this point, the Pueblo was contacted and arrangements were made to visit and map the bankline weekly.

Figure 3: Bank erosion just downstream from the rip-rap armoured bankline at the Bernalillo Priority Site.

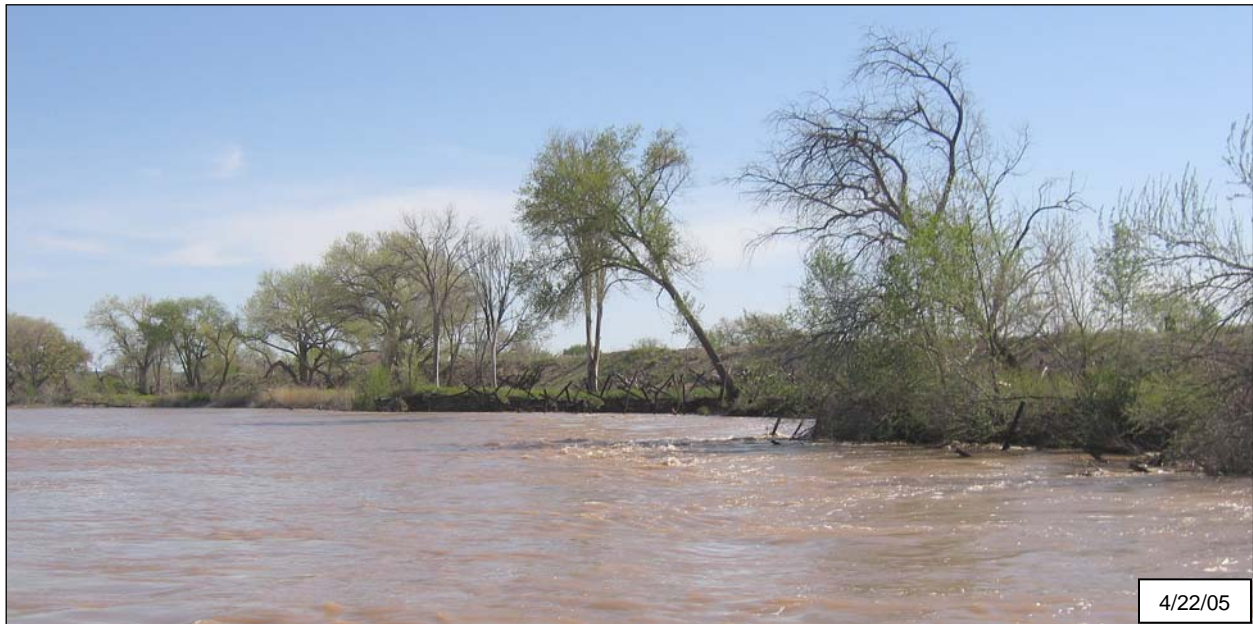
Bend migration was first observed on April 21st, with additional observations, photographs and notes on April 22nd (Figure 4) at which time, approximately 200 feet of bankline had already eroded. Runoff was just ramping up with river flows about 4,700 cfs on April 22nd, a moderately high flow. Prior to runoff, a row of Kellner jetty jacks lined the

rows of jacks that hindered the bank erosion. These jacks were partially buried and remained connected to the bank throughout most of runoff (line of jacks visible in center of Figure 4 near leaning tree).

Figure 4: Bank erosion/bend migration at the Bernalillo Priority Site on April 22, 2005.

bank (some visible on right of Figure 4 photo), with vegetation growing through them; these jacks were easily eroded and transported downstream. Also, based on observations of

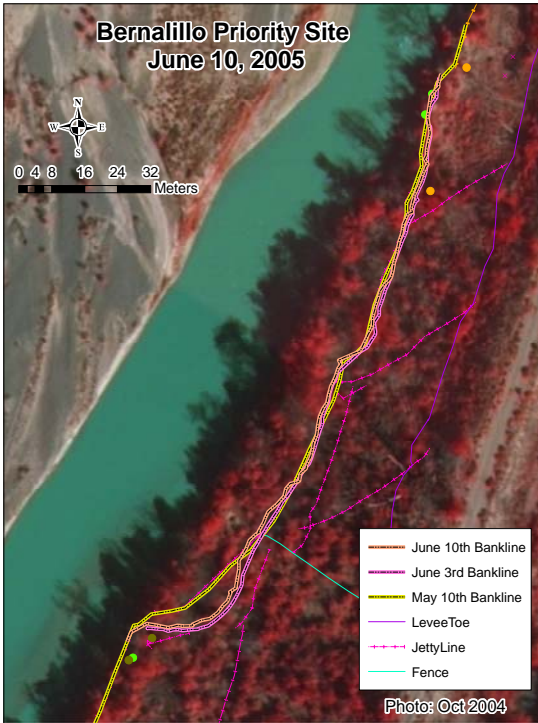
Olive/Tamerisk trees. After ‘hitting’ this erosion resistant location, the bend apex began to erode eastward, into the bank material which sculpted a bend with a larger curvature/radius (Figure 5); about 50 feet of bank material was eroded during the increased curvature event.

Figure 5: Bernalillo Priority Site map with bank line locations mapped periodically in Spring 2005.

In early June, bend migration essentially stopped (Figure 5). The two jetty jack lines that had prevented southeast erosion had become undermined and sections of the jack line began falling into the river channel (Figure 6). Although the sediment underneath the jetty jacks has been continuously eroded since the bend apex passed this location, the magnitude of the undermining appears to be decreasing, but may continue, even during low-flow periods.

In summary, approximately 350 feet of bank line downstream from the riprap lined bank was eroded during spring runoff 2005 (Figure 5). At the apex of the bend, the width of erosion is about 50 feet. Two lines of jetty jacks that were well anchored in the bank material appear to have initially hindered lateral migration of the bend apex towards the levee, while the already compromised jetties

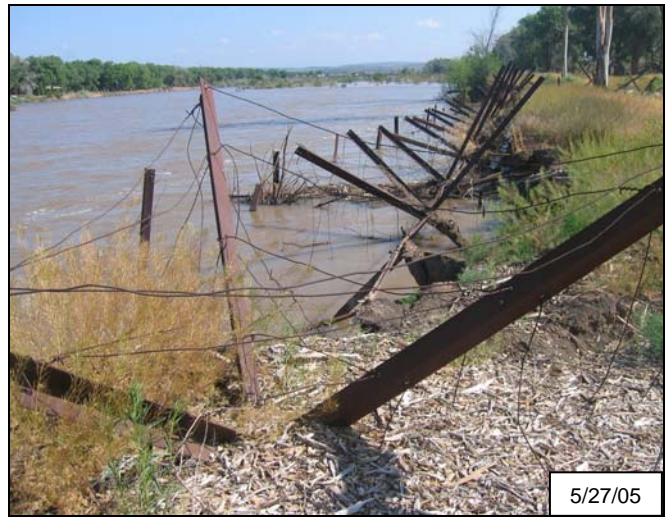
Figure 6: Bank erosion at the Priority Site on May 27th, showing the erosion of sediments underneath the jetty jacks.

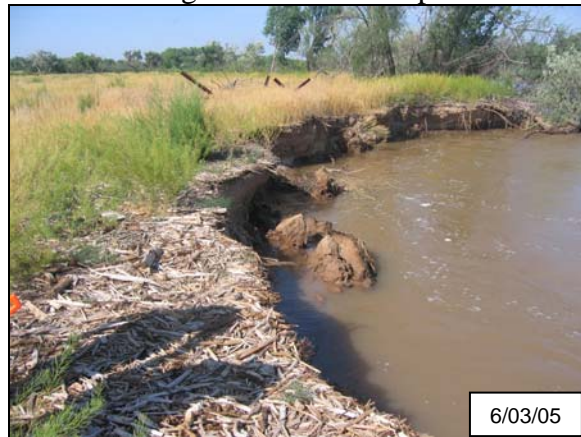
By late June, large blocks of bank material were un-transported by the Rio Grande, and began lining the eroding bankline (Figure 7) thus indicating that the bend location was stabilizing. Since that time, the bankline along the entire bend apex has

Figure 7: Small slump blocks fallen from the bank line at the bend apex on June 3rd.

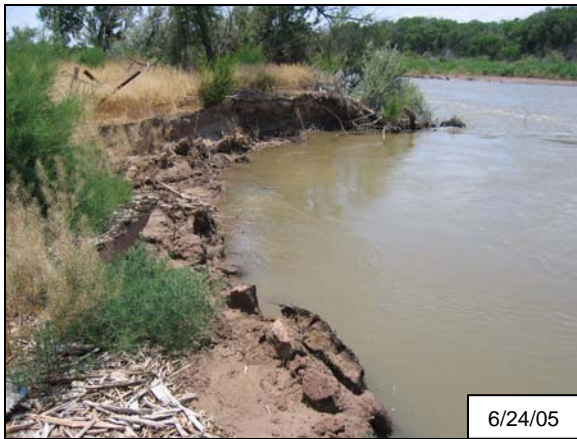
slumped (Figure 8). The result of the bank slumping is to form a toe at the river’s edge that ‘protects’ the remaining undisturbed bank sediments from lower riverine flows.

Figure 8: Extensive bank slumping/collapses at the bend apex; photo taken on June 24th.

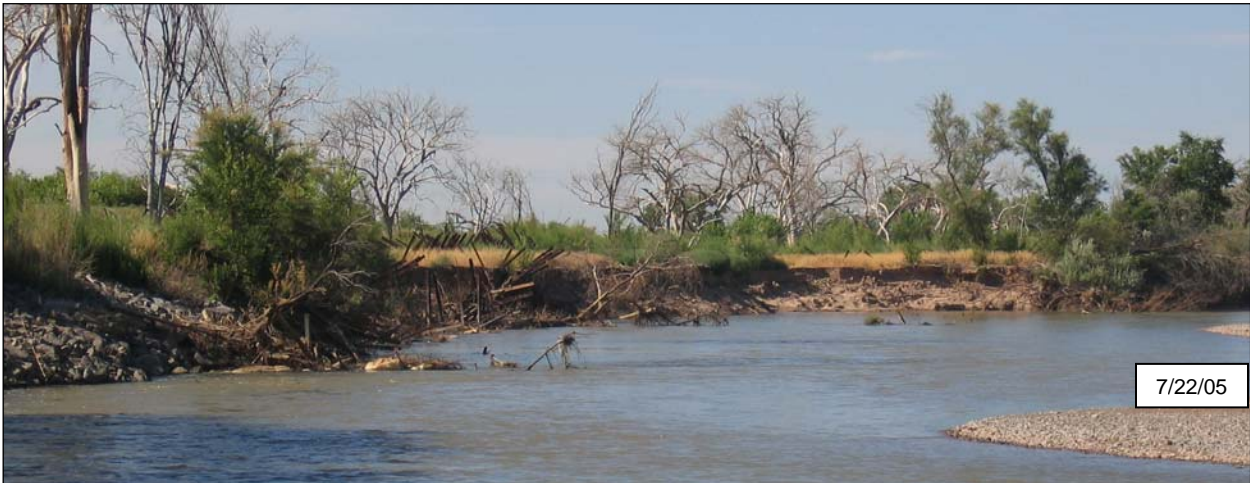
continuation of bank slumping along the new bank line, including under the jetty jacks (Figure 9). Bank slumping around jetty jacks has allowed them to completely fall into the river channel. The current water surface extends to the toe of the new bankline.

Figure 9: Site photo from July 22, 2005 that shows bank slumping along the bend apex, and a portion of the jetty jack line that has fallen into the river.

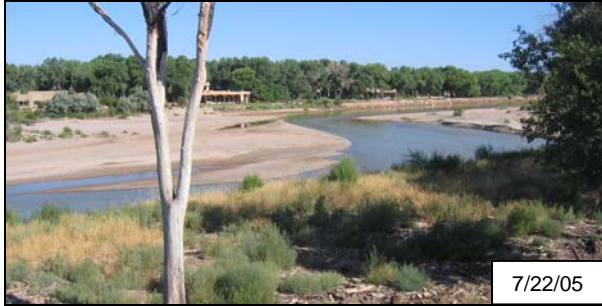
The other important feature, opposing bar (point bar), is also obvious at the site (Figure 10). Prior to the 2005 runoff, this bar existed; however it was connected to a small,

sparsely vegetated island to the west of the priority site. After the 2005 runoff, this bar was reshaped such that the top of the bar appears to have been partially eroded, but it also slopes gently to the current rivers edge (pro-grades), and extends some distance into the main channel. The most important aspect of this bar is that it appears to have grown in

size and is now narrowing the main channel at the upstream end of the bend.

Figure 10: Looking upstream from the Bernalillo Priority Site; photo shows a large point bar on the west bank of the main channel, opposite the priority site (photo date 7/22/05).

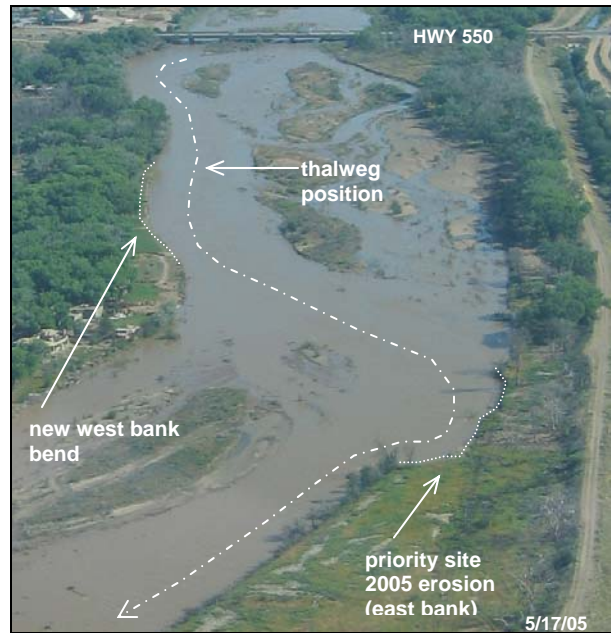
Figure 12: Aerial photograph during 2005 spring runoff looking upstream at the NM HWY 550 bridge crossing.

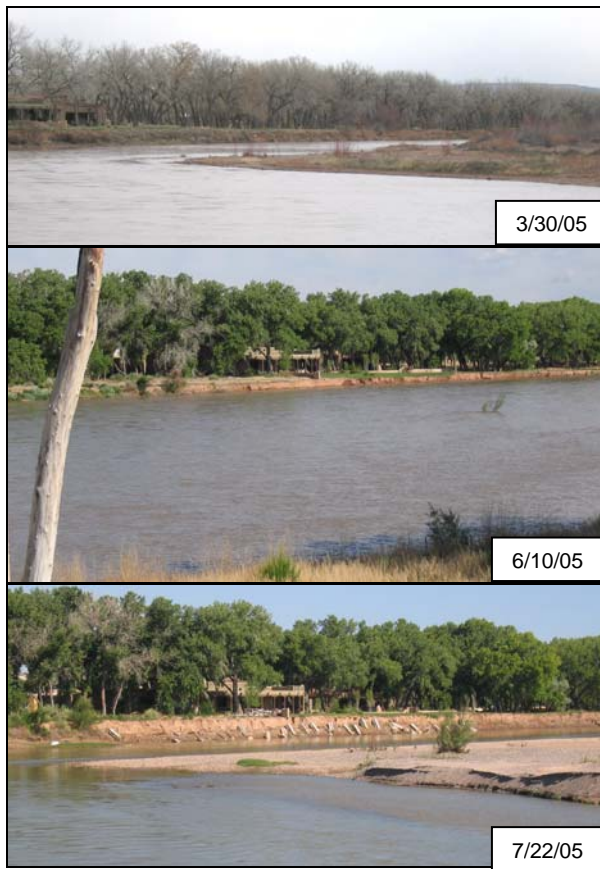
During runoff, as seen at the priority site, the thalweg in the Rio Grande shifted, such that new bank erosion occurred; however, this site erosion began in earnest when the spring runoff peaked in June. At this site, photography during the runoff shows that the thalweg shifted closer to the bank line in June, and consequently, the bankline gained curvature (began eroding). At approximately the bend apex, a local land owner placed large pieces of concrete along the eroding bankline in mid-June (Figure 13).

Figure 13: West bank bend: March to the end of July 2005, showing progression of bank erosion.

Additional monitoring of these sites is recommended, as the reach scale meander pattern is just setting up. The proposed long-term 'fix' at the Bernalillo Priority Site still appears feasible based on the current conditions, however additional erosion protection may be warranted if erosion continues after construction. The bank erosion upstream of the Priority Site is ongoing, but is not expected to significantly influence the priority site project.
