Macondo

T H E G U L F O I L D I S A S T E R

Chief Counsel's Report | 2011

National Commission on the BP Deepwater Horizon Oil Spill and Offshore Drilling

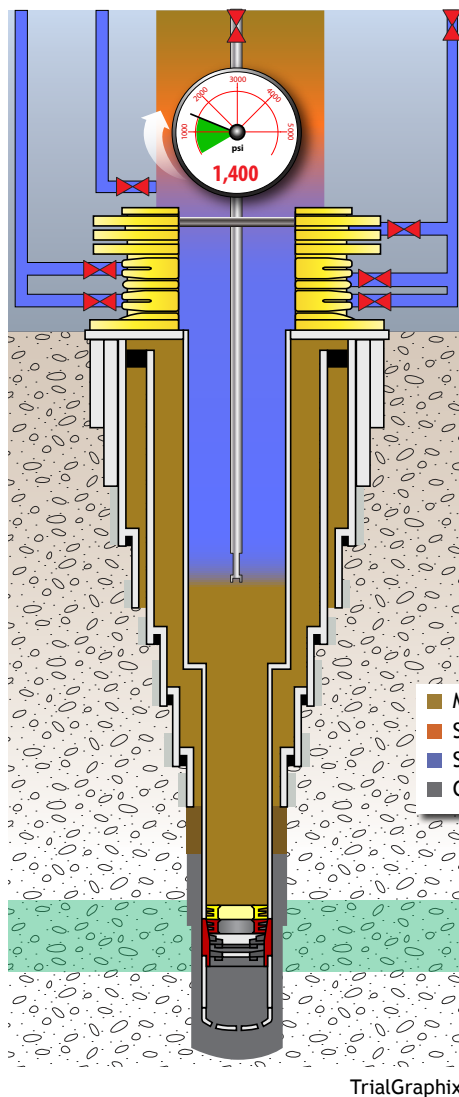
Figure 4.6.7. First test failure.

During the first negative pressure test, the crew repeatedly bled the drill pipe pressure down to 0 psi. However, more fluids bled than expected, and the drill pipe pressure repeatedly increased. After the last bleed, the drill pipe pressure rose from 0 to 1,400 psi, a clear failure.

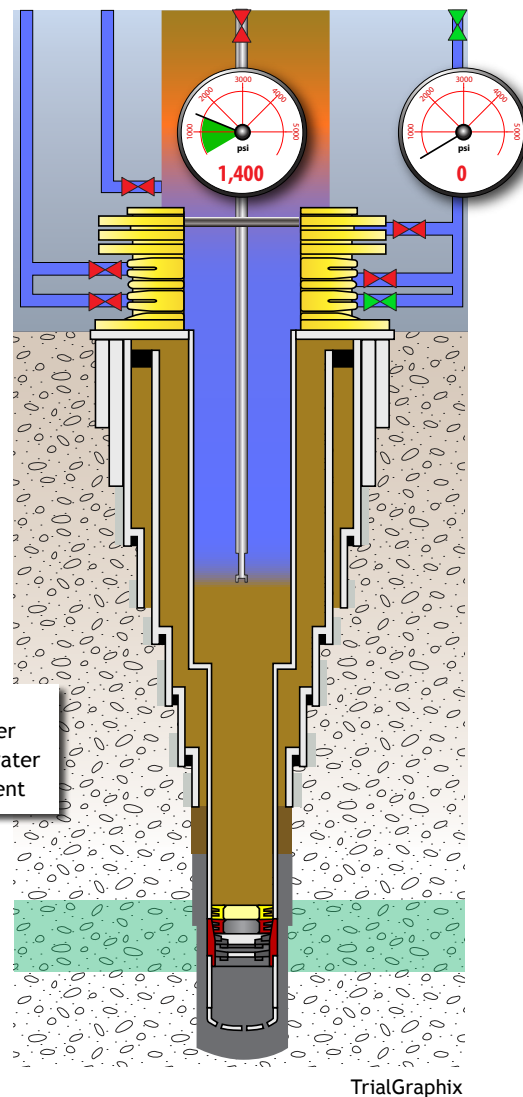
Figure 4.6.8. Second test failure.

During the second negative pressure test, the crew bled off the pressure in the kill line, rather than the drill pipe. The crew observed no excessive flow or pressure buildup on the kill line. The well site leaders and rig crew decided this was a successful test. But they had never accounted for the pressure on the drill pipe, which remained at 1,400 psi throughout the second test.

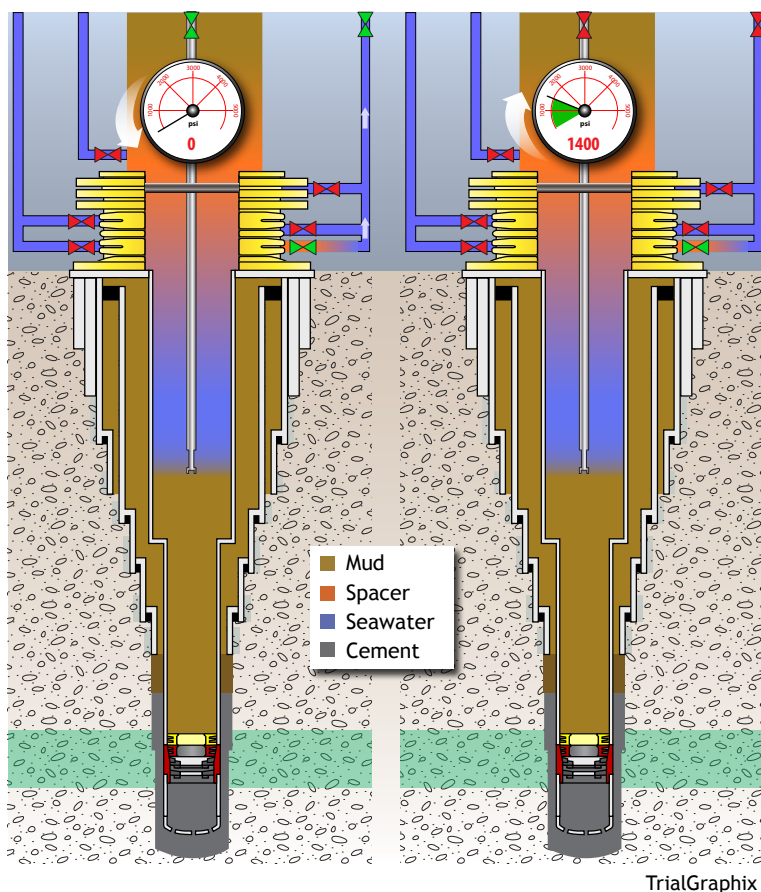
Figure 4.6.16. 5:53 p.m.

The rig crew bled drill pipe pressure down for a third time, this time through the kill line. Witnesses reported that three to 15 barrels were returned as the drill pipe reached 0 psi (left). When the drill pipe was shut, the drill pipe pressure rose to 1,400 psi. According to BP witnesses, the Transocean rig crew attributed this rise to a “bladder effect.” A 15-barrel return would have been excessive, and the rise of drill pipe pressure to 1,400 psi was a clear sign that the negative pressure test had failed (right).

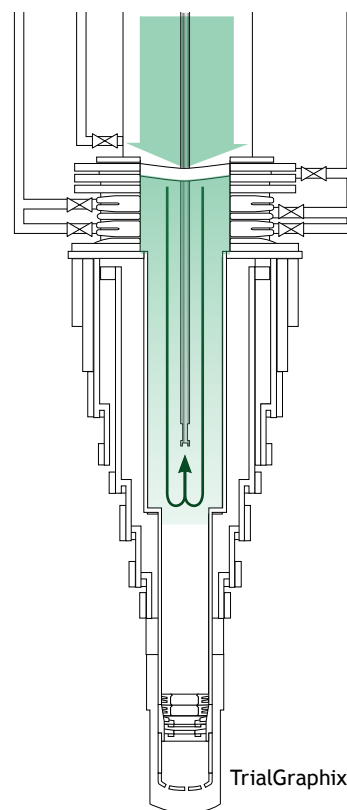
Figure 4.6.17

Bladder Effect. This figure represents the Chief Counsel's team's understanding of the "bladder effect" theory that supposedly explained the elevated pressure on the drill pipe. The "bladder effect" explanation contends that heavy fluids (mud and spacer) displaced to the riser were exerting force on the annular preventer from above, which in turn communicated pressure into the well. The Chief Counsel's team found no evidence to support this theory.

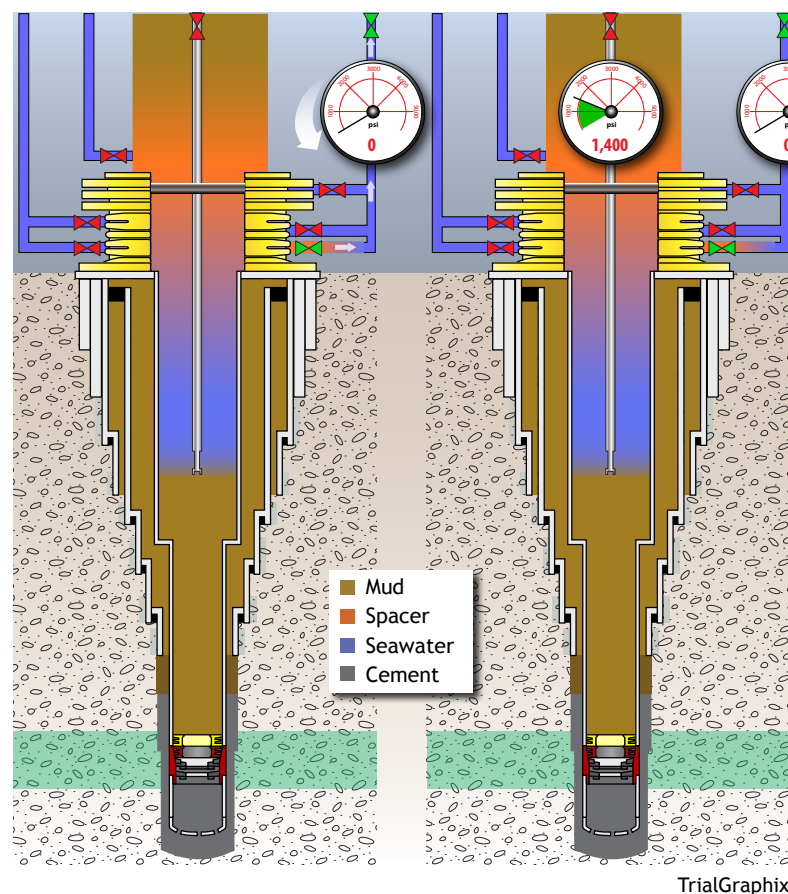
Figure 4.6.18. 6:40 p.m.

The rig crew conducted a negative pressure test on the kill line. The rig crew reduced the pressure on the kill line to 0 psi, bleeding an insignificant amount of water (left). No flow or pressure buildup was observed on the kill line, which on its own would have been a successful negative pressure test. However, the 1,400 psi on the drill pipe remained and was never properly accounted for (right).
