Purpose: RCRA Compliance Evaluation Inspection

Facility: Clean Harbors Buttonwillow, LLC.

EPA ID Number: CAD 980 675 276

Dates of Investigation: October 18 through 22, 2010

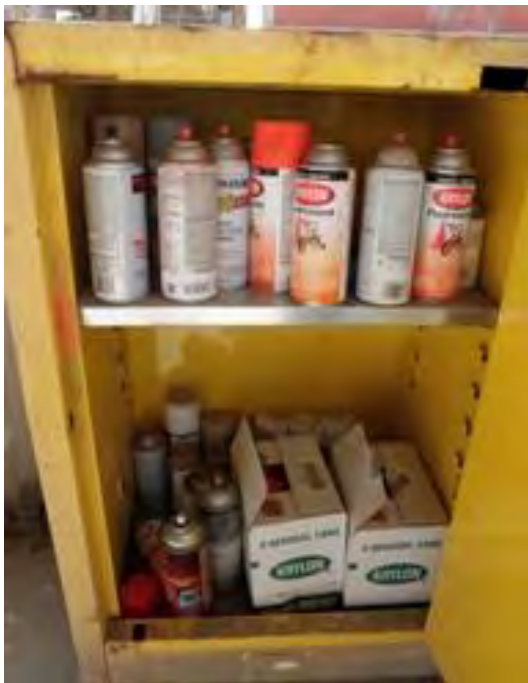
The Drum Unloading Area is located directly north of and adjacent to the Drum Unloading Bay. The Drum Unloading Area is constructed of concrete, and an overhead roof is present. During the CEI, inspectors identified a flammable materials storage cabinet with various aerosol canisters. Inspectors further noted that a nozzle on one of the aerosol cans was broken.

Olympus Stylus 8000, Photo #47; View of a flammable storage cabinet at the STU, holding aerosol products.

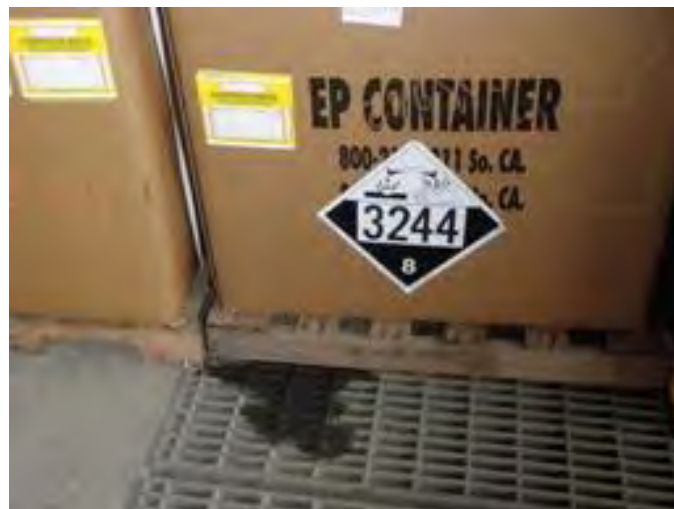
DSHA Area 2 is located in the northwestern portion of the DSHA, north of DSHA Area 1 and west of DSHA Area 3. At the time of the CEI, DSHA Area 2 contained several rows of double stacked, 55-gallon containers and pallets. In this area, inspectors observed a container holding hazardous waste hydrofluoric and sulfuric acids. Liquid was observed on the sump grate beneath this container. However, the liquid was determined to be rainwater by the facility representatives.

Olympus Stylus 8000, Photo # 16; View of the grate beneath the waste hydrofluoric and sulfuric acid container shown in Photo 15. The liquid on the grate was determined to be rainwater.

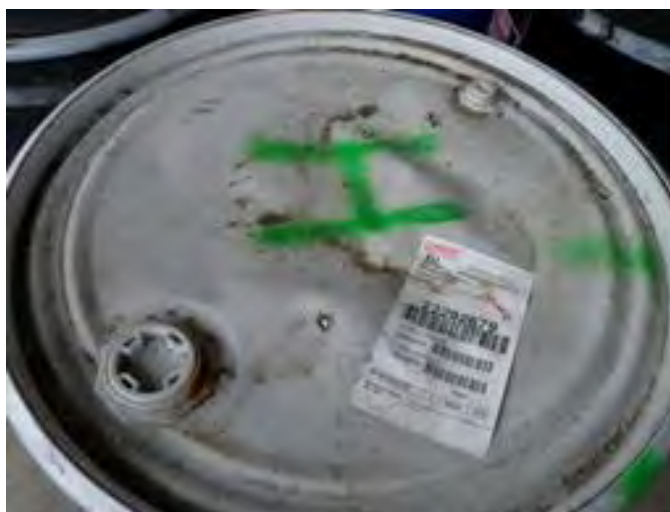
DSHA Area 4 is located east of DSHA Area 2 and north of DSHA Area 3. At the time of the CEI, DSHA Area 4 held two rows of 55-gallon containers, some of which were double stacked (approximately 20 total containers). The only potential concern observed by inspectors was a 55-gallon container of hazardous waste paint chips with a slightly-dented lid. However, the container still appeared to be closed and structurally sound.

Olympus Stylus 8000, Photo # 16; View of a 55-gallon container in DSHA Area 4, holding waste lead paint chips, dated 9/21/10. The lid is dented, but no evidence of leaks or releases.

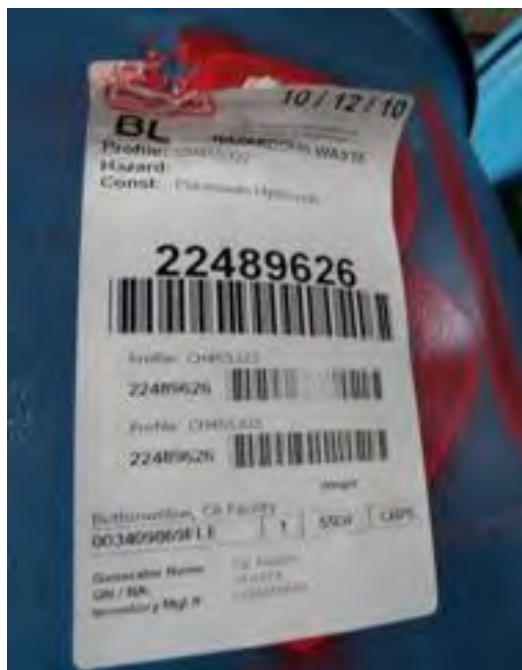
DSHA Area 5 is located east of DSHA Area 3 and west of DSHA Area 6. At the time of the CEI, DSHA Area 5 contained two rows of 55-gallon containers (total of approximately 31 containers). The inspectors identified a label on a container of hazardous waste potassium hydroxide that was affixed, but was starting to peel (photo to the right). Inspectors also observed another container of hazardous waste potassium hydroxide that had an oily liquid on its top. Both of these observations were relayed to Mr. Nielsen as concerns.

Olympus Stylus 8000, Photo # 25; Drum storage area at the STU, Area 5. View of a peeling label on a drum of potassium hydroxide waste, dated 10/12/10.

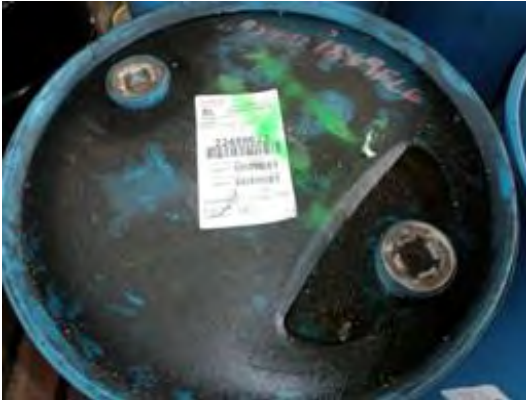
Olympus Stylus 8000, Photo # 26; Drum storage area at the STU, DHS A 5. View of a container of potassium hydroxide waste, received 10/12/10, with oily liquid on top of the lid. No visible leaks or releases.

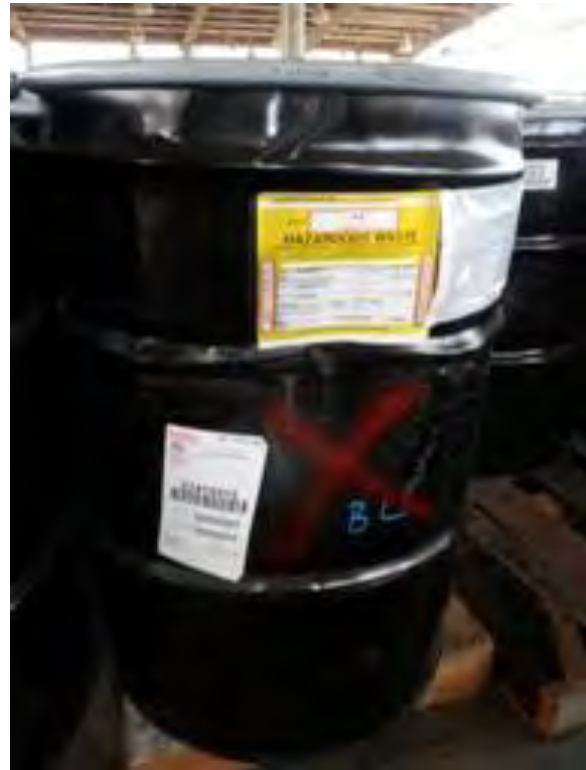
- A dented 55-gallon container of California hazardous waste. However, no visible leaks were observed (refer to Olympus Stylus 8000, Photo #27);

Olympus Stylus 8000, Photo #27; DSHA Staging Area. View of a dented container of a California hazardous waste. No visible leaks or releases.

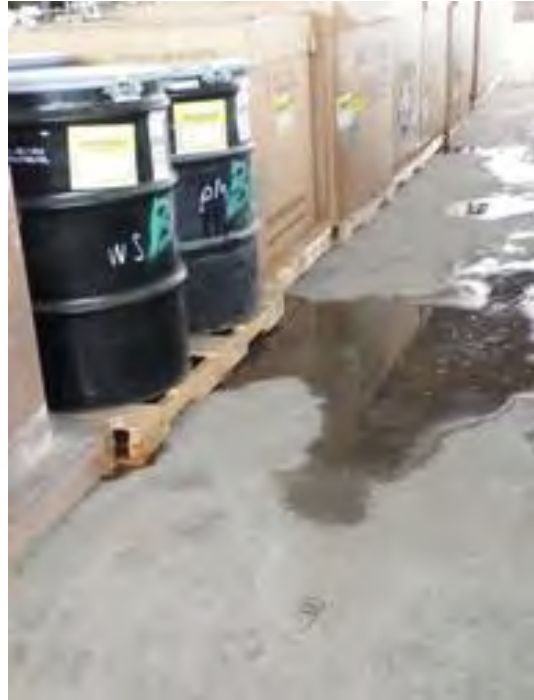
- Liquid on the floor (presumed to be rainwater) (refer to Olympus Stylus 8000, Photo #28);

Olympus Stylus 8000, Photo #28; DHS A Staging Area. View of liquid on the floor. The liquid is presumed to be rainwater.

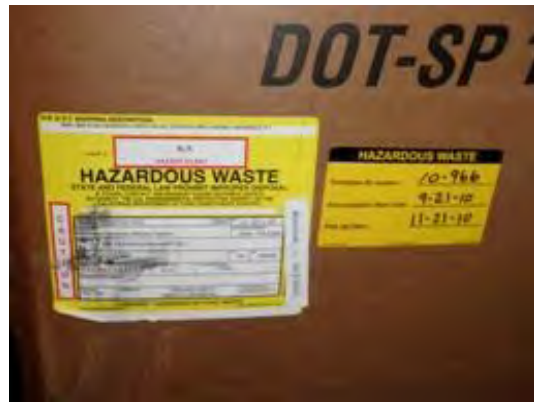
- An incorrect accumulation start date on a California hazardous waste container (refer to Olympus Stylus 8000, Photo #29);

Olympus Stylus 8000, Photo #29; DSHA Staging Area. View of a cardboard container of crushed containers with an incorrect accumulation start date (pickup date) of 11/21/10.

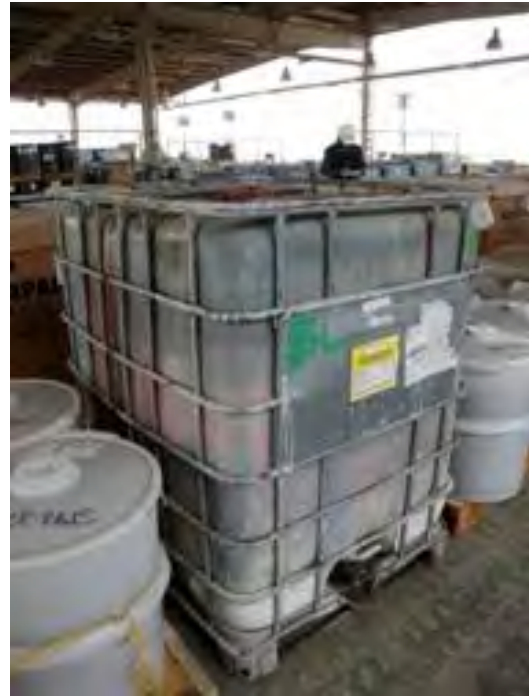
- A plastic and metal container containing California hazardous waste latex paint (refer to Olympus Stylus 8000, Photos #31 and #34 which was in poor condition and had a crack on top);

Olympus Stylus 8000, Photo #34; Close-up view of the top of the plastic container of latex paint shown in Photo #31.

Olympus Stylus 8000, Photo #31; DSHA Staging Area. View of a plastic container of latex paint (California hazardous waste), facing northwest.

The container of latex paint was repaired during the CEI by Clean Harbors personnel (refer to Canon EOS Rebel XSi, Photo #2);

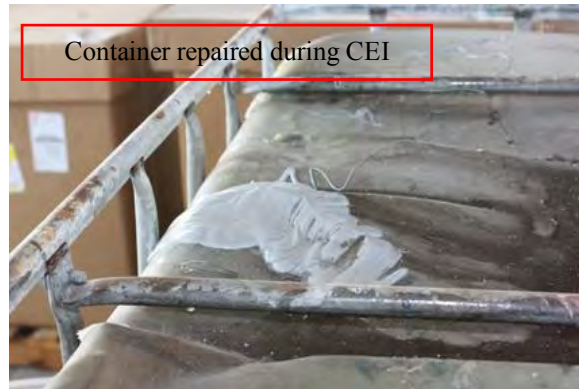
Canon EOS Rebel XSi, Photo #2 Return to compliance verification – container of latex paint in the STU repaired.

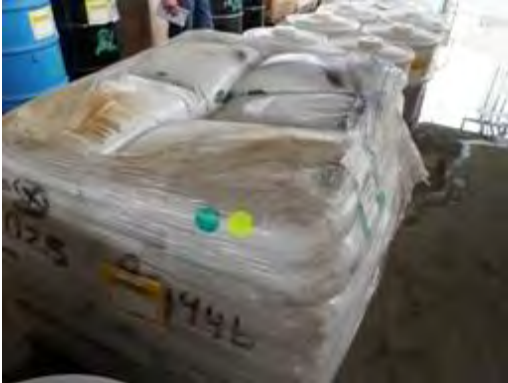
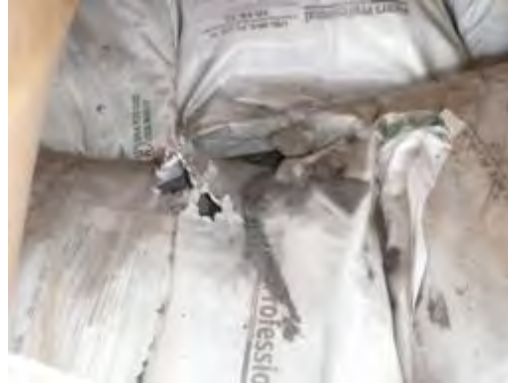
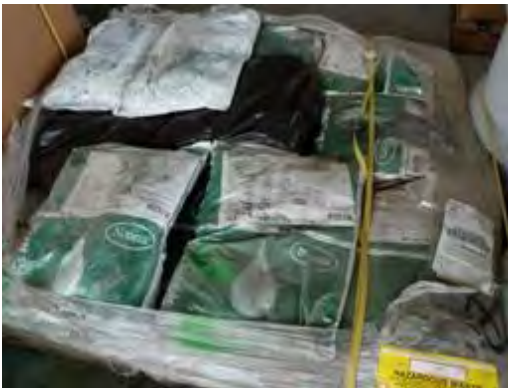
- Two pallets which contained California hazardous waste fertilizer. Both were shrink-wrapped and one of the pallets was loosely covered with cardboard (refer to Olympus Stylus 8000, Photo #35 below). The bags were observed to be releasing small amounts of fertilizer to the surrounding area (refer to Olympus Stylus 8000, Photo #36 and #40 below);

Olympus Stylus 8000, Photo #35; DSHA Staging Area. Shrink-wrapped bags of waste fertilizer.

Olympus Stylus 8000, Photo #36: DSHA at the STU, area near the control room. Shrink-wrapped bags of waste fertilizer. Cardboard was loosely covering the top, and bags underneath are torn. A release of a small amount of fertilizer (California hazardous waste) was observed.

Olympus Stylus 8000, Photo #40; Another view of the waste fertilizer bags (California hazardous waste) shown in Photo 36. Minor rips are present in the bags and the top of pallet is not covered or wrapped. Photo to the left.

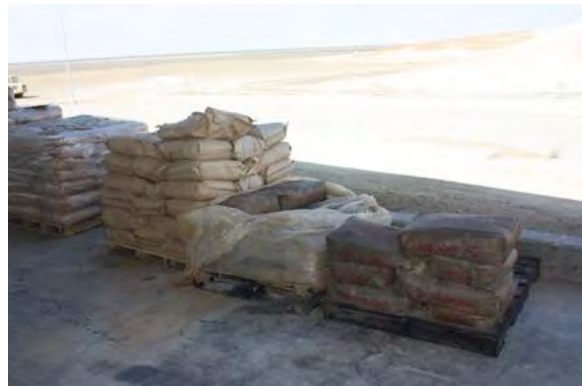
Canon EOS Rebel XSi, Photo #4; Return to compliance verification – cleanup of ferrous sulfate spill/leak in STU.

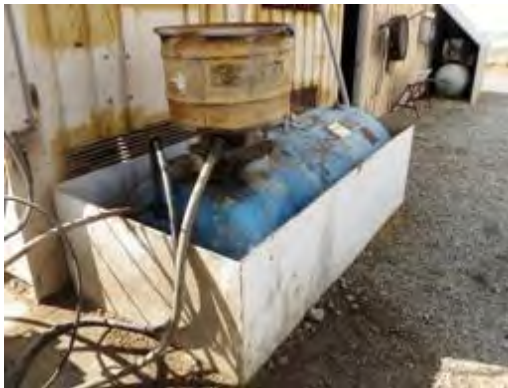
The Used Oil Storage Tank Area is located west of the Heavy Equipment Storage Area and the Maintenance Area. The used oil AST is located within secondary containment, the base of which was covered in liquid (refer to Olympus Stylus 8000, Photo #50 below). At the time of the CEI, the accumulation start date noted on the used oil storage tank label indicated that the 90 day accumulation date would be reached on July 22, 2010 (refer to Olympus Stylus 8000, Photo #51 below). Staining was identified in the area surrounding the used oil storage tank.

Olympus Stylus 8000, Photo #50; View of the used oil storage tank at the maintenance building.

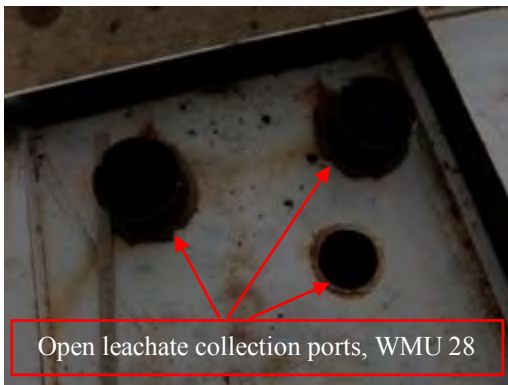
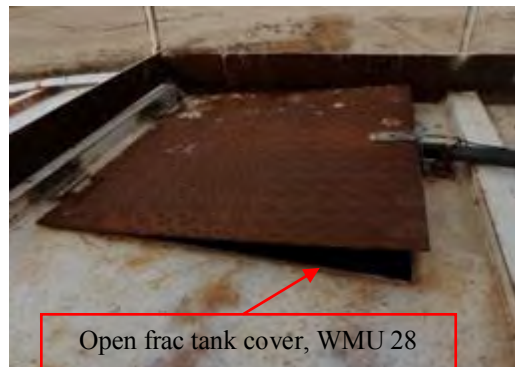
At the time of the CEI, the frac tank was structurally sound, labeled as hazardous waste and dated 9/14/2010. The inspectors observed that the ports on top of the frac tank were not closed. Photos of these open ports can be viewed below.

Olympus Stylus 8000, Photo #74; View of top of the leachate collection frac tank (Frac Tank 3) at WMU 28. Note the open ports.

Olympus Stylus 8000, Photo #75; View of top of the leachate collection frac tank (Frac Tank 3) at WMU 28. Note the open cover.

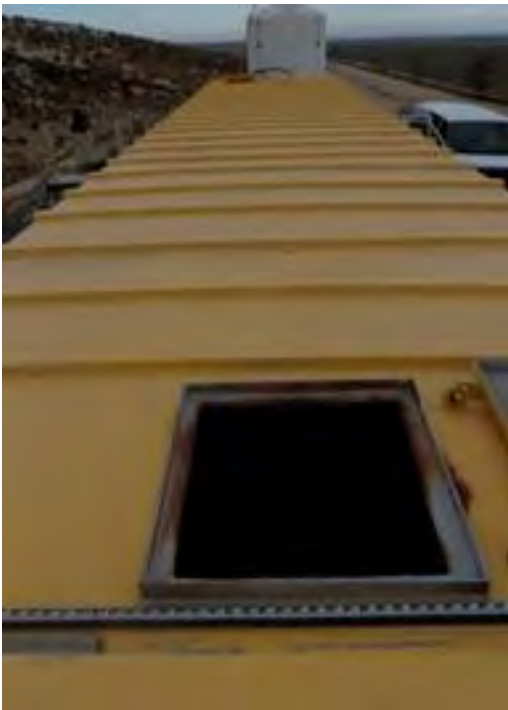
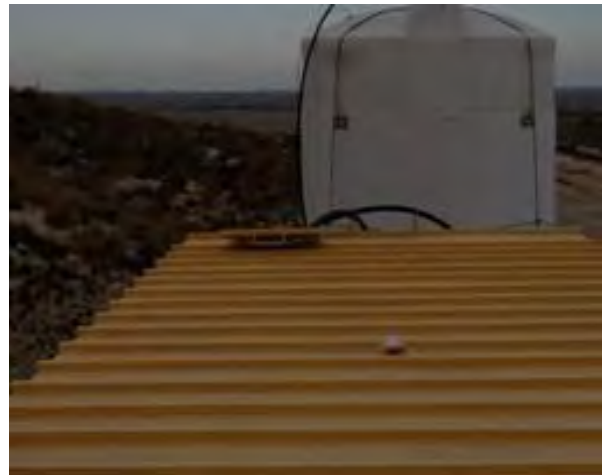
Olympus Stylus 8000, Photo #97; View of the leachate collection frac tank (Tank 80) at WMU 35, Cell #1. Note the top of the container is open.

Olympus Stylus 8000, Photo #98; View of the leachate collection frac tank (Tank 80) at WMU 35, Cell #1, shown in Photo 96. Note the top of the container is open.

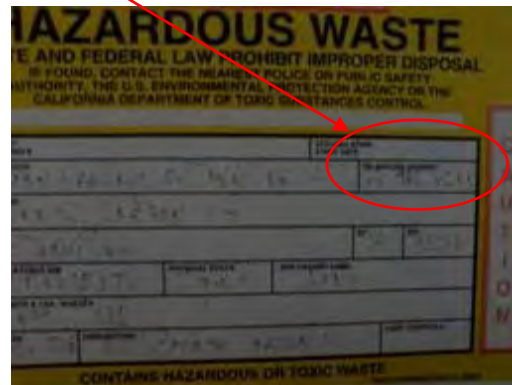
Olympus Stylus 8000, Photo #106; Label on the red, leachate collection frac tank at WMU 35, Cell #3. Note that the accumulation start date is not clearly visible.

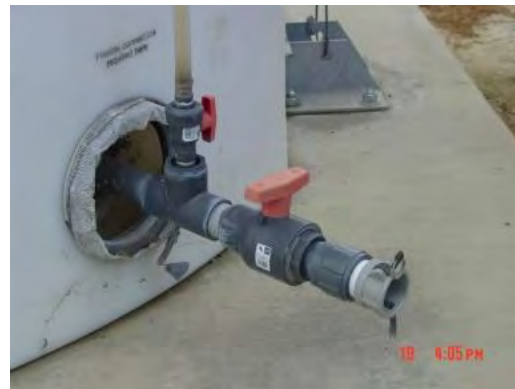
Sony DSC-S75, Photo #12; View of the piping and valve for draining the 5,000-gallon, plastic, leachate collection tank at WMU 35, Cell #3, facing northwest. Note: no secondary containment or cap/plug.

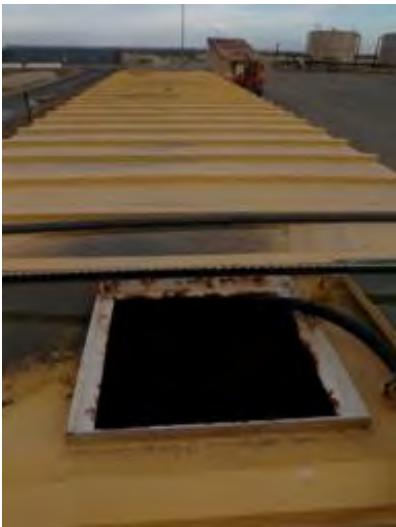
Olympus Stylus 8000, Photo #93; Leachate collection frac tank at WMU 34, near STU. View of the top of the frac tank (open), facing east.

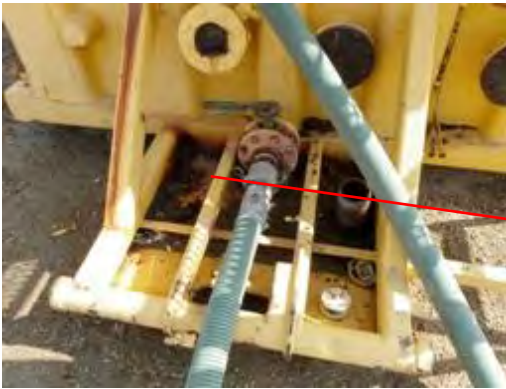
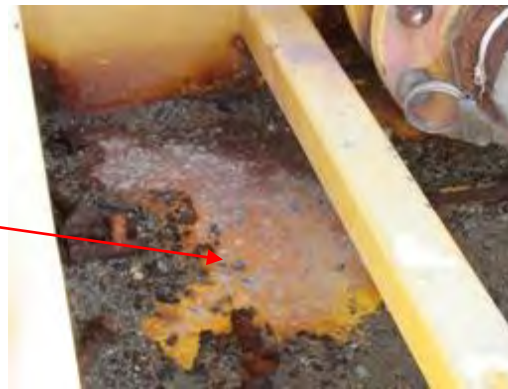
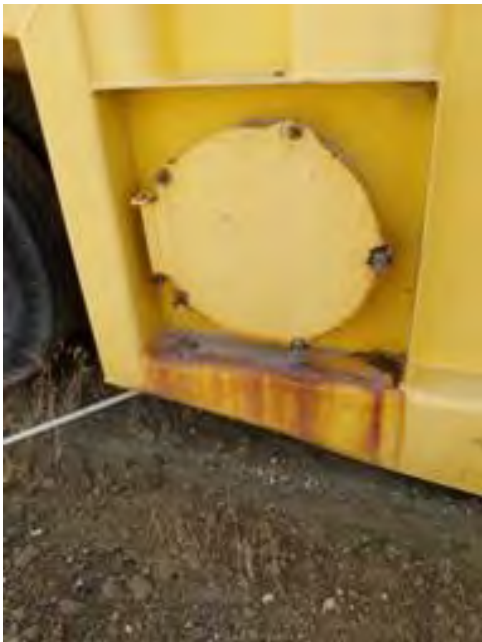
Olympus Stylus 8000, Photo #56; View of the leachate collection frac tank at WMU 34, facing east. Note the stains around the valve area and on the ground.

Olympus Stylus 8000, Photo #57; Close-up view of the ground near the valve of the leachate collection frac tank at WMU 34. Note the visible staining.

Olympus Stylus 8000, Photo #59; Close-up view of the valve port on the lower northeast corner of the leachate collection frac tank at WMU 34. Note the visible staining below the port.

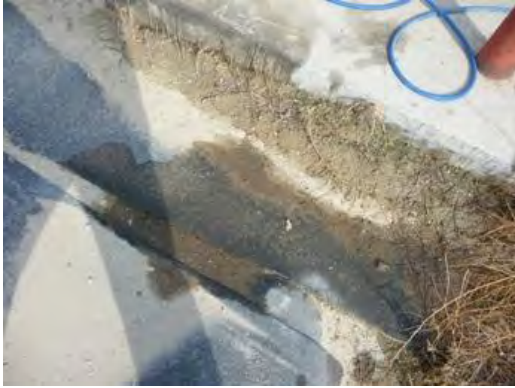
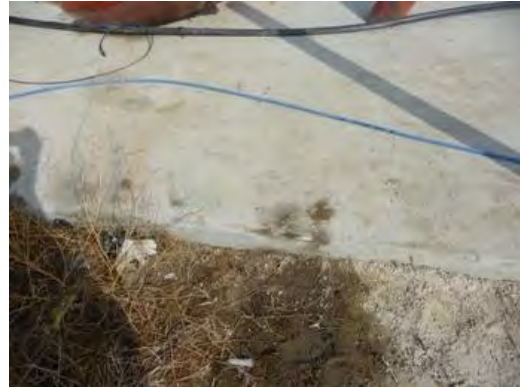
Panasonic Lumix DMC-TZ5, Photo #19; F039 leachate drippage observed on the ground at WMU 34.

Panasonic Lumix DMC-TZ5, Photo #28; WMU 34; F039 leachate dripping on the ground.

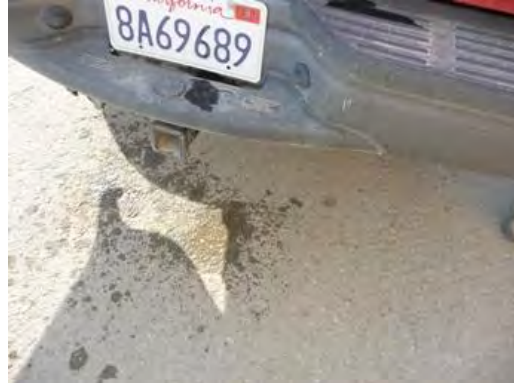
Panasonic Lumix DMC-TZ5, Photo #45; Leachate drippage on the ground from sample transfer into containers.
