Fontenelle Dam - March 2012

River Outlet Works & Powerplant

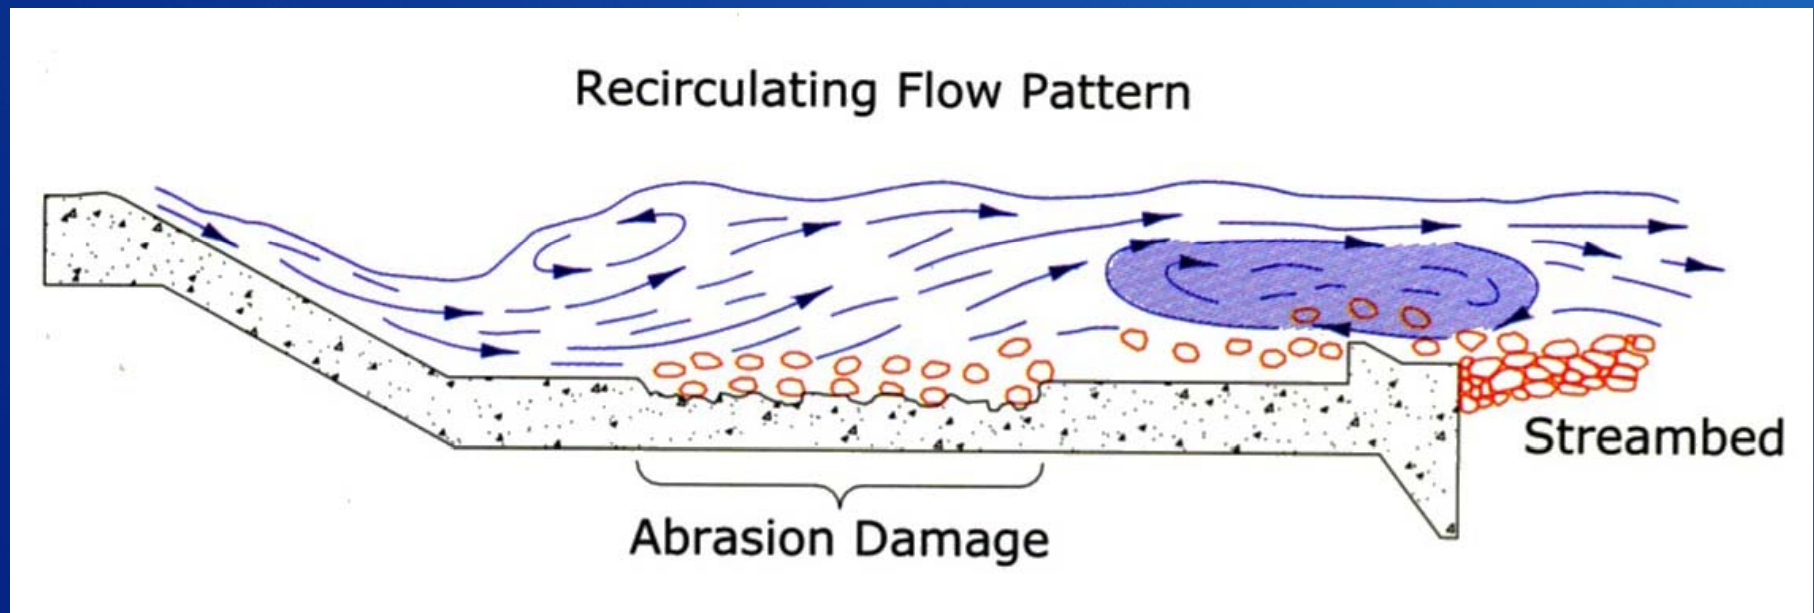
Type II stilling basins, such as the Fontenelle ROW stilling basin, have abrasion problems because of a recirculating flow pattern.

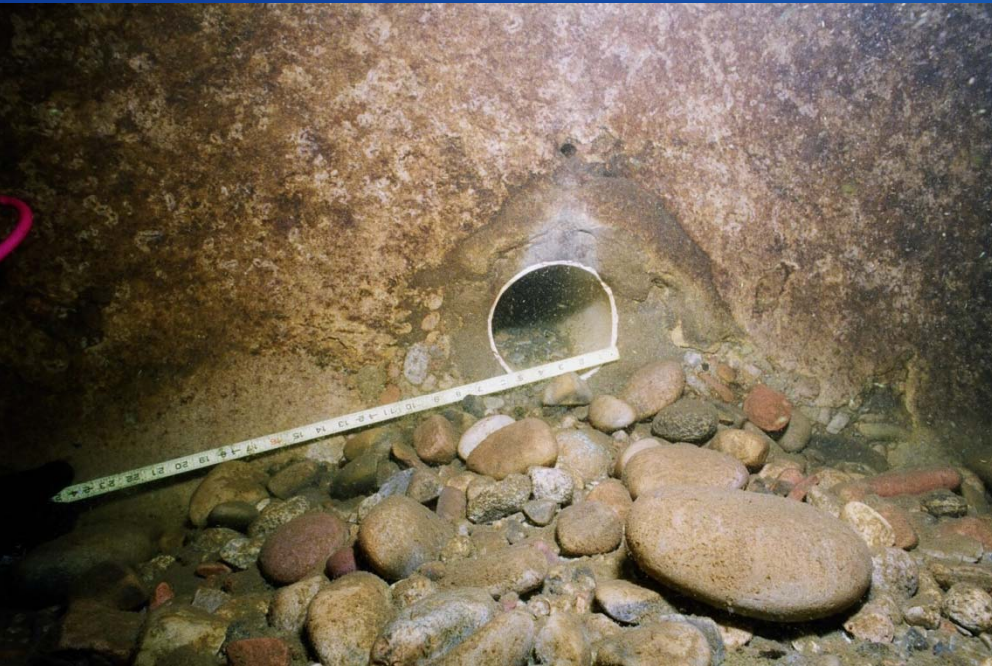
Gravel and cobble are trapped in the basin between the chute blocks and the dentates (2007 dive exam)

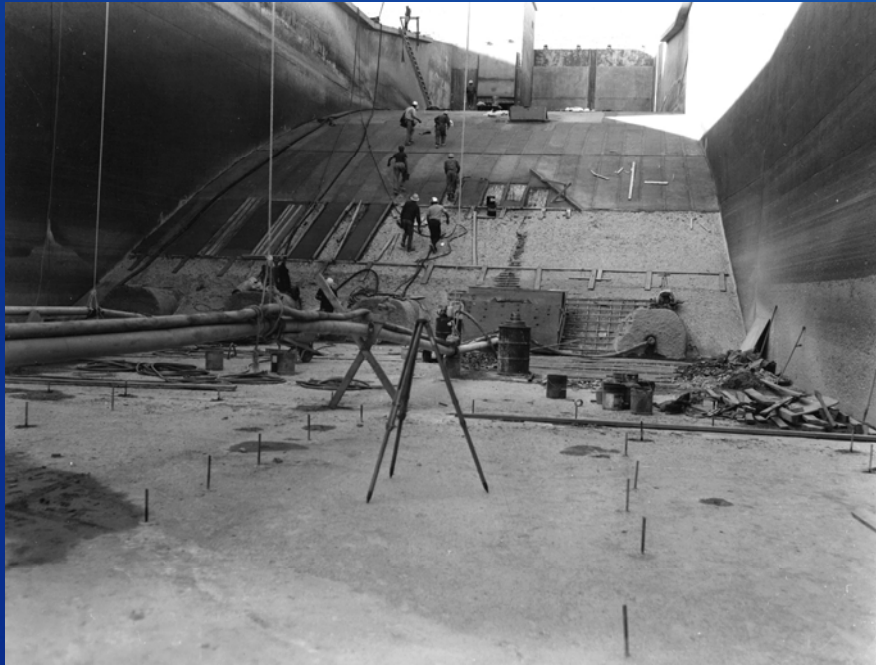
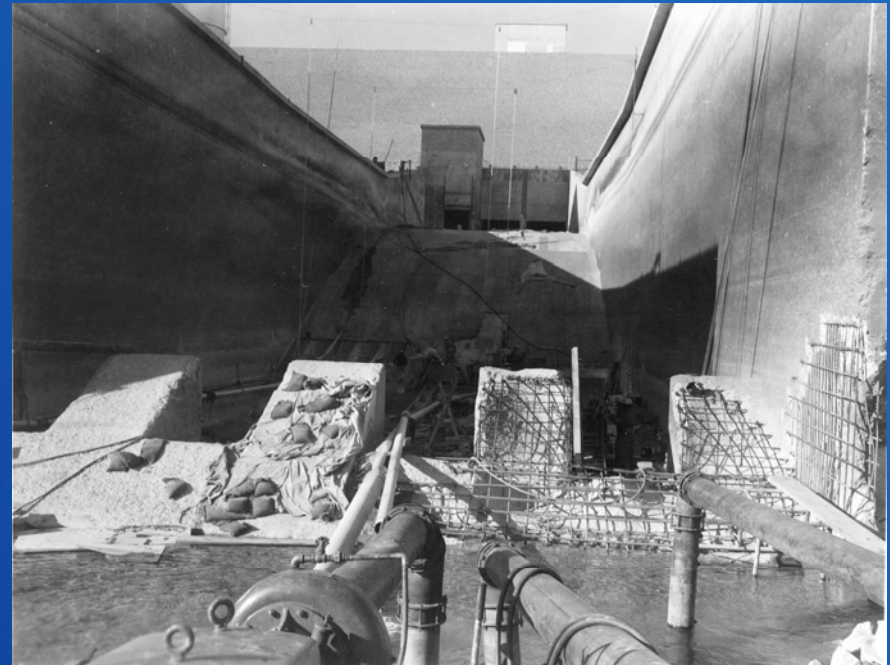
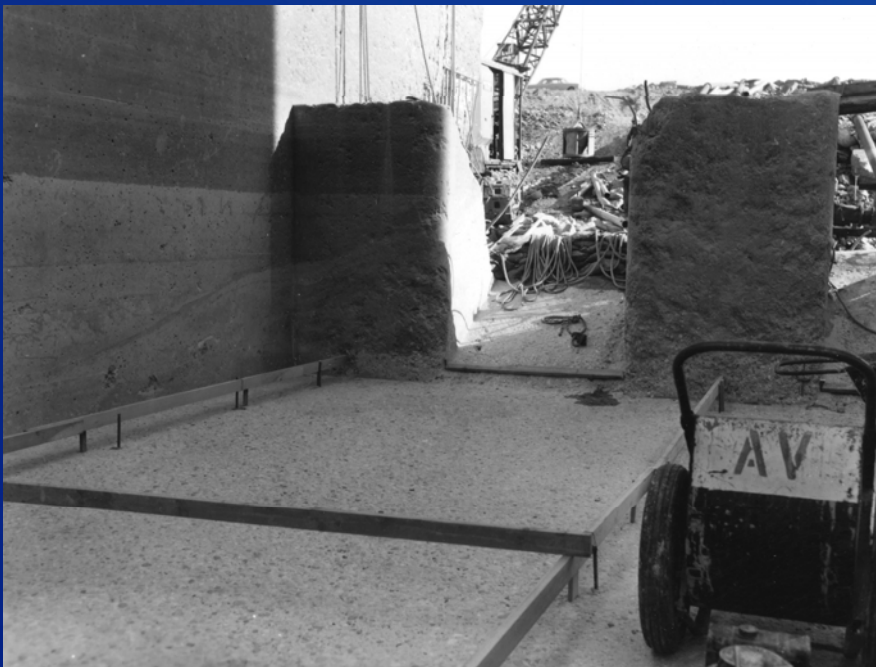
**And the recirculating flow
pattern with time results
in abrasion damage to the
concrete.
(1967)**

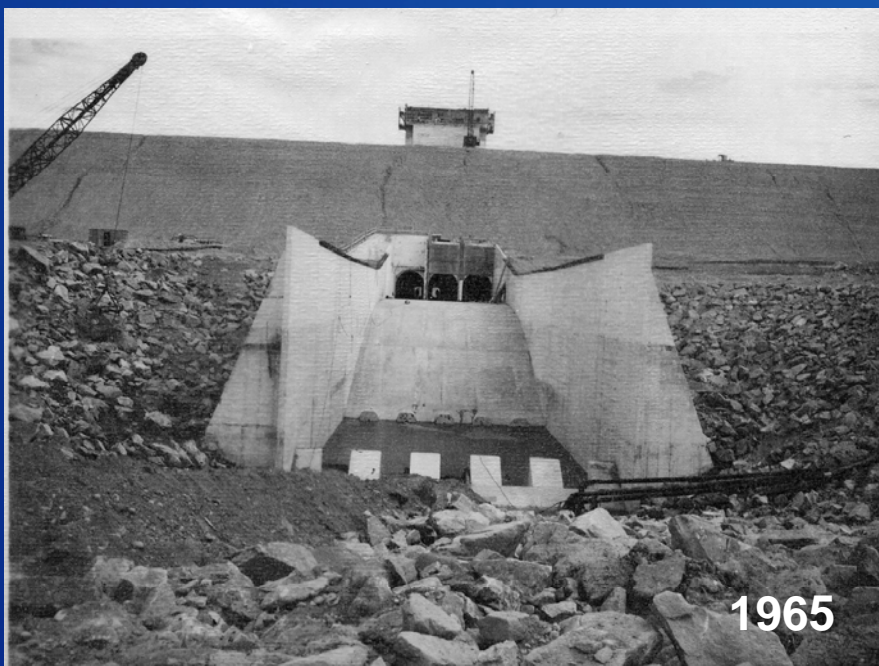
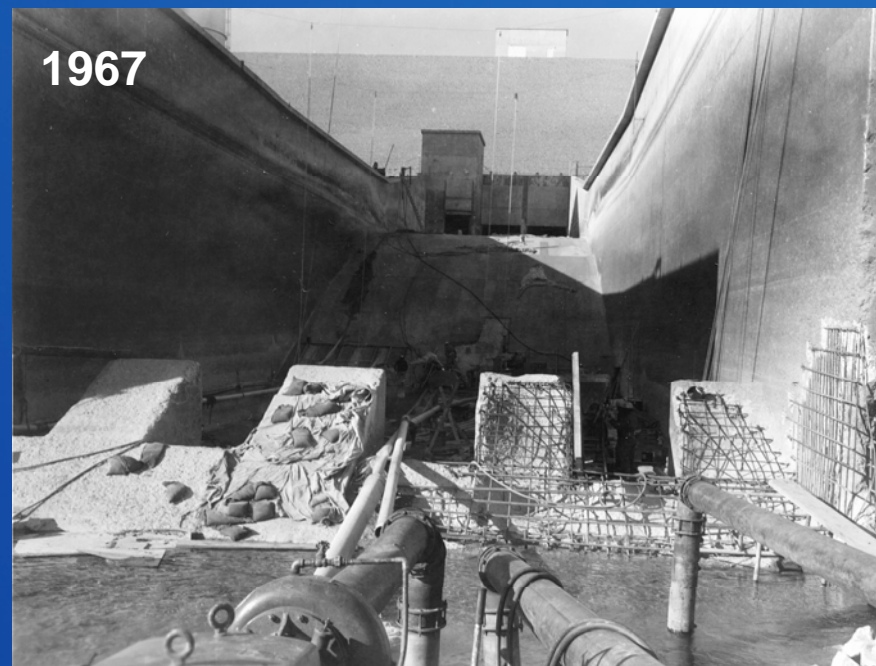
The ROW structure was completed in 1965;
extensive ROW repairs were needed in 1967.

Following the 1967 repair, abrasion damage was reported
in 1972 and repairs made in 1981;

Following the 1981 repair, abrasion damaged was reported
as early as 1989.

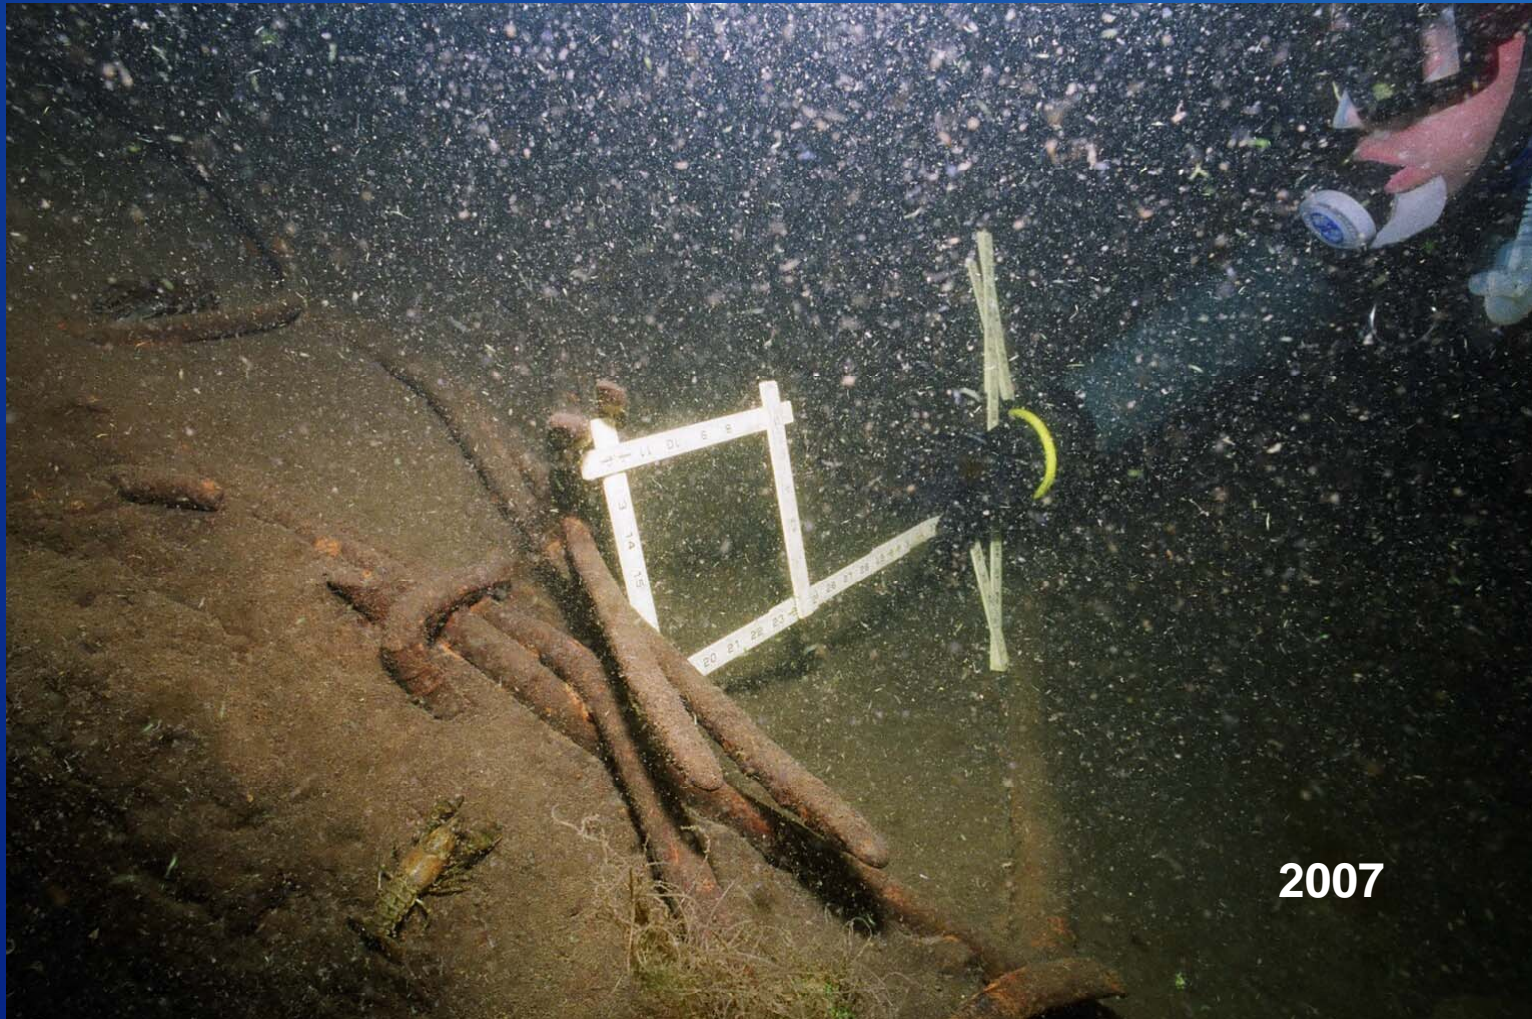
2007

Since 1998 the BOR has performed frequent dive exams to monitor the progression of the abrasion damage. No repairs have been made.

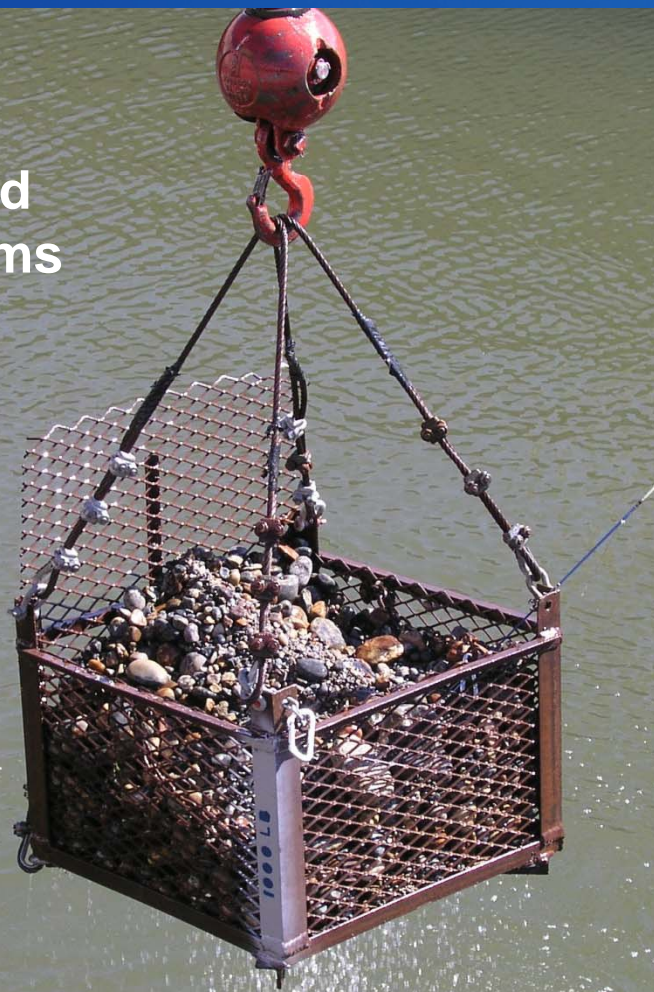
Removed cobble and gravel with dive teams and underwater dredges.

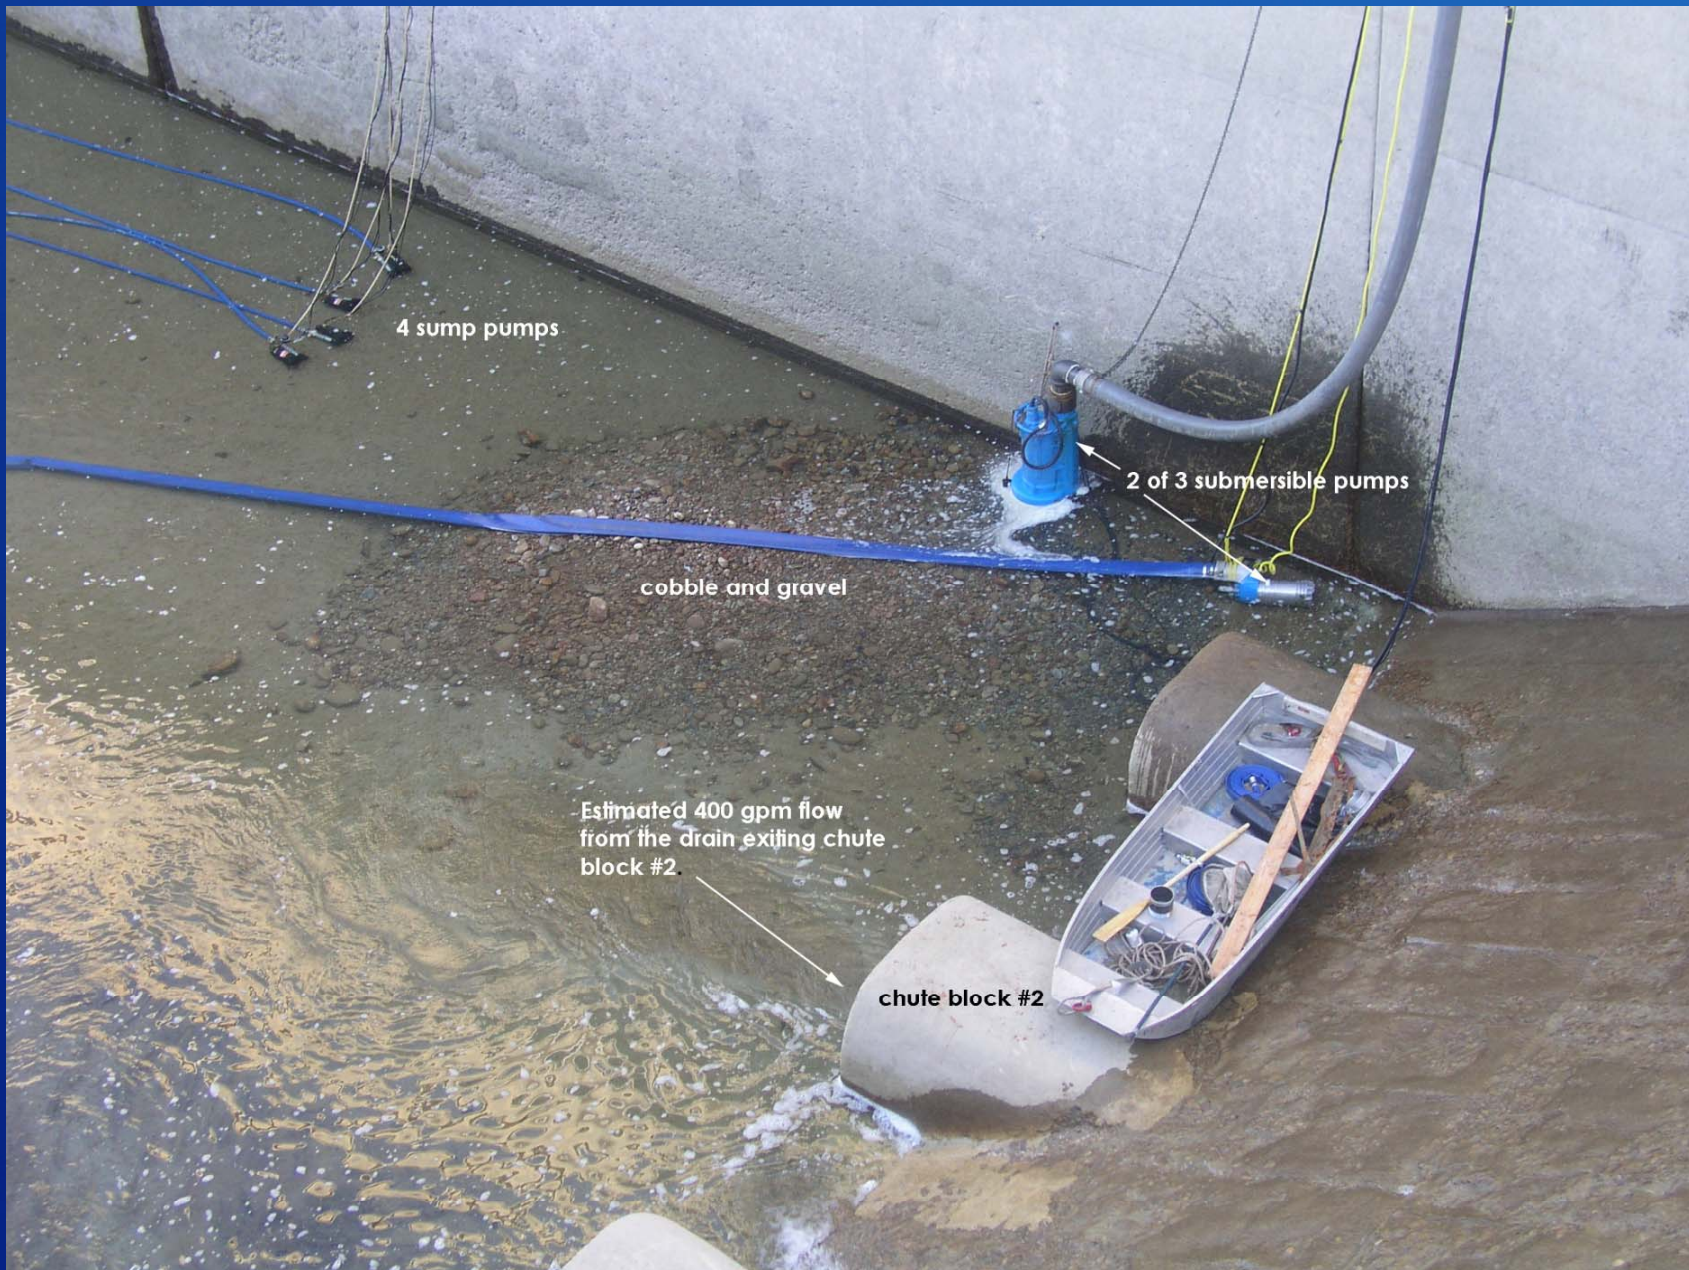
4 sump pumps

2 of 3 submersible pumps

cobble and gravel

Estimated 400 gpm flow
from the drain exiting chute
block #2

chute block #2
