UNITED STATES ENVIRONMENTAL PROTECTION AGENCY

Subject: Transmittal of "Port of Stockton Municipal Separate Storm Sewer Audit Report"

**Port of Stockton - Municipal Separate Storm Sewer System (MS4)
(Order No. R5-2004-0136)
Photograph Log**

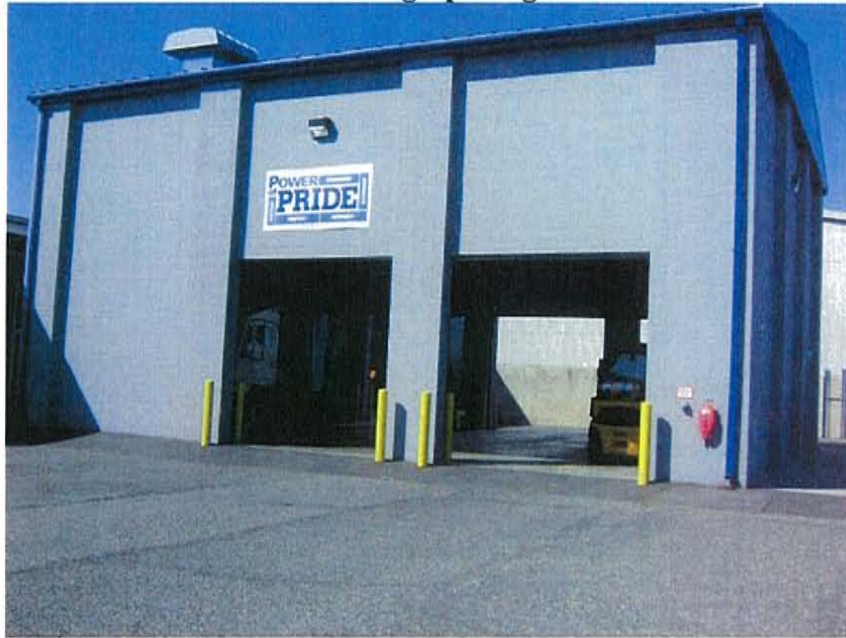
Photograph 11: View of Lowe's Distribution Center equipment maintenance shop.

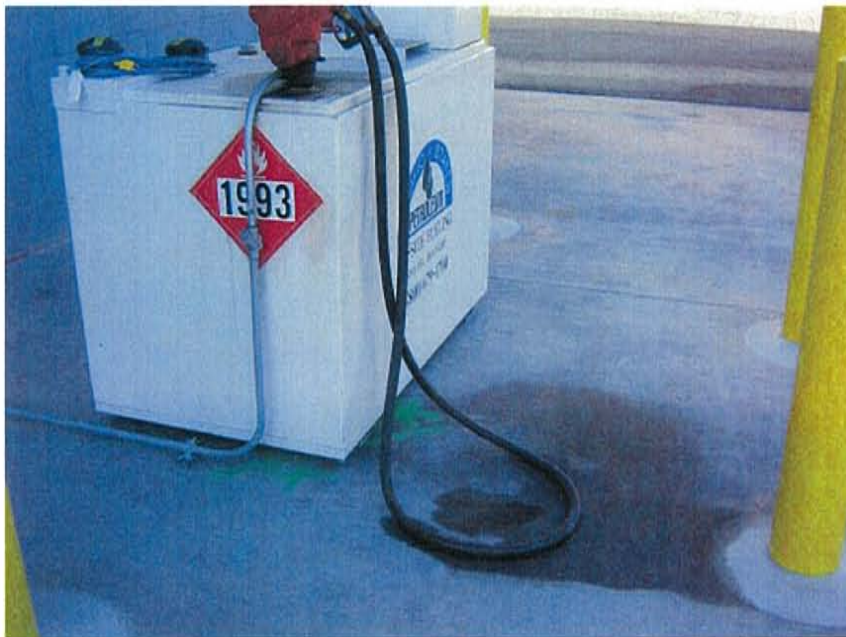
Photograph 12: View of Lowe's Distribution Center fuel storage tank located adjacent to the maintenance shop.
