**Alamosa River Watershed
Restoration Master Plan**
MWH in association with Agro
Engineering, Lidstone and
Associates, Inc. and SWCA

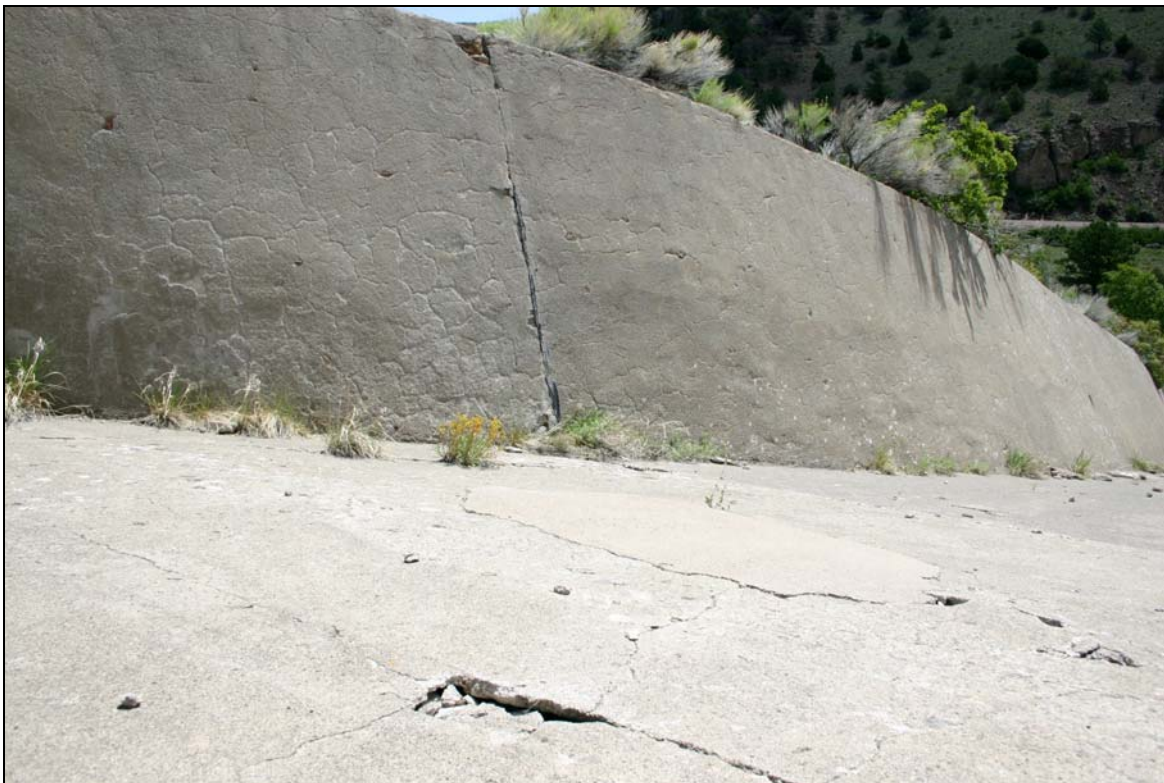
Figure 2-84. Condition of Terrace Reservoir Spillway Concrete and Masonry Approach Walls

The principal spillway is a masonry block chute structure with a concrete ogee crest control 99.5 feet in width, located on a saddle in the east abutment. The spillway is located in glacial end moraine deposits reportedly deposited on top of latite tuft. The condition of the concrete ogee crest is marginally acceptable. The masonry chute structure has been overlaid with concrete. The condition of the overlay concrete is extremely poor with the concrete deteriorating along the length of the chute and in several areas the spillway chute has been undermined. Soundings done on the overlay with a hammer revealed a “drummy sound” when the concrete was struck with the hammer, indicating the overlay is delaminating and/or the concrete is deteriorating. The overall condition of the spillway is poor and it should be replaced or extensively rehabilitated. There is no emergency spillway for the reservoir. **Figure 2–82** and **Figure 2–83** show the reservoir spillway. **Figure 2–84** shows the poor condition of the concrete and masonry.

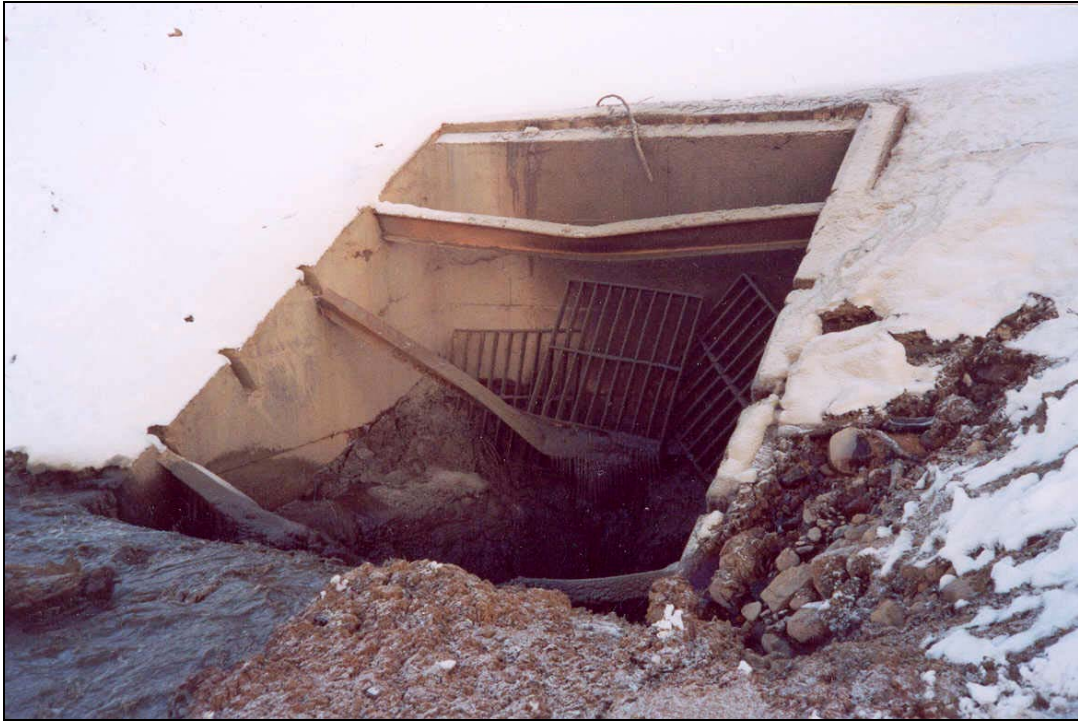
Figure 2-86. Terrace Reservoir Inlet Structure and Collapsed Trash Racks

The inlet structure of the outlet is an ungated sloping reinforced concrete structure positioned over the top of the inlet shaft. The inlet shaft is about 15 feet in height and has an approximate square cross section. The inlet structure was constructed in 1959 with the trash racks failing and requiring replacement twice. The trash racks failed in 1971, were redesigned by USBR and replaced. In 2003 the trash racks once again failed during the draining of the reservoir, were redesigned by Davis Engineering Service and subsequently replaced in early 2004. The condition of the inlet structure is relatively good. **Figure 2–86** shows the inlet structure and damaged trash racks that were replaced. **Figure 2–87** shows the inlet structure with the new trash racks.

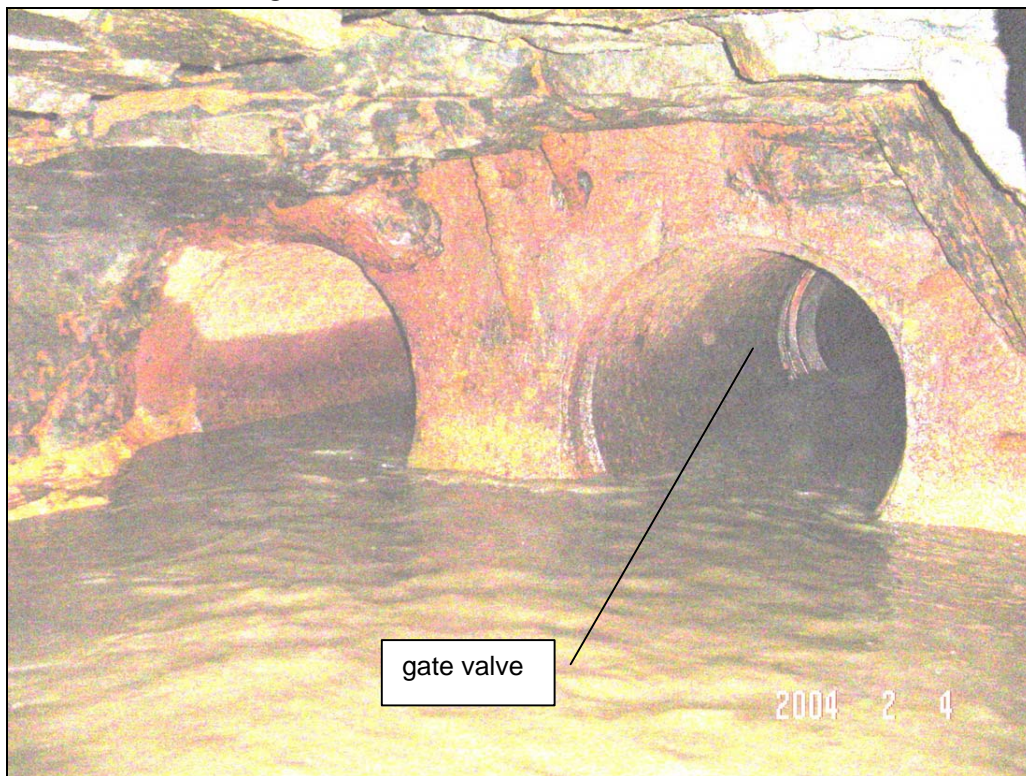
Figure 2-88. Gate Valve Chamber in Tunnel

A pair of 48–inch diameter high–pressure double disc gate valves mounted side by side within the valve chamber control flow through the tunnel (see **Figure 2–88**). Additionally, a single 42–inch diameter Howell–Bunger valve is mounted at the downstream end of the tunnel (see **Figure 2–89**). The right gate valve (facing downstream) discharges directly to the unlined tunnel section downstream of the valve chamber. The left gate valve discharges into a 48–inch diameter steel conduit, which is constructed along the left side of the downstream tunnel section. The 48–inch conduit terminates at the Howell–Bunger valve and is the primary discharge mechanism for the reservoir. The combined discharge of the outlet with all of the gates and the valve open is about 1,160 cfs. The capacity through the left gate and Howell–Bunger valve alone is about 510 cfs.

The mechanical components of the outlet works were state of the practice when the dam was constructed in 1912. Major repairs to the 48–inch double disc gate valves have been required on eight occasions to allow for the continued safe operation of the reservoir. The primary cause of damage to the gate valves has been the combined effect of the sediment load being passed through the gates and the use of the gates for throttling discharge flows. A listing of the year and which valve was repaired is included in **Table 2-23**.

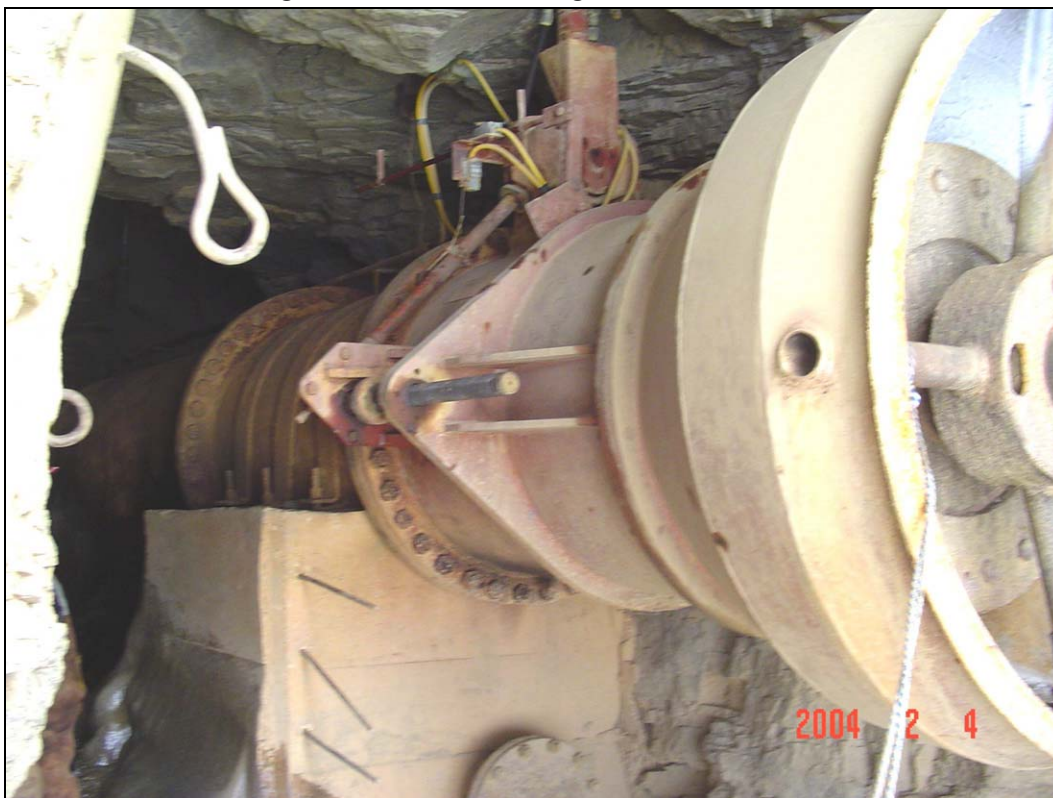
Figure 2-89. Howell-Bunger Valve at Outlet

Considerable corrosion has been observed on the 48–inch diameter steel outlet pipe and on the 42–inch diameter Howell–Bunger valve. The 48–inch steel conduit was designed as having a wall thickness of 0.313 inches. The design did not require a protective paint coating on the conduit because an allowance of 0.063 inches of corrosion was included in the design. Because of the observed corrosion on the valve and conduit and the low pH of the reservoir, the State Engineer, in 1993, requested that the Terrace Irrigation Company hire a metallurgist to evaluate the condition of the steel conduit and the Howell–Bunger valve. To date this study has not been done, or the State Engineer has not seen the results. For the long–term assessment of the outlet it was suggested that this be done.

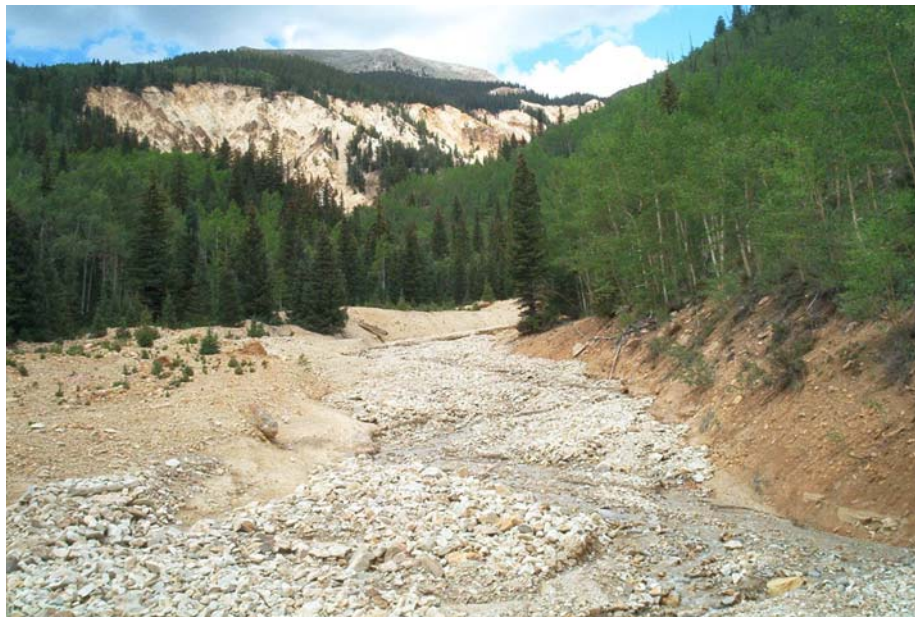
Numerous landslides and debris flows, typical of a steep and geologically active area, have also contributed to the Alamosa River sediment loading. Alum Creek and other tributaries in the upper watershed are capable of depositing large amounts of pyritic soils in the river during debris flows triggered by intense thunderstorms (CGS, 1995). **Figure 2–93** shows the high sediment load deposited by a tributary channel. The large amount of material present during the July 2004 site visit at the Iron, Alum, Bitter, and Burnt Creek confluences indicates that these tributaries contribute significant amounts of sediment.

Figure 2-93. Photo of Alum Creek Channel Showing High Sediment Load

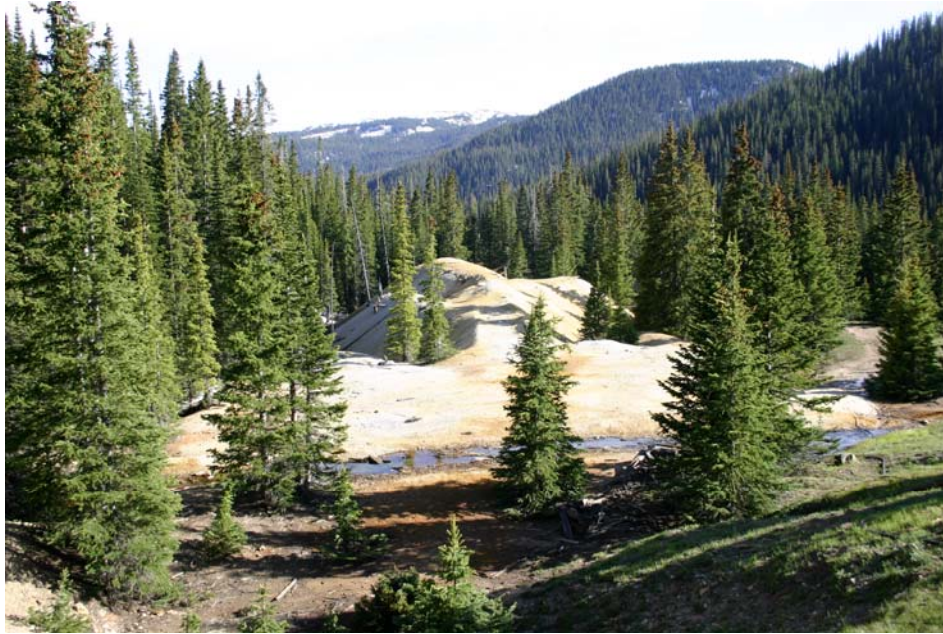
In addition to the highly erodible material present across much of the upper Alamosa River watershed, there are also numerous abandoned mine openings and spoil piles, which may contribute to the sediment loading. CGS inventoried 219 mine openings and 130 mine dumps in the Alamosa River Basin in 1993 and 1994. The majority of these mines are in the upper watershed and have tailings piles containing less than 1,000 cubic yards of material. The Pass Me By Mine is located in the Iron Creek drainage and has the second largest spoils pile (10,000 cy), exceeded only by the spoil pile at the Summitville Mine. Following a mine inventory in 1993, the CGS concluded that “the mine dumps are generally stable and add little to the sediment load, especially when compared to the erosion that affects outcrops of weathered, altered bedrock.” (CGS, 1995). **Figure 2-95** shows trees growing through the Pass-Me-By spoils pile indicating the pile is relatively stable.

Figure 2-95. Photo of the Pass Me By Mine Spoils Pile

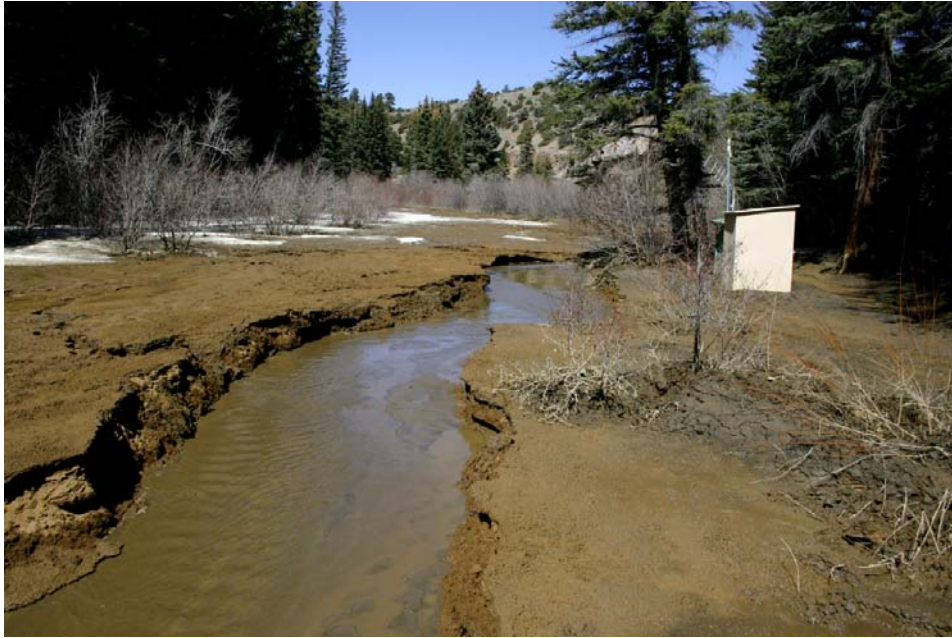
Terrace Reservoir was also drained in the winter of 2003/2004. During the draining, the river cut a deep channel through the fine sediments that have collected in the reservoir (see **Figure 2-9** in **Section 2.2**) and carried the sediments downstream into the lower Alamosa River. Approximately three feet of sediment were deposited in upper reaches of the lower Alamosa River, approximately two feet were deposited upstream of Gunbarrel Road, and approximately one foot was deposited downstream of Capulin. **Figure 2-96** shows a photo of the sediment deposition near the USGS gage downstream of Terrace Reservoir. There were no sediment samples taken here.

Figure 2-96. Photo of Terrace Sediments Deposited Near USGS Gage in 2003/2004

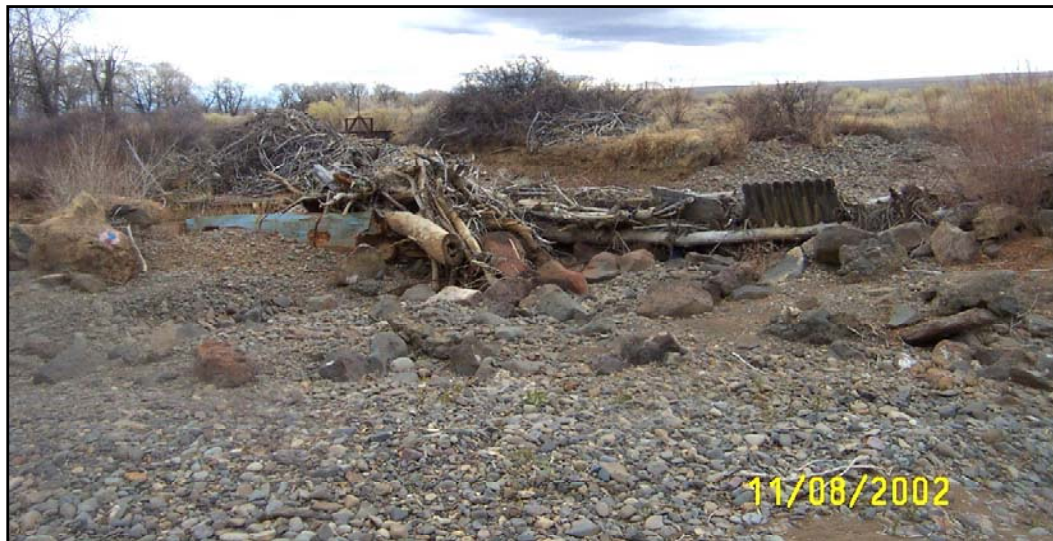
Figure 2-105. Poor River Condition– San Jose Ditch No. 1

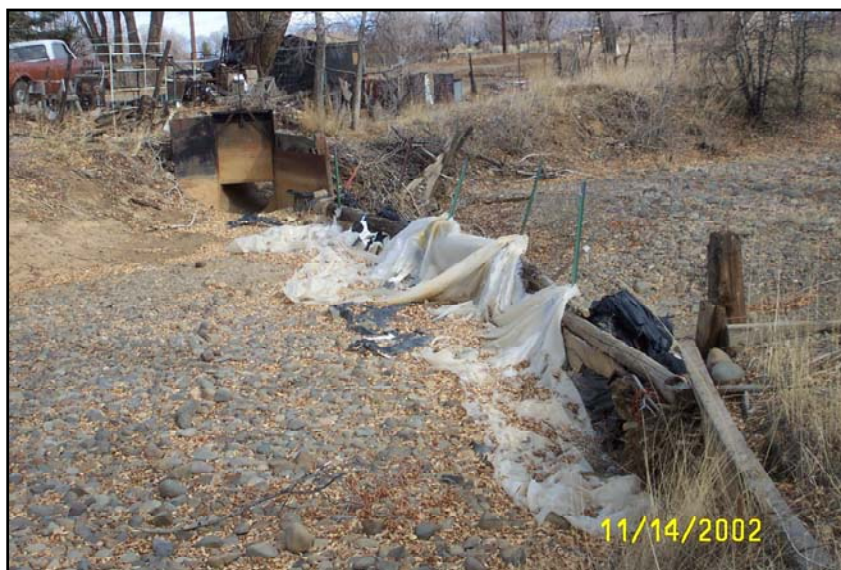
Figure 2-106. Dam Constructed of Marginal Materials – Cristobal Rivera Ditch

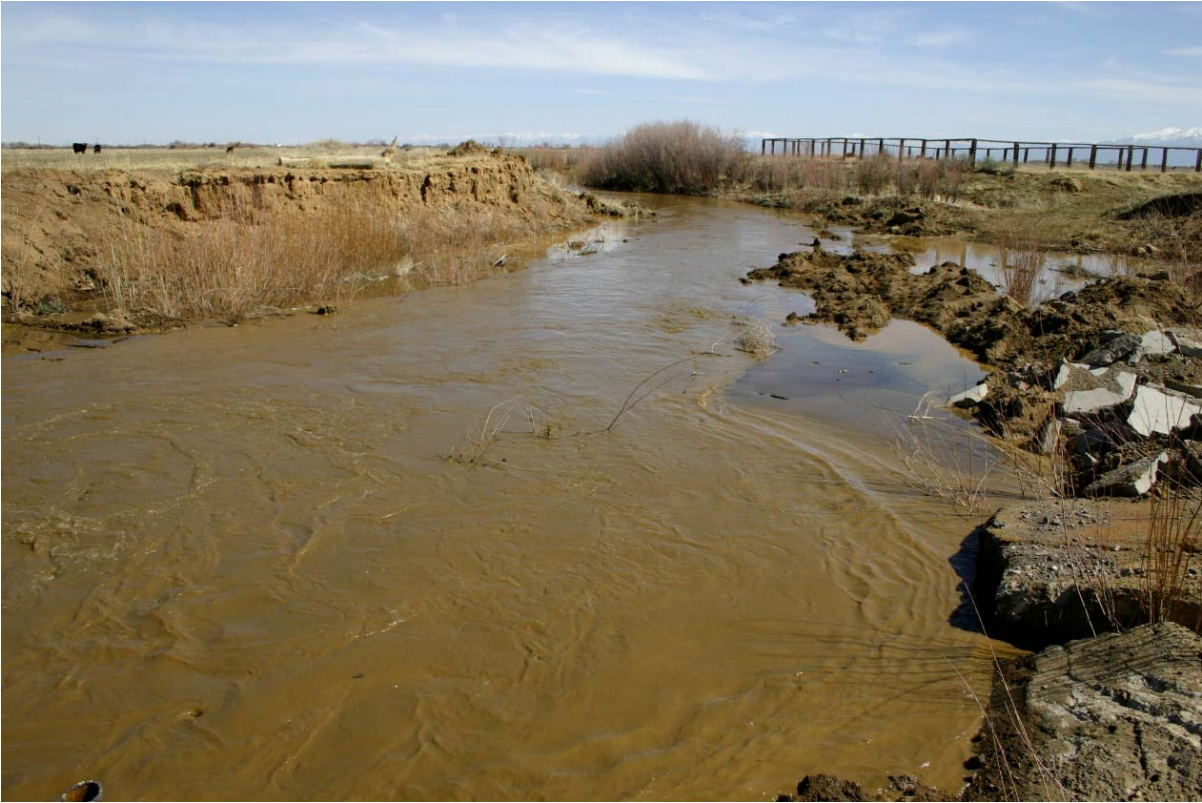
Figure 2–107. Photo of Terrace Sediments Flushed into Head Overflow #5 Ditch

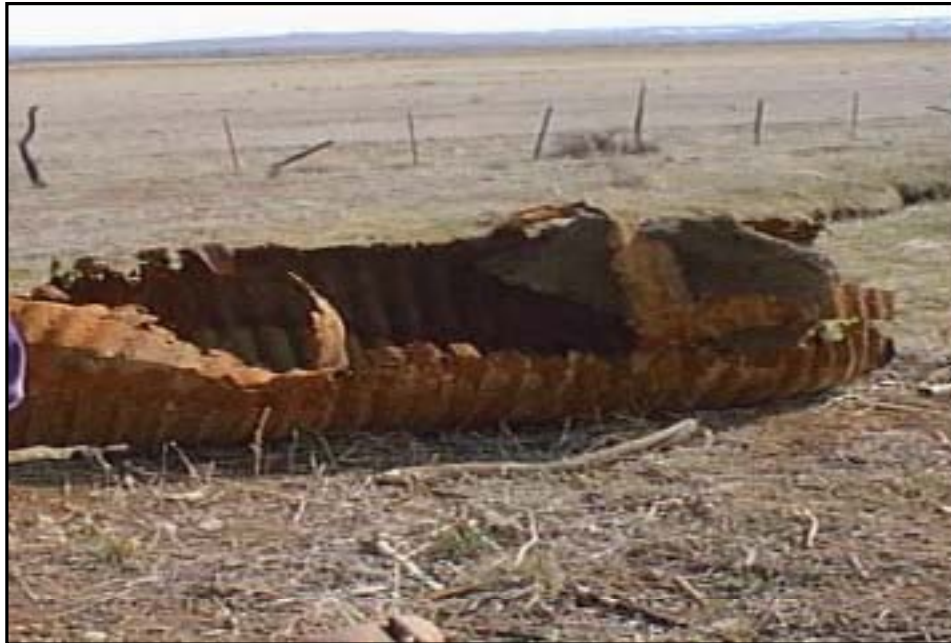
Figure 2-108. Photo of damage to culvert after exposure to Alamosa River Water
