Watershed Rehabilitation Program Watershed Protection and Flood Control Act of 1954

Watershed Rehabilitation Projects Completed in Wisconsin as of August 2006

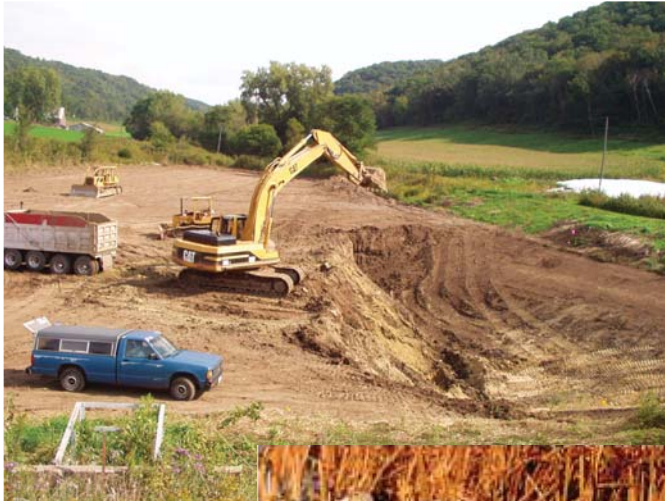
Alma Mill Creek Watershed Structures 2,3 and 5

Removal of sediment from Alma Mill Creek structure No. 3.

Considerable sedimentation occurred behind these dams over the years, reducing the ability of the structures to provide storage for floodwater. Separation at joints in the main pipe carrying water through the structure was likely to cause failure of one of the dams if left unchecked. Rehabilitation included repair of the pipe and removal of sediment, restoring floodwater and sediment storage capacity to the dams. Removal of sediment allows more space for trapping of sediment. Sedimentation has an adverse effect on sago pondweed, a favorite food source of tundra swans.

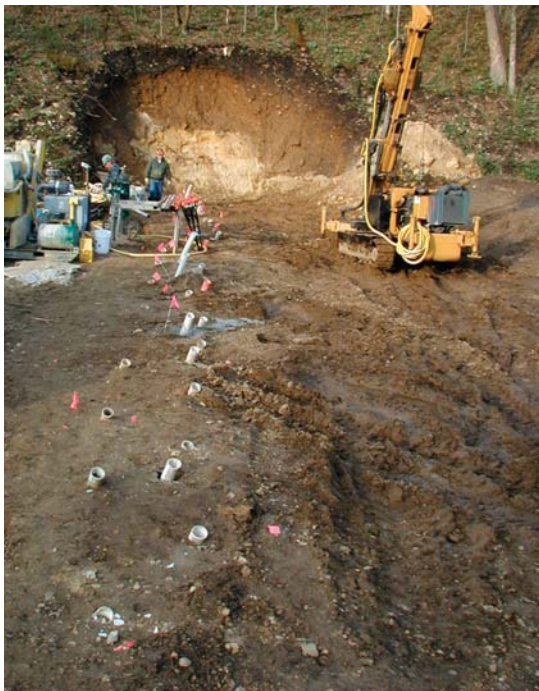
Bad Axe Watershed Structure No. 24

Grout is injected through boreholes to slow water movement beneath and around the dam.

From May 31st to June 1st, 2000, the watershed received 6.75 inches of rain in 36 hours, causing a partial failure of the structure. Part of the rock in the hillside adjacent to the dam was eroded internally. To repair the rock, grout, a mixture of cement, water and clay, was injected through boreholes into voids in the rock. The grout curtain reduces water flow through rock in the dam's foundation. As a result of rehabilitation, the dam will continue to provide flood protection to cropland, infrastructure and trout habitat downstream of the dam.

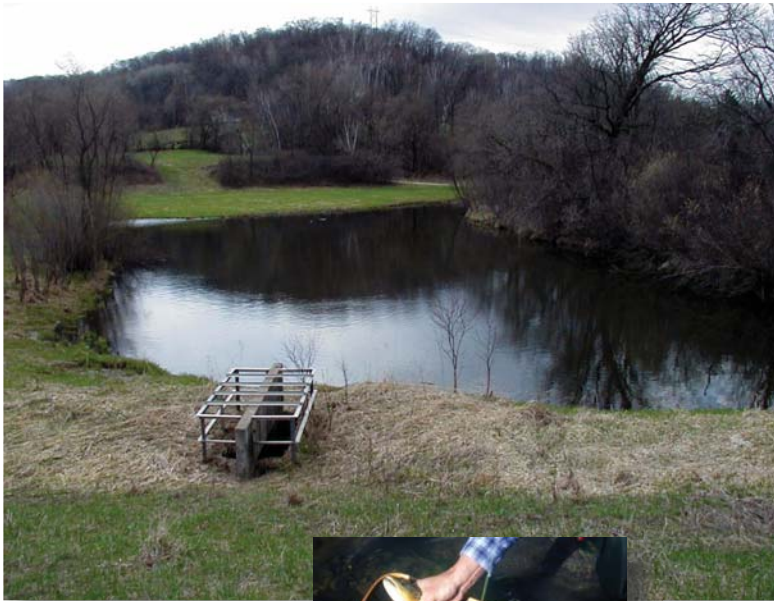
Plum Creek Watershed

Sediment accumulated behind the dam, reducing its floodwater storage capacity. In addition, separation of the joints in the main pipe carrying water through the dam was occurring. The pipe was repaired and the sediment removed, ensuring that the dam will continue to provide flood protection and prevent gully erosion. Watershed surveys in the 1940's found no game fish in Plum Creek. Today, portions of Plum Creek are rated as a Class II trout stream, due in part to conservation practices applied in the Plum Creek Watershed.

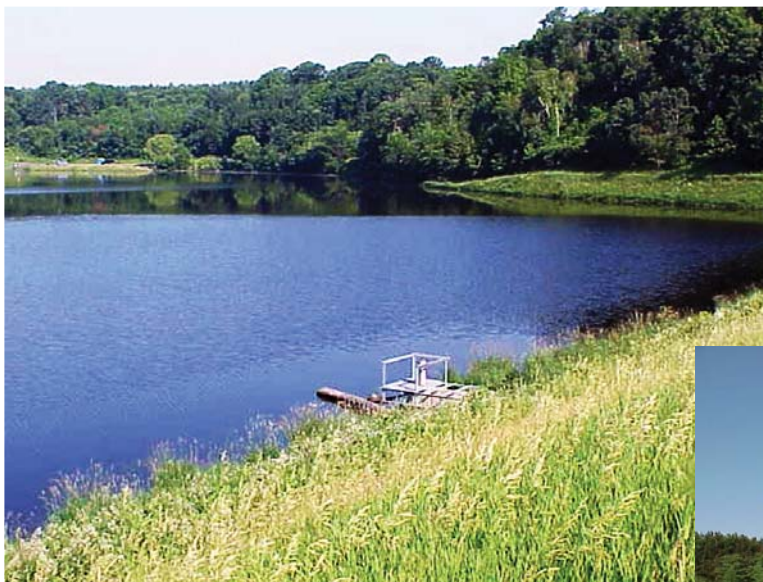
Glen Hills Watershed

A home located in the floodplain downstream of the dam was relocated out of the floodplain, reducing the risk to its inhabitants.

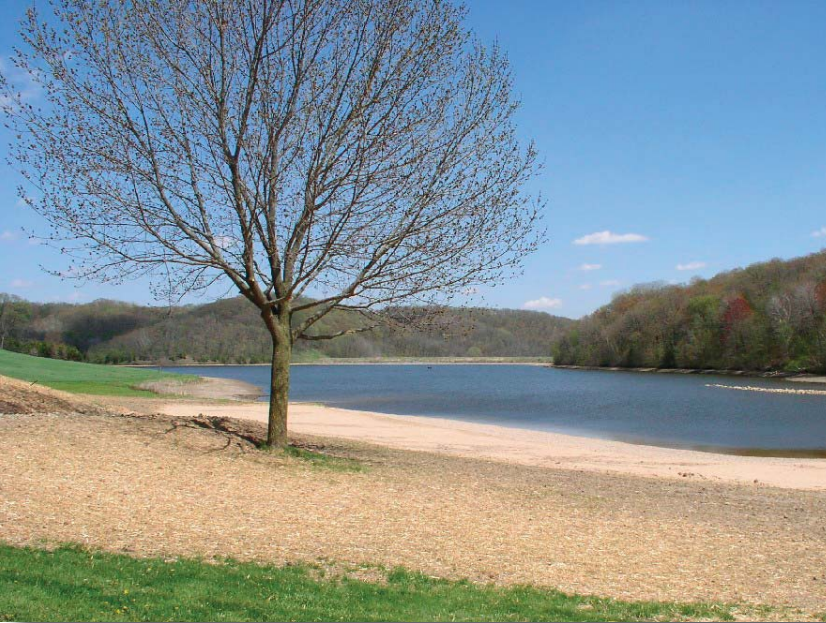
Plain Honey Creek Watershed Dam No. 3

Repair of the main pipe carrying water through the dam was completed, the inlet structure was modified to allow more flexibility to balance the needs of coldwater fish downstream of the dam with warm water species in the lake. Also, sediment was removed from the lake to allow more sediment storage capacity. The swimming beach was renovated.

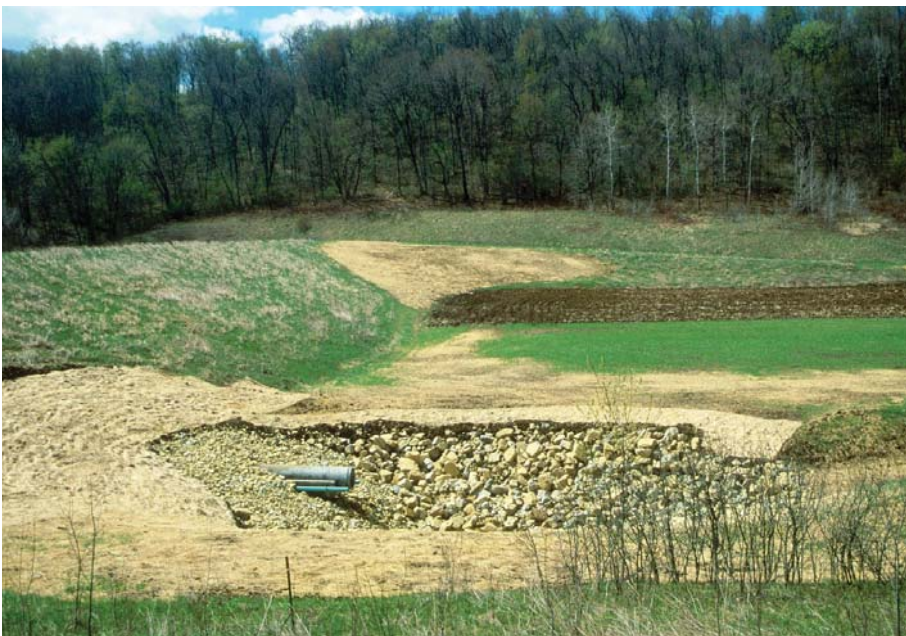
Twin Parks Watershed Structure No. 10

This dam was raised slightly to be in compliance with new federal dam safety standards. Also, the main pipe carrying water through the dam was repaired to prevent damage to the dam.

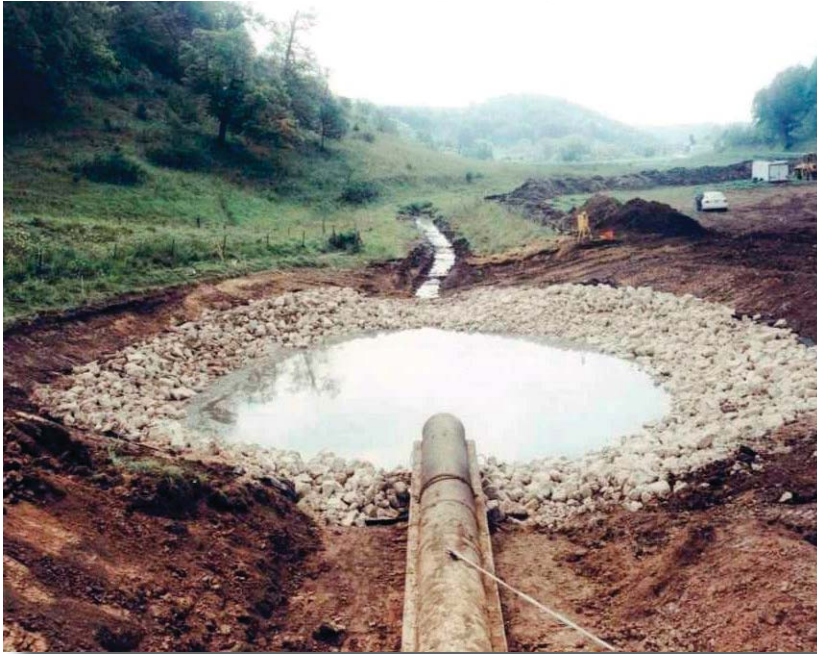
Mill Creek Watershed

Rehabilitated plunge pool.

Two homes downstream of the dam were found to be in the breach inundation area of the dam. Through the dam rehabilitation program, these two homes were “floodproofed” which protects them from high flows should the dam fail. Also, sediment was removed from behind the dam and the plunge pool where water exits the dam was renovated. Water inlet structures of the dam (riser and drawdown pipe) were replaced.

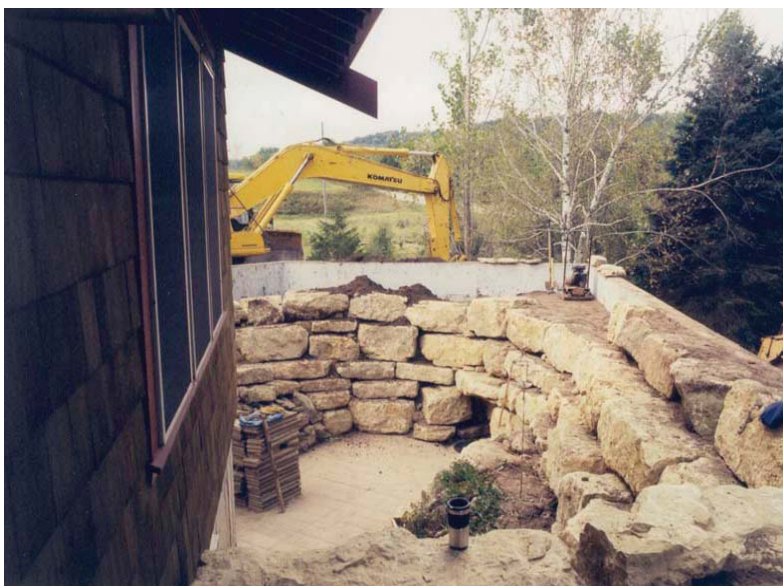
Otter Creek Watershed

Flood wall installed to protect home in case of dam breach.

One home downstream of the structure was found to be in the breach inundation area of the dam. If the dam should fail, this home would be inundated with at least two feet of water. Through the dam rehabilitation program, this home was protected from flooding and the inlet to the main pipe carrying water through the dam was modified to allow more flexibility to balance the needs of coldwater fish downstream of the dam with warm water species in the lake.

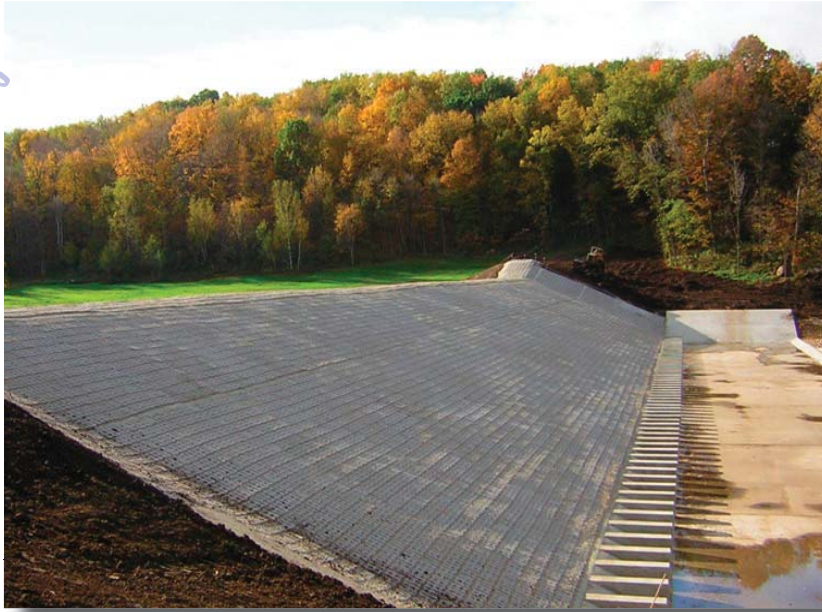
West Fork Kickapoo Watershed Pilot Structure - Klinkner Dam

Four homes and a school were found to be in the breach inundation area of the dam, making them susceptible to flooding should the dam fail. Through the dam rehabilitation program the school and residences were protected by upgrading the dam to meet the criteria for a high hazard structure. An engineering design innovation greatly reduced the cost for this project. Concrete block mats secured to the top and downstream face of the dam eliminated the need to increase the height of the dam.

During high flows when the dam is overtopped, concrete blocks connected with cables protect the down stream face of the dam.
