JOSEPH BARKER, JR. HOUSE
FEATURES OF SIGNIFICANCE WITH PRESERVATION RECOMMENDATIONS

SUBMITTED BY
THE CENTER OF EXPERTISE FOR THE PRESERVATION OF HISTORIC STRUCTURES AND BUILDINGS
U.S. ARMY CORPS OF ENGINEERS, SEATTLE DISTRICT
FOR THE
U.S. ARMY CORPS OF ENGINEERS, HUNTINGTON DISTRICT

16 JULY 2014

FEATURES OF SIGNIFICANCE WITH PRESERVATION RECOMMENDATIONS

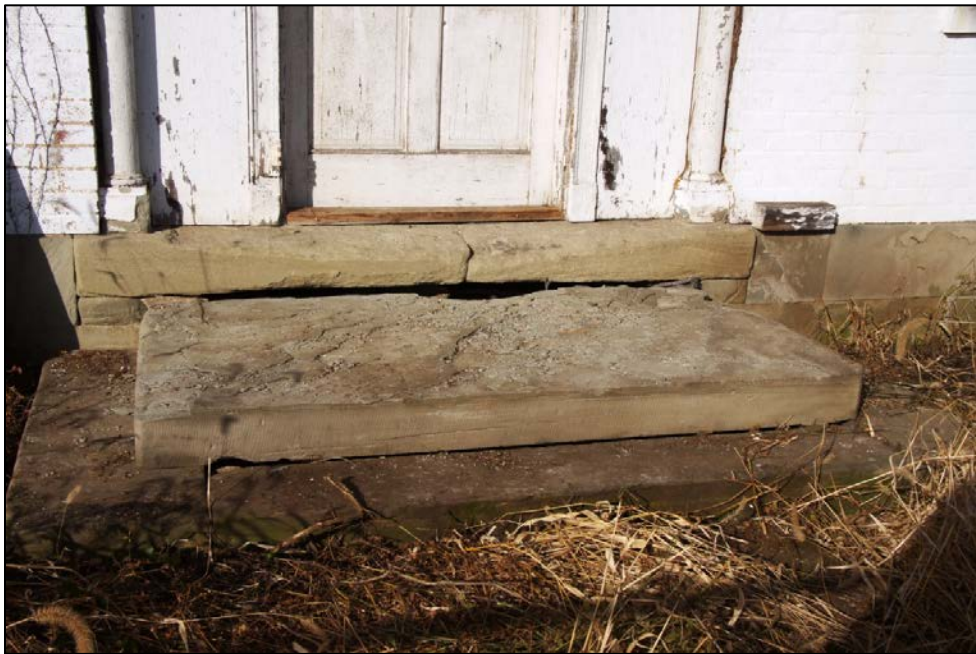
Photo 2.

Front elevation step at the entrance door. Severe delamination of the sandstone step and cracked threshold stone require immediate stabilization.

Recommendation: The entrance step and threshold are cracked and badly delaminated. Immediate attention is required to support the threshold crack and stabilize the sandstone material from further deterioration.

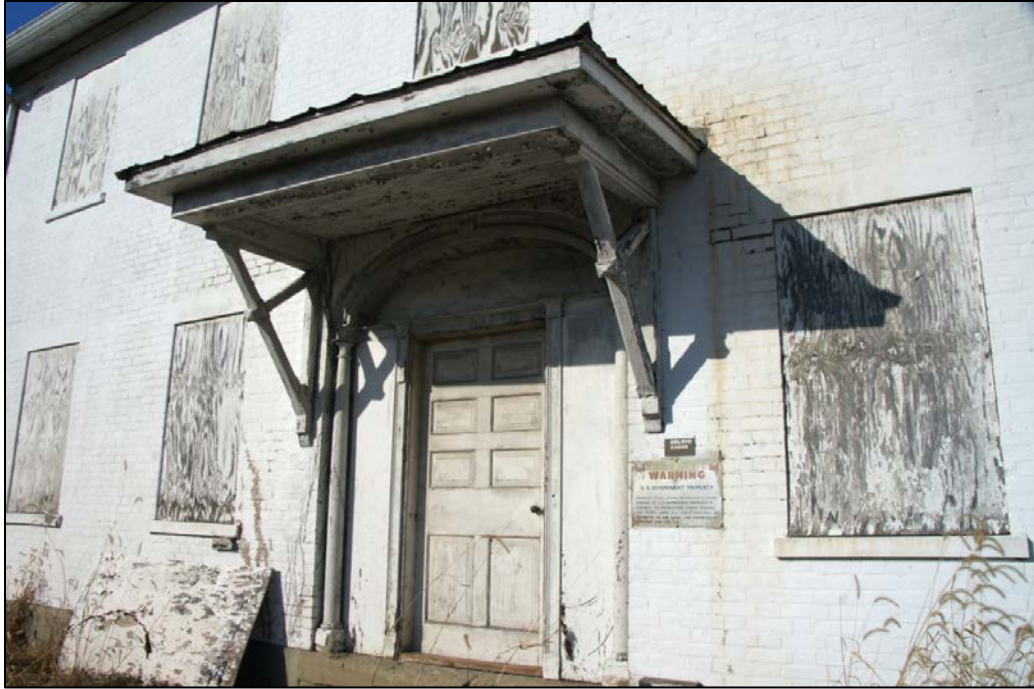
Photo 3.

Front entrance detail. The Eastlake style door “hood” with knee brace brackets, was likely added in the last quarter of the nineteenth century.

Recommendation: The Eastlake style hood over the door is a late nineteenth century addition, but has achieved some significance in its own right. It has served to protect the entrance, and should be inspected for damage to the standing seam metal. Soldering repairs should be made if needed.

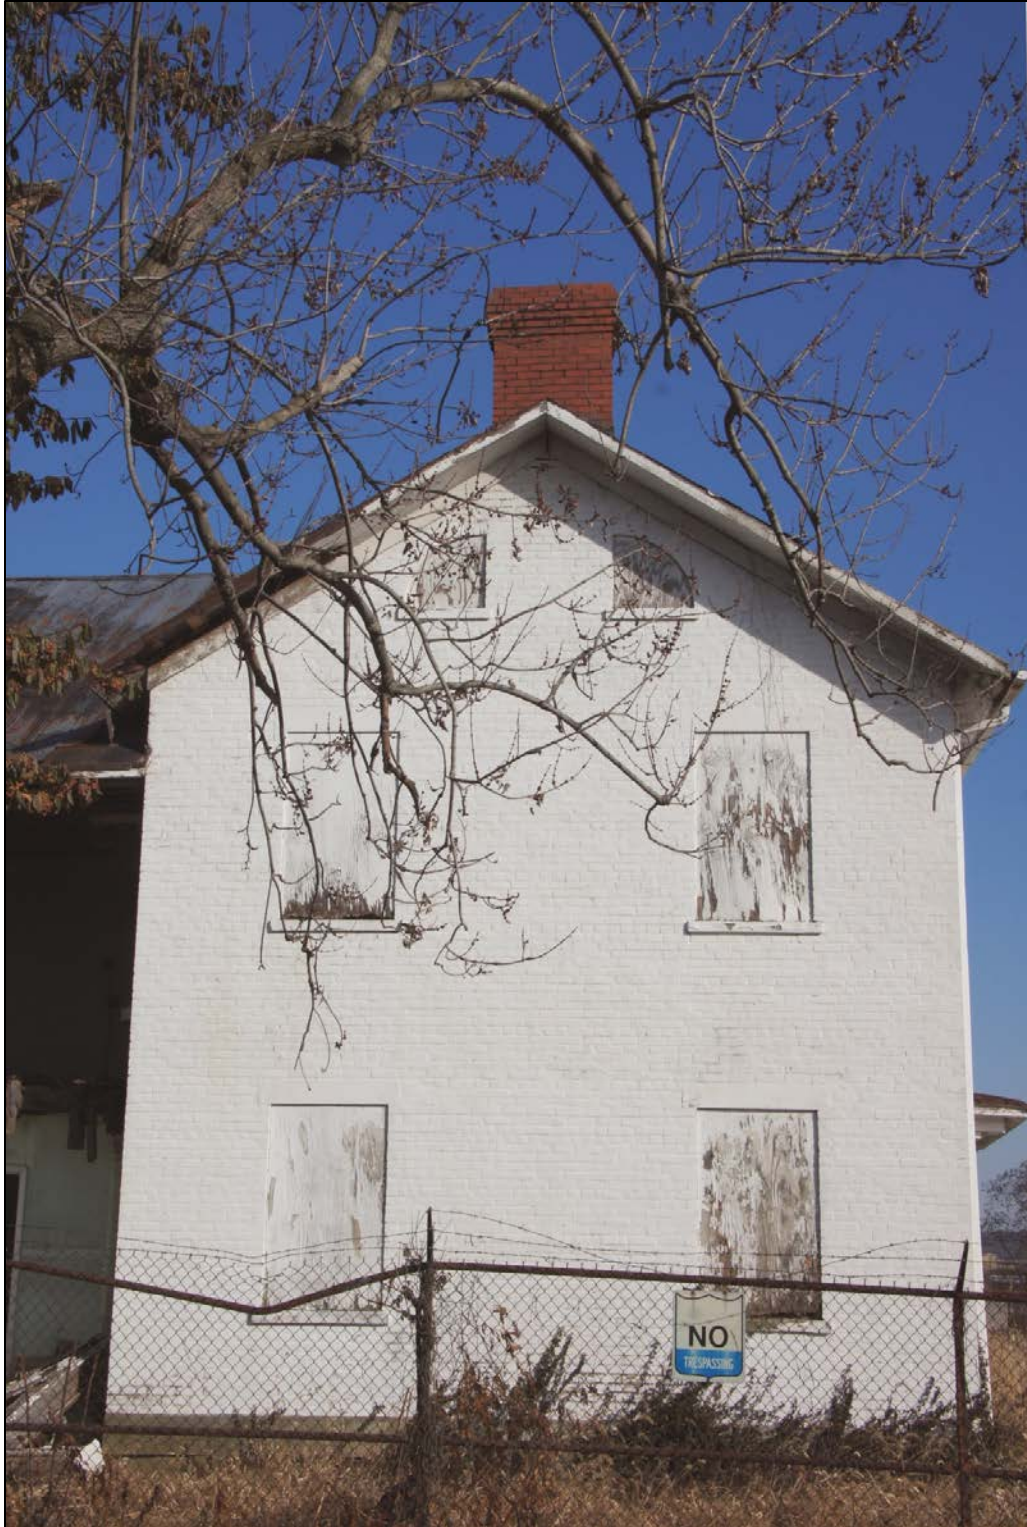
Photo 5.

West end of brick house. Mortar joints and paint coating are intact and no recent cracking or other masonry failure is evident.

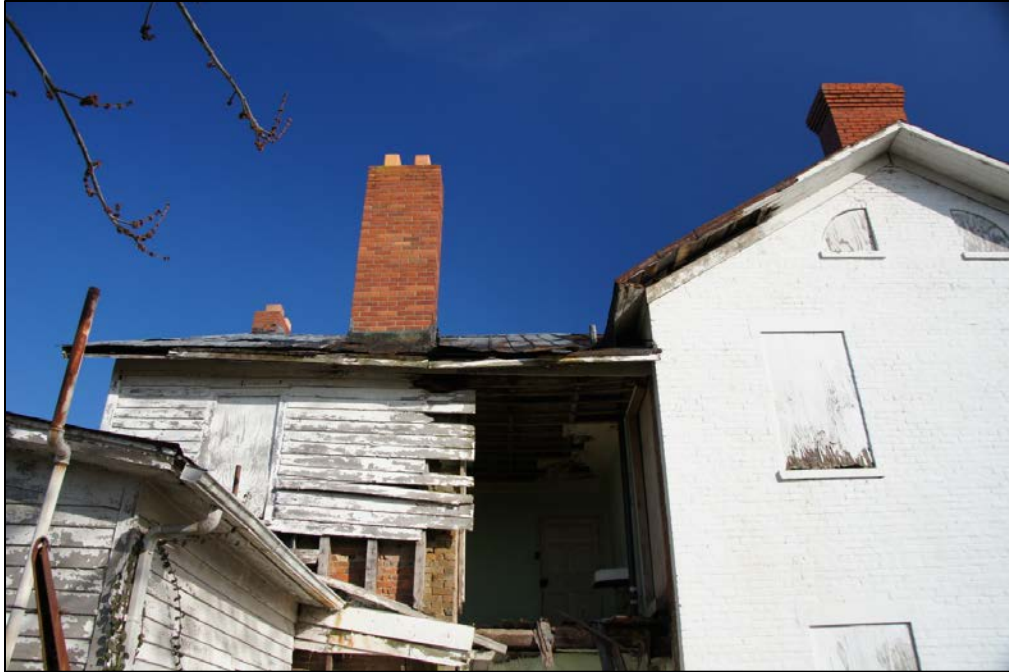
Photo 6.

Juncture of brick house (right) and frame building (left). The mid-twentieth century fireplace is revealed by structural failure. The brick section has not been significantly affected.

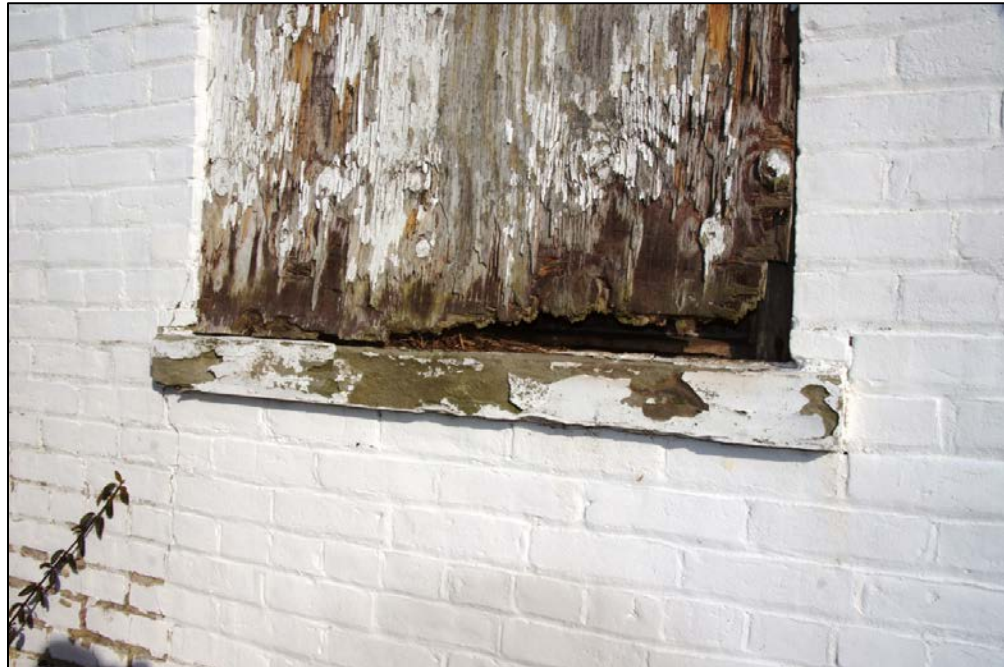
Photo 7.

Original sandstone lug sill at southwest corner of brick house. A crack extending downward from the left sill appears to have occurred since the 1970s painting, and may be a consequence of water entrapment behind the plywood boards.

Recommendation: The 6/6 wood sash windows and gable-end quarter windows are original and should be preserved. Plywood cover panels should be removed so windows can be inspected. The panels are likely causing further damage by retaining water and dampness, which in turn may cause dry rot and loss of historic material. The lower southwest window on the west elevation, in particular, exhibits damage to the sandstone lug sill, probably due to water and biological entrapment by the plywood panels. On a periodic basis, panels should be removed and replaced when damaged; and windows should be allowed to dry and cleaned of insect or bird nesting or other biological invasion. Where sandstone lug sills are delaminating from moisture, they should be dried out. See Figure 6.

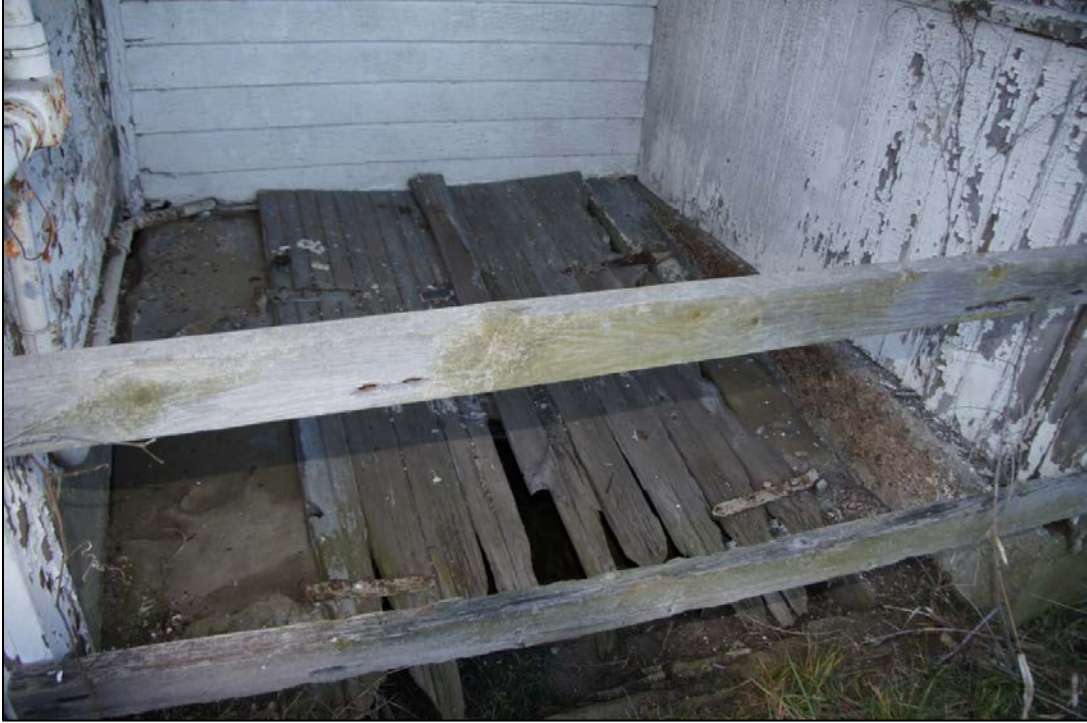
Photo 13.

Badly deteriorated cellar entrance doors are located in the east side porch.

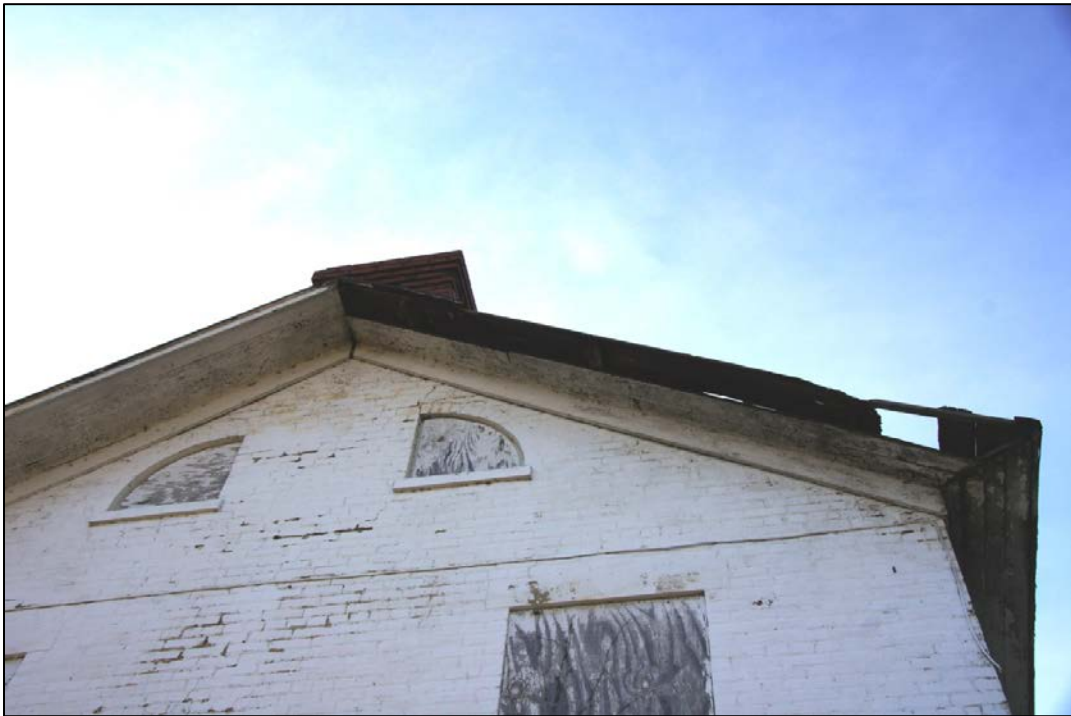
Photo 14.

View of gable and deteriorated soffit on the east elevation of the brick house, looking southwest. Failure is likely due to the damaged chimney, above.

Recommendation: The masonry is a significant aspect of the building's integrity, as are the composition of the mortar joints and execution. Overall, conditions are very good on the south, west, and east elevations. The rear/north elevation (northeast wall of Room 3) requires immediate bracing to prevent further failure. The cause - ongoing water migration from exposed chimney opening and roof damage - should be arrested. To ensure no structural decline is imposed on the brick house by the deteriorating frame house, regular inspection and emergency stabilization of the north wall may be necessary.

Recommendation: The corbel cap of the east chimney should be repaired, and mortar joints replaced where missing (using a mortar composition, pigment, and application identical to the original). Chimneys should also be covered to prevent water access into the interior of the house.

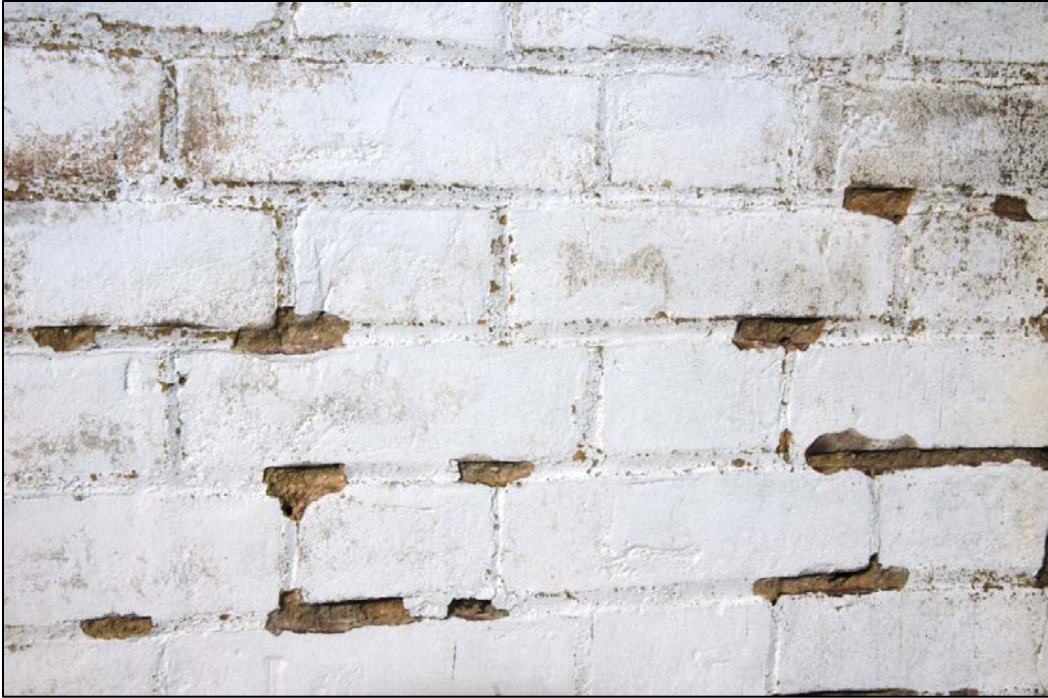
Photo 15.

Detail of typical brick surface on the east elevation of the brick house. Water has migrated outward through mortar joints and pushed paint away.

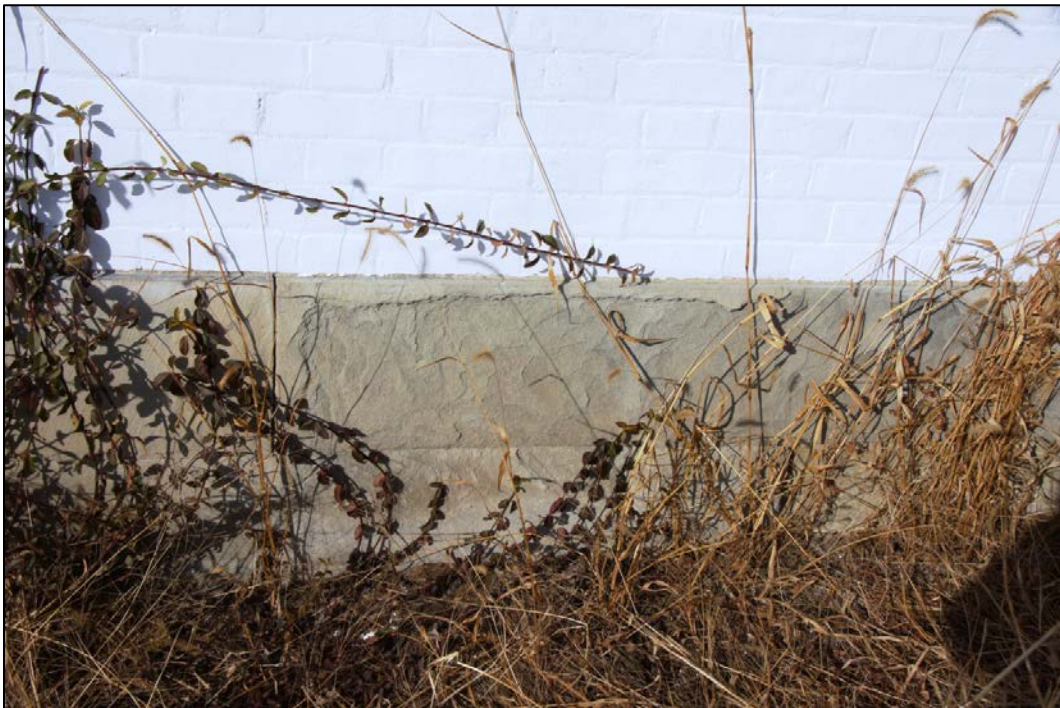
Photo 16.

Original east elevation foundation shows de-lamination of some sandstone surfaces.

Recommendation: The dressed cap stones around the foundation perimeter and entrance threshold step are original. No immediate treatment is required, however regular inspection should be made to clean biological infestations and ensure no structural failure is occurring.

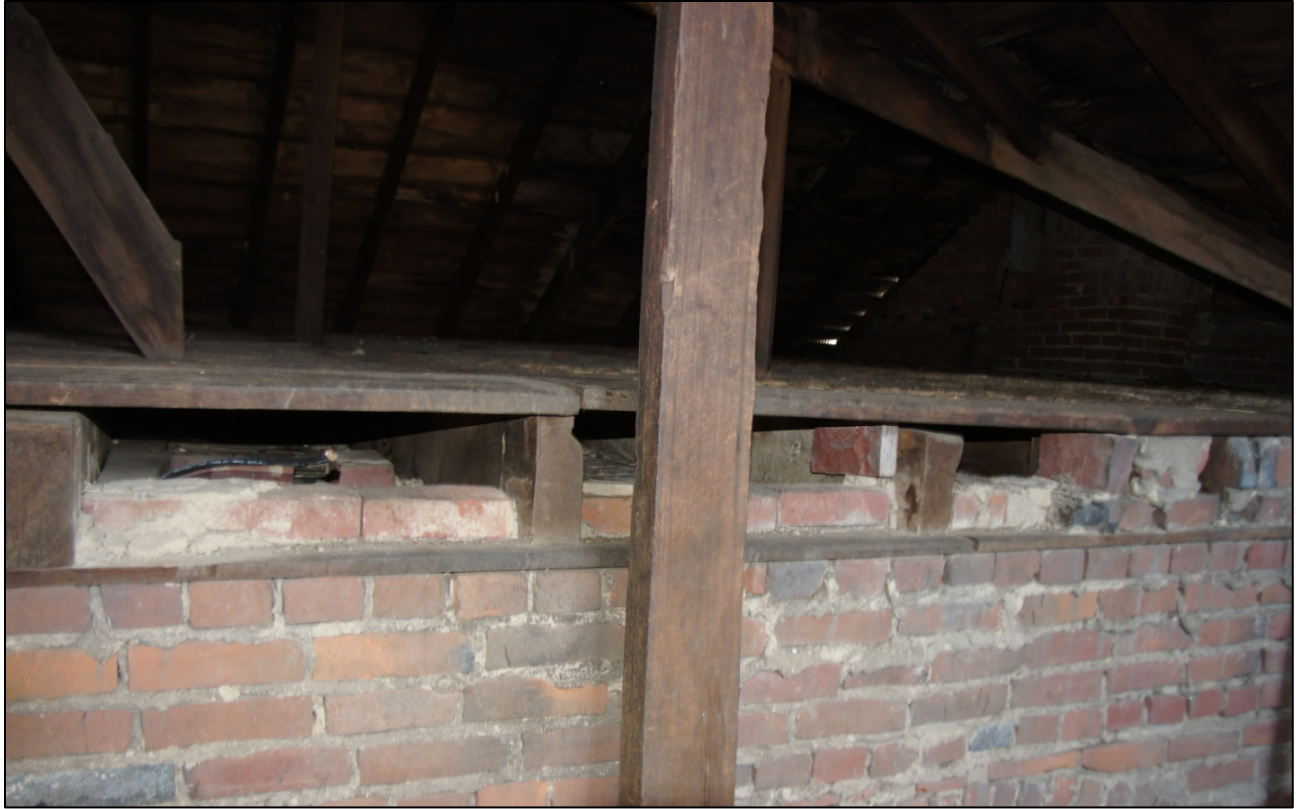
Photo 19.

Exterior/North wall of the brick house that meets the frame section, looking southwest. Original attic floor and floor joists are apparent. This wall presents several types of mortar and mortar joints which could be tested to determine age and relative dates of execution. Left of the column, mortar joints appear to have similar composition and application as other exterior elevations. Joints at the far right are darker in color, have different composition, and are not struck. This suggests a period of repair perhaps when the frame section was adjoined to the brick house.

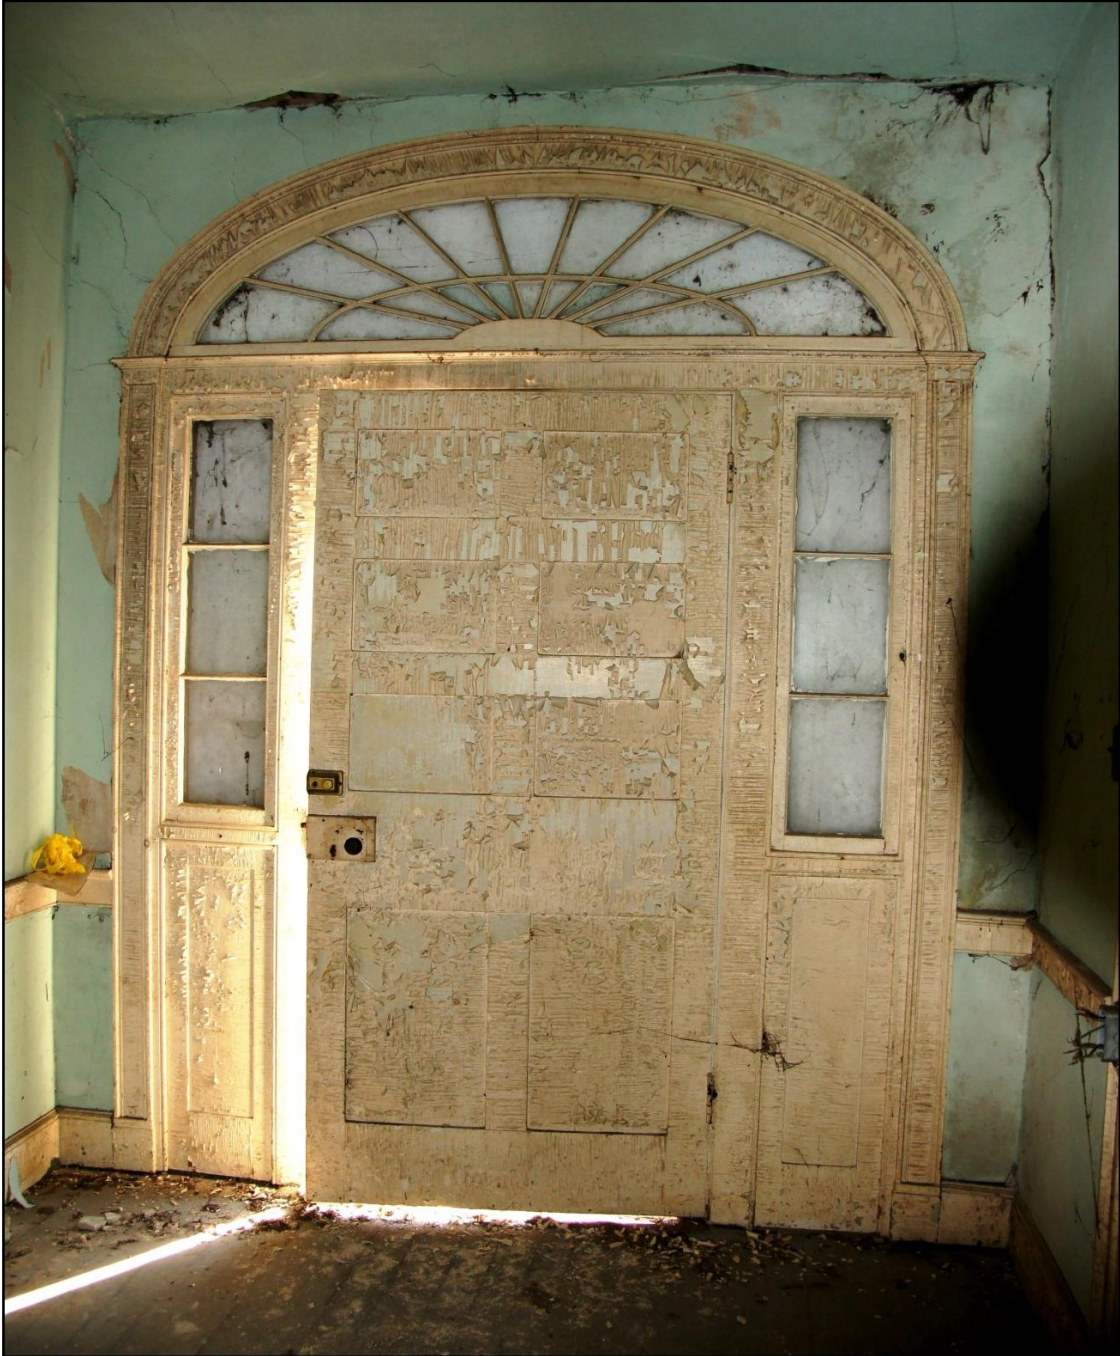
Photo 20.

Room 4 – Foyer view of front door, side lights, and fan light, looking south. All features and hardware are original and present good integrity, aside from peeling paint and deferred maintenance.

Recommendation: Features include the entrance door and side rooms doors, door knobs, hardware, interior surround/side lights/fan light; two-story staircase to include balusters, scrolled end; scrolled stair end details; stair treads and risers and moldings; doorway framing trim, chair rail. Because this space presents a high level of integrity and has some of the most significant Federal features, high emphasis should be placed on its preservation. Features are in good condition but exhibit paint flaking, though no structural or material damage is evident. Surfaces should be cleaned/de-humidified.

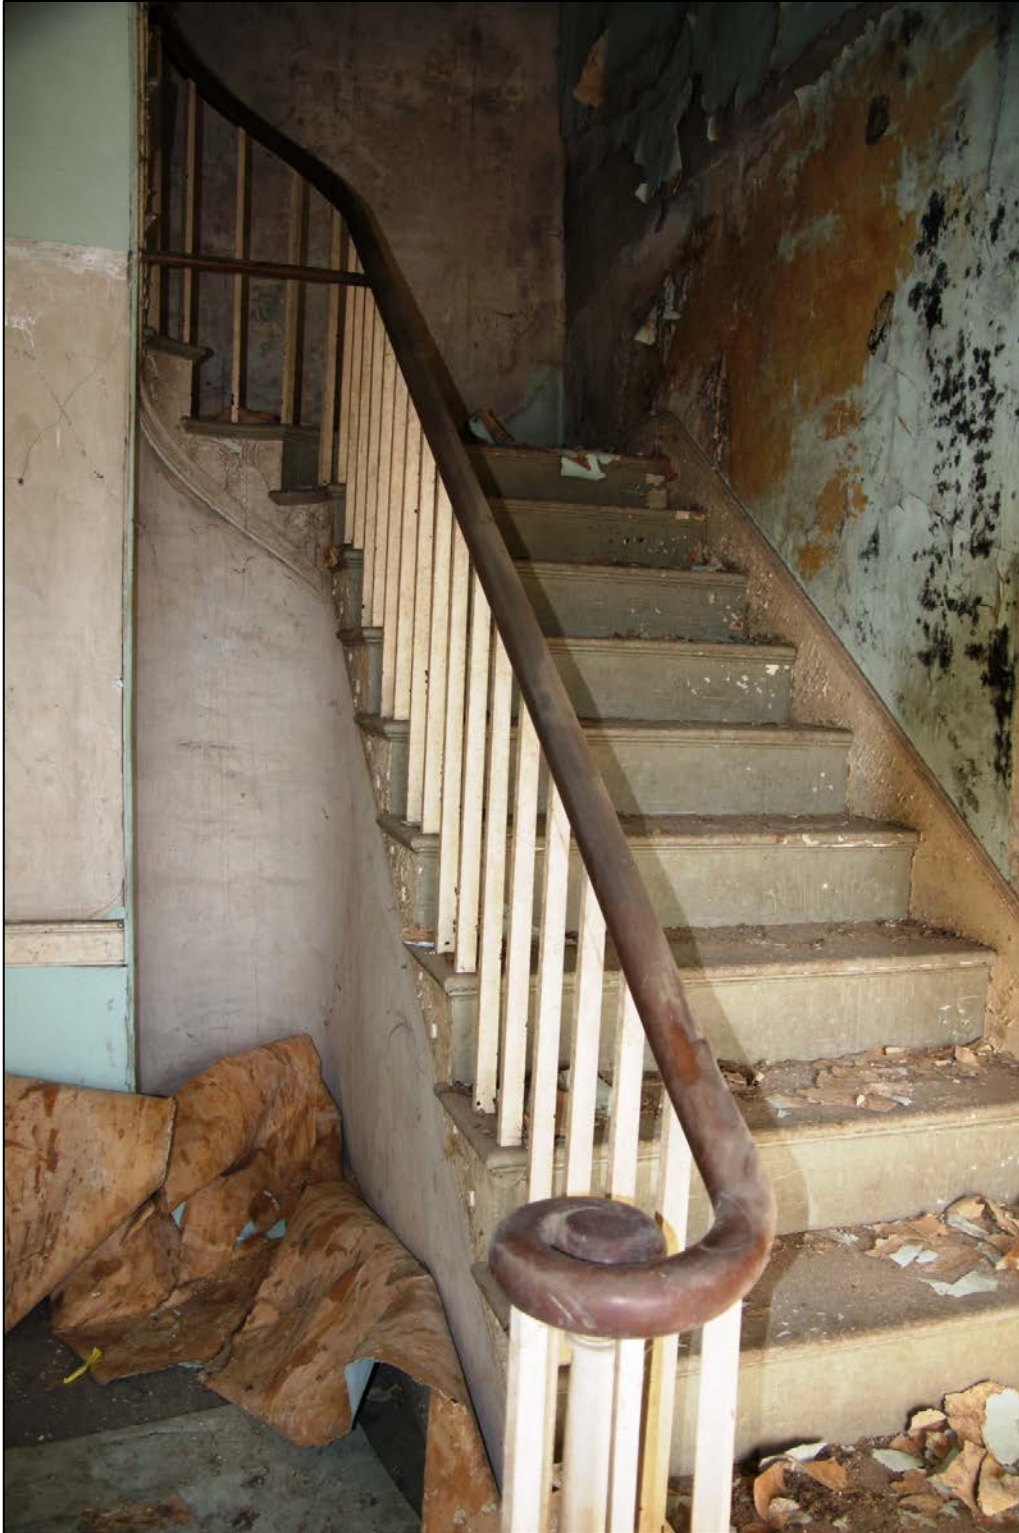
Photo 22.

Room 4 – Original staircase looking upward to the north. Staircase handrail, square balusters, railing spiral, and tread moldings are original. Wall surfaces reflect damp conditions and mold growth.

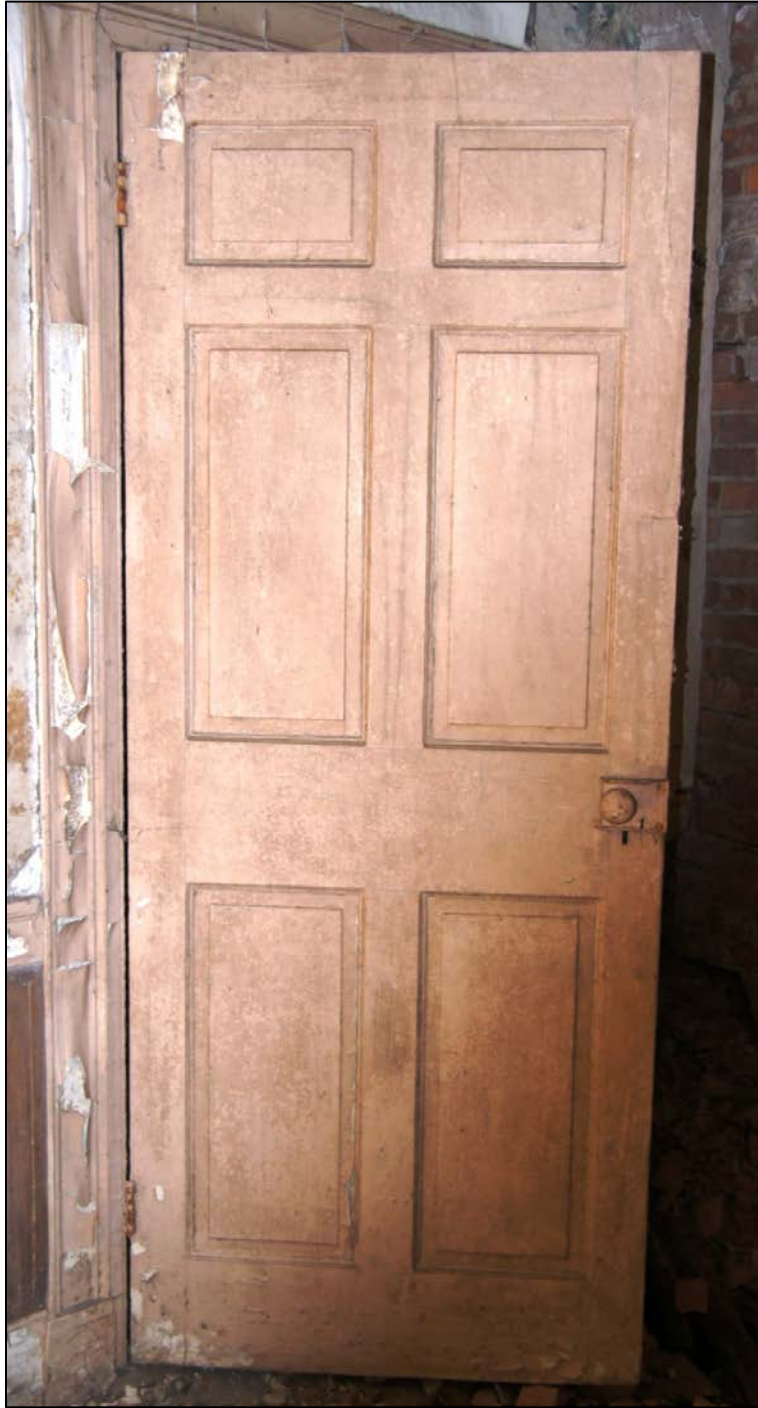
Photo 34.

Room: Interior door to closet at northwest corner of room. Trim and moldings are badly peeled and have surface dirt and other accumulations that should be lightly scraped and cleaned.

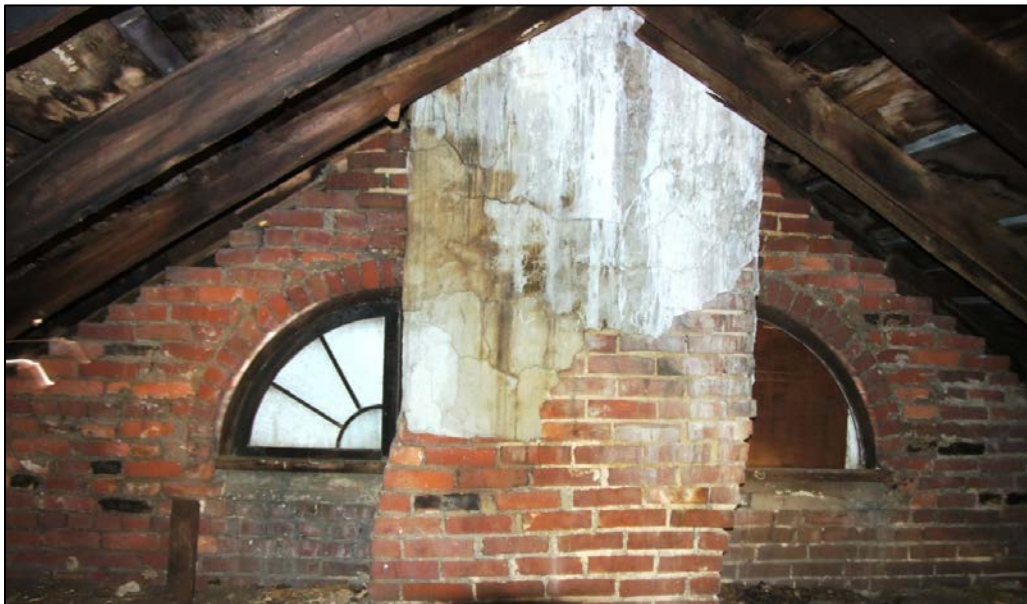
Photo 43.

West gable end with original quarter lights, and chimney repair evident in repointing and partial stucco finish. The off-set accommodates the placement of the fireplace on the second floor.

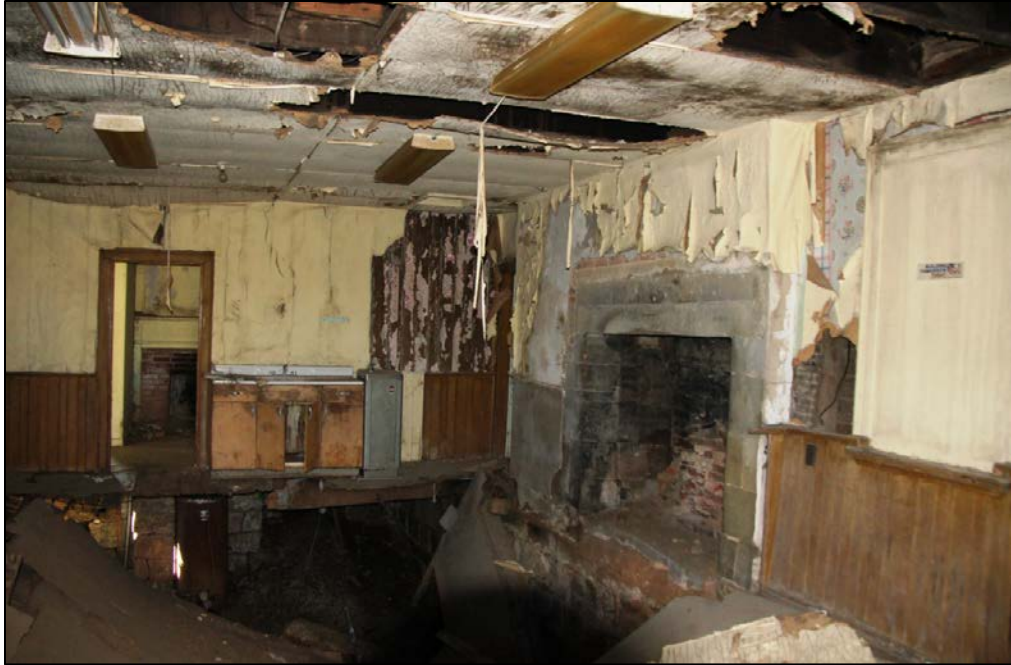
Photo 47.

Room 8 – First floor of the frame house showing collapsed floor and large hearth, looking northwest.

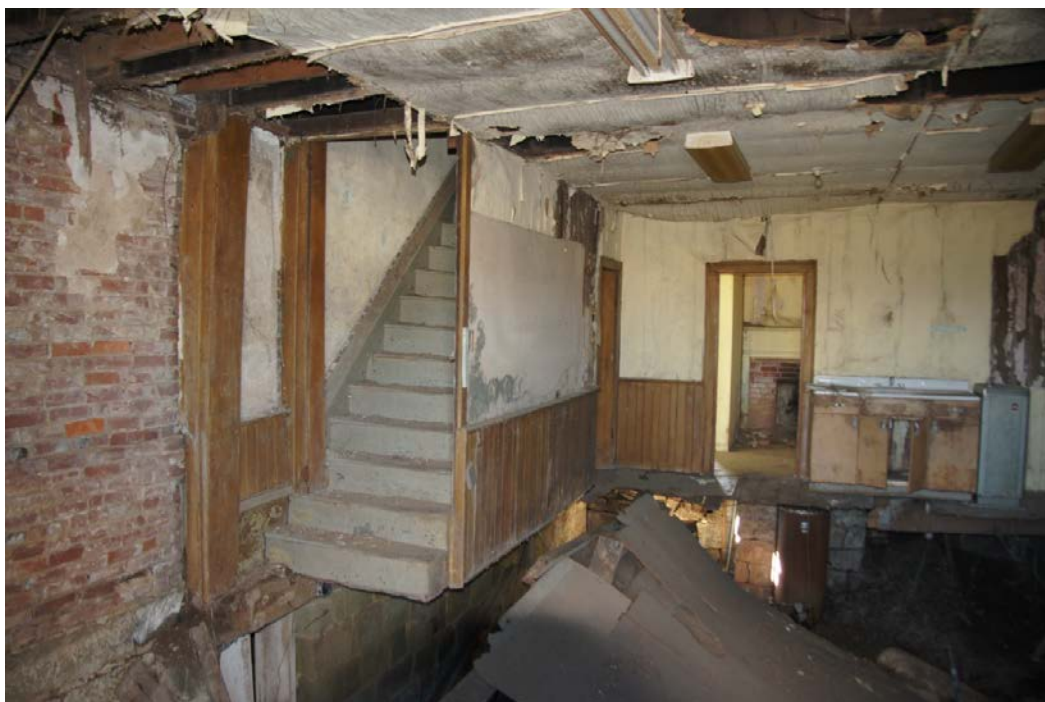
Photo 50. Room 8 – First floor of frame house showing collapsed floor and stairway to second floor, looking southwest.

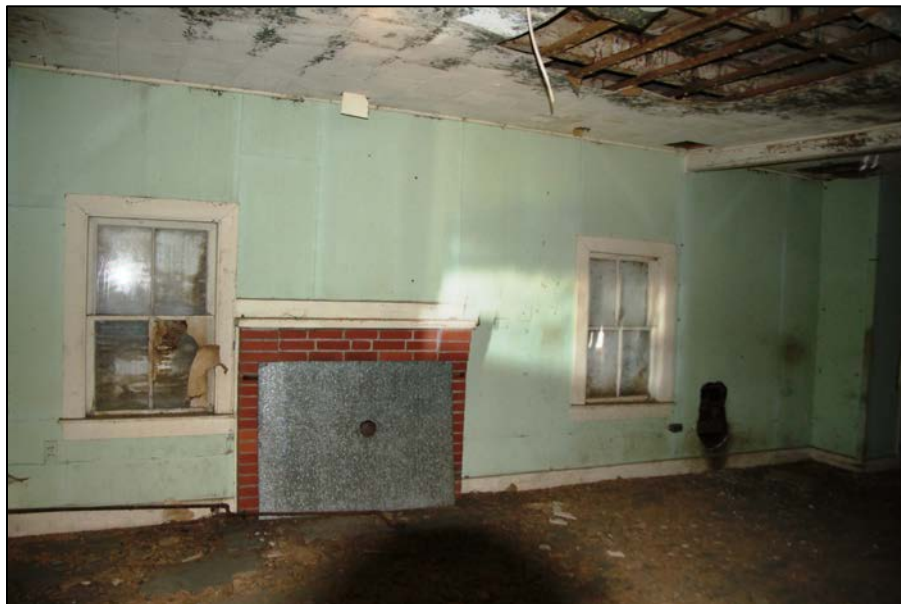
Photo 52.

Room 16 – West wall of frame house, mid twentieth century fireplace and two-over-two sash windows. Wood flooring and joists are structurally compromised from animal infestation and water damage.
