**US Army Corps  
of Engineers** ®  
Kansas City District

# **Evaluation of Reported Notch Problem Locations Below Rulo, Nebraska**

**April 2013**

## **FINAL REPORT**

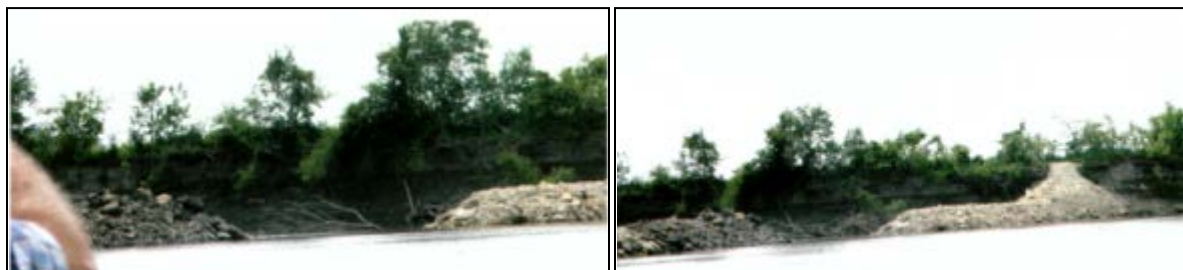
Figure 2-2(a): Submitted Photos for Location 1

At Location 1, Mr. Kuenzel stated, “200 yards below MM 57 dike repair done this winter but still has notch in it should be closed up. This is in Labadie bottoms. Right bank.” His pictures of this area can be seen in Figure 2-2(a).

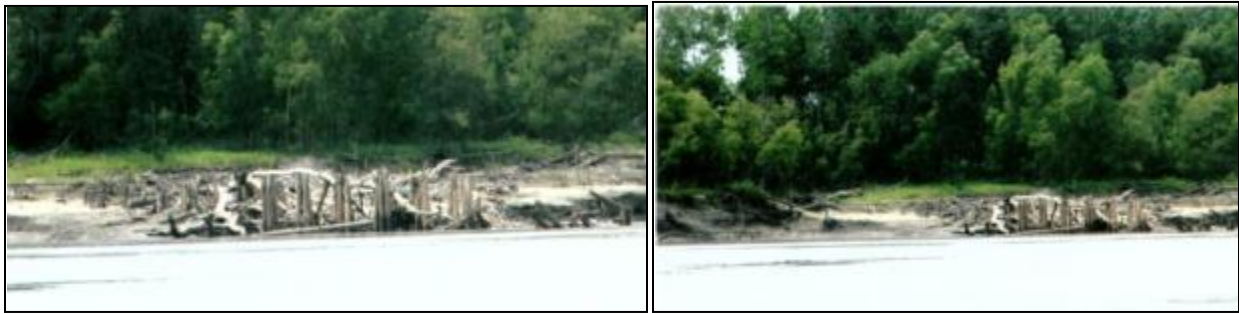
**Figure 2-2(b): Submitted Photos for Location 2**

At Location 2, Mr. Kuenzel stated, “Rock revetment in same location in major need of repair. 200 yards below MM 57 right bank.” Photos of this location can be seen in Figure 2-2(b).

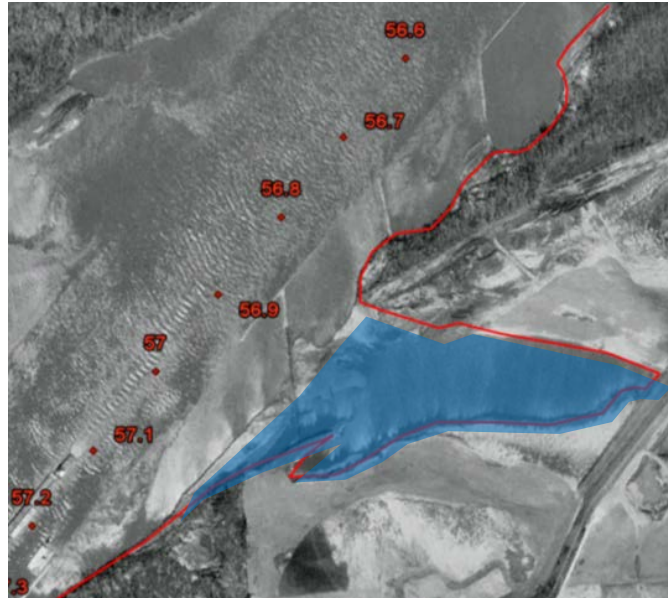
**Figure 2-2(d): Scour Hole from 1995 Flood**

After the 1995 flood event, a large scour hole developed at this location. The area affected by the scour hole is highlighted in blue in Figure 2-2(d). The revetment was repaired with 21,585 tons of stone fill immediately after the flood.

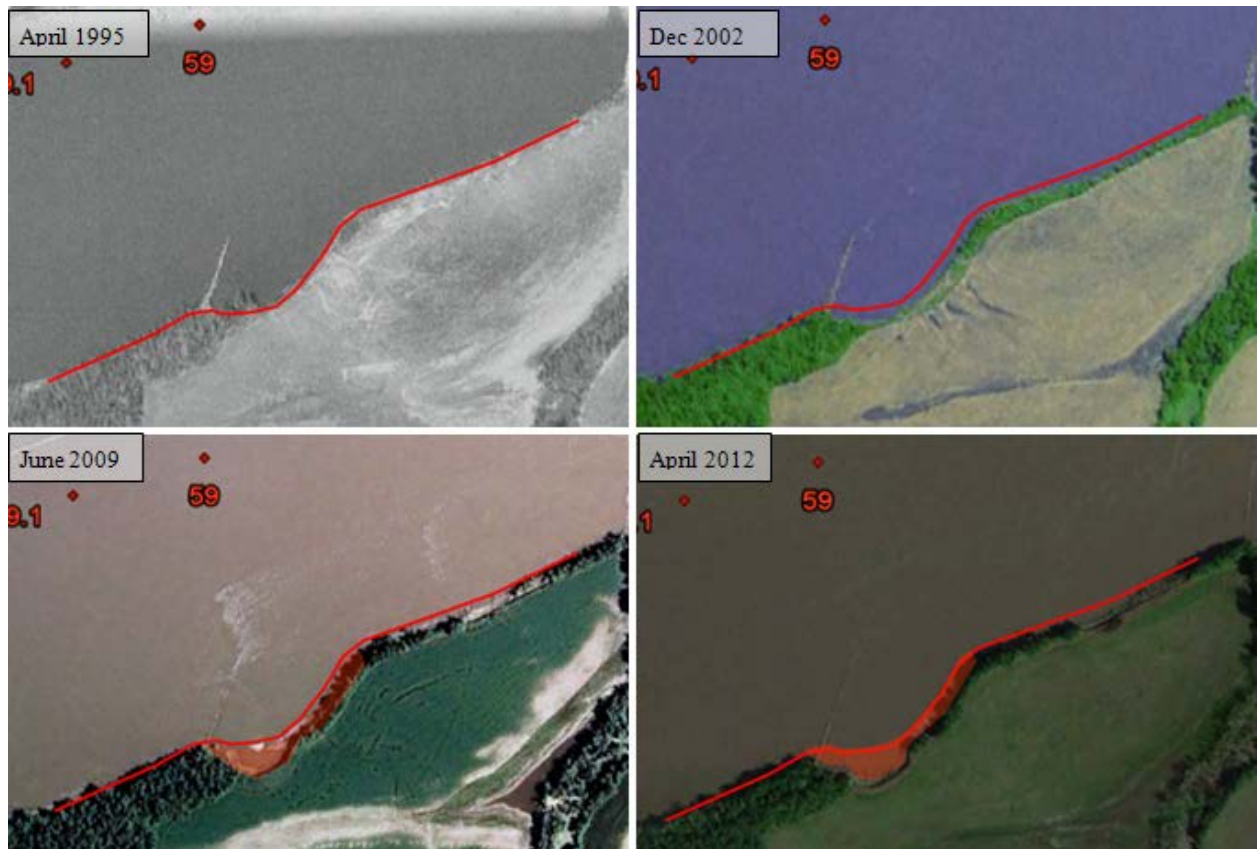
**Figure 2-3(c): Aerial Photo Comparison of Location 3 over 17 years**

Aerial photos between 1995 and 2012 were compared. The photos in Figure 2-3(c) indicate the bank has eroded near the root of D062.2.

The bank near the root of the dike shows some erosion in the 2002 photo. By 2009, the bank had moved 120 feet from the bank location of April 1995. The bank location does not appear to have moved since 2009 when the dike was repaired. Over the period of 17 years shown in the aerial photos, the bank line moved as indicated by the red shaded area in Figure 2-3(c).

There is erosion at this location near the root of the dike structure. The dike contains a notch that is 20 feet wide with a bottom elevation one foot below the top of the adjacent dike height, and is at least 250 feet from the bankline. Since the notch is only 20 feet wide and 1 foot deep, located out on the dike and slightly downstream of most of the erosion, and has been in place since 1985, it is unlikely the cause of the erosion that has occurred near the root of the dike. The dike repair completed in 2009 should help prevent further erosion.

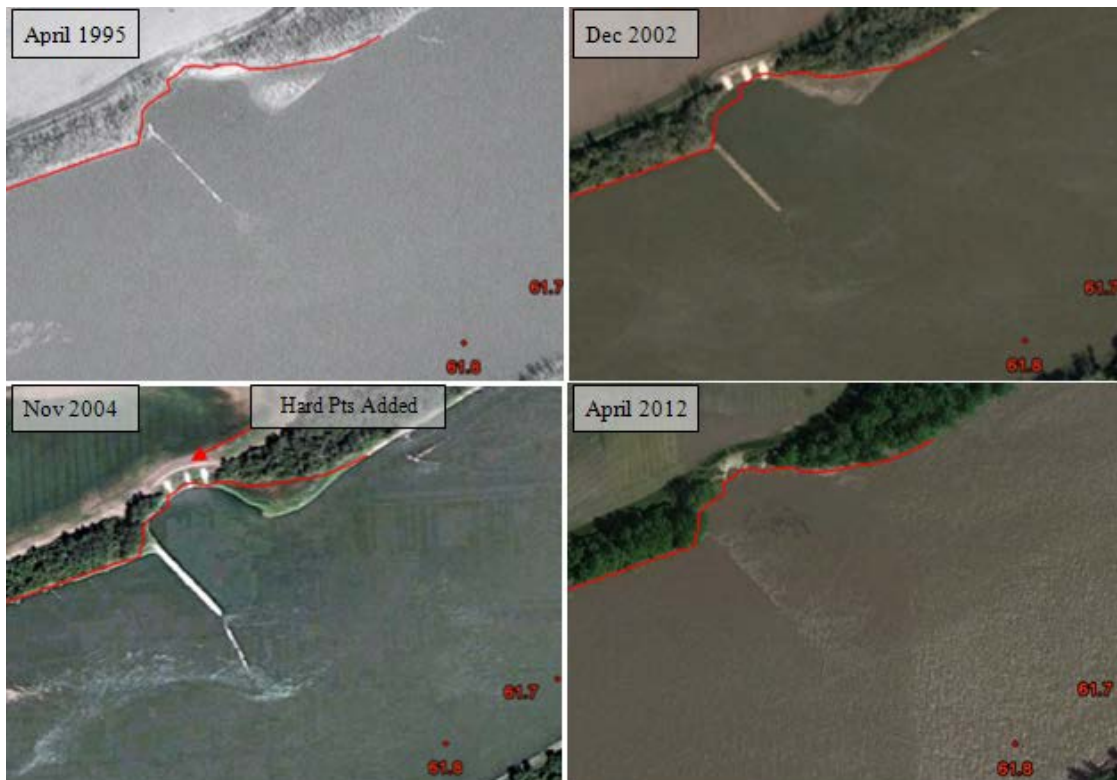
**Figure 2-4(c): Aerial Photo Comparison of Location 4 over 17 years**

Aerial photos were compared over the past 17 years. The photos in Figure 2-4(c) indicate the bank eroded between 1995 and 2002 near the root of D064.8.

Since the notch is a small/medium notch, located 400 feet away from the bank, and not aligned so as to direct water toward the bank, it is unlikely the notch is the cause of the bank erosion that occurred near the root of the dike. Hard points were added in 2002 and the bank line has not changed since that time.

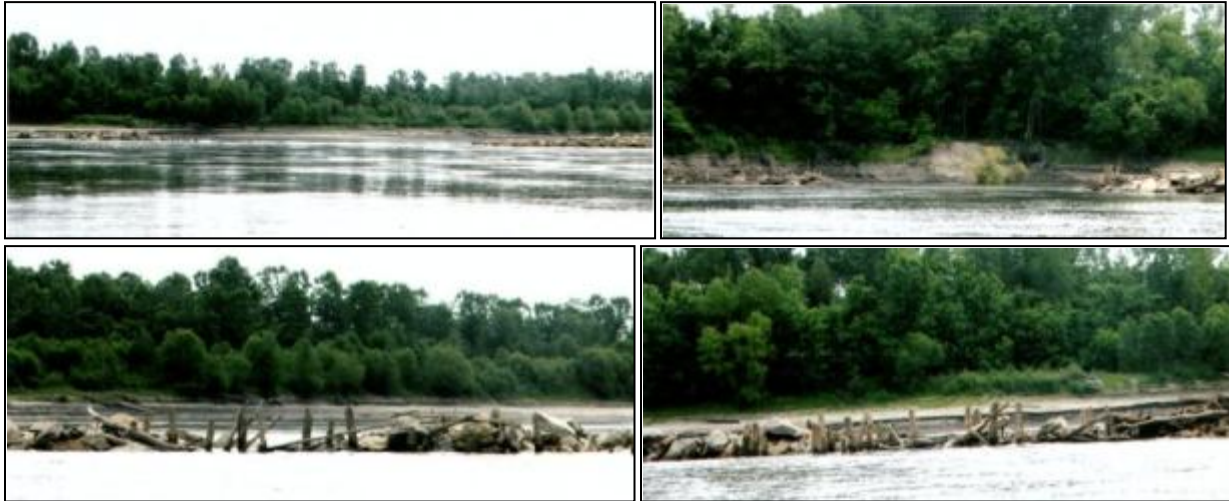
**Figure 2-5(a): Submitted Photos for Location 5**

Mr. Kuenzel stated, “Pictures...show rock revetment needing major repair this is MM 65 left bank.” His submitted photos can be seen below in Figure 2-5(a).

The notches in the revetment are small and between 750 – 800 feet from the bank. The notch in the dike is medium size and almost 400 feet from the bank. Most of the bank erosion is near the root of the dike which is upstream of all three notches and not affected by flow through the notches. Therefore, it is unlikely the notches are the cause of the bank erosion. The dike structure, D067.8, is currently on the deficiency list as being 3 feet low and will be repaired at the next opportunity. The erosion could be caused due to the deficient elevation of the dike structure next to bank.

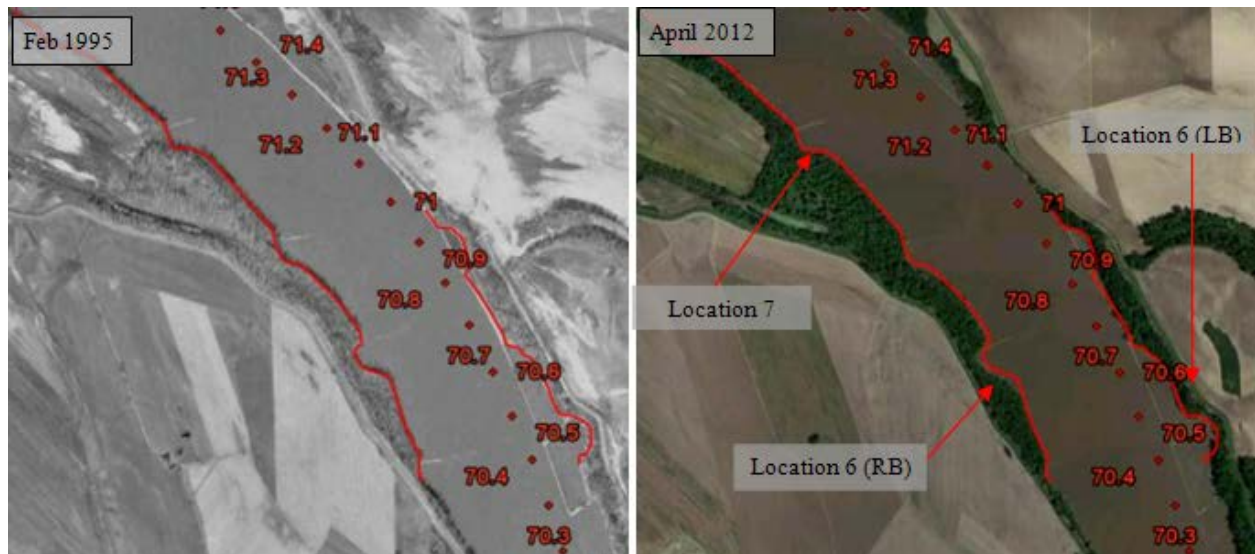
**Figure 2-7(d): Aerial Photo Comparison near Location 6 and 7 over 17 year period**

Aerial photos from 1995 to 2012 were analyzed for Location 6 and 7 and are shown in Figure 2-7(d). The red line indicates the bank line location in February 1995.

The left bank line and the right bank line areas for Location 6 and Location 7 have shown no movement since 1995, therefore, the notches have not caused any bank erosion.

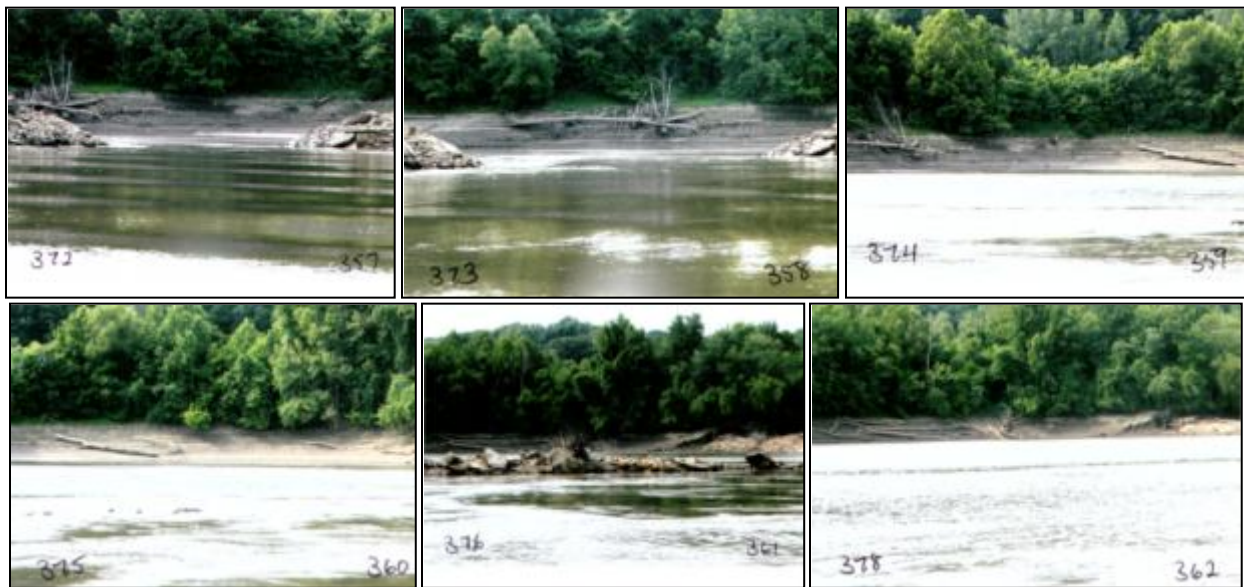
**Figure 2-9(b): Submitted Photos for Location 10**

At Location 10, Mr. Kuenzel states, “Pictures... show bank ate away from dike is at MM 73.5 right bank. MM 73.5 right bank very heavy bank erosion. Notched dike at MM 73.5 right bank this has been a problem since this has been notched. We have lost about 7-10 acres of land since the cut was made and the first rock they put in here in the late 90s was 78 foot deep at the river bank. Take note to this problem. This is your fault and no one else. I would still have my land if not for your notch!!!!” His submitted photos can be seen in Figure 2-9(b).

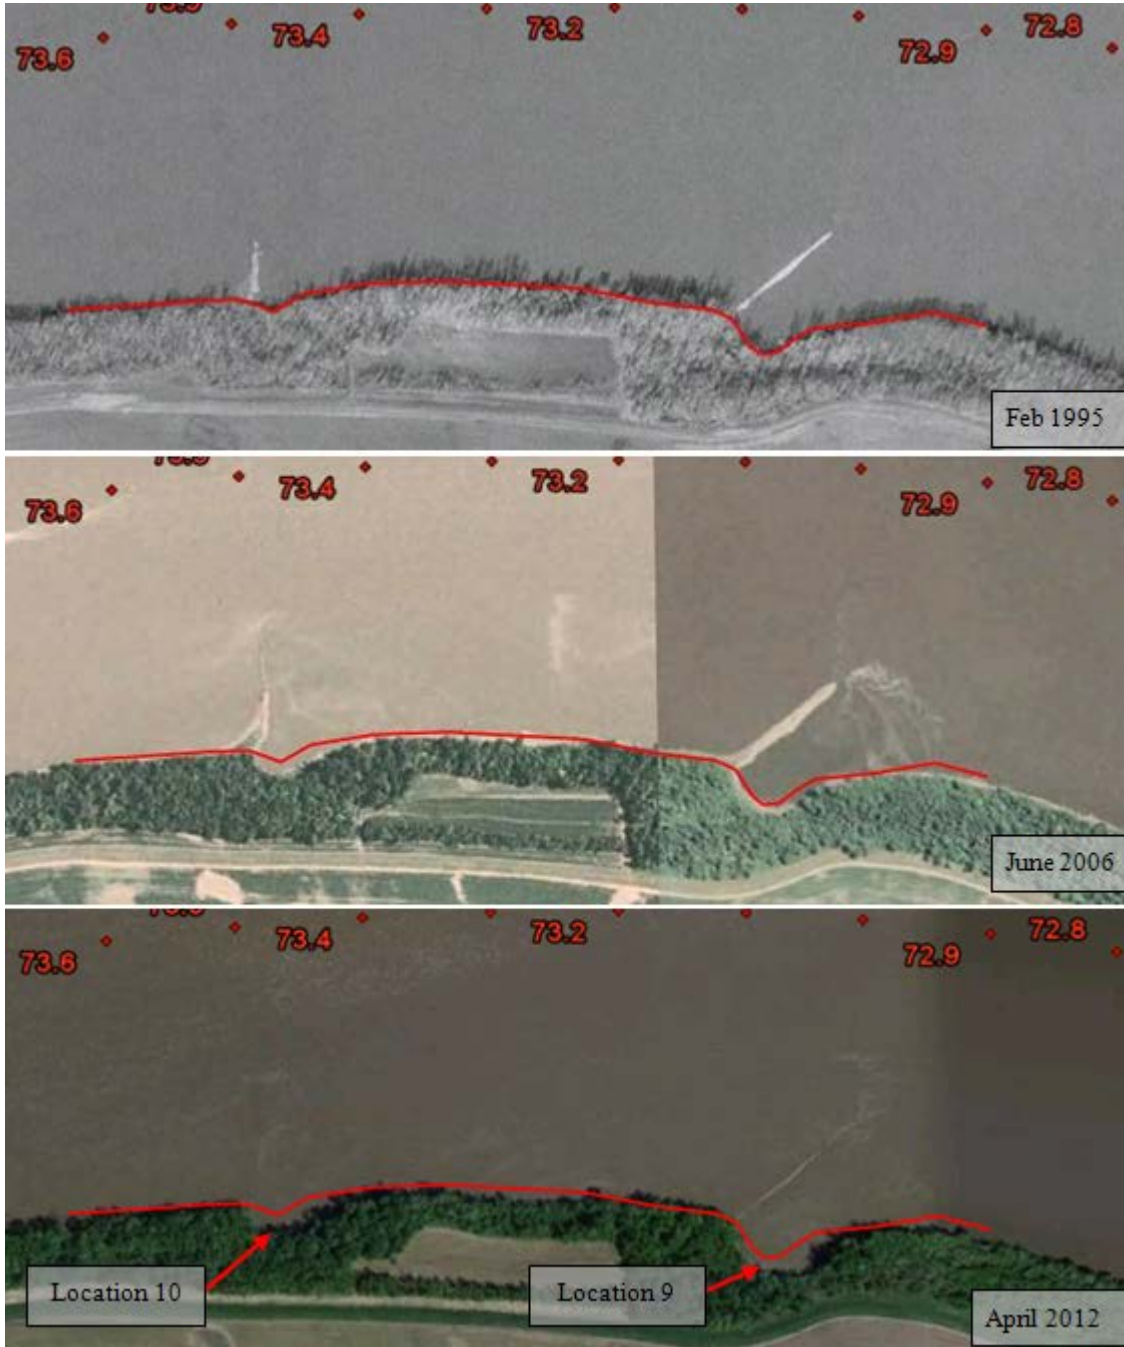
**Figure 2-9(d): Aerial Photo Comparison at Locations 9 and 10 from 1995 to 2012**

Photos from 1995 to 2012 were analyzed to determine movement of the bank line. The red line indicates the bank location during February 1995. These photos are shown in Figure 2-9(d).

Erosion over the 17 year period is apparent near the root of each dike at both locations. Since the notches are small (20 ft wide), located 300 to 400 ft away from the bank, and the erosion is near the root of the structures, it is unlikely the notches are the cause of the bank erosion. The worst erosion occurred at Location 9 which was repaired in 2009. The repair should help prevent additional erosion.

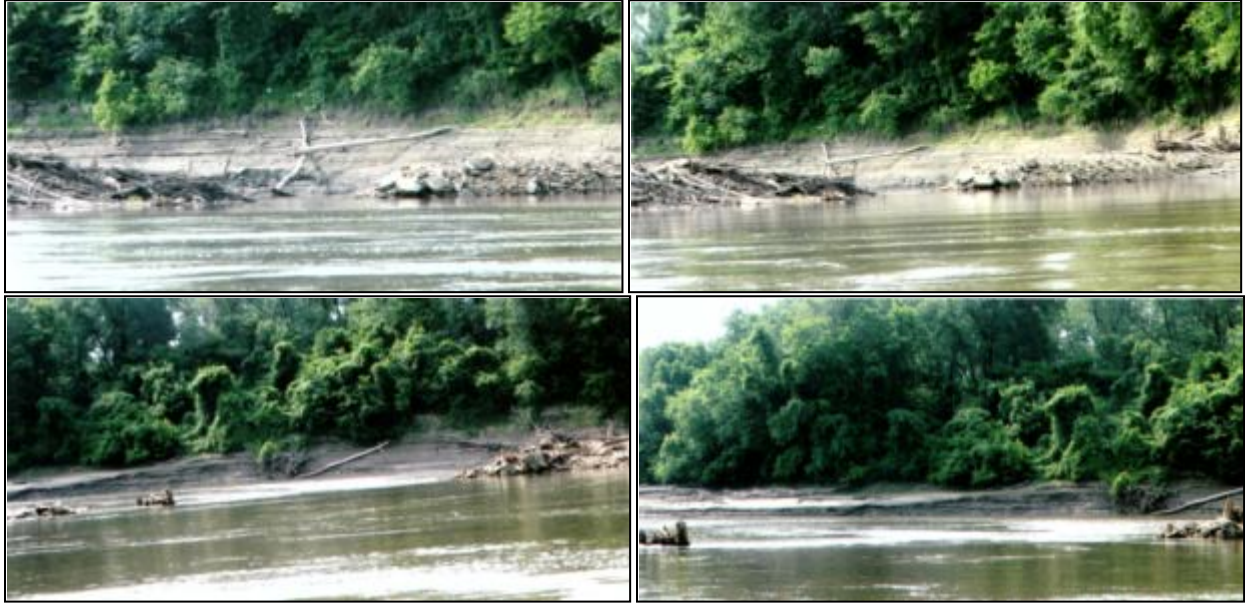
**Figure 2-10(a): Submitted Photos for Location 11**

At Location 11, Mr. Kuenzel stated, “MM 78 right bank very heavy erosion. In same area MM78 right bank Railroad tracks is real close here.” His submitted photos can be seen in Figure 2-10(a).

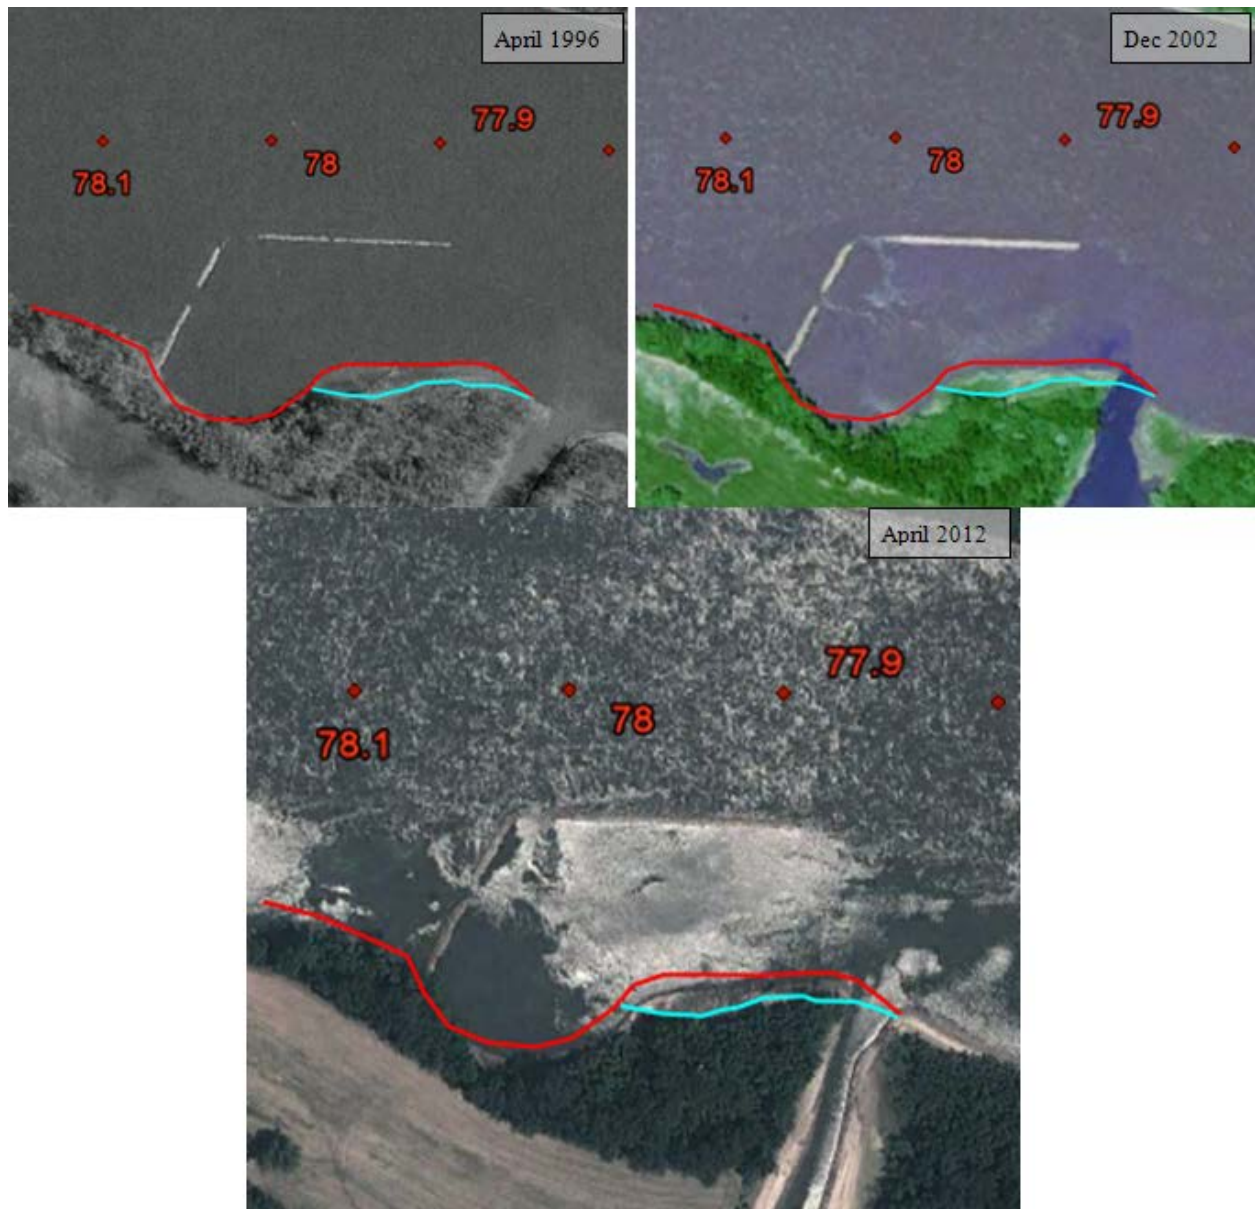
**Figure 2-10(c): Aerial Photo Comparison at Location 11 from 1996 to 2012**

Photos from 1996 to 2012 were analyzed to determine movement of the bank line. The red line indicates the bank location from April 1996. The bank line downstream of the dike is a sloping bank and therefore water's edge will vary greatly depending on water level. The blue line indicates the tree line, which is a better visual reference for fluctuating water levels. These photos are shown in Figure 2-10(c).

The bank has moved less than 50 feet at its greatest point over the 16 year period and the bank is over 650 feet from the railroad tracks at this location. The notch in the dike is a medium notch and located approximately 250' from the bank. The notch in the revetment small and located over 600 feet from the bank. Both notches were constructed in the late 1970's. Due to the size and locations of the notches, they are unlikely the cause of the bank erosion. The bank will be monitored for additional bank movement and the notch filled or moved riverward if determined to be the cause of erosion.

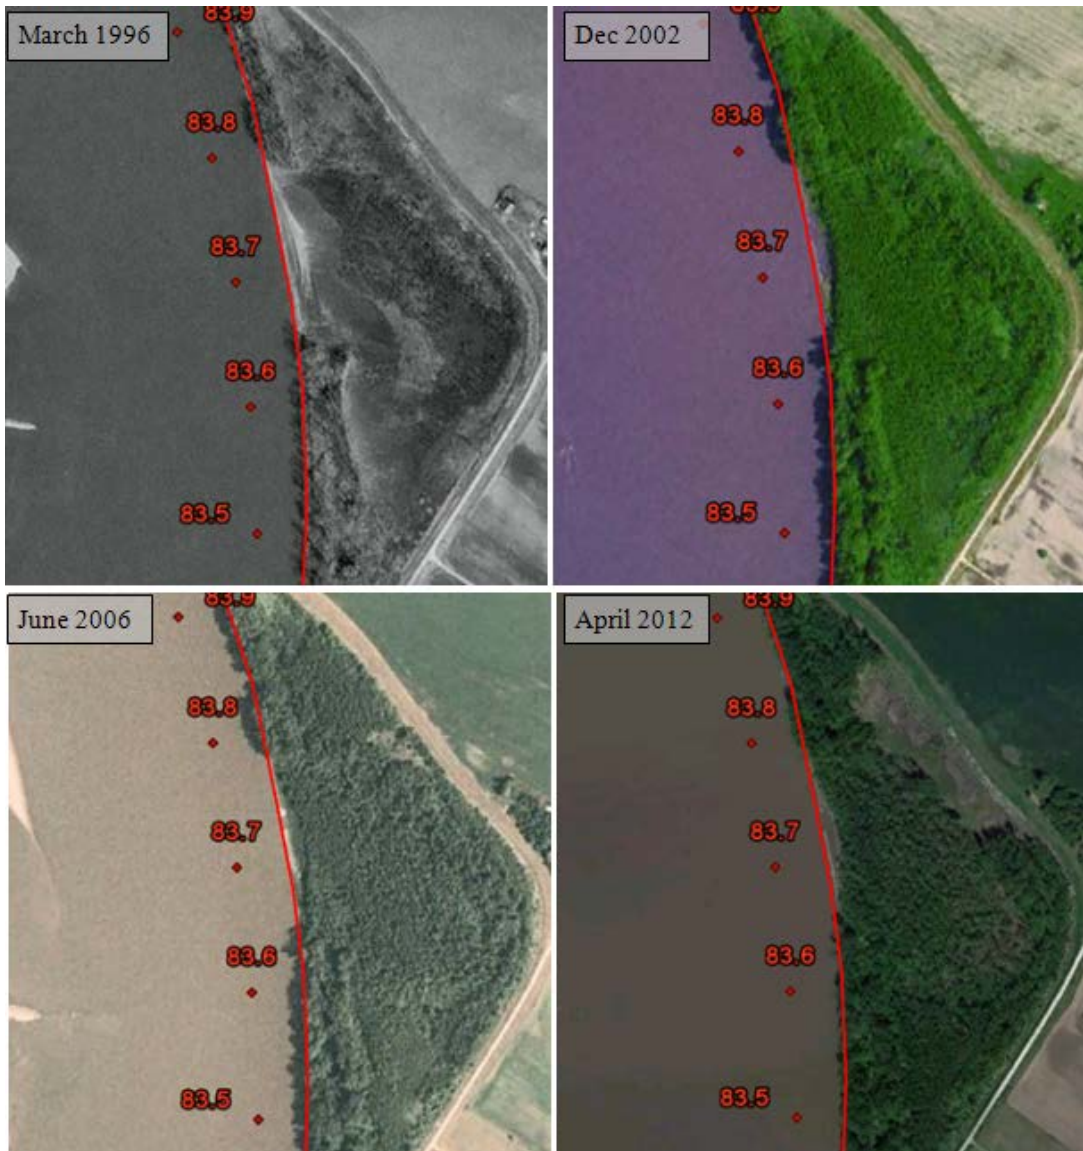
**Figure 2-12(c): Aerial Photo Comparison for Location 12 from 1996 to 2012**

Photos from 1996 to 2012 were analyzed to determine movement of the bank line where the notch is located. The red line indicates the bank location during March 1996. In the 1996 photo, it appears that a scour hole developed during the 1993 or 1995 floods and the levee was relocated around the scour hole. The exact aerial extent of the scour hole is unclear in the 1996 photo. These photos are shown in Figure 2-12(c).

The scour hole from the 1993 or 1995 flood has almost completely filled in. It does not appear that the notch has caused any erosion. The notch was created to connect the aquatic area landward of the revetment to the river. Since the notch was placed for aquatic connectivity and not bank erosion, only one 50 foot wide notch was placed in the location

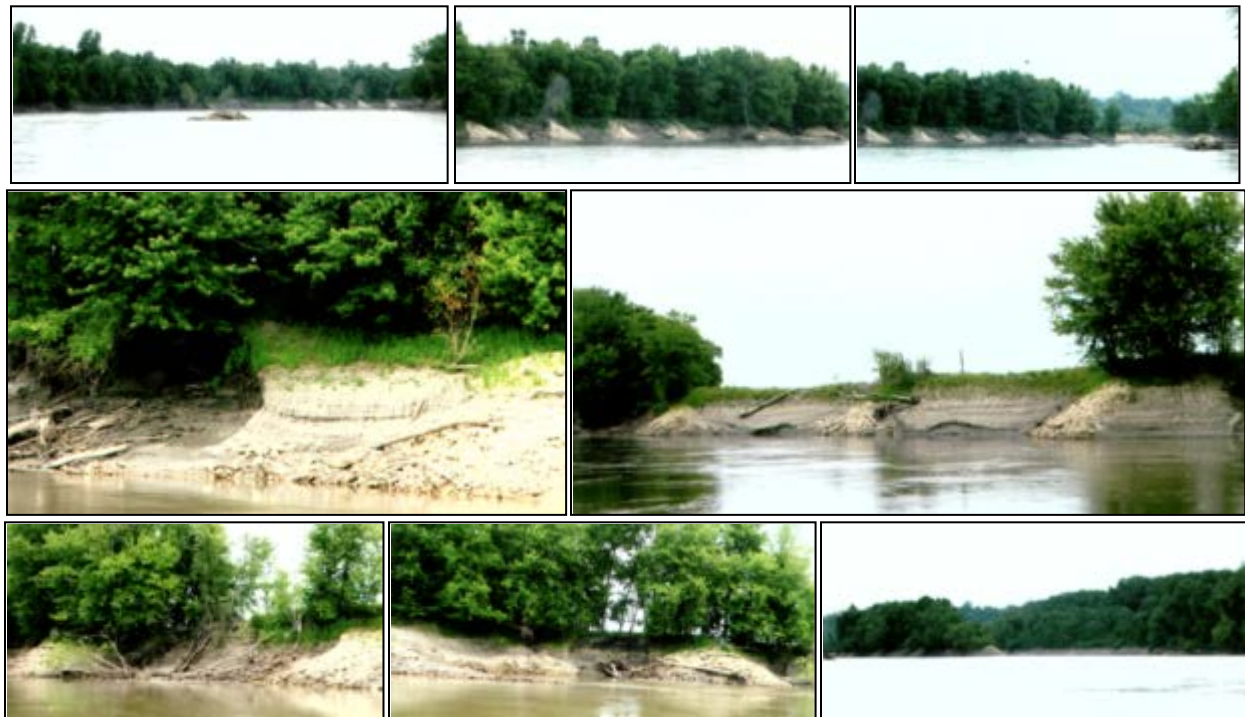
**Figure 2-14(a): Submitted Photos for Location 15**

Kuenzel also stated, “MM 93 left bank show more pictures of the hard points that have been put in but still not working right because bank erosion down stream is very bad. MM 93 left bank side channel about 75-100 yards long and about any where from 2-5 feet deep for about 1/3 of the distance from the main river channel.” Lastly, Mr. Kuenzel stated, “Please note Dan Kuenzel farms a 60 mile stretch of the Mo river and the pictures here on only on about 35 miles of river. Another note to point out that mile marker 93 has been a big problem for 20 years and the CORP has done very little to fix this. All that has been done is put a dike at the top of the side channel that was there originally to stop the water from going through. But this would to easy and this is not what they want.” His submitted photos can all be seen in Figure 2-14(a).

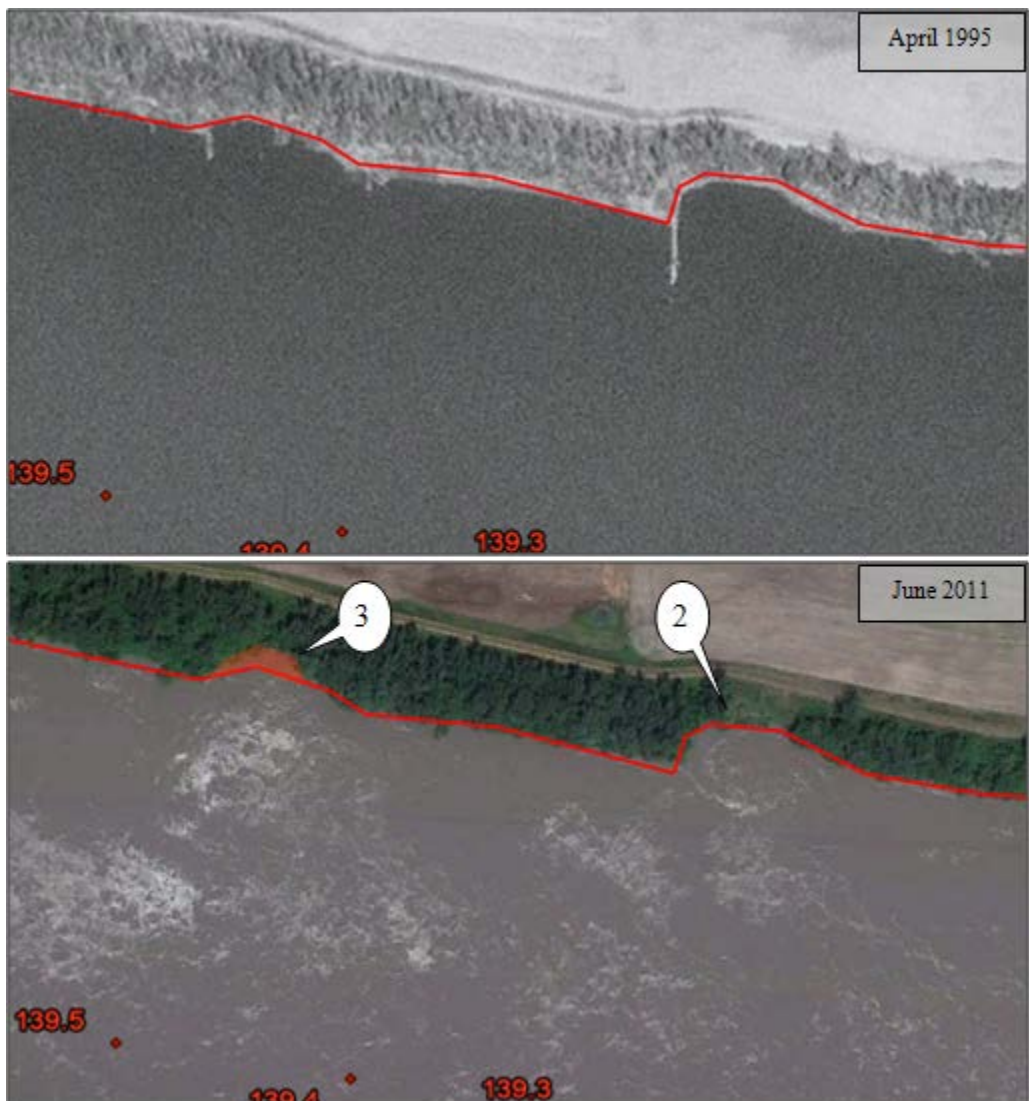
Figure 2-17(d): Aerial Photo Comparison at Locations 2 and 3

The change in the bank line for Location 2 and 3 was analyzed by comparing aerial photos from 1995 to 2011 as seen in Figure 2-17(d). The red line represents the bank line location in 1995. Location 2 shows no bank movement and Location 3 shows bank movement near the root of the dike as indicated by the red shaded area in the June 2011 photo.

Location 3 does not contain a notch and shows bank erosion near the root of the structure. Location 2 contains a small notch out on the structure and shows no bank erosion. Location 1 contains a notch at the juncture of the dike and revetment and shows bank erosion near the root of the dike. It is unlikely the notch at Location 1 is the cause of the erosion near the root of the dike since the notch is small, located away from the bank, and slightly downstream of the erosion. The revetment (portion of the structure parallel to river flow) at location 3 is approximately 3 feet low and will be repaired when the next repair contract is in the area. All other structures in the area are up to grade.

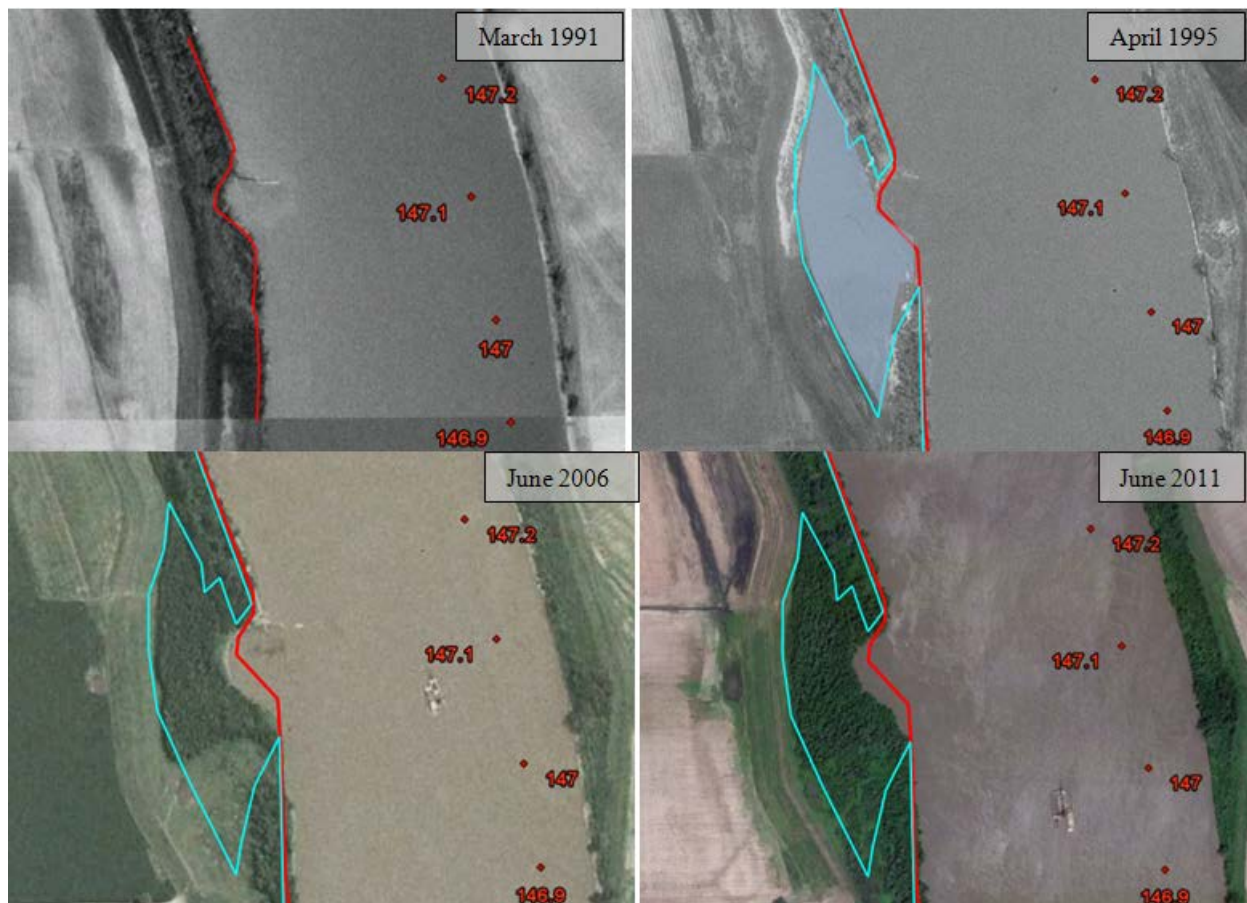
Figure 2-18(c): Aerial Photo Comparison Near Location 1 from 1991 to 2011

Aerial photos were compared from 1991 to 2011. As seen in Figure 2-18(c) it is evident that the bank line movement was caused by the scour hole which formed during the 1993 flood event. The red line indicates the bank line location in 1991 and the blue line indicates the bank line location in 1995.

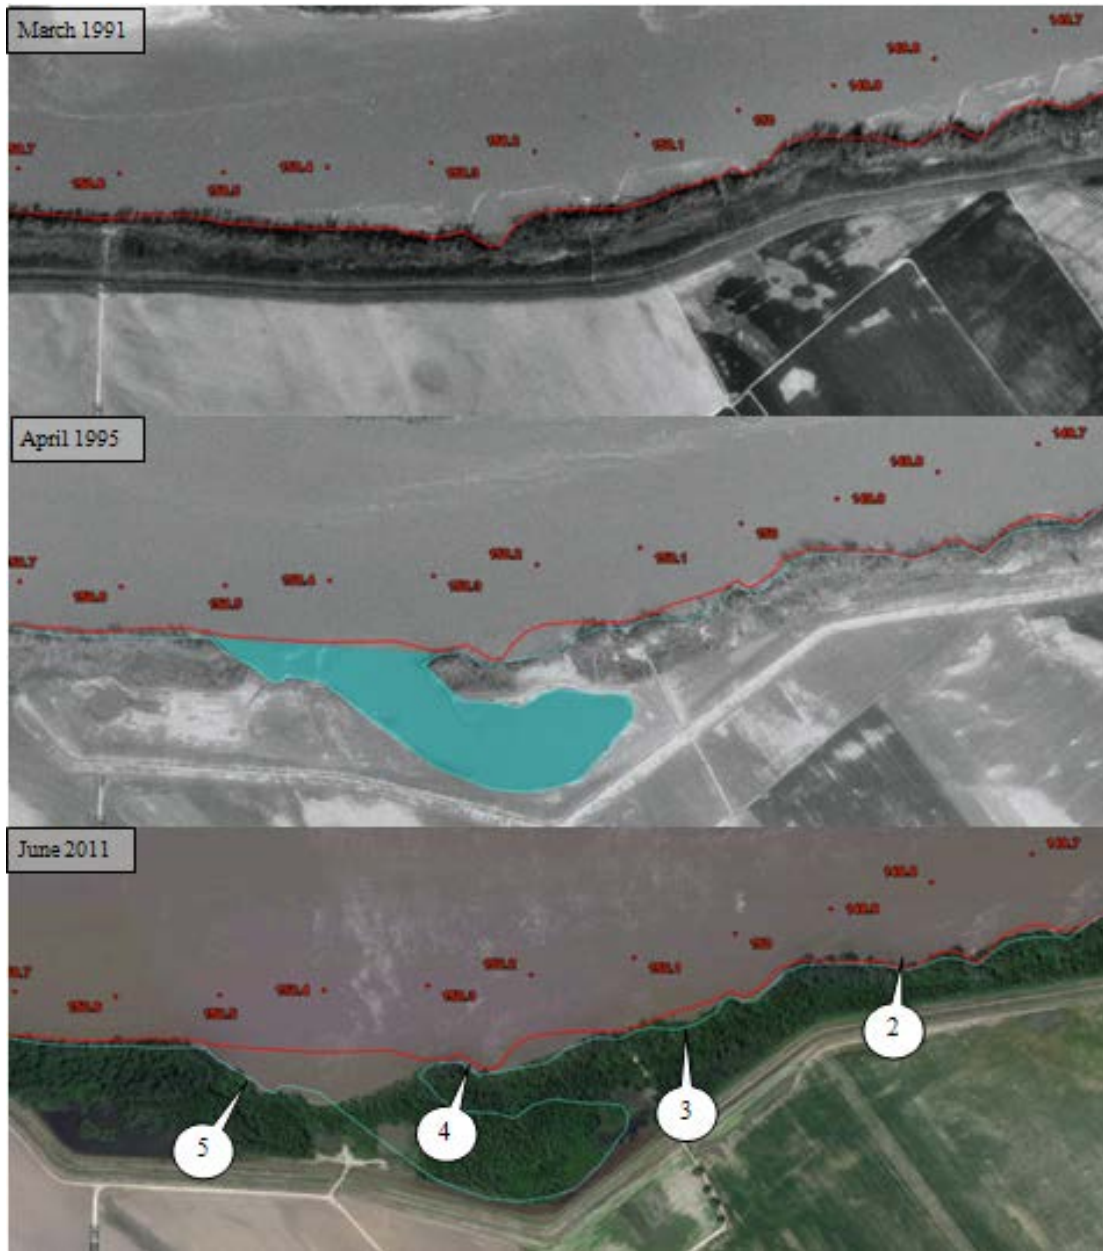
**Figure 2-18(e): Aerial Photo Comparison for Loaction 2-5 from 1995 to 2011**

As shown by the aerial photos in Figure 2-18(e), a scour hole formed at this location during the 1993 flood which resulted in significant bank erosion. The eroded area is shaded blue. Since the flood, the scour hole has partially filled and the bank has otherwise shown no movement.

Corps staff met on-site with Mr. Lepage approximately ten years ago. The analysis of all five locations shows no bank erosion since the formation of the scour holes during the 1993 flood. The scour holes have almost completely filled in. Since the bank erosion was due to the scour holes and the scour holes were due to flood events, the notches are not the cause of any bank erosion. Structure D157.5 is listed as deficient and will be repaired to design criteria. In addition, no other dikes in any of the areas identified have been lowered and are all maintained to design standards in place since 1974.

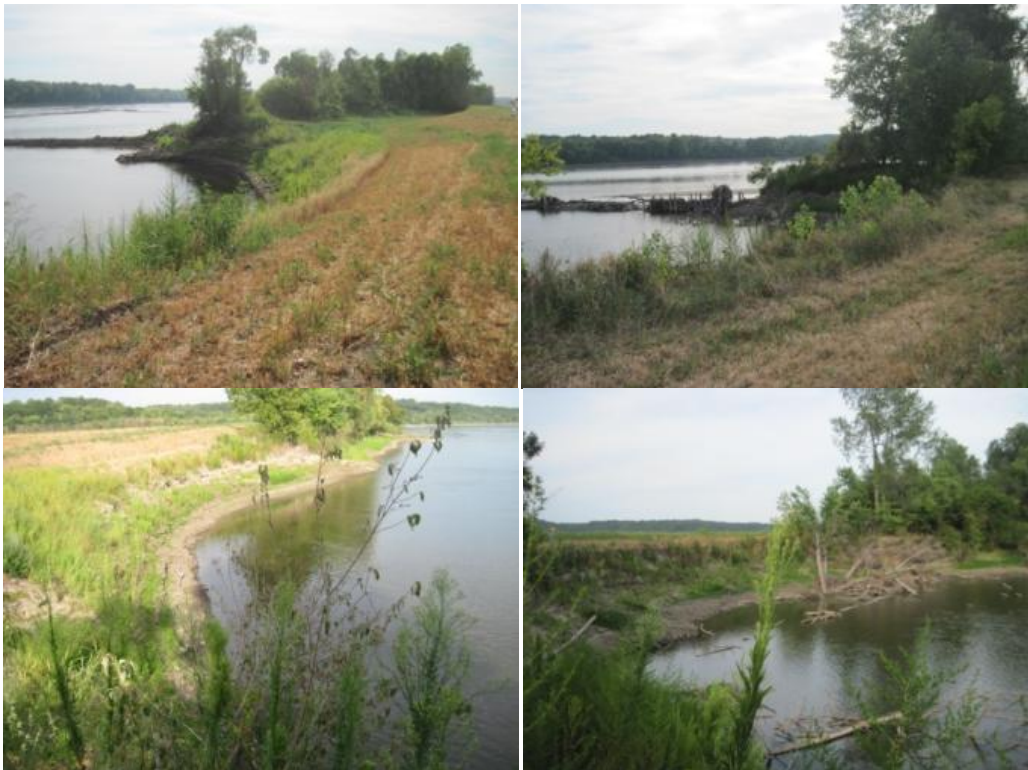
**Figure 2-19(a): Submitted Photos of Area of Concern between RM 163 and RM 164**

Stephen Diedrich submitted photos concerning the bank between river miles 163 and 164. He did not provide any specific location or contact information for further inquiry. However, based on Corps records and Mr. Diedrich's submitted photos, the area of concern has been determined to be the left descending bank, upstream of structure D171.5. Mr. Diedrich's submitted photos are shown in Figure 2.19(a).

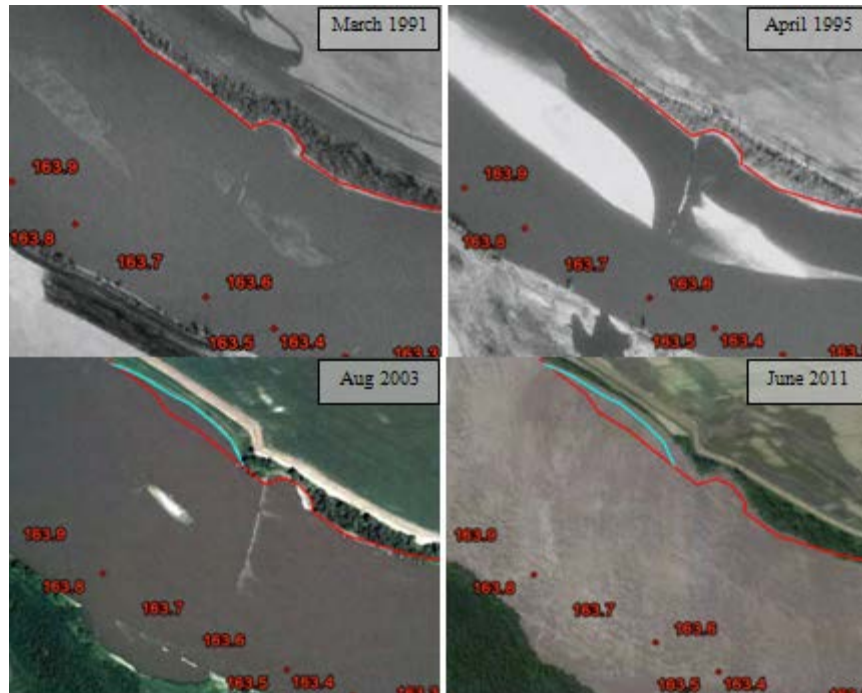
Figure 2-19(c): Aerial Photo Comparison for Area of Concern from 1991 to 2011

Aerial photos of the area were compared. The red line is the location of the bank in 1991 and the blue line is the location of the bank in 2003. Significant erosion occurred between 1995 and 2003. Additional erosion has occurred since 2003 as is evident in the 2011 photo near the downstream end of the blue line. The photos are shown in Figure 2-19(c).

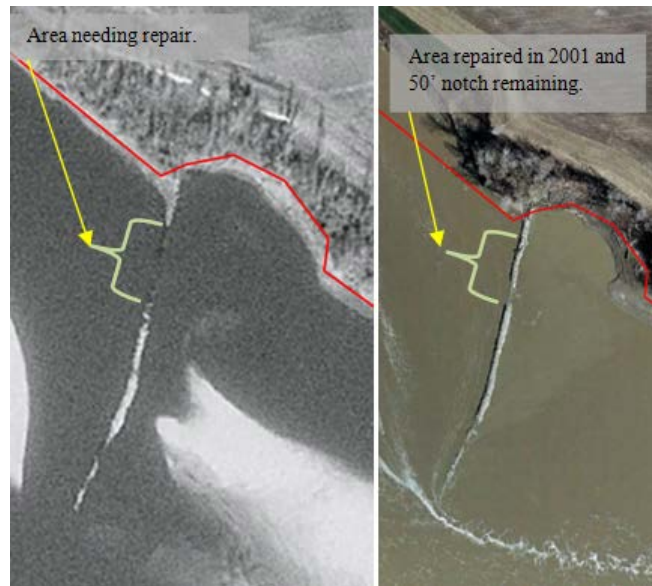
**Figure 2-19(d): Structure D171.5 Repair Details**

The notch closest to the bank was filled and moved riverward as part of the 2001 structure repair work. In Figure 2-19(d), the 1995 photo on the left shows the degraded portion of the structure and the 2006 photo on the right shows the repaired structure with the notch left at the current riverward location.
