Accident Investigation Report

Underground Salt Haul Truck Fire at the Waste Isolation Pilot Plant February 5, 2014

March 2014

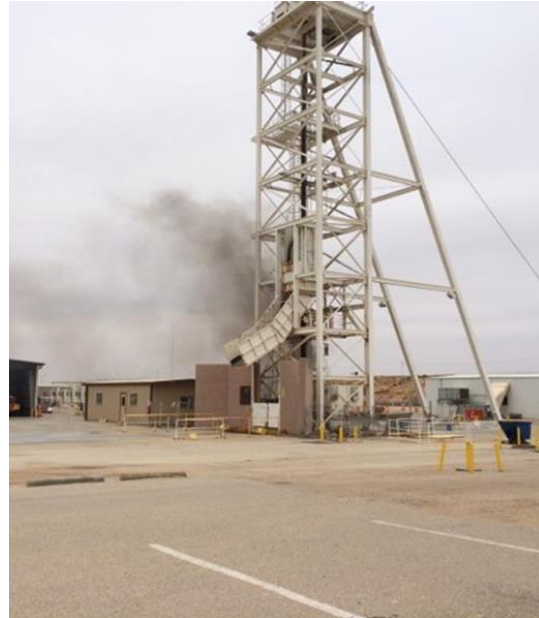
Figure 10: Smoke Visible Exiting through the Salt Shaft
