U.S. Department of Energy Office of Environmental Management

Accident Investigation Report

Phase 1 Radiological Release Event at the Waste Isolation Pilot Plant on February 14, 2014

April 2014

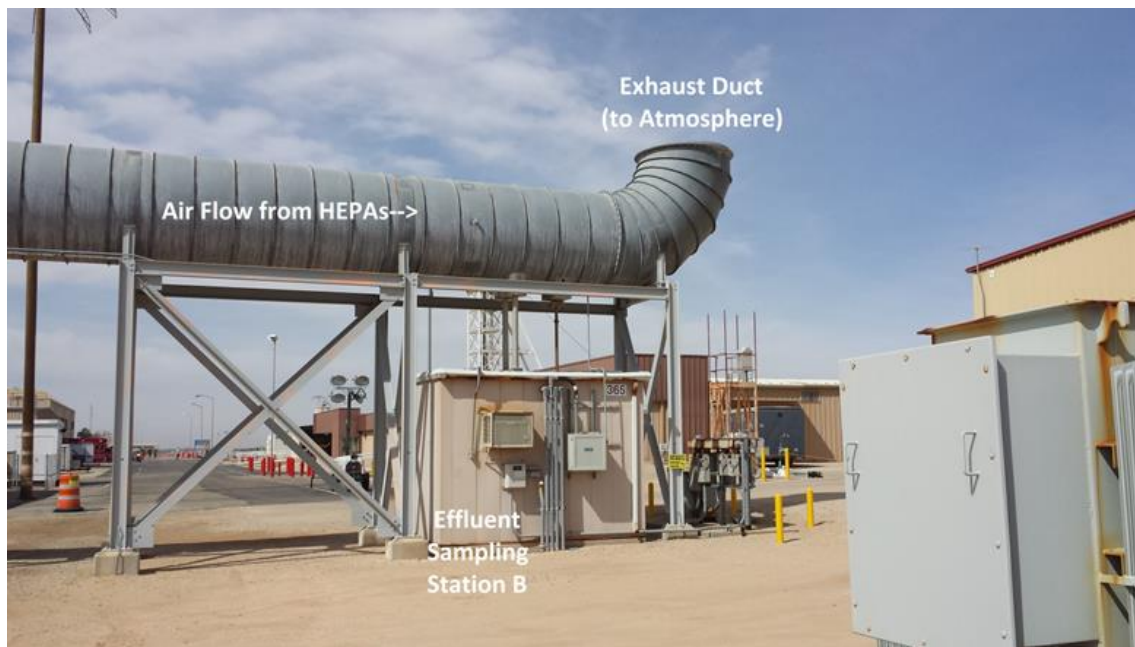
Figure ES-3: Station B and Exhaust Duct

Results from analysis of filters from the effluent sample station downstream of the HEPA filters (Station B) and at the discharge point to the atmosphere (Figure ES-3) were reported at 0915 and indicated 28,000 dpm alpha and 5,900 dpm beta contamination. This was the first indication that there was a release of contamination downstream of the HEPA filters to the environment.
