Bureau of
Safety and
Environmental
Enforcement

QC-FIT EVALUATION OF CONNECTOR AND BOLT FAILURES SUMMARY OF FINDINGS

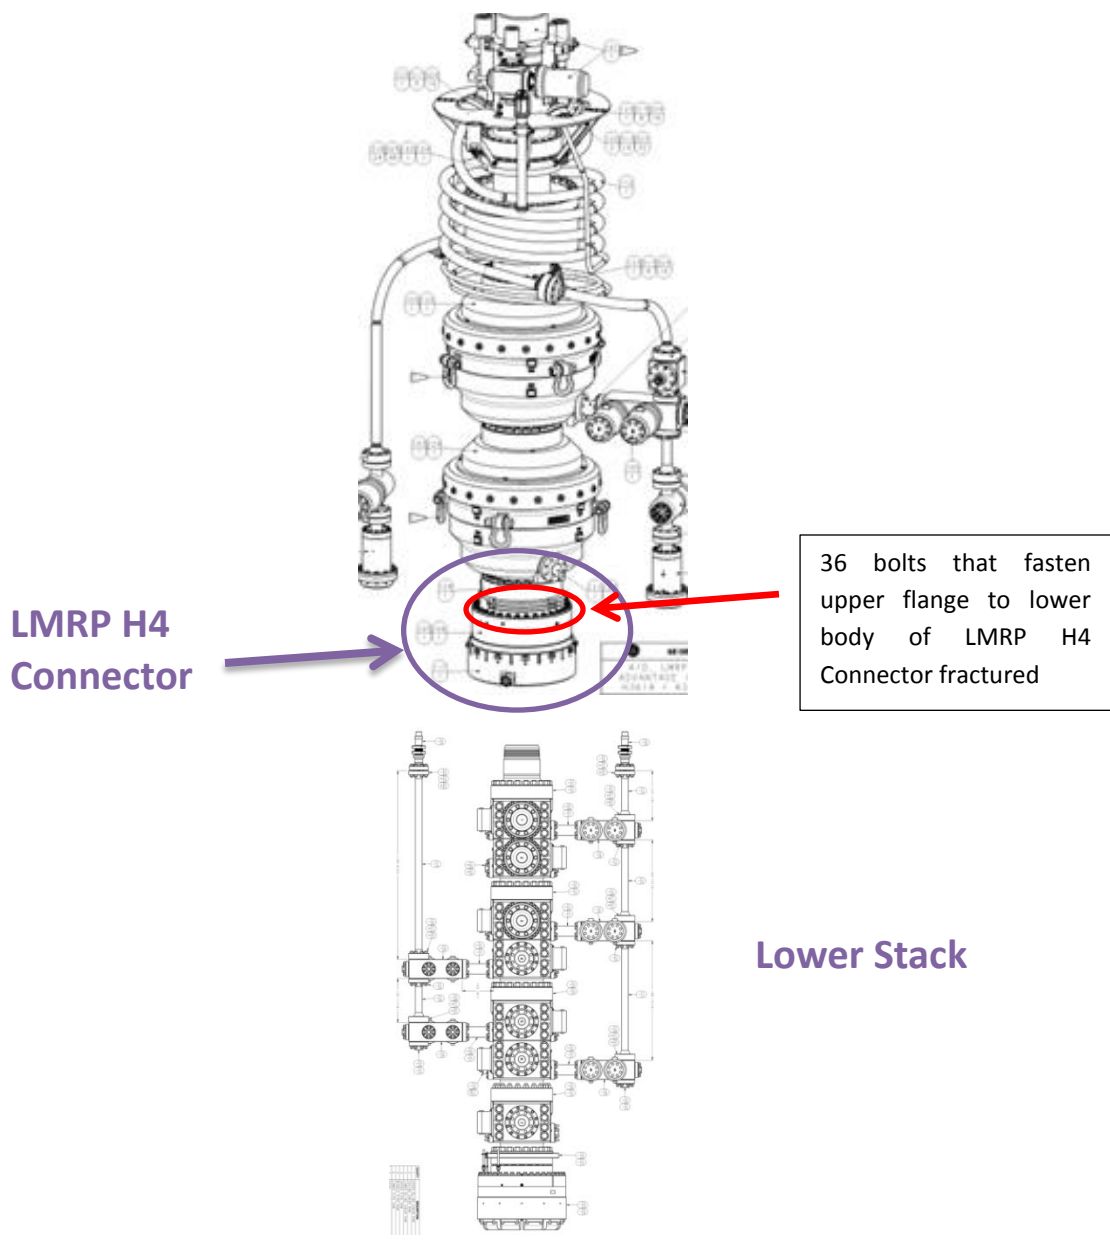
FIGURE 2 - SCHEMATIC OF LMRP H4 CONNECTOR AND MANDREL INDICATING LOCATION OF 36 CONNECTION BOLTS, DEPICTING SEPARATION (REF. 2013 GE PRESENTATION TO BSEE) GE COPYRIGHT, NON FOIA

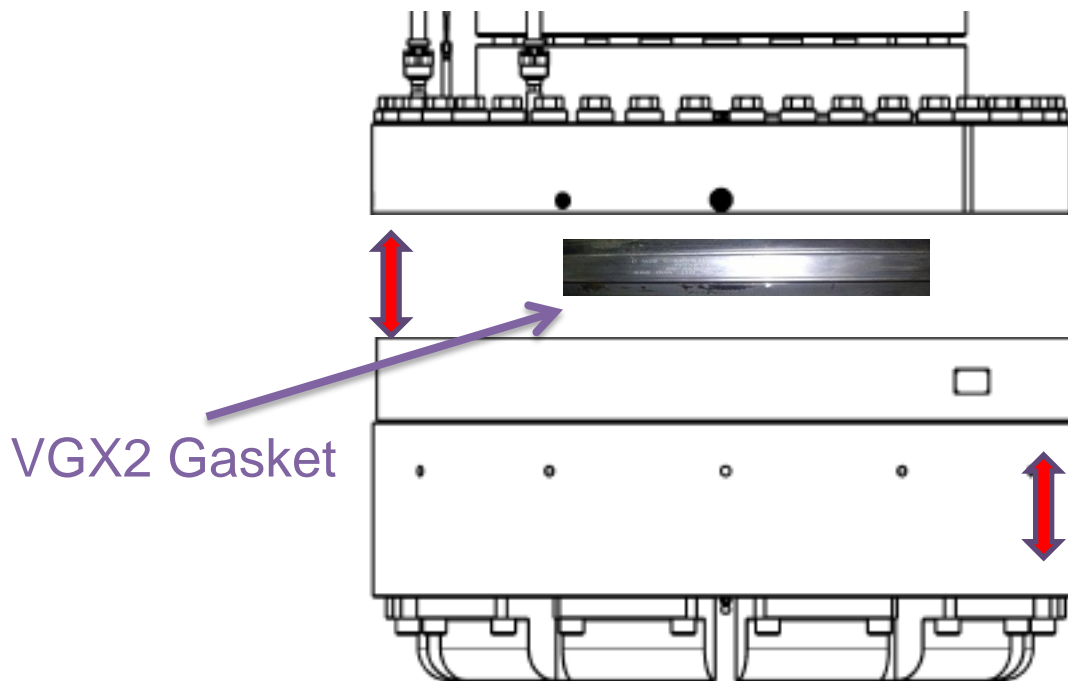
- The failure of the GE H4 connector bolts was primarily caused by hydrogen induced stress corrosion cracking (SCC) due to hydrogen embrittlement, which led to the fracturing of the installed bolts. This finding is consistent with the conclusions of the Transocean/Chevron/GE root cause analysis.

FIGURE 3 - SCHEMATIC DEPICTION OF LMRP H4 CONNECTOR SEPARATION. ALL 36 BOLTS THAT FASTEN THE CONNECTOR FAILED (REF. 2013 GE PRESENTATION TO BSEE) (GE COPYRIGHT, NON FOIA

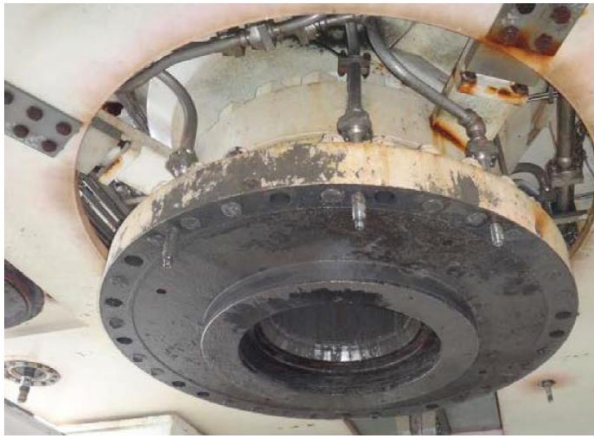
Upper half of failed LMRP Connector

BSEE. You should also consult with your contractors and subcontractors to determine the appropriate inspection, disposition and/or corrective actions. BSEE will require an independent third-party certification that confirms proper inspection and refurbishment processes were completed prior to reinstallation of any affected bolts.

Operators should review the QA/QC programs for all equipment vendors (contracted and sub-contracted) to ensure that all equipment is being manufactured to the required specifications. Special attention should be given to ensure proper heat treating has taken place in accordance with the specifications.

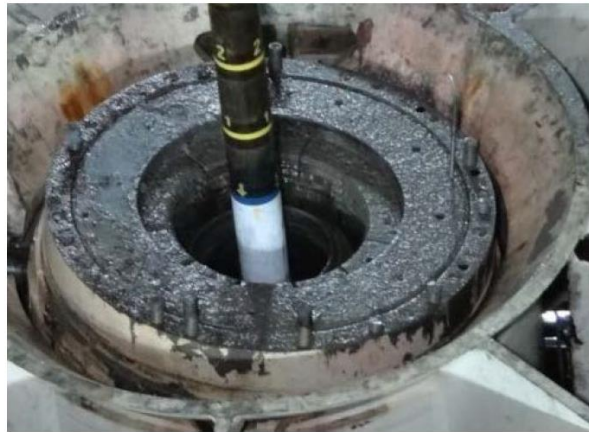
Lower half of failed LMRP Connector

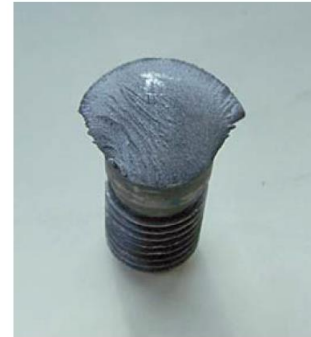
Fig. 3 — Hydrogen embrittlement and failure of a hard chromium-plated chain conveyor bolt.

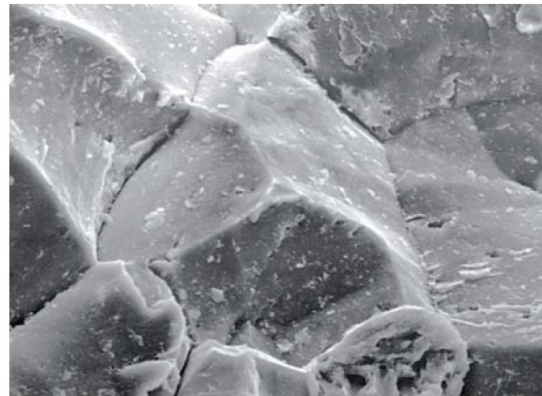
Fig. 4 — Intergranular fracture due to hydrogen embrittlement (photo courtesy of Aston Metallurgical Services Co., Inc.).
