**TASK ONE:
ECONOMIC ANALYSIS
OF HANGARS 113, 114, AND 115
NAVAL AIR STATION (NAS)
JACKSONVILLE, FL**

**SUB-TASK 4:
FINAL ECONOMIC
ANALYSIS**

**Prepared for:
NAVAL FACILITIES AND ENGINEERING COMMAND
SOUTHEAST
NAVAL AIR STATION JACKSONVILLE
JACKSONVILLE, FLORIDA**

SEPTEMBER 2013

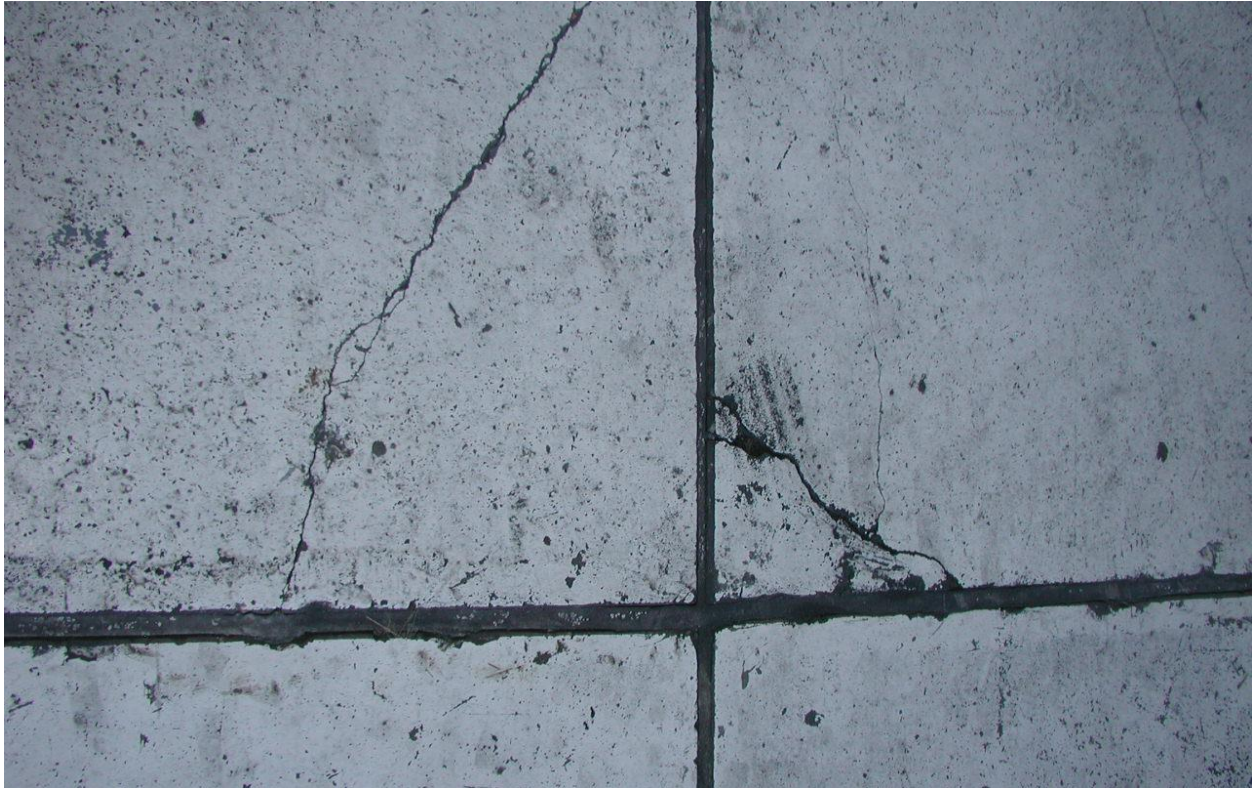
Substructure. The substructure includes the building foundation and concrete floor slabs. The project team's historic architect did not observe any areas with foundation settlement problems and NAS JAX staff did not indicate any foundation issues. Intermittent cracking and spalling was observed in the floor slab (Figures 8 and 9), but those conditions do not significantly impact use of the facility. Floor areas that are in need of repair appear to constitute less than five percent of the floor area.

Figure 8. Typical example of minor cracking in concrete floor slab (Mr. Richard Simonton, 2013).

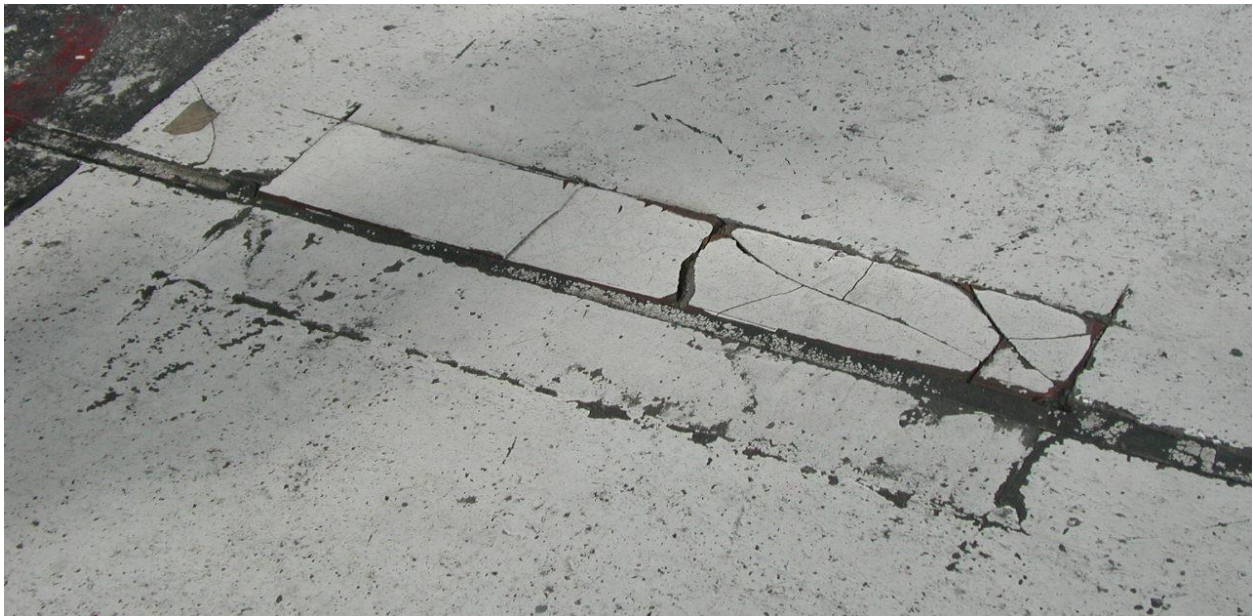
Figure 9. Typical example of minor spalling in concrete floor slab (Mr. Richard Simonton, 2013).

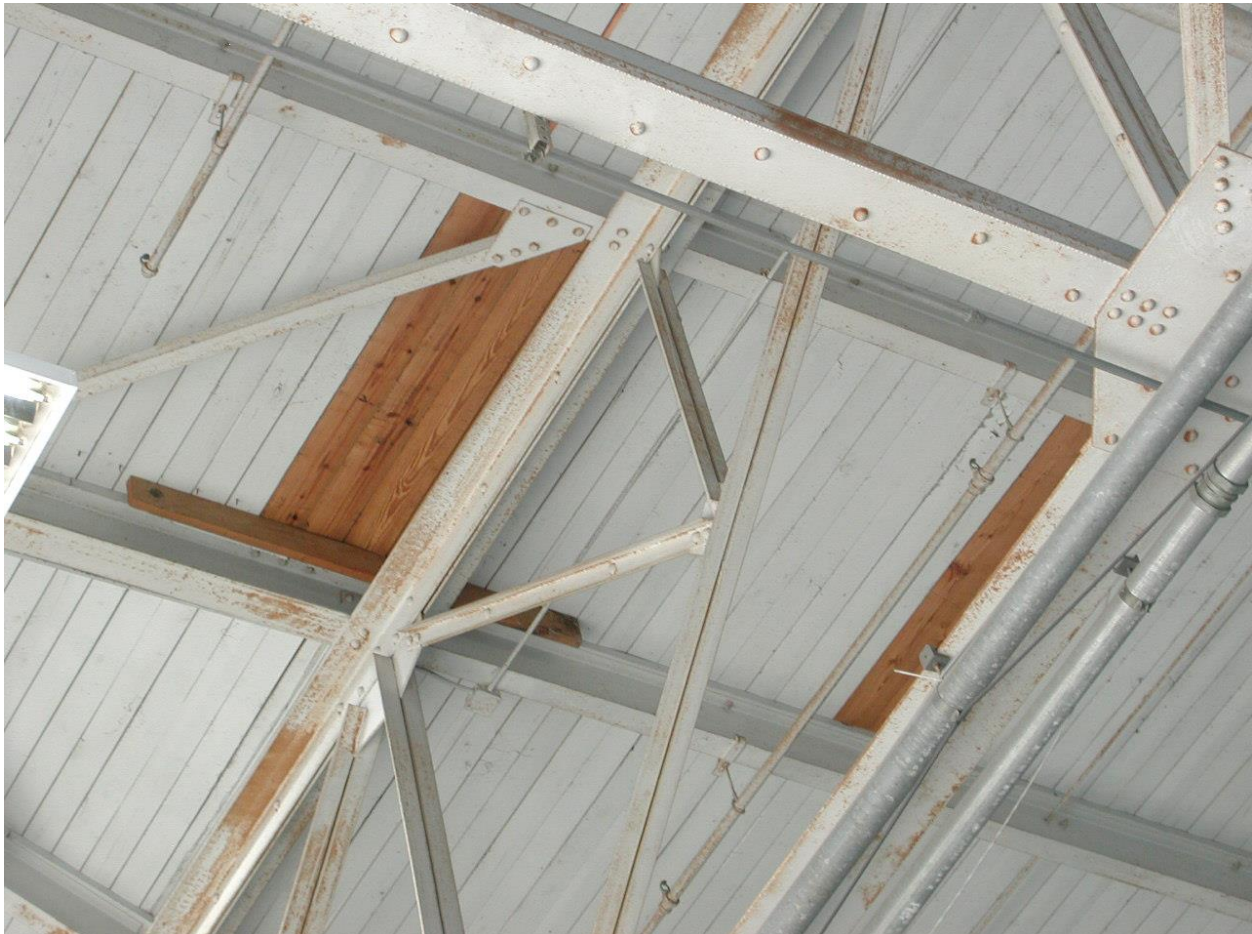
Figure 10. Typical example of spotted corrosion and wood roof deck replacement on Hangar 113 (Mr. Richard Simonton, 2013).

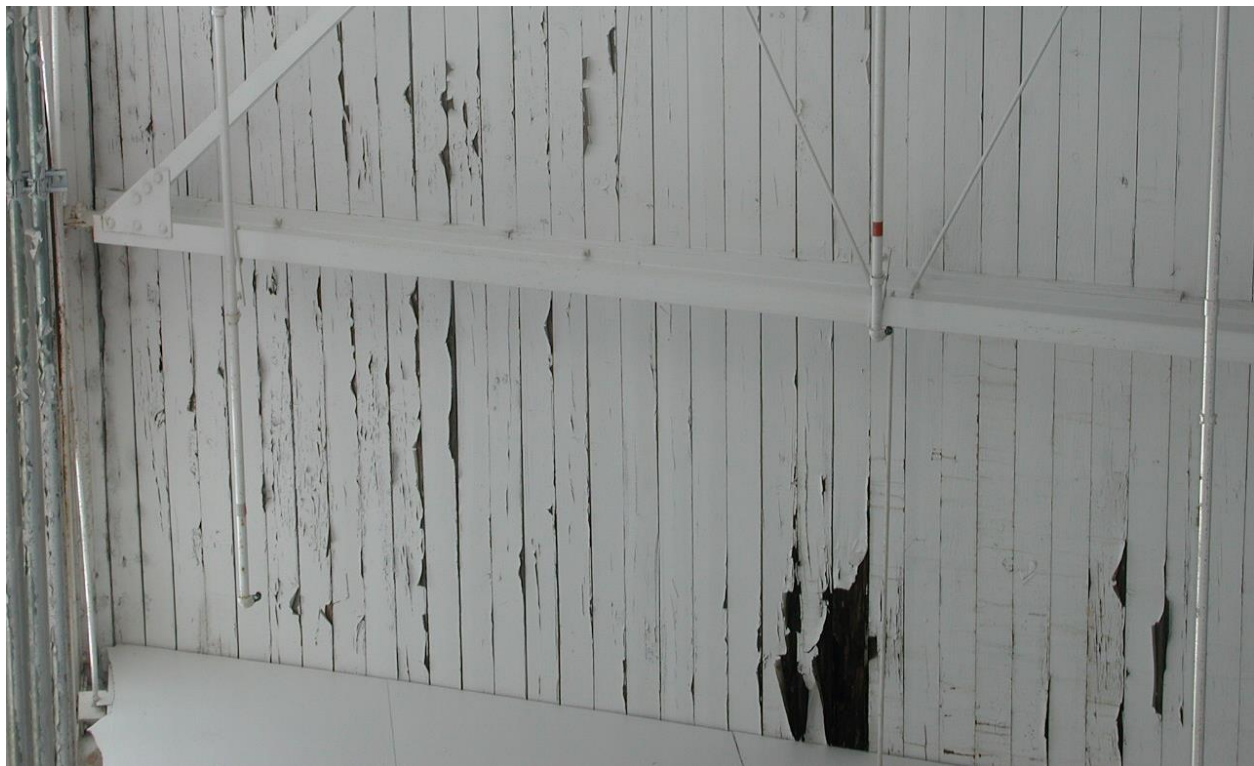
These hangars have a history of roof leaks that have resulted in rotting of the wood roof deck. In particular, NAS JAX maintenance personnel have cited problems with leaks at clerestories (Mr. Troy Thompson, personal communication 2013; Figure 11). There are numerous locations where rotten wood is visible from below, but these areas

Figure 11. Peeling paint indicating possible moisture damage at wood deck above sawtooth clerestory (Mr. Richard Simonton, 2013).

do not appear to be extensive. From observation of the underside of the deck it appears that the majority of rotted wood has been replaced, however that could be deceptive. Without removing the existing roofing, the top side of the wood decking cannot be visually evaluated. For estimating purposes is prudent to include some wood deck replacement in the Full Rehabilitation and Partial Rehabilitation scopes.

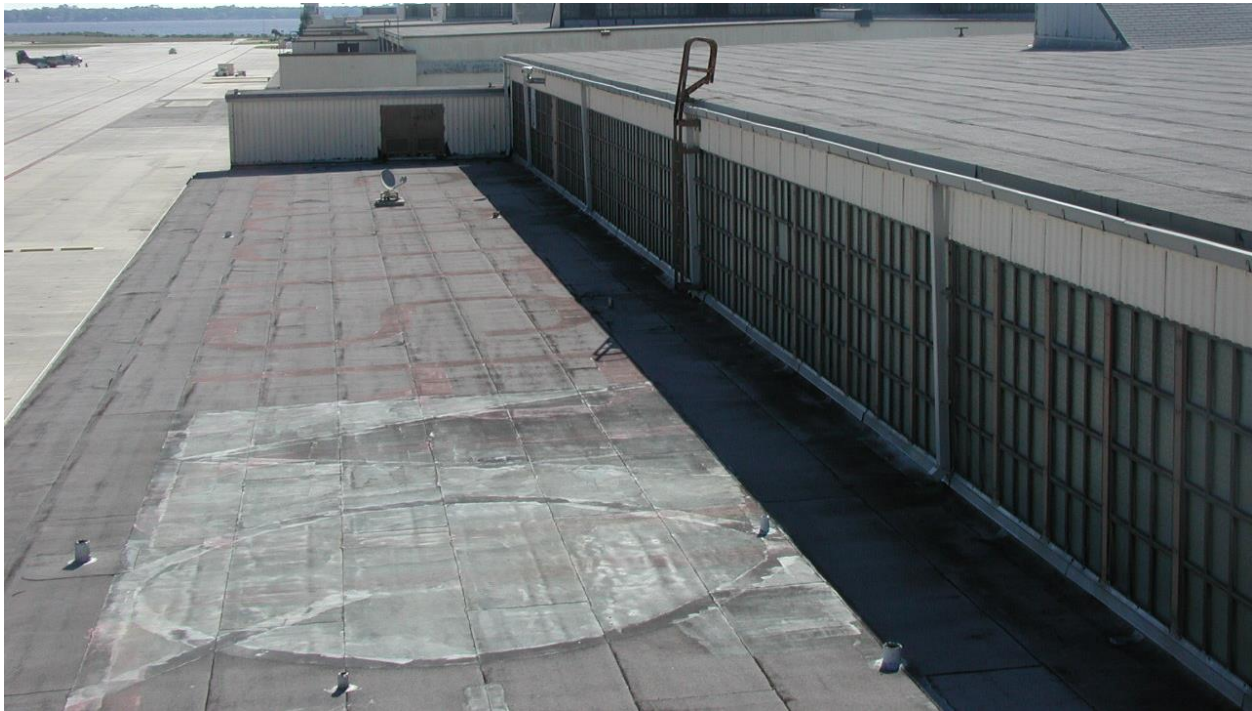
Roofing. Roofing includes roofing membranes, roof insulation, flashing and trim gutters and downspouts, sawtooth clerestory glazing, and soffits. Nearly all of these roofing components are at the end of their useful service life (Figure 12). The roofs do not currently leak, but there are frequent service calls to repair them (Mr. Troy Thompson, personal communication 2013). Uncertainty with the structural integrity of the roof deck and the lack of safety tie-offs creates a safety problem for roof maintenance.

Figure 12. Existing modified bitumen roof near end of service life on Hangar 113 (Mr. Richard Simonton, 2013).

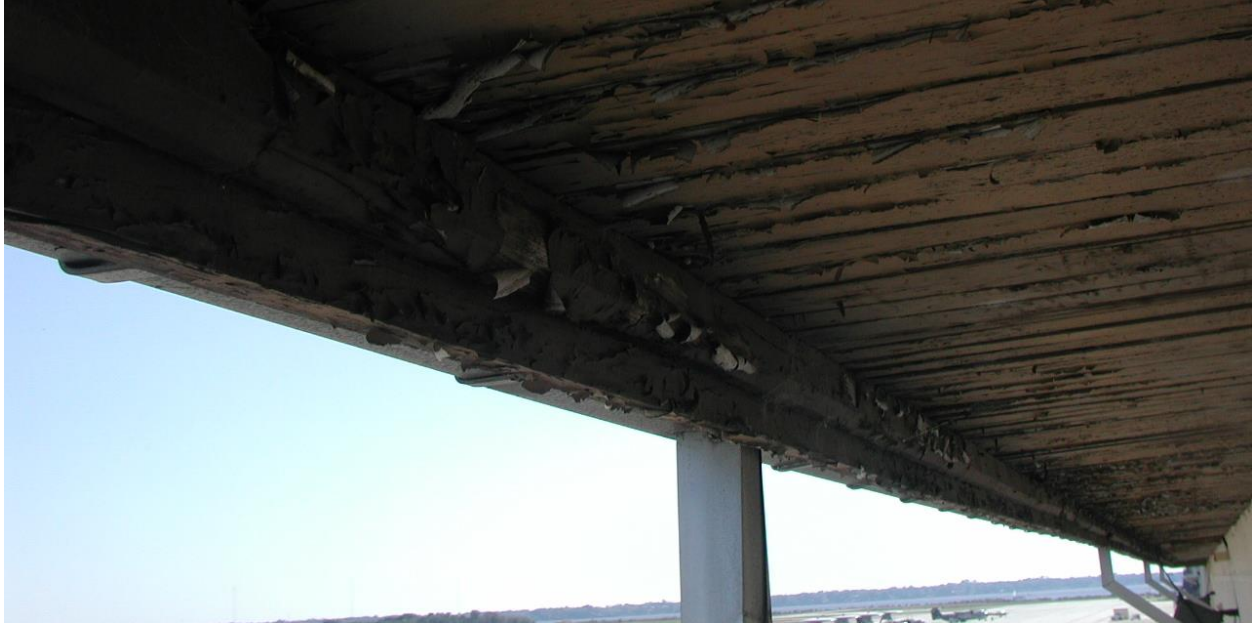
The existing hangars do not have any roof insulation which is in violation of the current Florida Energy Code. The tongue-and-groove wood soffits and fascia boards need repainting (Figure 13). The existing paint in these areas should be tested for lead content.

Figure 13. Severe paint peeling at wood tongue-and-groove soffit on north side of Hangar 113 (Mr. Richard Simonton, 2013).

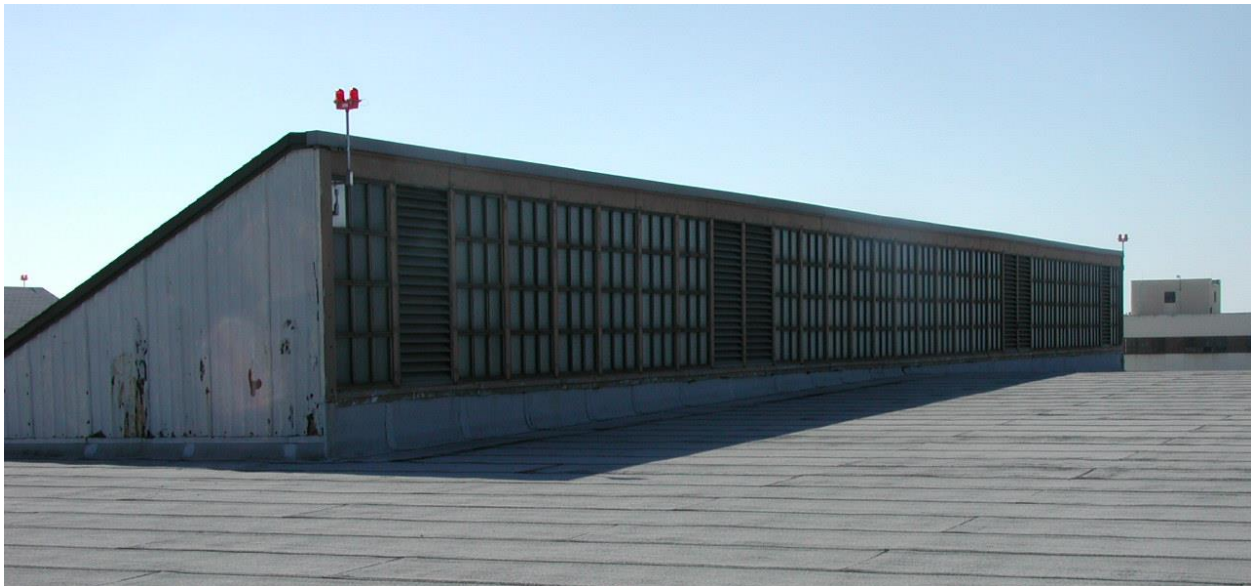
The original louvers and glazing are still intact at the large sawtooth clerestories on the roof at each end of the hangars (Figure 14). The project team’s historic architect was not able to get close enough to fully evaluate the condition of the assemblies, but it appears that repainting and re-glazing the assemblies are feasible.

Figure 14. Typical rooftop sawtooth clerestory (Mr. Richard Simonton, 2013).

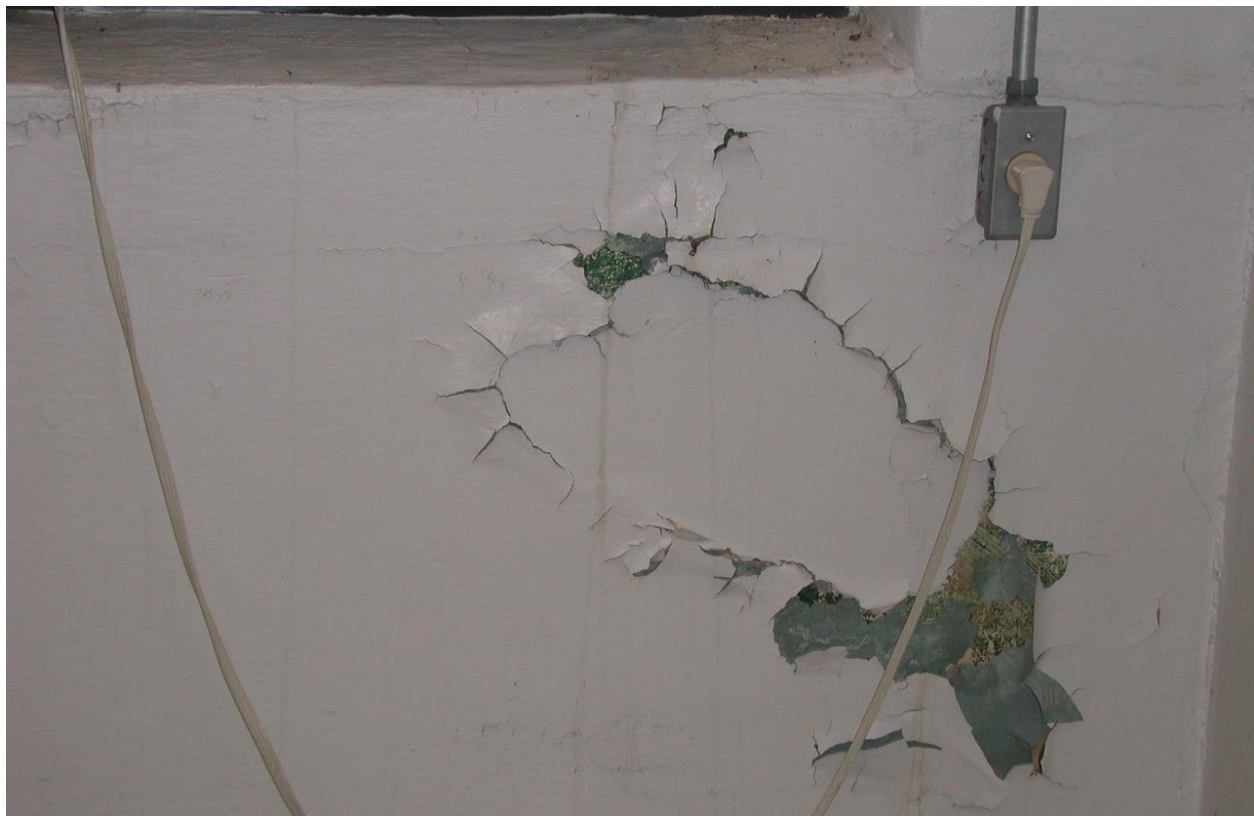
Approximately 80 percent of the wall finish on the north and south walls of the hangar is painted stucco. The stucco is applied over both the concrete masonry units (CMU) and the cast-in-place concrete knee walls. The auxiliary maintenance and administrative spaces flanking the high-bay hangar space were not originally air conditioned, and the hangars' building envelope was not designed to account for the temperature differential and vapor drive created by the subsequent addition of HVAC systems. The HVAC retrofits have caused moisture problems: peeling paint and some mold growth on the interior face of these exterior walls are apparent throughout each hangar (Figure 15). At least four possible contributing factors to the moisture problem are described below.

Figure 15. Example of moisture problems on interior face of exterior wall (Mr. Richard Simonton, 2013).

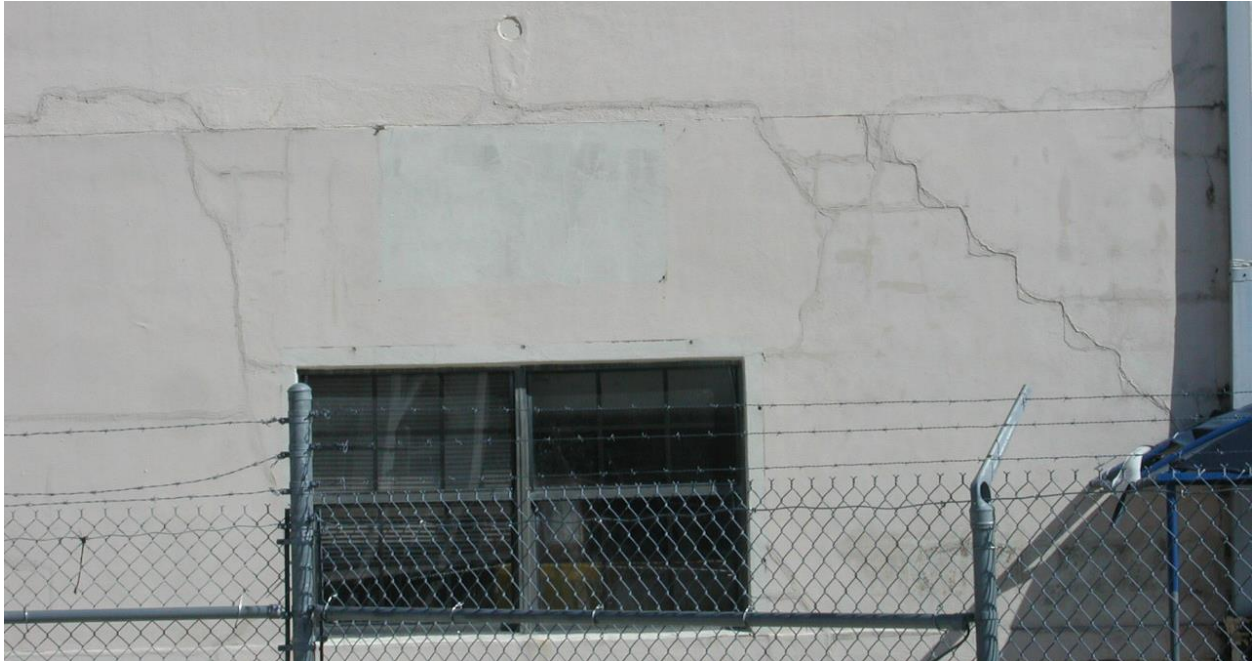
In several locations stair-step cracks are visible in the stucco (Figure 16). The most likely source of this cracking is differential movement between the structural steel building frame and the CMU wall construction. These cracks can transmit liquid water through capillary action and can also be a conduit for vapor diffusion. The porosity of the CMU and stucco wall system is likely contributing to the problem. Both materials absorb water

Figure 16. Example of exterior cracks in stucco and concrete masonry units at south elevation of Hangar 113 (Mr. Richard Simonton, 2013).

and will transmit water vapor to the interior of the building. The problem will be exacerbated if no moisture barrier was installed between the stucco and CMU (or if the barrier has deteriorated). Another factor is that the walls are not insulated. This contributes to the problem of water vapor condensing in unpredictable locations in a compromised wall system. The un-insulated walls also do not comply with the Florida Building Code. The last factor could be that windows and doors have been installed without sufficient flashing and are providing pathways for water-vapor entry into the wall system at these openings.

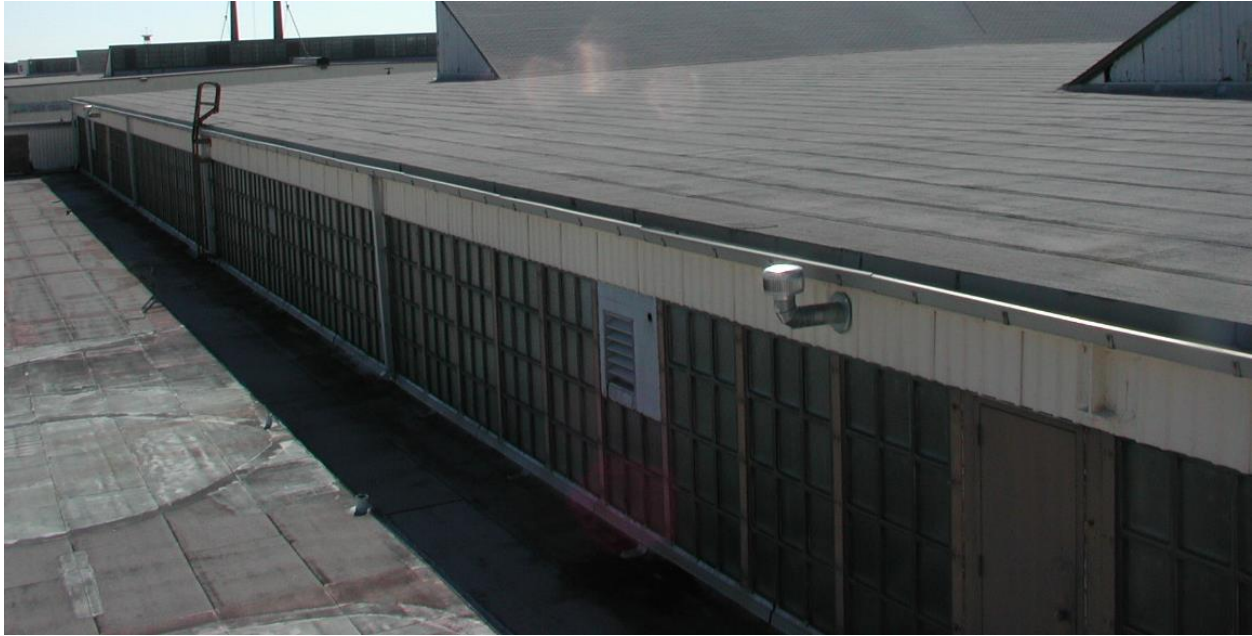
The original clerestory windows for the high-bay hangars on the north and south sides of the building remain and are in fair condition (Figure 17). Since the hangars are not air conditioned, the low performance of the single-glazed windows is not a significant issue. If the hangars are to remain, these windows should be retained as a historic feature.

Figure 17. Typical example of original clerestory windows remaining north and south sides of hangar (Mr. Richard Simonton, 2013).

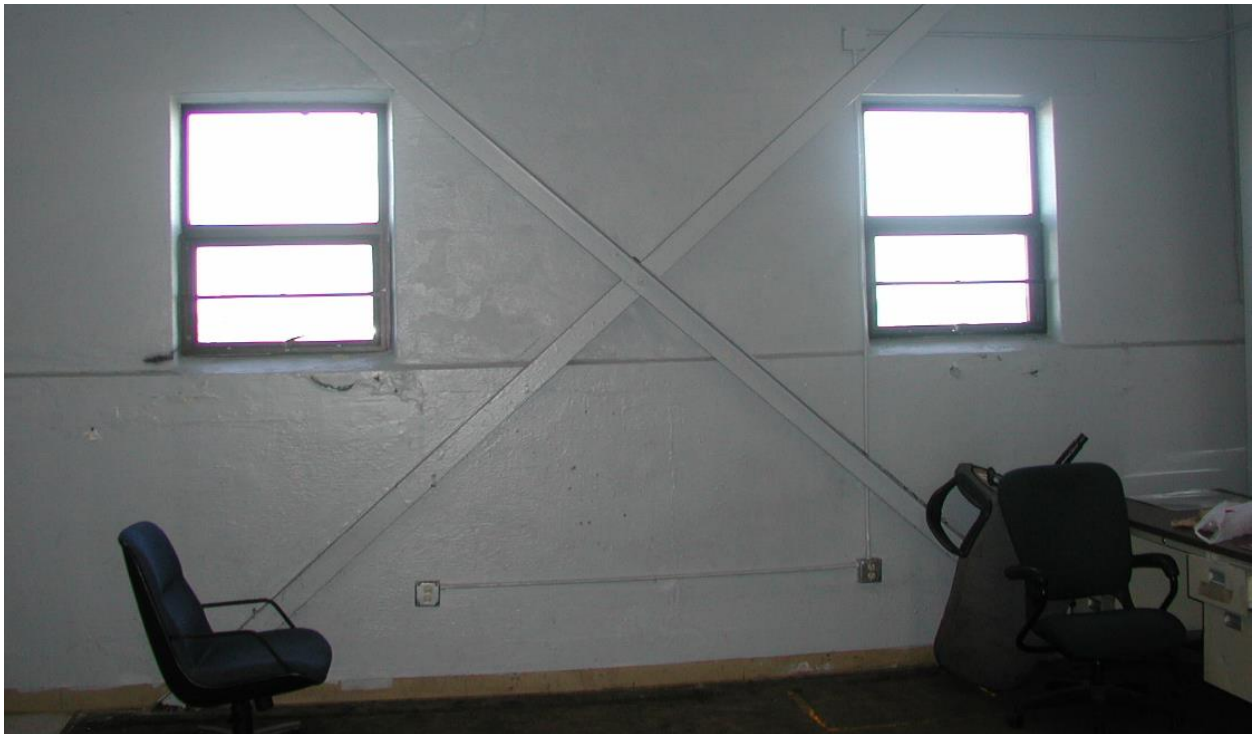
The original Albert Kahn drawings depict strip industrial windows on the north and south building elevations rather than the existing punched openings in concrete masonry. It is not clear if this deviation is the result of changes in the original construction or the result of subsequent renovation. Additional research could be undertaken to determine the original window configuration if the SHPO determines that documentation is needed for one of the alternative actions. The punched windows into the air-conditioned service and administrative spaces have been replaced with insulated double-glazed windows (Figure 18). These windows are in good condition, but they do not conform to the design of the six-over-six pane windows shown on some record drawings.

Figure 18. Typical replacement windows on north and south elevations (Mr. Richard Simonton, 2013).

None of the windows appear to be of blast-resistant construction to comply with minimum DoD antiterrorism standards. The windows would require upgrades to comply with current energy efficiency and antiterrorism standards if the hangar's use is changed or if the rehabilitation cost exceeds 50 percent of the Plant Replacement Value (PRV). The DoD defines PRV as the cost to replace facilities at current standards.

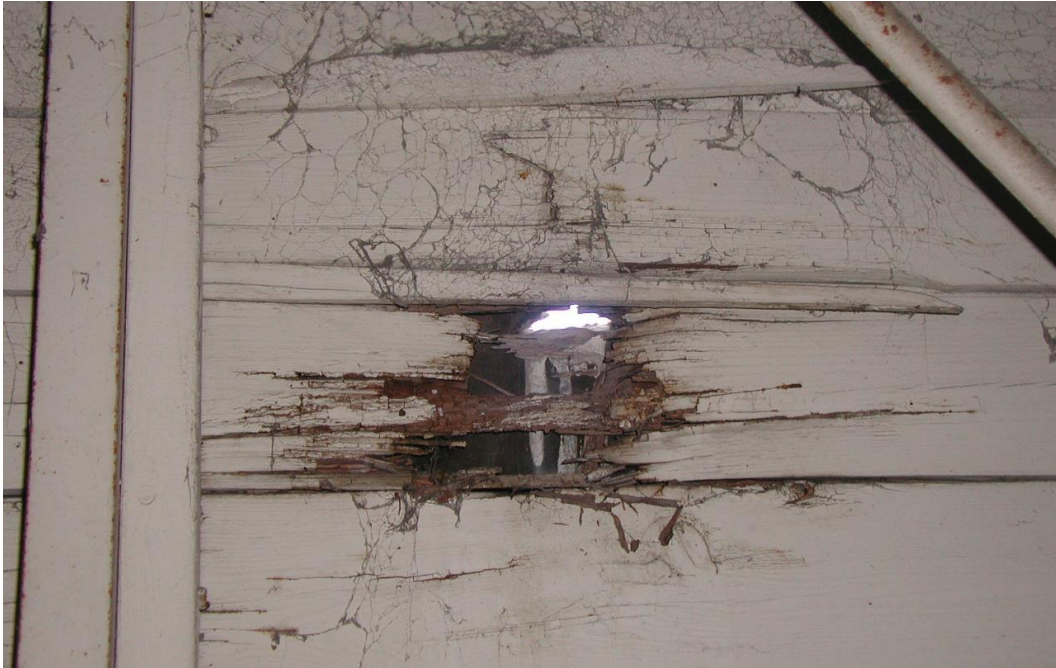
The east and west ends of the hangar bays are enclosed by the hangar bay doors and door pockets (Figure 19). The construction of the hangar door pockets on the east and west ends of the hangars consists of steel girts supporting tongue-and-groove wood planks that are covered on the exterior with corrugated wall panels. Spotted corrosion is visible of the steel framing members (Figure 20). Note that on other hangars of this design, the steel framing in the hangar pockets has been subject to severe corrosion—particularly at the top of the door pockets. These areas should be carefully inspected by a structural engineer to evaluate their condition. The wood plank substrate appears to be in generally good condition, but there are isolated areas with damaged or rotted wood (see Figure 20).

Figure 20. Example of damage to tongue-and-groove wood plank substrate in hangar door pockets and spotted corrosion on steel framing (at upper right) (Mr. Richard Simonton, 2013).

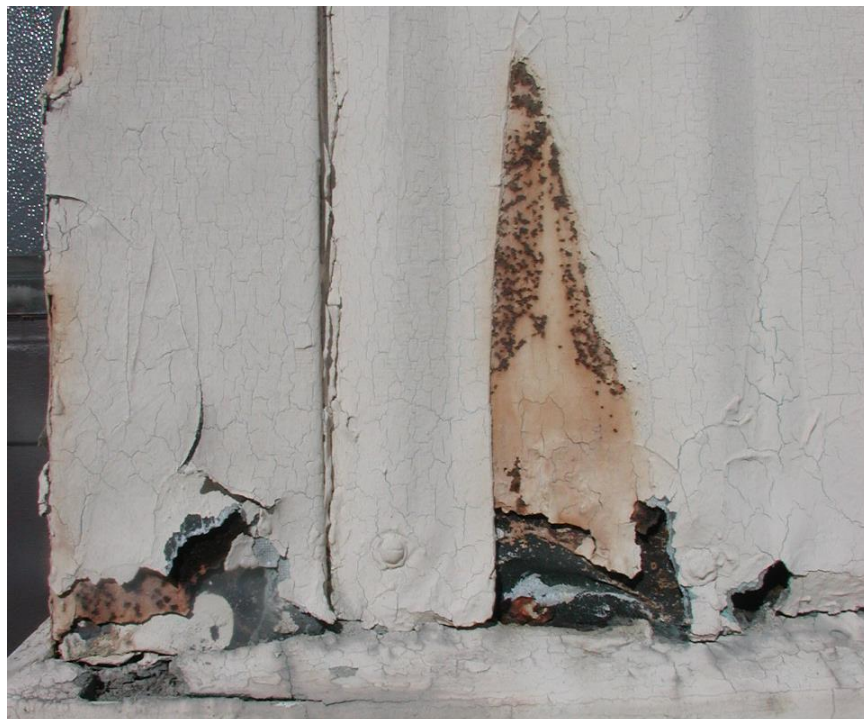
The exterior corrugated panels are still functional, but show signs that they are at the end of their service life. The panels have several coats of paint that are beginning to peel at the edges of the panels. The paint would need to be stripped before the panels were repainted, but it is questionable if paint could be removed without damaging the panels. The panels are starting to rust along the bottom and panel edges (Figure 21).

Figure 21. Typical deterioration of corrugated wall panels where bottom of panels abut concrete knee walls (Mr. Richard Simonton, 2013).

All painted exterior surfaces and building components need to be repainted. As stated previously, paint needs to be stripped from the corrugated wall prior to repainting. Replacement of the panels with another product that matches the profile of historic panels is likely to be a better solution. The painted concrete and concrete masonry is not preventing moisture problems in the exterior walls. Prior to painting the masonry, insulation, and moisture/vapor barrier issues should be resolved. Wood surfaces need to be prepped and repainted.

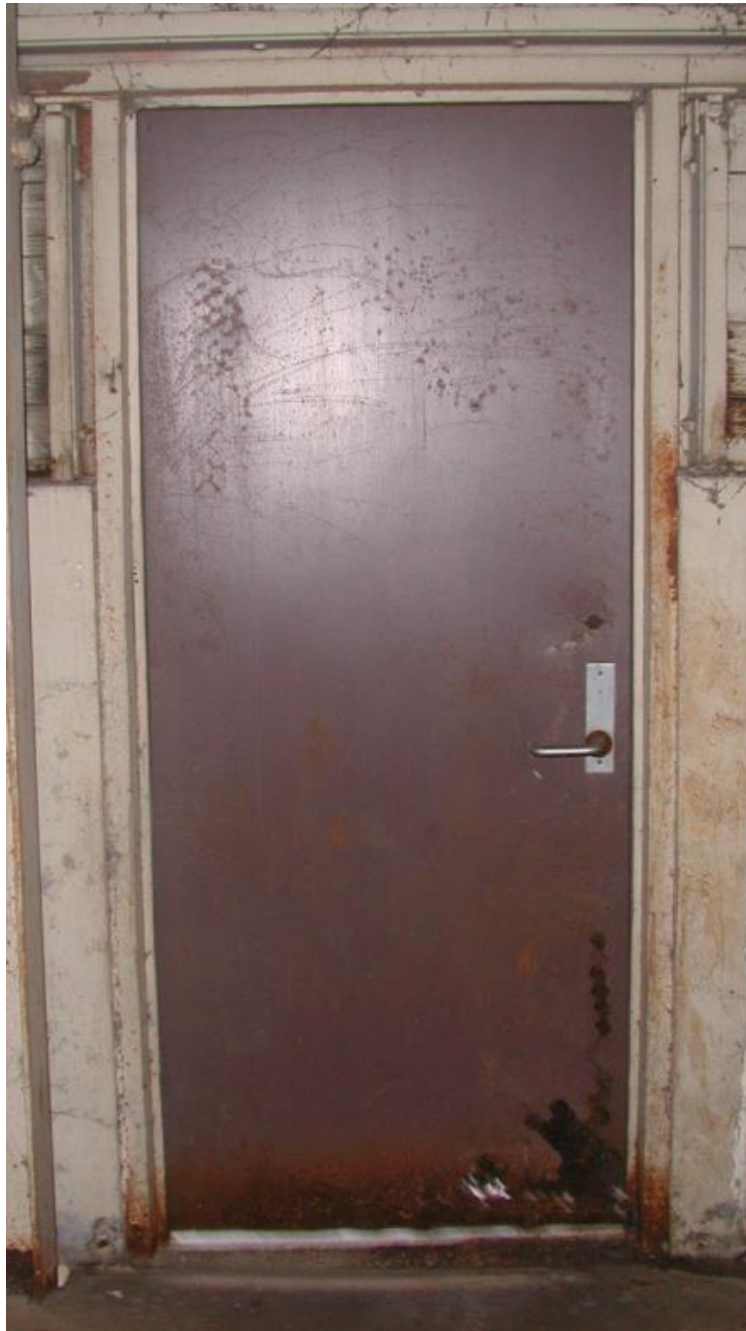
The majority of the exterior man doors are in very poor condition. Rust, holes, dents, and poorly functioning hardware are all problems (Figure 22).

Figure 22. Typical exterior man door that needs replacement (Mr. Richard Simonton, 2013).

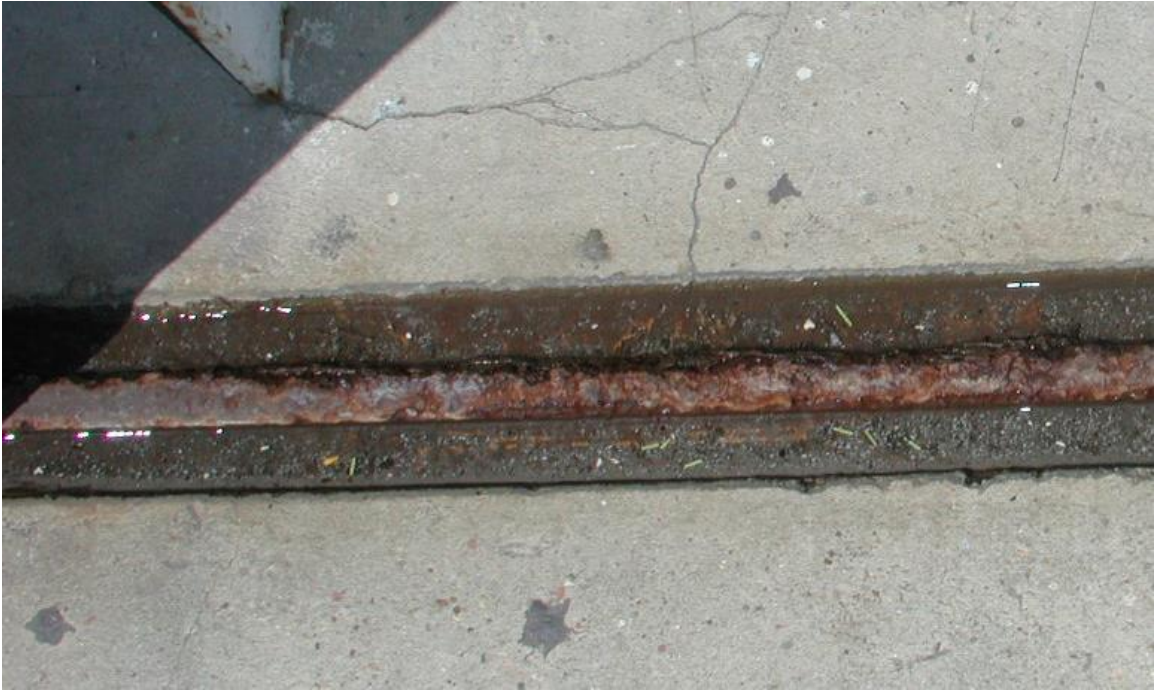
The large glazed hangar doors are a key historic element in these hangars (Figures 23 and 24). The weight of these hangar doors is supported by steel rollers that move along a steel track that is recessed in the concrete floor slab (Figure 25). The doors appear to be in good condition, but there are issues with the steel rails. All of the steel rails exhibit pitting or some degree of section loss as a result of rusting (Figure 26). Section loss is a severe problem inside the hangar door storage pockets where rails are submerged in standing water for long periods (Figure 27). Deterioration of these rails prevents the hangar doors from fully recessing in the storage pockets.

Figure 26. View of hangar door rail with reduced steel section (Mr. Richard Simonton, 2013).

Because of the deteriorated bottom tracks and uncertain condition of the upper track supports, these hangar doors pose potential safety issues. If the hangars continue to be used, a structural engineer should be engaged to evaluate the structural integrity of the entire hangar door support system including the rails, upper tracks, track supports and rollers.

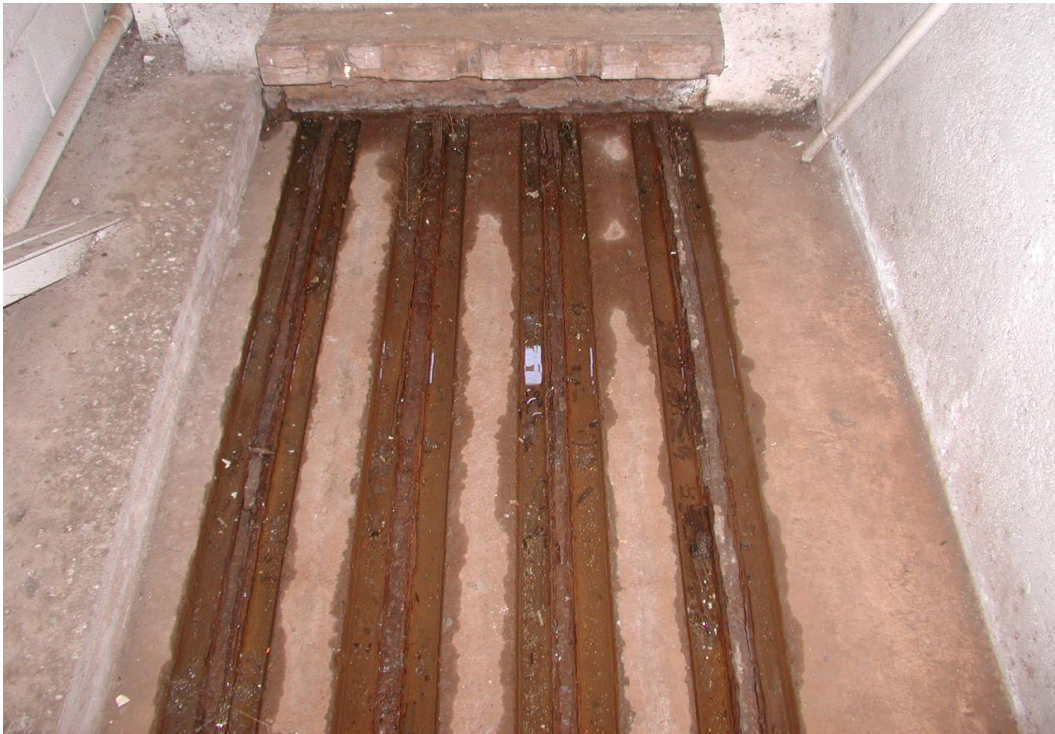
Figure 27. Interior view of hangar door pocket showing steel rails with severe section loss and standing water in concrete recess (Mr. Richard Simonton, 2013).

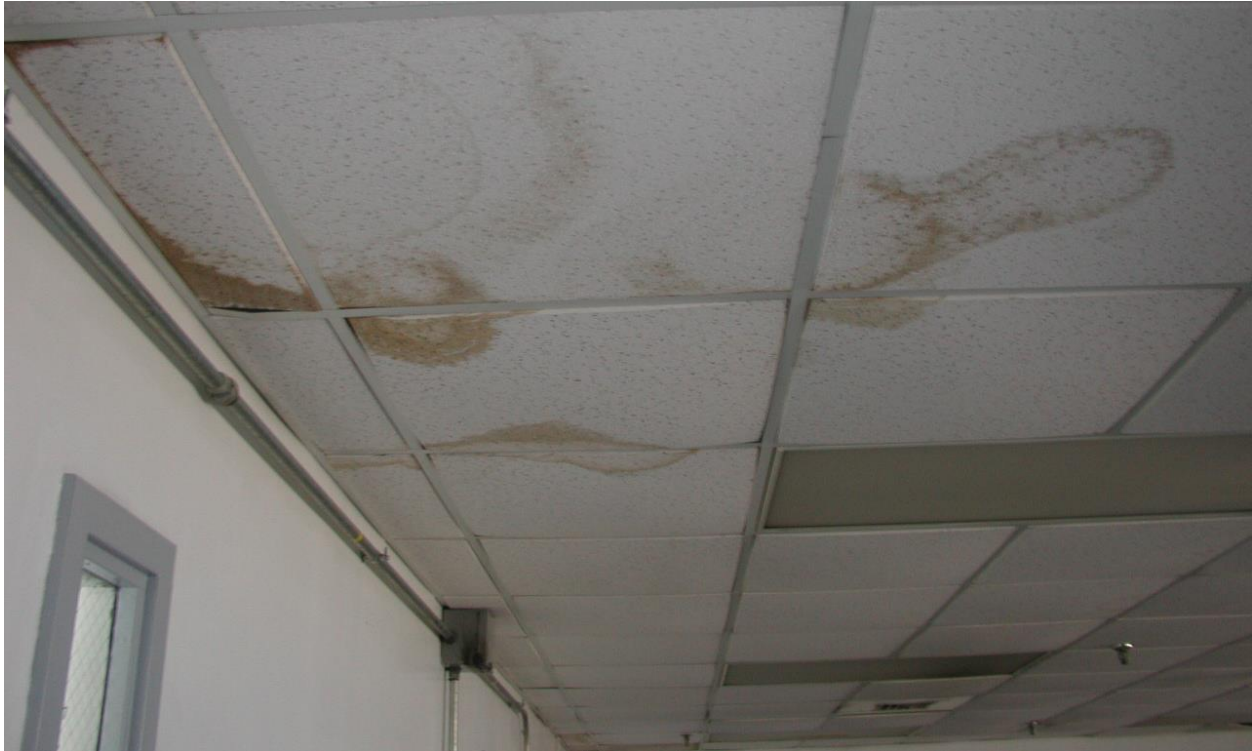
Interior Finishes. Interior finishes include wall plastering, floor coverings including epoxy paint, suspended ceilings, and painting. Suspended ceilings exhibit sagging panels and water damage in many areas (Figure 30). The majority of spaces outside the hangar bays in Hangar 114 need all surfaces painted (Figure 31). Unless the existing space configuration works well for future needs the vast majority of interior finishes should be replaced.

Figure 30. Suspended ceiling with water damage (Mr. Richard Simonton, 2013).

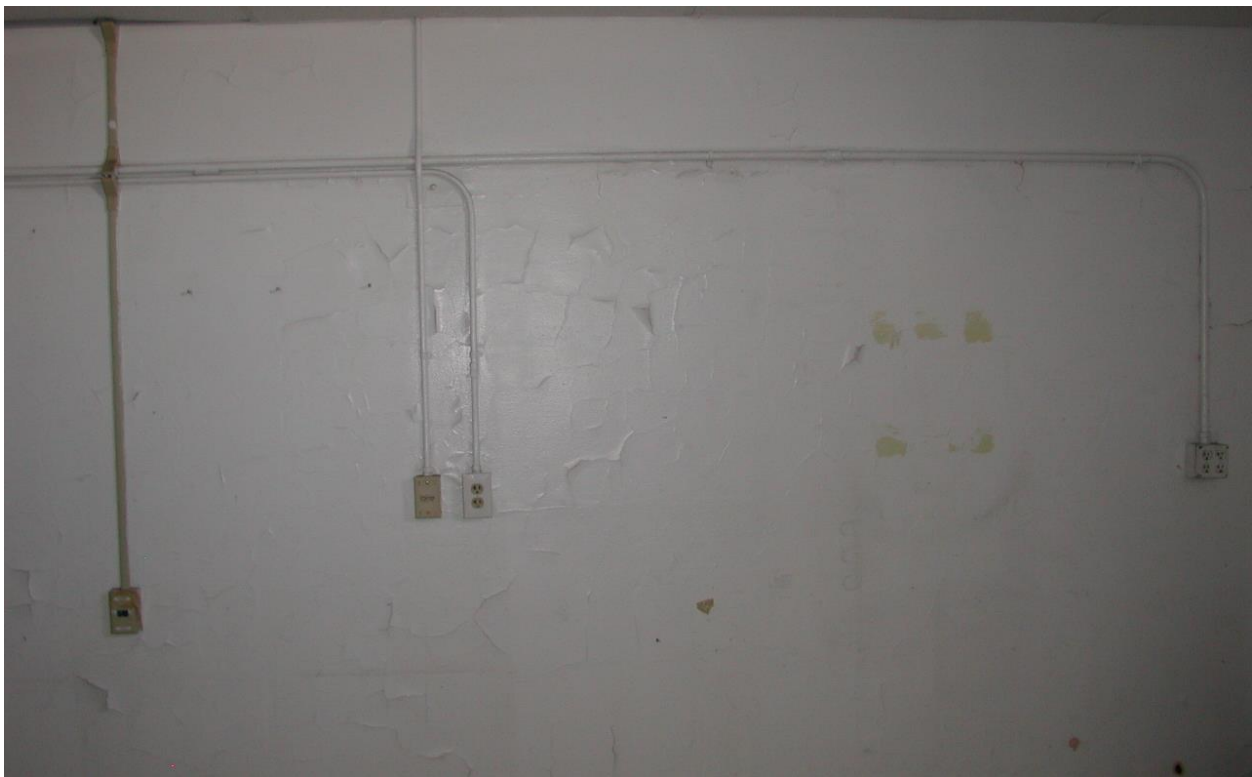
Figure 31. Typical concrete wall in need of repainting (Mr. Richard Simonton, 2013).

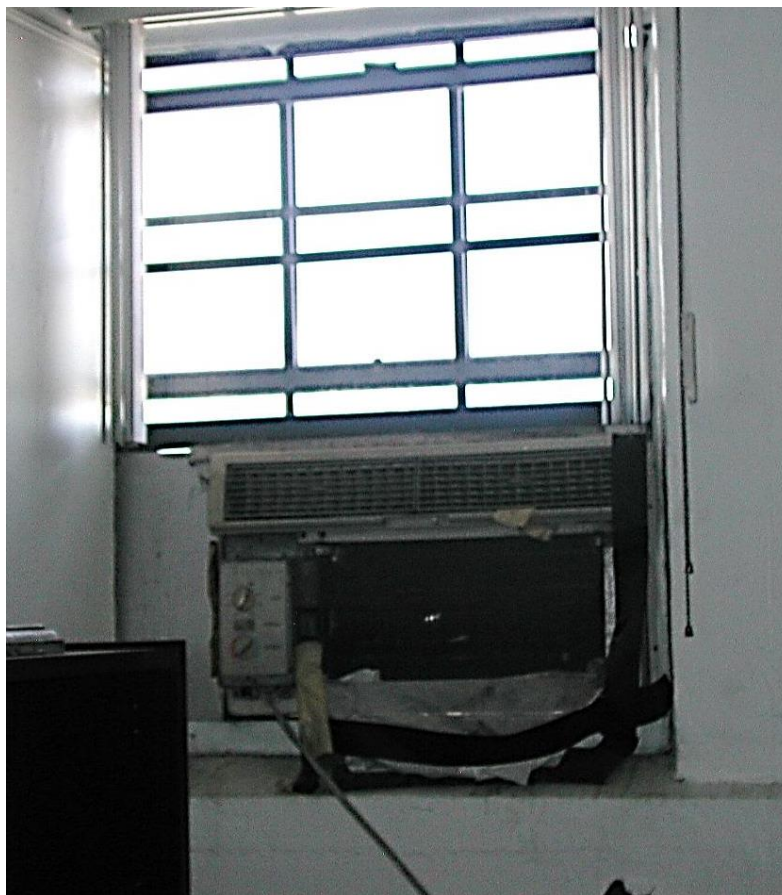
HVAC. HVAC includes chillers, boilers, condensing units, exhaust fans, ductwork, mechanical piping, diffusers, window air-conditioning units, and control systems. The buildings employ a patchwork of systems for heating, cooling, and ventilation. Many of the spaces are simply air conditioned with window air conditioners that are in poor condition (Figure 32). Property Records indicate that the latest upgrade was to Hangar 114 in 1990. Given the age and apparent condition of the HVAC systems the majority of these systems should be replaced in any rehabilitation project.

Figure 32. Example of window air-conditioning unit for offices (Mr. Richard Simonton, 2013).
