Volunteer Fire Fighter Dies When Tanker Crashes Into Boulder and Tree - Oregon

Fatality Assessment and Control Evaluation Investigative Report #F2001-36

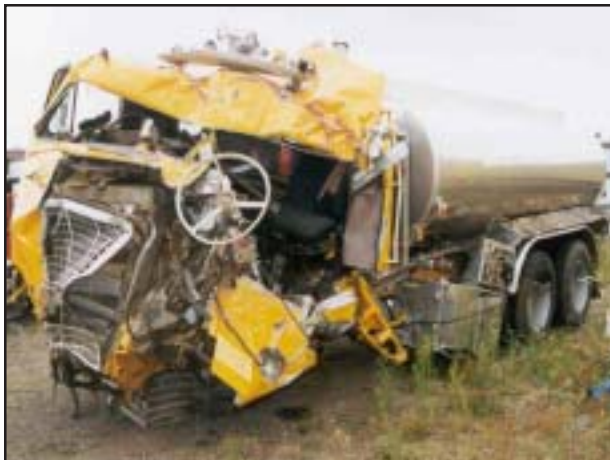
Tanker Involved in the Incident

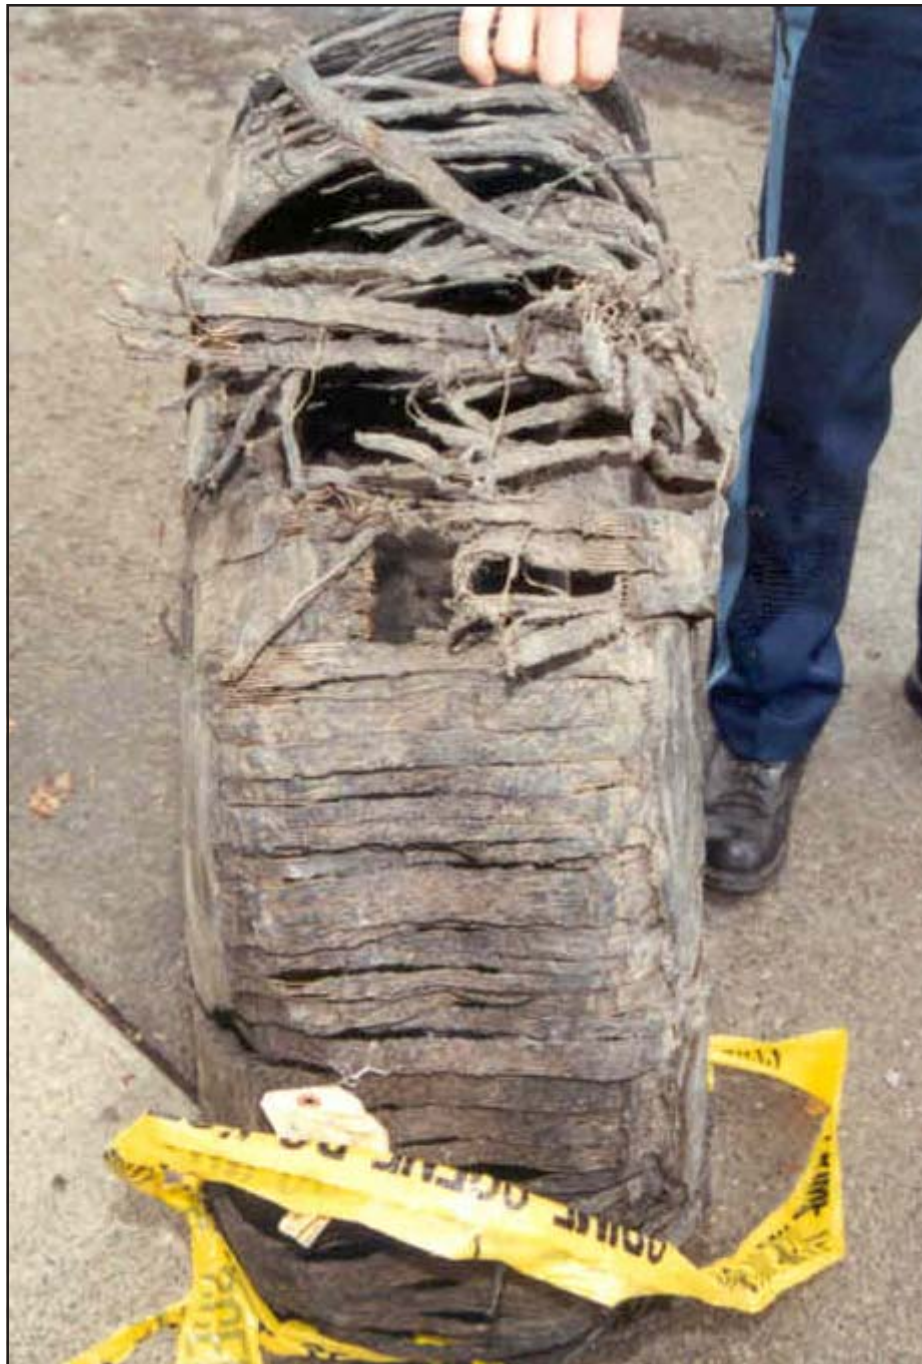
At the time of the investigation, the State police and the crash reconstructionist determined that the right front tire which experienced the blowout was in a depleted condition. The department in this incident uses a checklist to perform and document weekly visual inspections of the department vehicles; however no procedures were in place on how to identify and remove an apparatus from service until major defects (e.g., the braking, steering, electrical, and coolant systems, hydraulic fluids, tires, and belts) were repaired and/or replaced. The State police and the crash reconstructionist determined that the tire was a 1979 model. The post-crash examination performed by the State police and the reconstructionist revealed

that the outer shell fragment of the tire was brittle and cracked. In addition, pieces of the steel cords showed signs of rust from years of moisture exposure due to openings in the tread.

Photo 1. Tire That Experienced a Blowout on the Tanker Truck

Recommendation #1: Fire departments should develop comprehensive apparatus maintenance programs in accordance with manufacturer's specifications and instructions that include regularly scheduled inspections, documentation, and procedures for removing apparatus out of service until major defects are repaired.^{1,2}

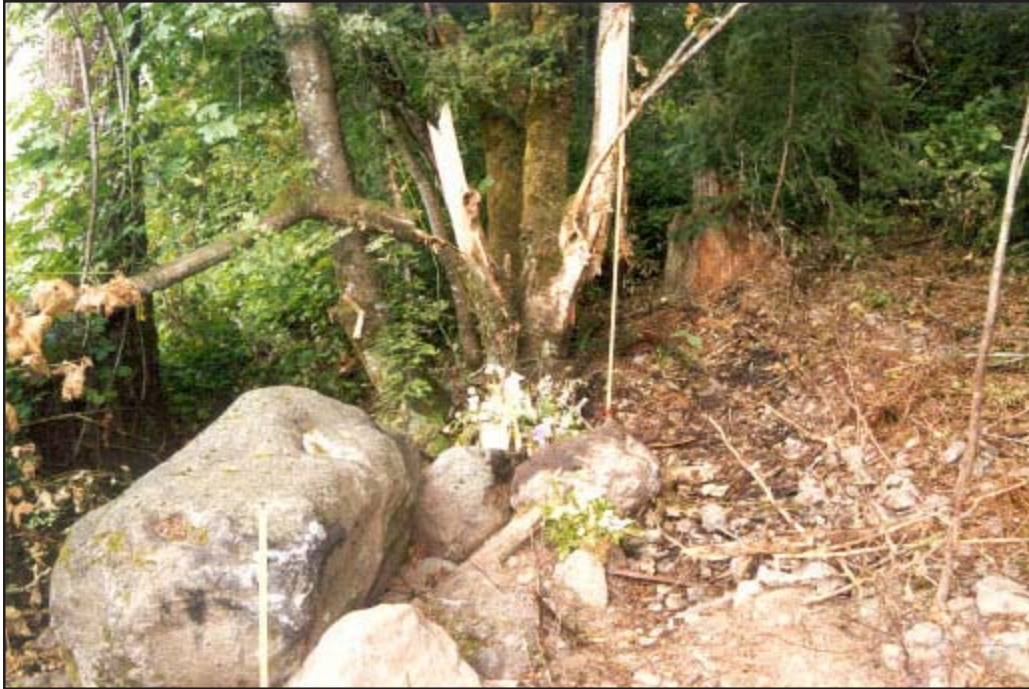
that was approximately 8 feet wide and 4 feet high (Photo 2). The truck overrode the boulder and struck a tree that was approximately 18 inches in diameter. The truck came to rest facing southeast in full contact with the tree and with the right front corner resting against a tree stump. The truck sustained heavy damage to the left front of the cab (Photo 3).

Photo 2. Boulder and Tree That the Tanker Truck Impacted

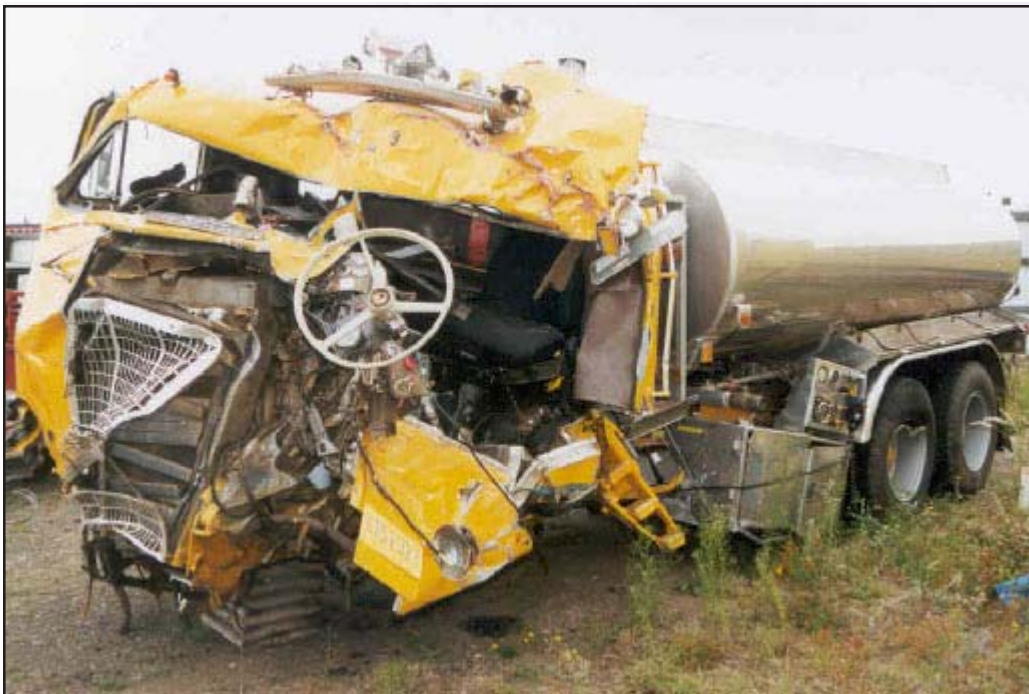
Photo 3. Tanker Truck Involved in This Incident
