Volunteer Fire Fighter Dies After Being Run Over by Brush Truck During Grass Fire Attack - Texas

SUMMARY

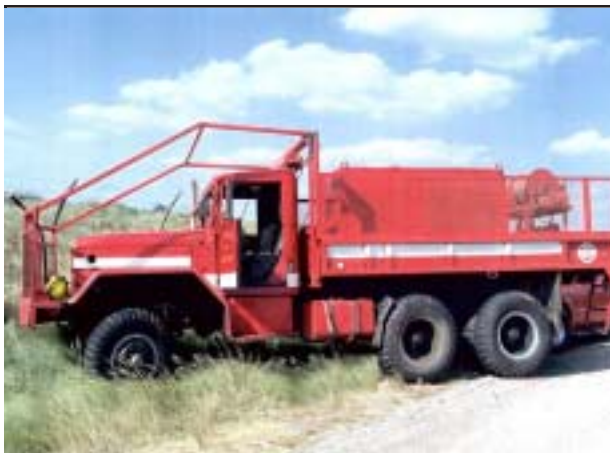
Brush truck involved in incident

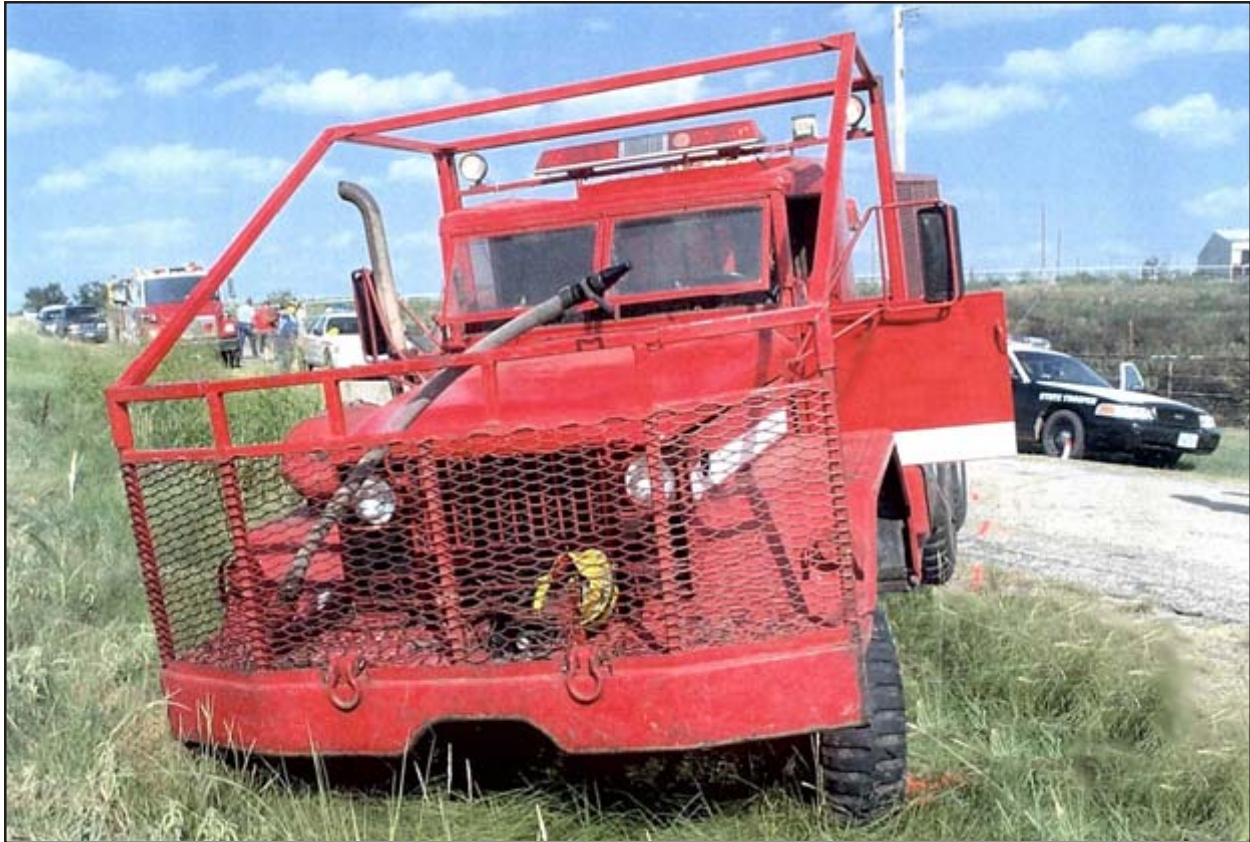
Photo 1. Front view of the front-bumper mounted platform

The working platform was built by the fire department onto the front bumper of the brush truck and extended out approximately 36 inches. The platform had an open frame that extended up to the cab and then down the sides of the bumper. The lower front portion

of the frame was mesh wire, which extended 39 inches from the top of the bumper to the cross member. The rest of the frame was open allowing uninhibited access from either side (Photo 1).

Discussion: In this case, the victim was holding a charged hoseline and attacking the fire from the front-bumper-mounted working platform on the brush truck. There was a 39-inch metal guardrail open-sided at both ends. The platform was mounted on the front bumper, which is where the victim was working while the brush truck was moving.

Recommendation #1: Fire departments should ensure that fire fighters attack a brush fire from a safe place on the apparatus or walk alongside the moving apparatus.^{1,2,3,4}

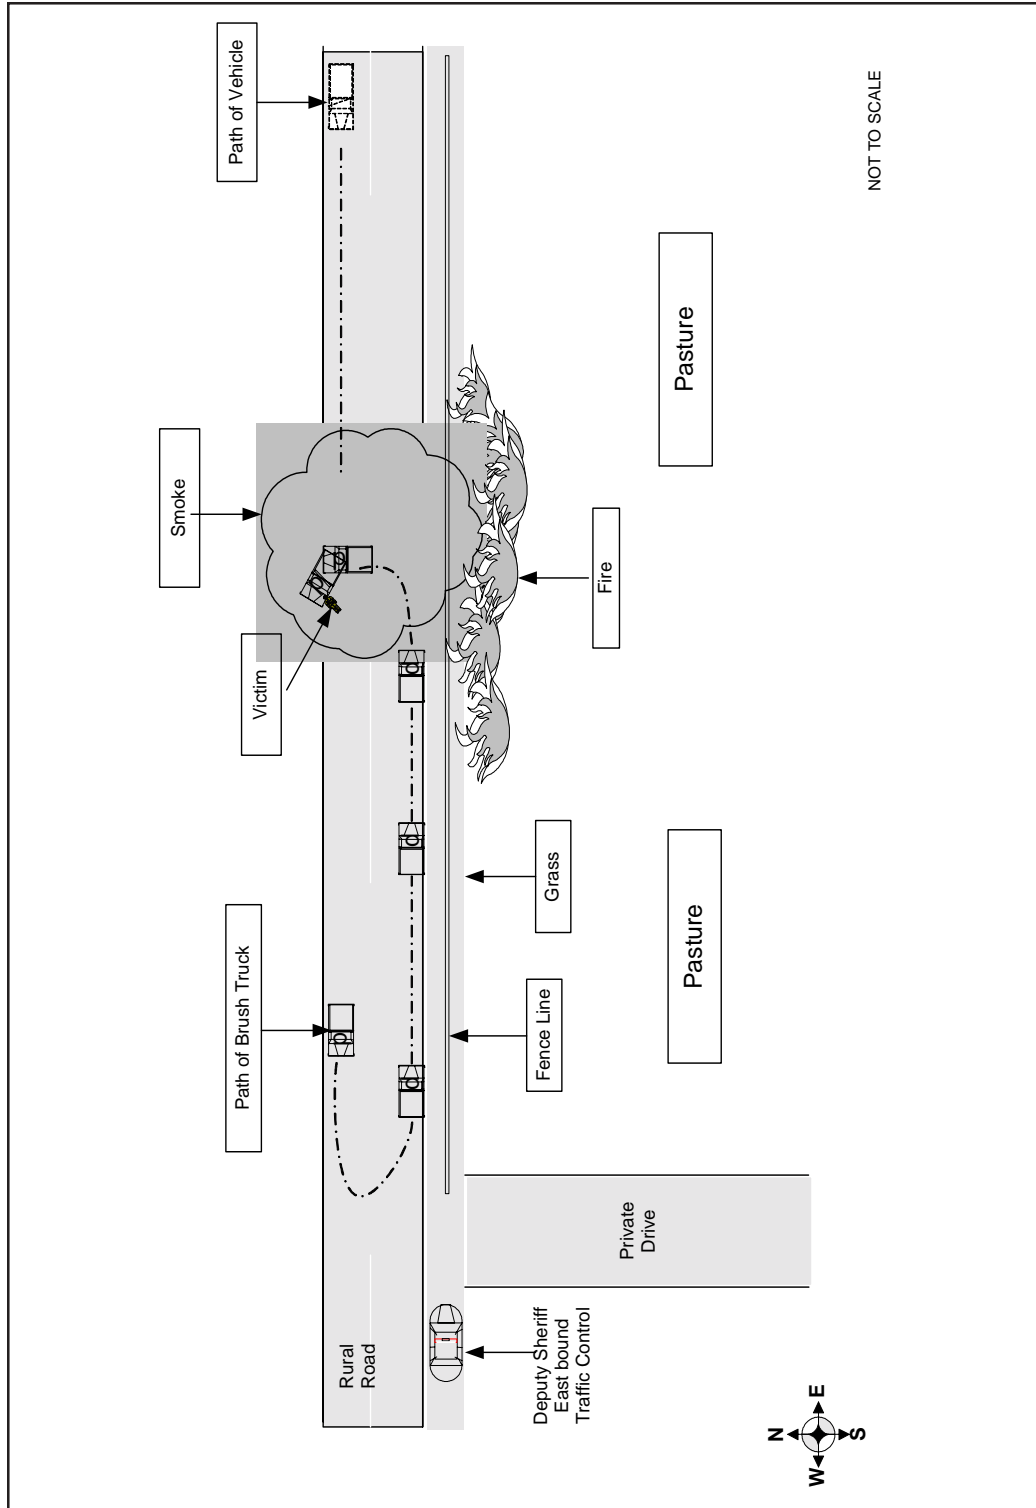
Diagram. Aerial view of brush truck incident scene

The Assistant Fire Chief was first on the scene at 1626 hours and assumed incident command (IC). The IC called for traffic control and sized up the area of fire origin on the residential property. The fire was noted to have started in a pasture near a manure pile between the State road and the rural road (Diagram). The fire was spread approximately 300 feet long and was burning near the fence line, threatening to cross the rural road.

Crews with the two engines were attacking the fire from the State road on the south side where smoke had become thick and was blowing across the roadway, diminishing visibility. The deputy sheriff arrived on the scene for traffic control at the west end of the rural road (Diagram). Traffic control for the east end was en route at the time of the incident. The brush truck made a pass at the fire with a charged hose line from west to east and then turned north, making a U-turn across the roadway presumably to make another pass to extinguish the fire near the fence line. A witness stated that he saw the driver of the brush truck reach the end of the fire line and make a U-turn across the roadway where the truck came almost to a halt. A pickup truck traveling in the westbound lane at approximately 30-40 miles per

(Diagram). Note: *According to the state fire marshal's report, the driver of the brush truck was not wearing a seat belt, and upon impact, was thrown across the interior, losing control of the vehicle. The impact caused the victim to be ejected from the work platform to the ground directly in front of the rotating front left tire of the brush truck.*
