Structural Collapse at an Auto Parts Store Fire Claims the Lives of One Career Lieutenant and Two Volunteer Fire Fighters - Oregon

NIOSH investigators concluded that, to minimize the risk of similar occurrences, fire departments should

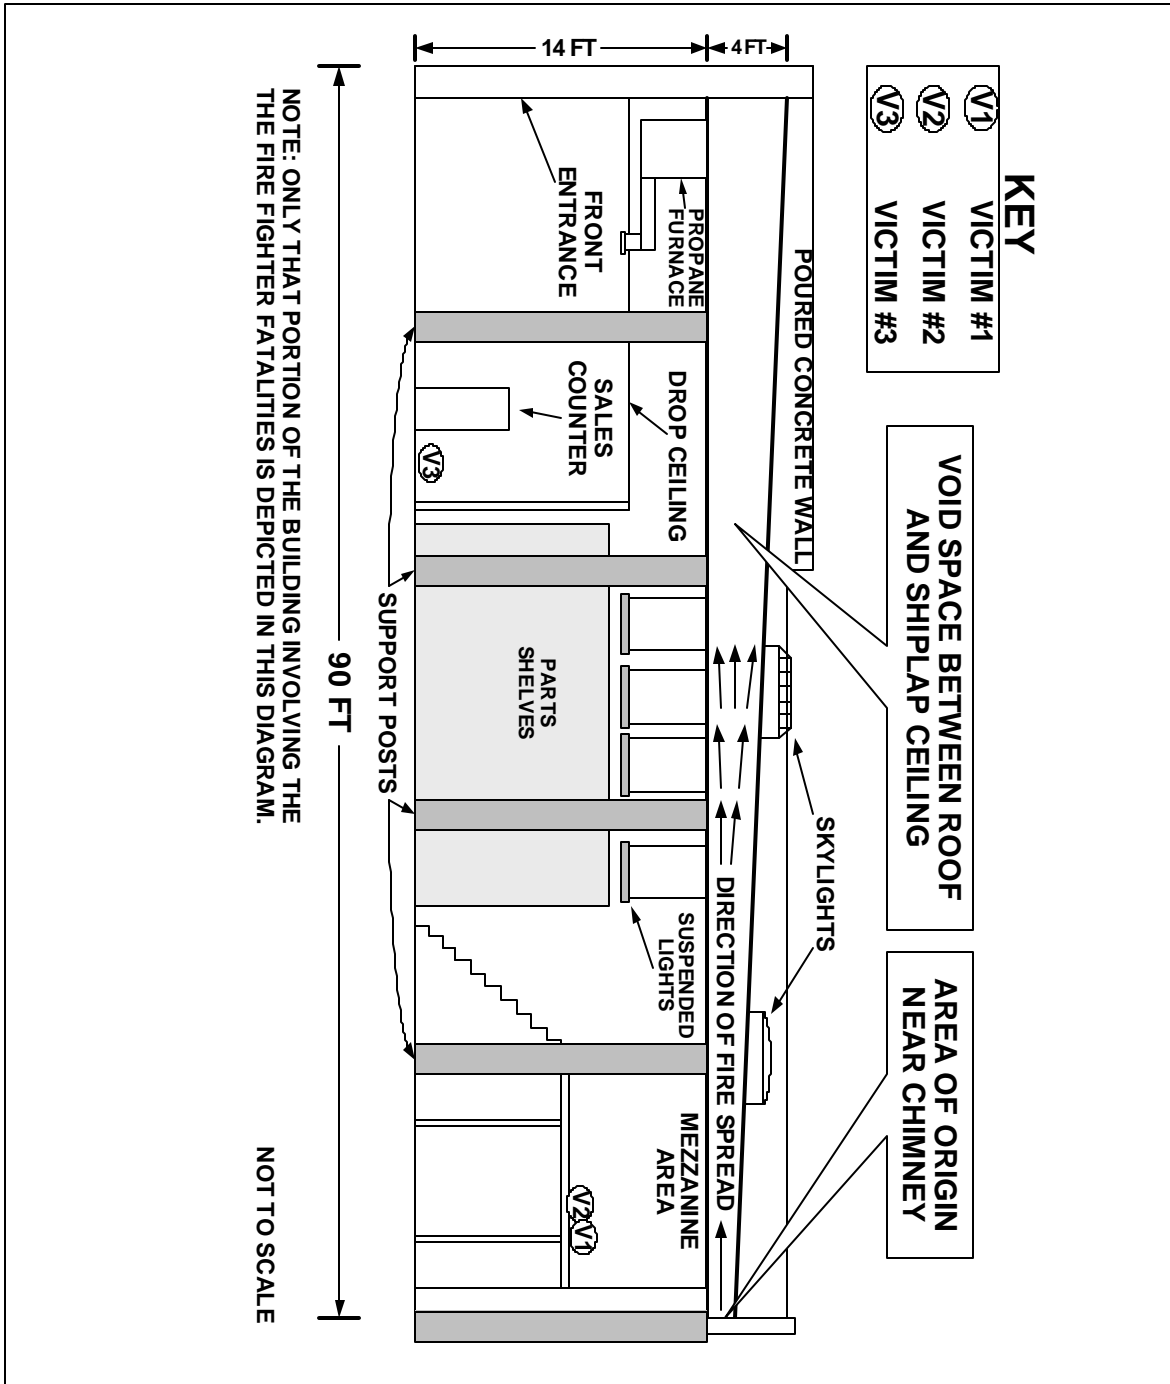
Diagram 2. Profile view from the south of the auto parts store depicting the area of origin, fire spread, and approximate locations of victims

Fire Fighter #1 and Fire Fighter #2 from Ladder 8151 advanced a 1 3/4-inch handline (200 foot pre-connect) through the front door. The two fire fighters advanced the line toward the north end of the sales counter. They saw fire at the ceiling level approximately 20-25 feet from the front wall in the northwest corner of the building. *Note: It is believed that the fire was coming from a scuttle/vent space.* The crew then applied water and knocked the fire down. The two fire fighters repositioned the line to the center of the sales counter before proceeding down the center aisle leading to the stairs of the mezzanine (Diagram 1). The two fire fighters could hear crackling as they reached the stairs (Diagram 2).

Operations went defensive until, approximately 2 hours later, conditions improved for crews to enter and locate Victim #1 and Victim #2 on the mezzanine. Crews left Victim #1 and Victim #2 in place for further examination by the State Fire Marshal and the Deputy Medical Examiner. The victims were pronounced dead about an hour later by the Deputy Medical Examiner (Diagram 1, Diagram 2, Photo 2 and Photo 4).

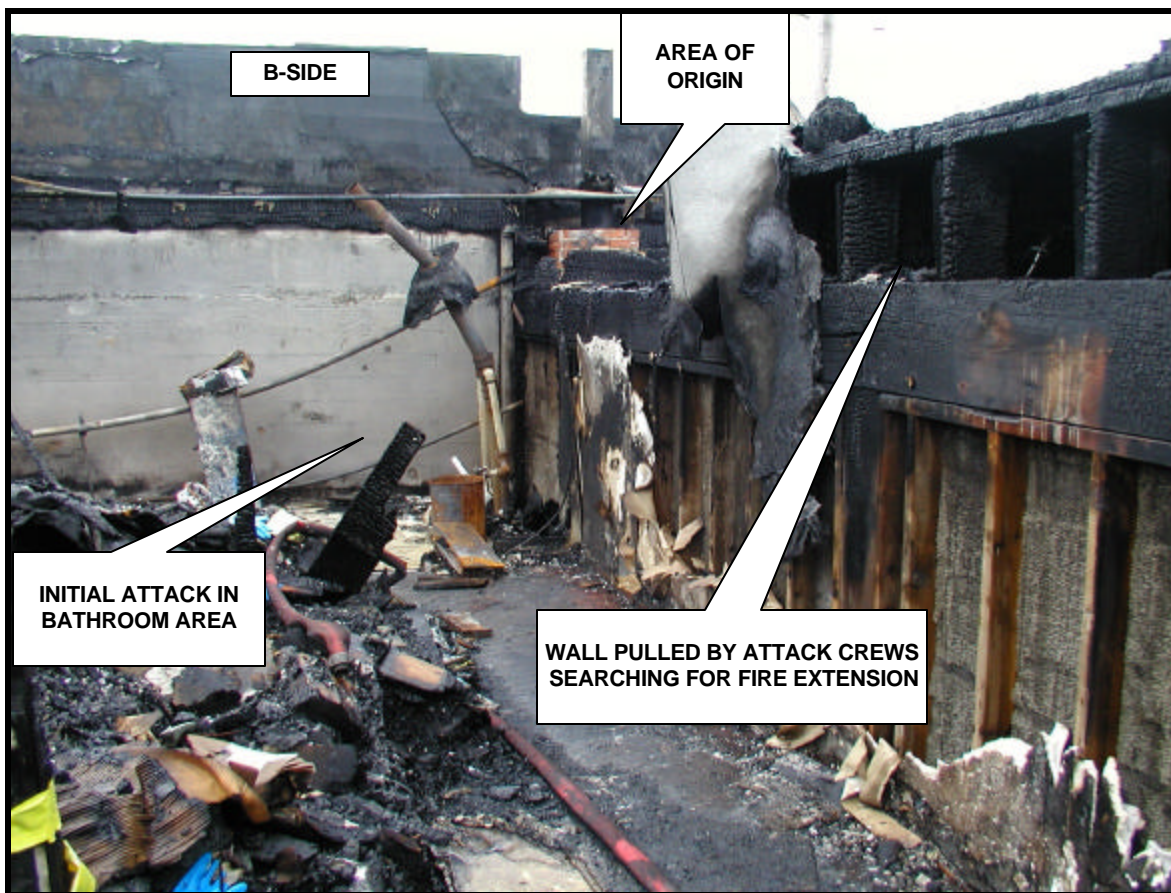
At 1356 hours, the Chief (Staff 8101) of the fire department arrived on the scene. The initial IC (Command 8111) transferred command to the Chief. Brown smoke was now visible at the roof level near the chimney with no visible fire. The IC then radioed responding units to advise them that it was a working fire in a commercial structure. The property owner, standing near the front door (A-Side) with the IC, pointed toward the mezzanine and said that the fire was in the bathroom up on the mezzanine (Photo 1 and Diagram 1).

each had a nozzle and were hitting fire between the rafters of the automotive machine shop while Victim #1 (working with Victim #3 near the bathroom) and Fire Fighter #5 (working with Victim #2 along the back wall of the mezzanine) continued pulling ceiling and wall material (Photo 1).

Photo 1. North-East corner of mezzanine where attack crews were operating
