## **Partial Roof Collapse in Commercial Structure Fire Claims the Lives of Two Career Fire Fighters - Tennessee**

### **SUMMARY**

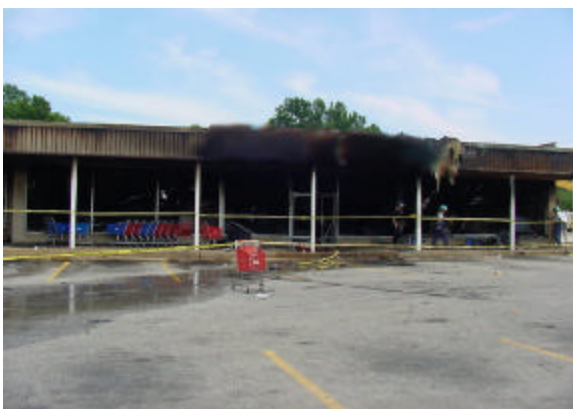
*Commercial structure involved in arson fire*

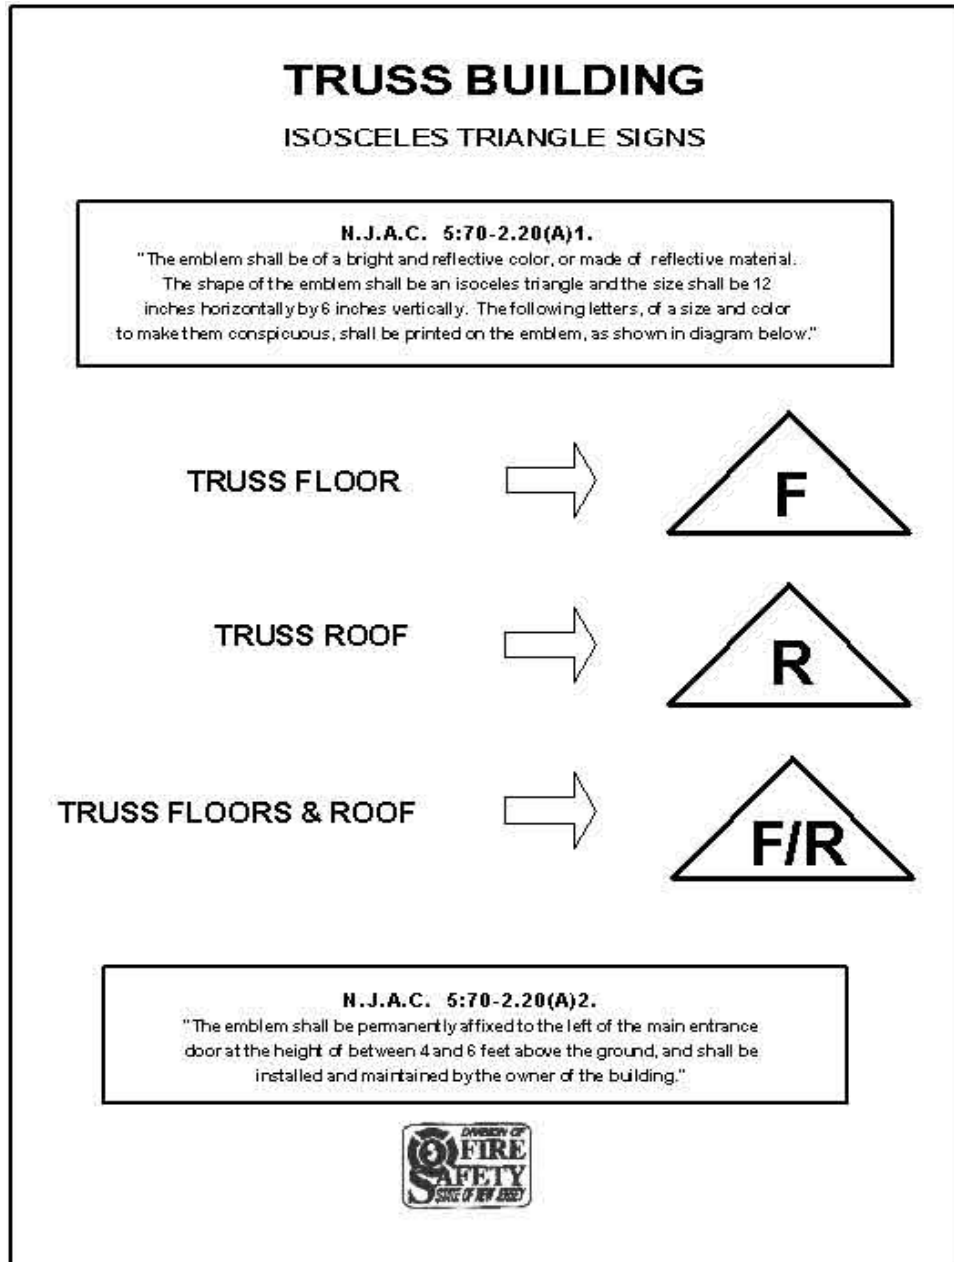
Figure 1. Truss Placard - State of New Jersey

***Municipalities should consider requiring specific building construction information on an exterior placard.***<sup>20</sup>

roof loads (HVAC units, displays, etc.), sprinkler system(s), standpipe location, utilities (gas or electric), occupancy, occupancy hours, chemicals on site, pressurized cylinders, contact numbers, and the interior floor layout. This information could save the IC time when planning the fire attack. Additionally, the information would provide fire fighters with important information that they might not otherwise have. However, the presence of building construction placards should not preclude doing pre-incident planning and inspections. At a minimum, buildings could be marked with a triangle or the letter "T" on the outside of the building to warn fire fighters of the presence of truss construction. To ensure that fire fighters are aware of structures that might have a truss roof, the State of New Jersey has passed a law requiring all building owners to place an exterior placard on structures which incorporate a truss roof. Figure 1 shows the signage used in New Jersey.

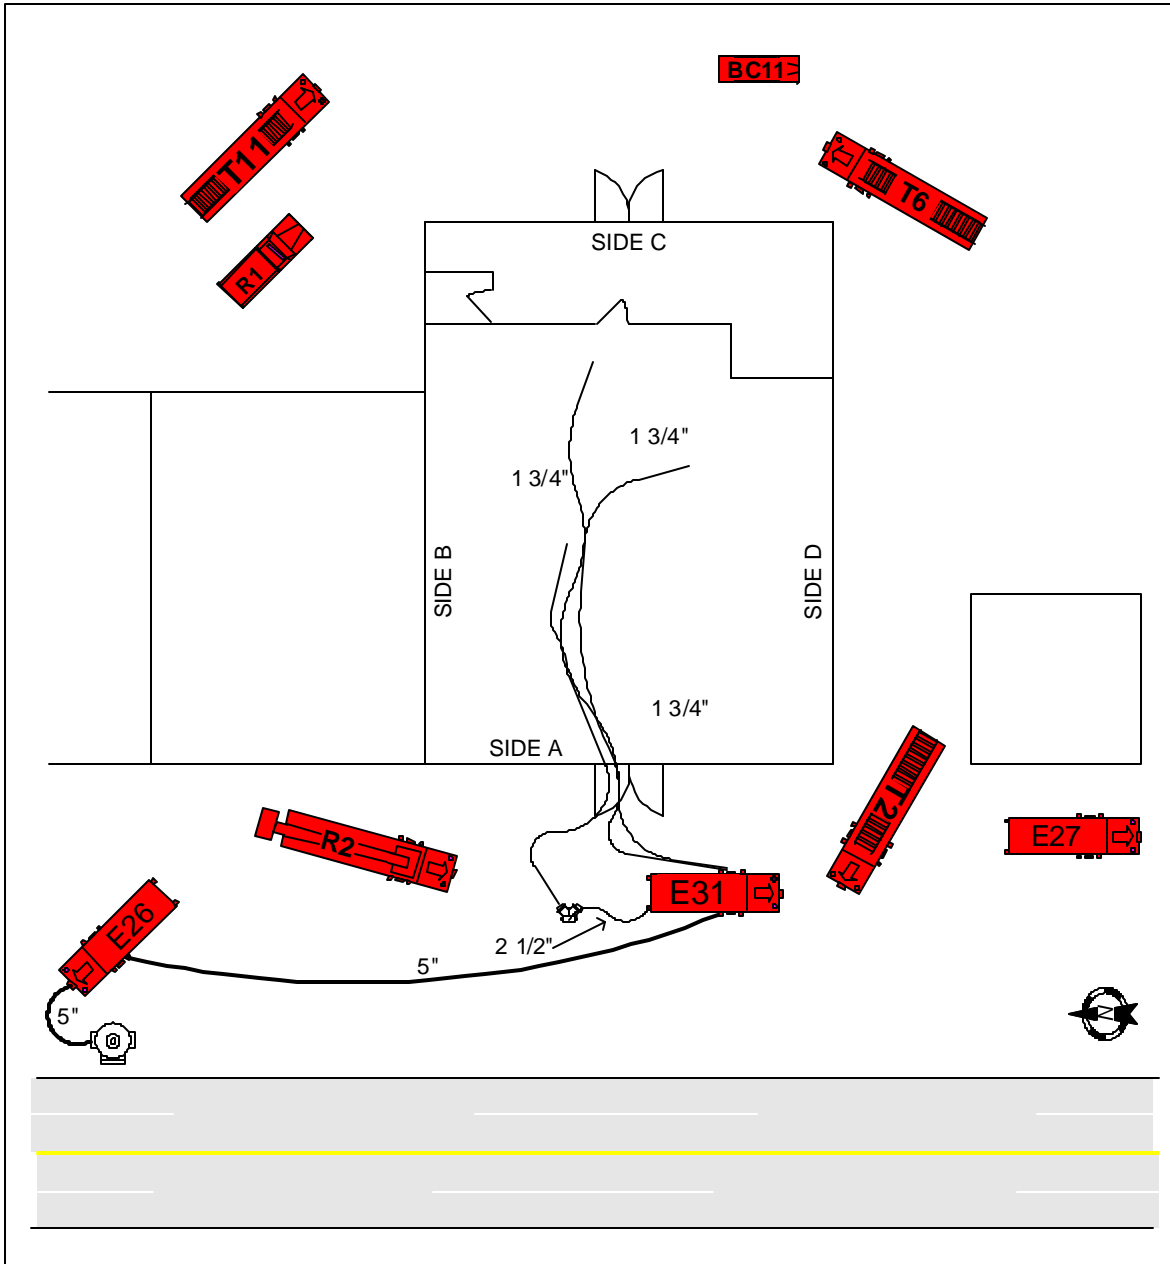
*Diagram 1. Incident scene aerial view*

received a call of a structure fire in a commercial occupancy with a possible entrapment and dispatched the first alarm assignments. Engine 31 (E31) was the first to arrive on the scene at 1950 hours and radioed Central Dispatch to report light smoke showing from the roof and in the building. The Lieutenant from E31 (Victim #1) assumed incident command (IC). The driver/operator from E31 began forcing the front door while the crew prepared to enter the store. Engine 26 (E26) and Truck 11 (T11) arrived on the scene at 1951 hours. Engine 26 began laying a 5-inch supply line from a hydrant to Engine 31. Truck 11 was ordered to the roof to investigate the air conditioning unit for a possible malfunction. Engine 27 (E27) arrived on the scene at 1952 hours and began assisting E31. Truck 6 (T6) arrived on the scene at 1953 hours and began forcing the door at the rear of the building, C-side (Diagram 1).

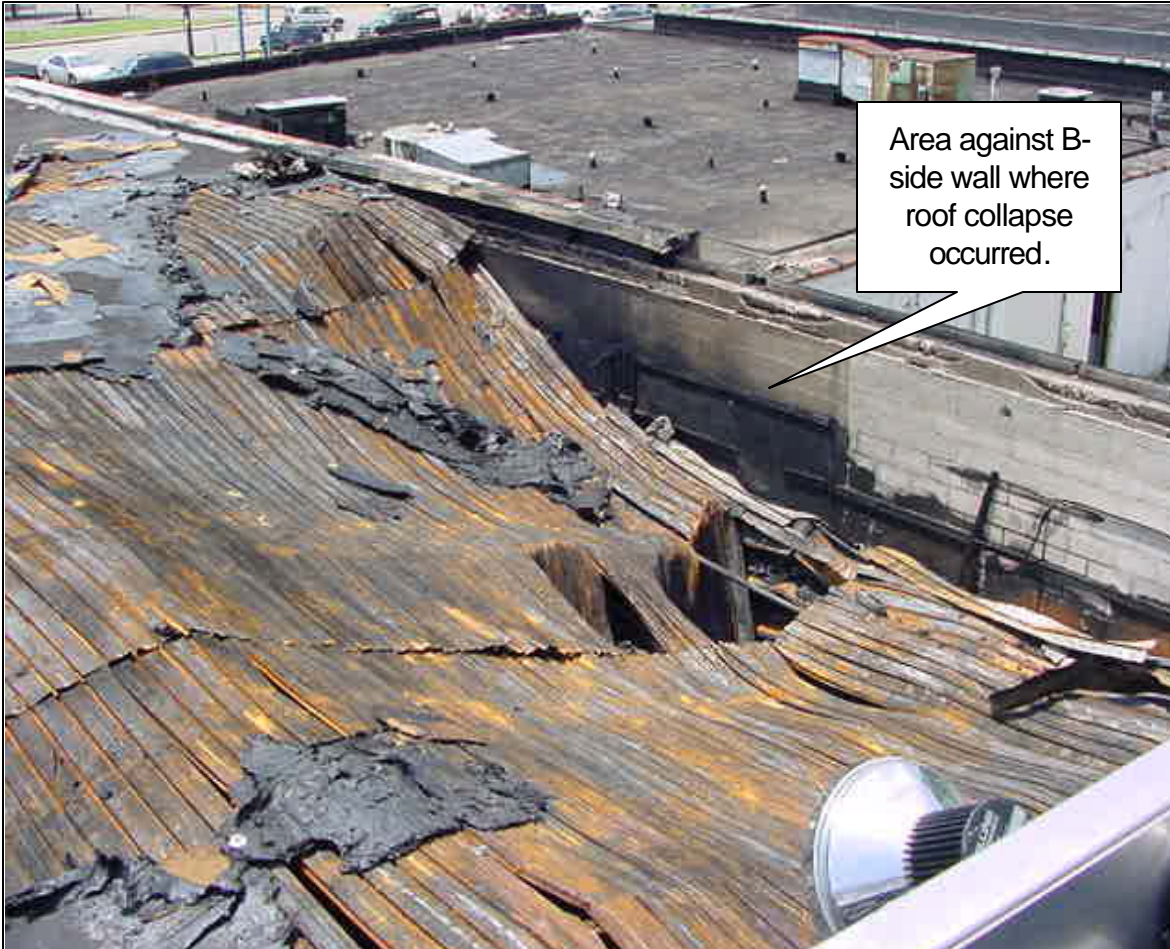
The two fire fighters on the roof from T6 reported a large roof sag at 2014 hours with fire extending through the roof on the B-side. They immediately exited the roof having completed only a partial ventilation hole. Additional attempts were made to rescue Victim #1; however, with conditions worsening it was decided to go to a defensive attack. Command sounded the evacuation horns at 2024 hours.

*Photo 2. Roof collapse B-Side*

***Recommendation #6: Fire departments should ensure that fire fighters performing fire fighting operations under or above trusses are evacuated as soon as it is determined that the trusses are exposed to fire.***<sup>4, 10, 15</sup>

Discussion: Even though standard fire engineering calculations show that lightweight trusses may be expected to collapse as soon as 6 to 13 minutes after exposure in a fully developed fire, it is not recommended to set a time limit on working under or above burning trusses. As stated in *Building Construction For the Fire Service*, “under fire conditions, truss failure is unpredictable.” When fire fighters arrive on the scene of a building with trusses exposed to fire, it is virtually impossible to identify how long the trusses have been exposed to fire and set a time limit for fire suppression. When it is determined that the trusses have been exposed to fire, any fire fighters operating under or above them should be immediately evacuated. If it is not clear

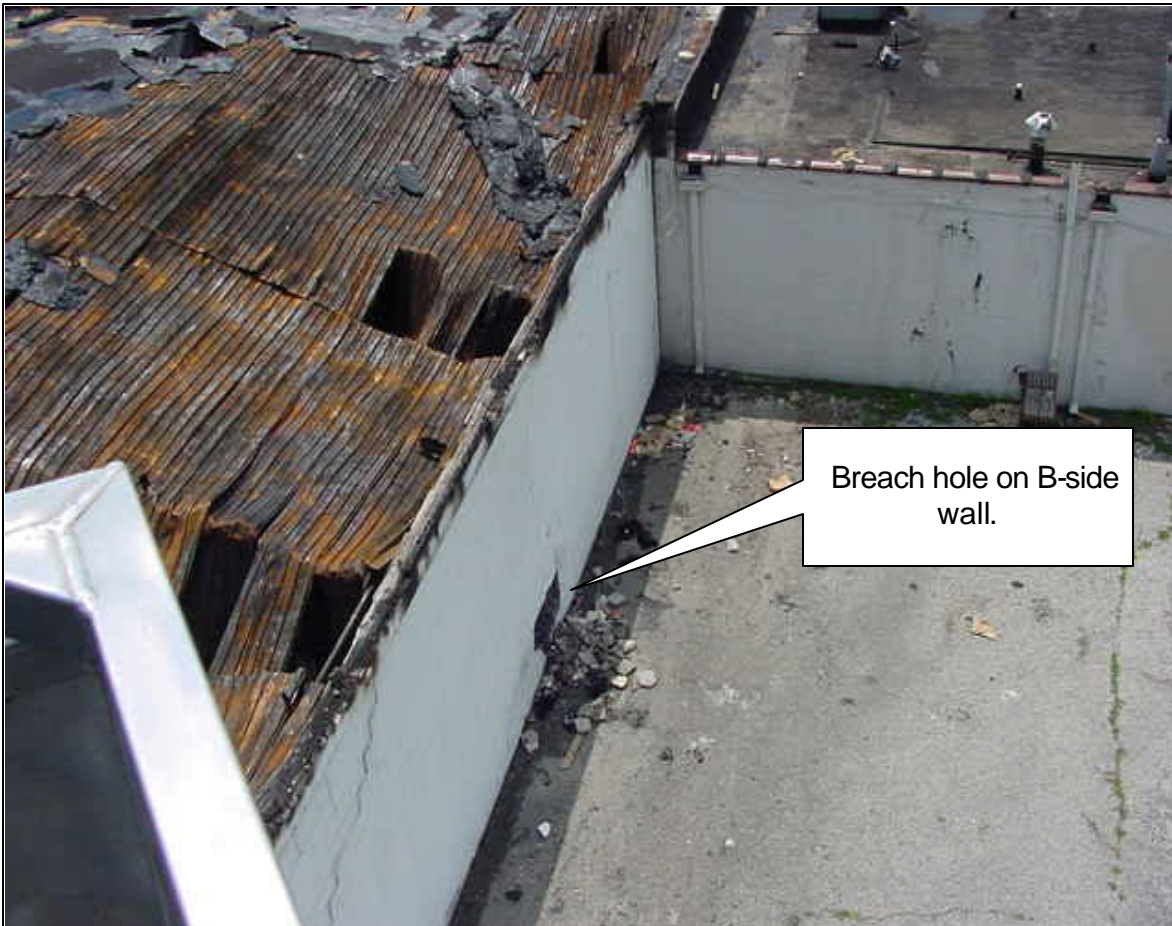
Crew members formed a rescue group and breached a hole in the B-side wall at 2110 hours (Photo 3). Victim #1 was removed and placed in an ambulance at approximately 2126 hours and transported to a local hospital where he was pronounced dead.

*Photo 3. Extrication point B-Side*
