Career Fire Fighter/Emergency Medical Technician Dies and Paramedic is Injured in a Three-Vehicle Collision - Nebraska

SUMMARY

On August 6, 2003, a 43-year-old career fire fighter/emergency medical technician [the victim] died after the ambulance he was driving was struck from behind and pushed into a straight truck. The victim and a lieutenant/paramedic were conducting a non-emergency transport between two hospitals. The ambulance was traveling through a highway workzone and as the ambulance driver slowed down to move around a line painting crew, a tractor semi-trailer struck the rear of the ambulance and pushed it into the straight truck (Photo 1). Although the victim was using the vehicle occupant restraint, the front cab sustained such extensive damage that he was fatally injured. The lieutenant/paramedic and a patient, who had been riding in the ambulance patient compartment, were also injured during the collision.

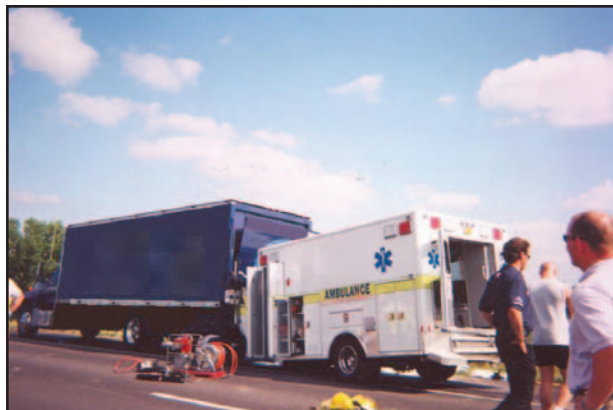
Photo1. Ambulance was pushed into rear of straight truck during the crash.

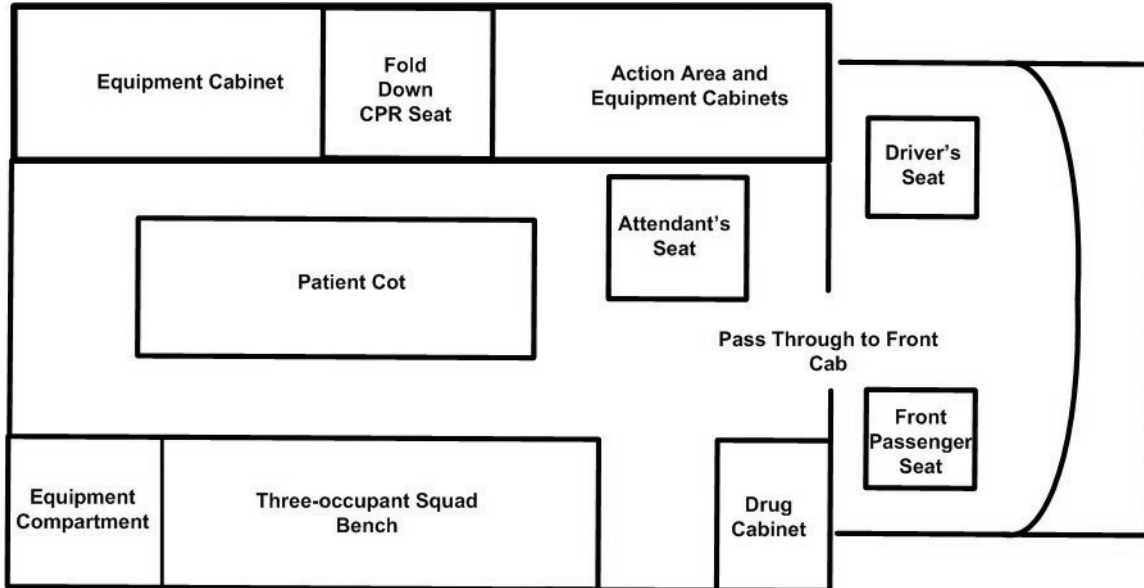
Equipment The vehicle involved in this incident was a 2002 Type III^a ambulance with a 159-inch wheelbase and 168-inch patient compartment. It was powered by a 7.3 liter turbo-diesel engine and automatic transmission. The gross vehicle weight listed for the vehicle was 14,050 pounds: 4,600 pounds for the front axle and 9,450 pounds for the rear. Actual weight of the vehicle at the time of the crash could not be established. It was equipped with an anti-lock braking system and three-point lap and shoulder seat belts for the front seat occupants. The patient compartment of the ambulance was configured with five seating positions, each equipped with two-point lap belt-type restraints. (Diagram 1) These positions included a rear-facing high-backed attendant's seat, a squad bench with accommodation for three occupants, and a fold-down CPR seat. Up-to-date ambulance maintenance and inspection logs were maintained by the department.

Diagram 1. Patient compartment and front seat layout of ambulance

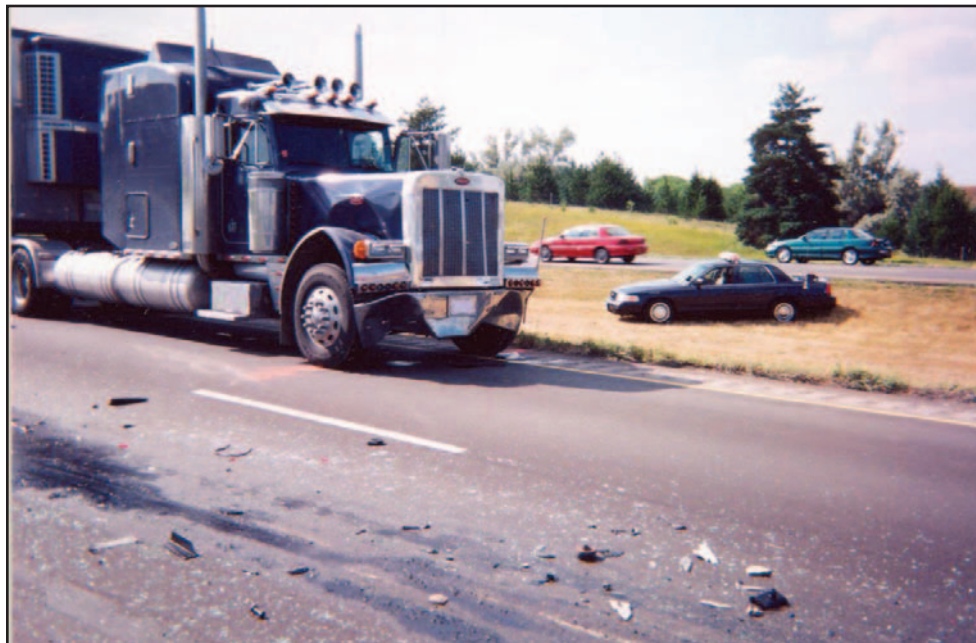
The vehicle that hit the rear of the ambulance was a tractor semi-trailer combination, consisting of a 2000 model year, three-axle conventional cab tractor with a 50-foot semi-trailer. (Photo 2) After the incident, the tractor semi-trailer weighed 79,300 pounds. This vehicle was being operated by a 46 year-old driver who possessed a valid Commercial Driver's License. Investigators were not able to determine his experience or training history. No vehicle defects for this vehicle were noted by the police investigators.

The physical evidence gathered by the state police investigators indicate that the tractor semi-trailer collided with the ambulance only 2 feet beyond the point at which the semi-trailer's wheels had been braked to the point of skidding. This suggests that the tractor semi-trailer driver's attention may have been distracted from driving, or he significantly misjudged either the rate he was overtaking the ambulance, the distance between the ambulance and the tractor semi-trailer, or the braking capacity of the tractor semi-trailer. The police report indicates that the tractor semi-trailer driver was cited for following too closely.

Photo 2. 2000 conventional cab tractor after collision

Recommendation #2: Trucking companies should train drivers to maintain safe following distances and to be aware of work zone hazards and slowing traffic.

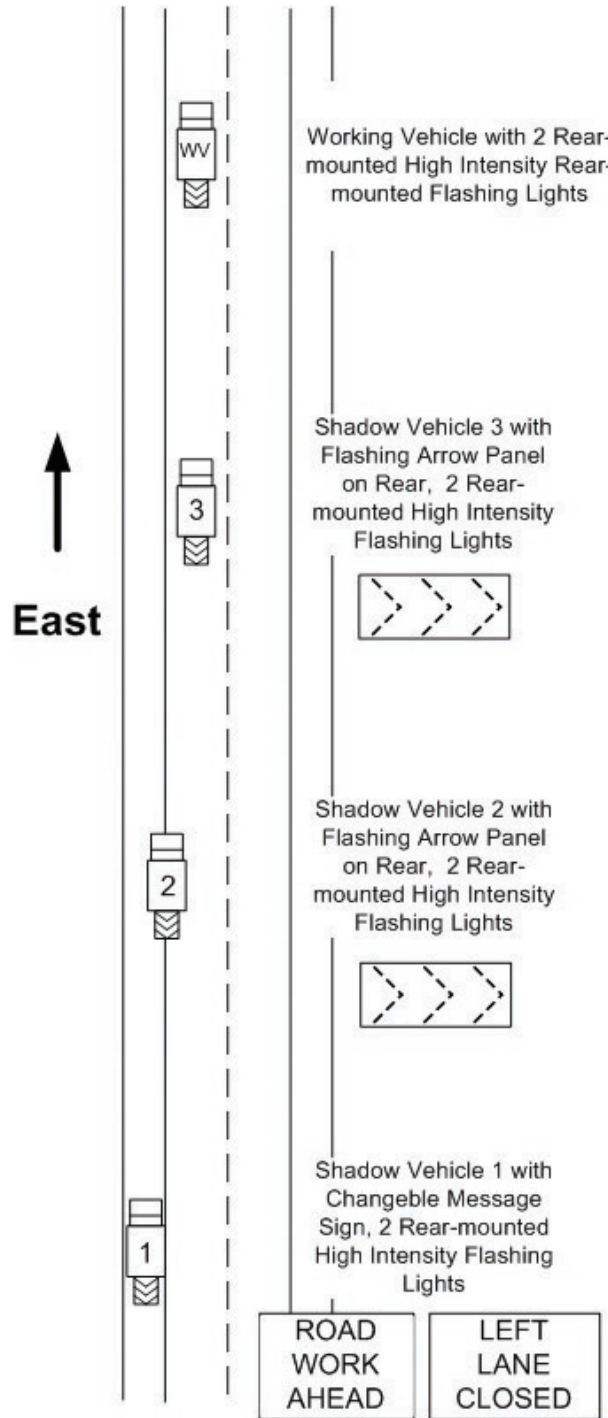
Street Conditions/Weather The ambulance was traveling east on an interstate divided highway comprised of two eastbound and two westbound lanes with paved shoulders. The weather was clear and sunny and the road surface was dry. The section of highway was located within a 14-mile repaving project that was nearly complete. The road surface was new asphalt. A mobile line painting crew was operating within the project area. The western approach to the project was marked according to the Manual on Uniform Traffic Control Devices (MUTCD)¹ with permanent signs indicating a 75 mph maximum speed limit, road work for the next 14 miles, and the doubling of fines for exceeding the speed limit. Temporary traffic control devices including speed limit reduction signs were posted within the project area depending on the type and location of the construction operation. On the day of the incident, a message board sign was in place at the beginning of the project area advising motorists of a left lane closure, to use caution, and that slow traffic was possible. At the time of the incident, the mobile operation was a little over 7 miles from the western start of the project. The mobile operation which included a working vehicle and three shadow vehicles at 1000-foot intervals, was set-up as depicted in Diagram 2 and conformed to the MUTCD specifications for mobile operation

on multi-lane high-speed roadways. The rearmost shadow vehicle was being driven on the left hand shoulder of the roadway and was equipped with two rear-mounted high intensity flashing lights and a changeable message sign that alternately flashed "ROAD WORK AHEAD" and "LEFT LANE CLOSED." The second shadow vehicle was driven straddling the roadway edge line and was equipped with two rear-mounted high intensity flashing lights and a flashing arrow sign indicating "merge right." A third shadow vehicle, being driven directly behind the working vehicle, was equipped with 2 rear-mounted flashing high intensity lights and a flashing arrow sign indicating "merge right". The working vehicle was equipped with two rear-mounted high intensity flashing lights.

Diagram 2. Mobile operation set-up

Recommendation #1: State department of highways and highway construction companies should consider the use of signs and warnings supplemental to those specified by the Manual on Uniform Traffic Control Devices (MUTCD) when conducting mobile operations (such as line painting).

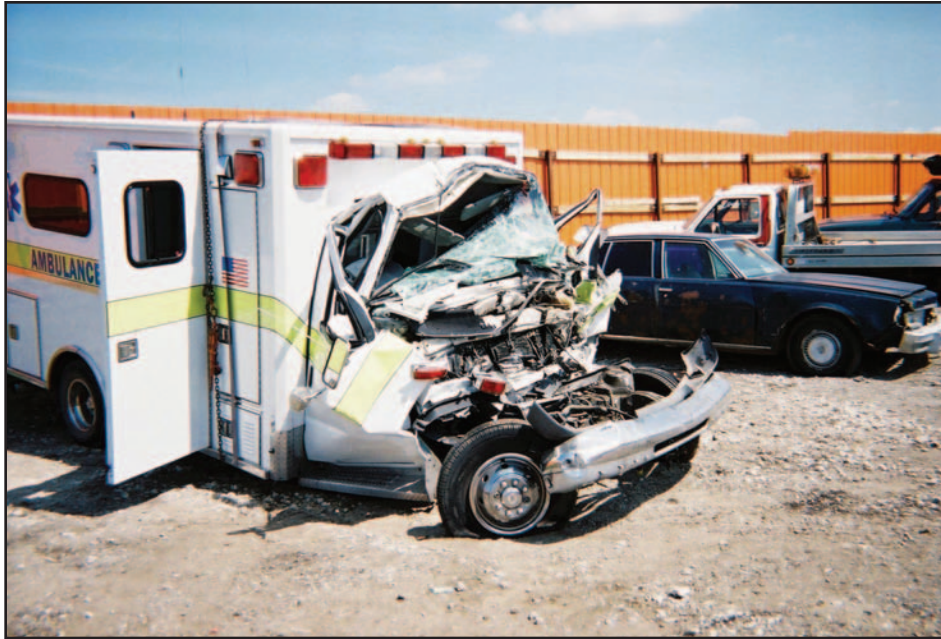
straight truck came to rest on the right shoulder of the road. The collision forces crushed the front of the ambulance and pushed its engine back into the cab (Photo 3). The State Patrol investigators estimated the tractor semi-trailer's speed at 61 mph at the time the driver applied the brakes.

Photo 3. Front cab of ambulance after collision

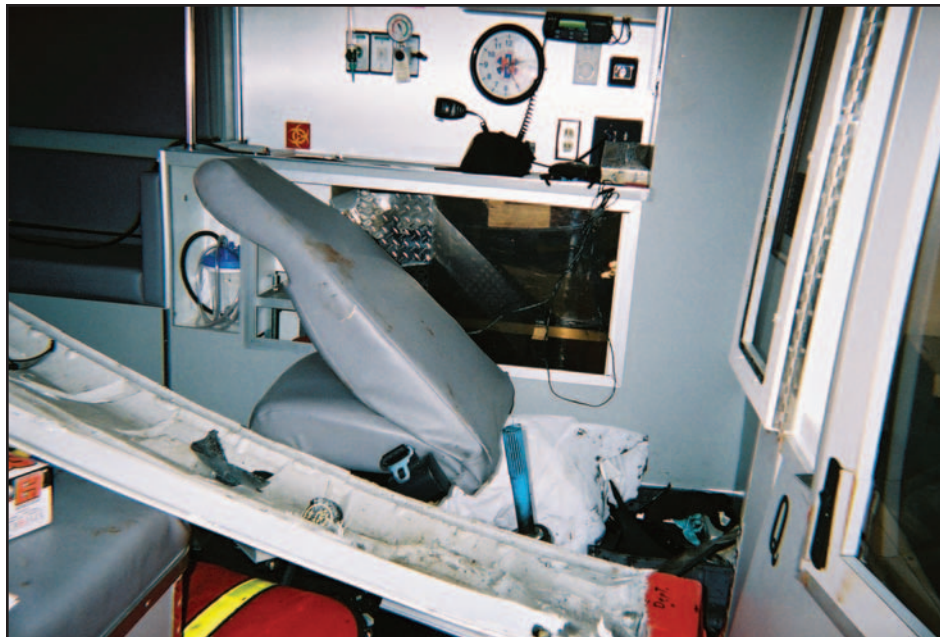
Photo 4. Attendant's seat after crash; note intrusion of drive shaft into compartment

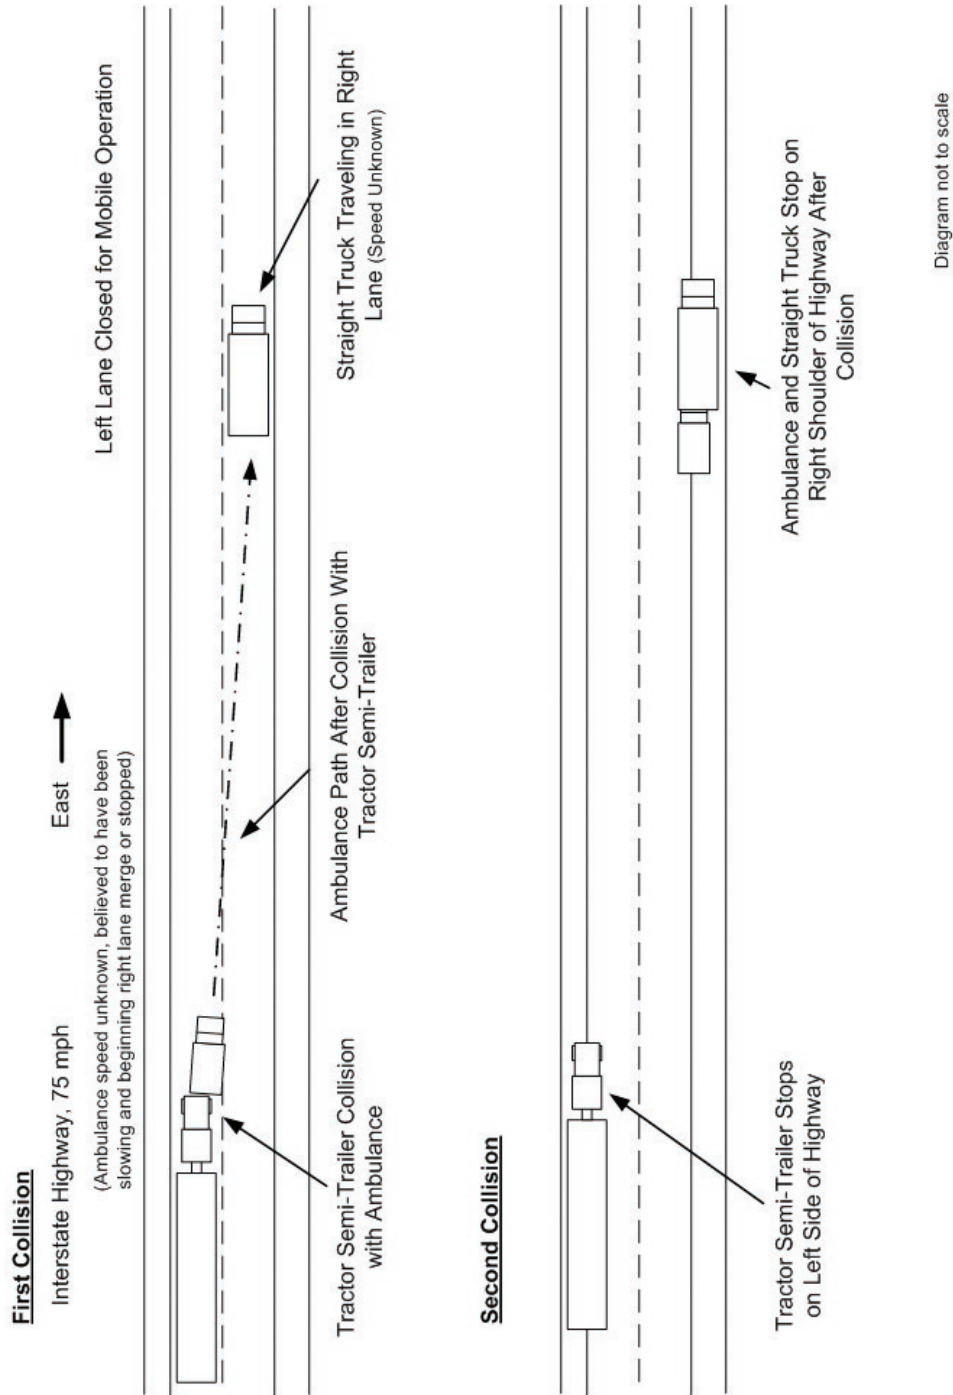
At 1605 hours, while traveling eastbound in the left lane, the ambulance approached the mobile operation engaged in painting lines on the road. Meanwhile, the patient had asked to borrow the lieutenant/paramedic's mobile telephone. The lieutenant/paramedic unbuckled his seat belt, moved over and sat on the squad bench, and handed his phone to the patient. The patient dialed the phone and talked, while the lieutenant/paramedic returned to the attendant's seat. As the lieutenant/paramedic was sitting down in the seat he observed through the rear windows of the ambulance a tractor with a semi-trailer quickly approaching. The ambulance had slowed or nearly stopped as it approached the line painting crew and the tractor semi-trailer struck it in the rear. The tractor semi-trailer driver applied the brakes and steered left and the tractor semi-trailer came to a stop with its left wheels on the left shoulder of the road. (Diagram 3) The ambulance which may have been steering right to merge was pushed approximately 240 feet until it collided with the rear of a straight truck traveling in the right lane. The ambulance and

Diagram 3. Path of Ambulance
