## Volunteer Assistant Chief is Struck and Killed at Road Construction Site - Minnesota

## Fatality Assessment and Control Evaluation Investigative Report #F2003-37

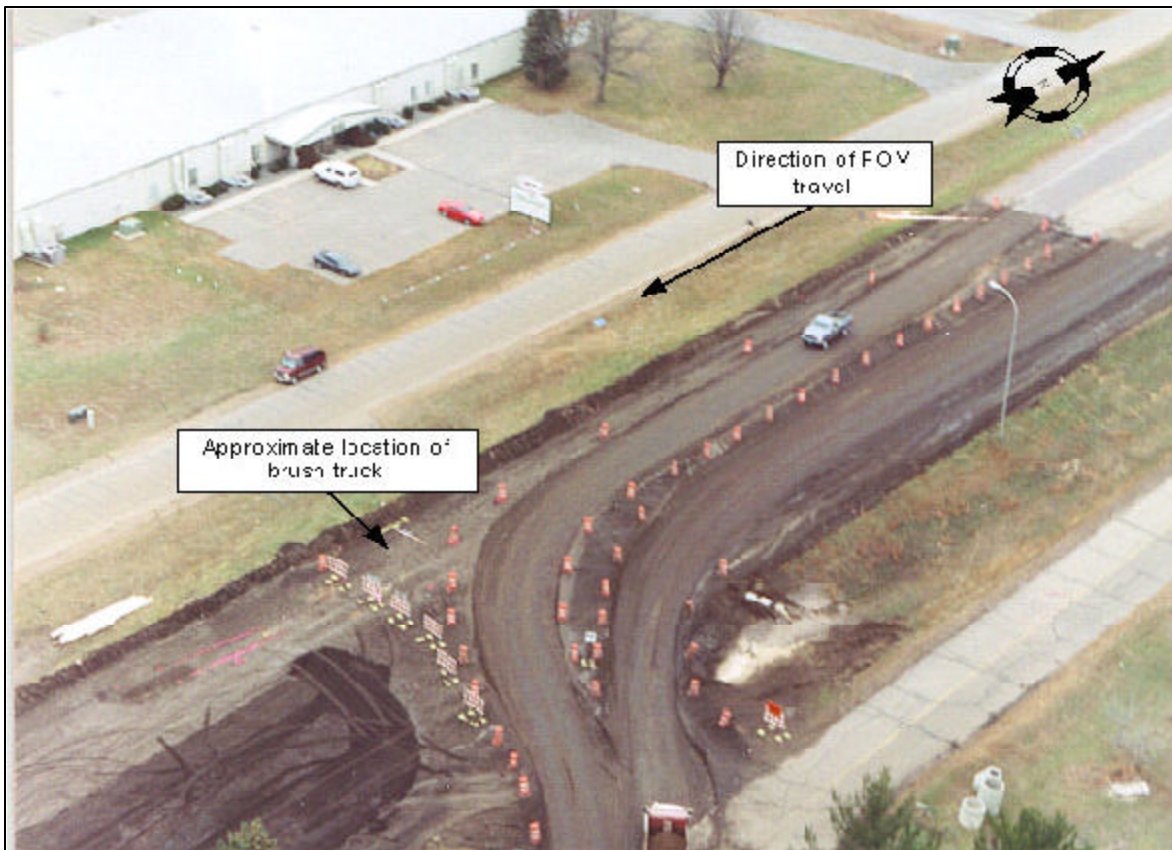
construction had been ongoing for over three months at the time of the incident. Near the construction site, the main road narrowed from four lanes to two, the pavement ended, and the main highway was closed. Main traffic heading south on the highway was detoured to the southeast via a sharp left turn. The detour was marked by 20 mph construction and curve signs. A traffic lane was formed using orange plastic barrels located on both shoulders (Photo 1). The temporary road at the detour site consisted of dirt and gravel and had a rough, washboard surface. According to the State OSHA report and the investigating police officer, a representative of the state Department of Transportation (DOT) office visited the construction site and verified that appropriate traffic control signs (Road Work Ahead, Reduced Speed Limit 20 mph, and curve signs) and barricades appeared to be in place at the time of the incident. At the time of the incident, it was dark and the temperature was 34 degrees F with light rain.

*Photo 1. Aerial view of detour around construction site - Courtesy of Police Department*

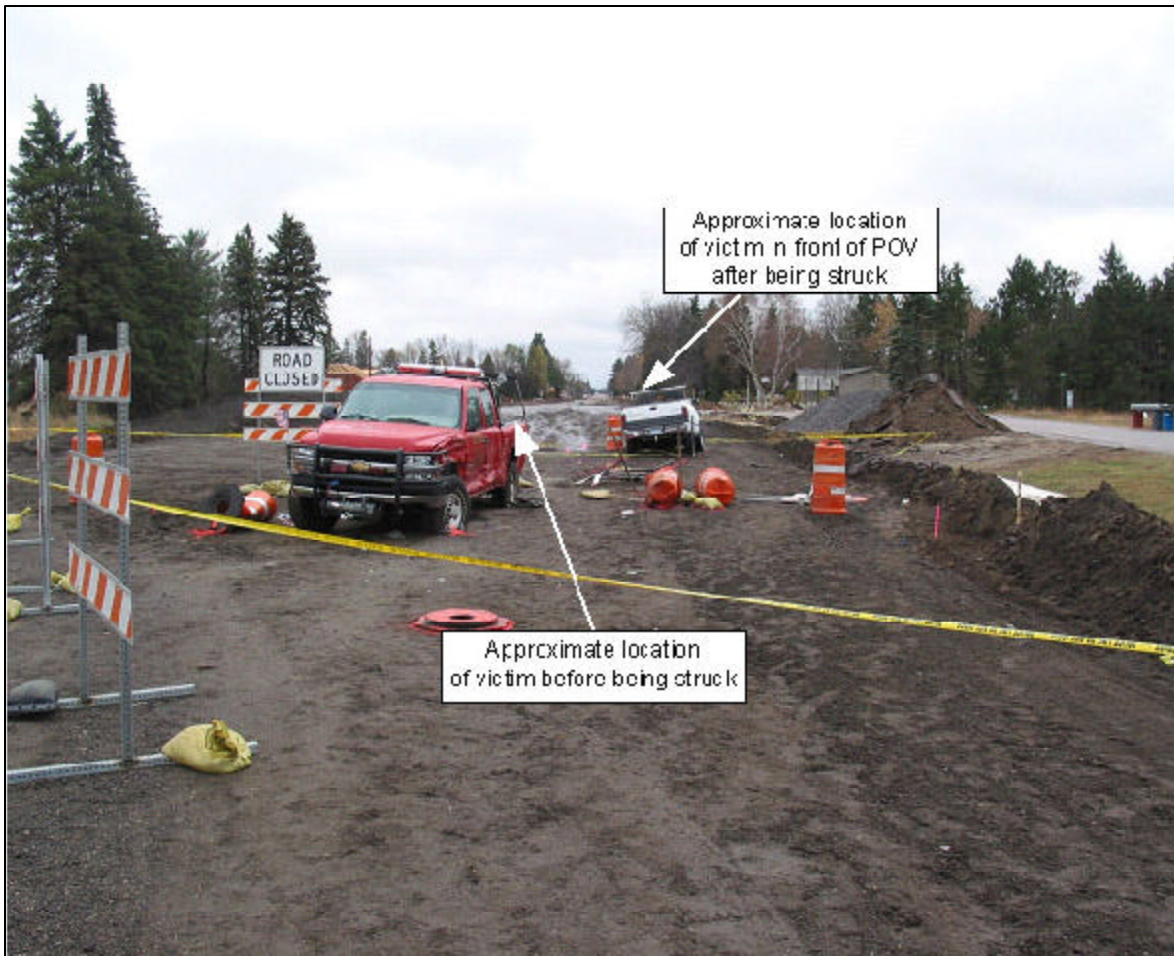
a 1994 pickup, failed to make the sharp left-hand turn necessary to detour around the construction site. It then hit the left front corner of the brush truck, continued along the side of the truck, and struck the victim who was standing towards the rear. The victim was dragged approximately 60 feet before the POV came to a stop (Photo 2). The POV had struck three construction barrels on the right shoulder of the roadway before striking the brush truck and the fire fighter.

*Photo 2. Incident Scene - Courtesy of Police Department*

***Recommendation #1. Fire departments should ensure that fire apparatus are positioned to protect fire fighters from traffic.<sup>2-6</sup>***

Discussion: As stated in NFPA 1451 (8.1.4.1), “fire service vehicles shall be utilized as a shield from oncoming traffic whenever possible.” Apparatus should be angled on the roadway to create a physical

barrier between the work area and approaching traffic. Emergency personnel should stay within the “shadow” created by the blocking apparatus at all times. Forward-facing lights such as headlights should be turned off to prevent distracting motorists traveling in the opposite direction.
