Career Fire Fighter Drowns While Conducting Training Dive - New Hampshire

SUMMARY

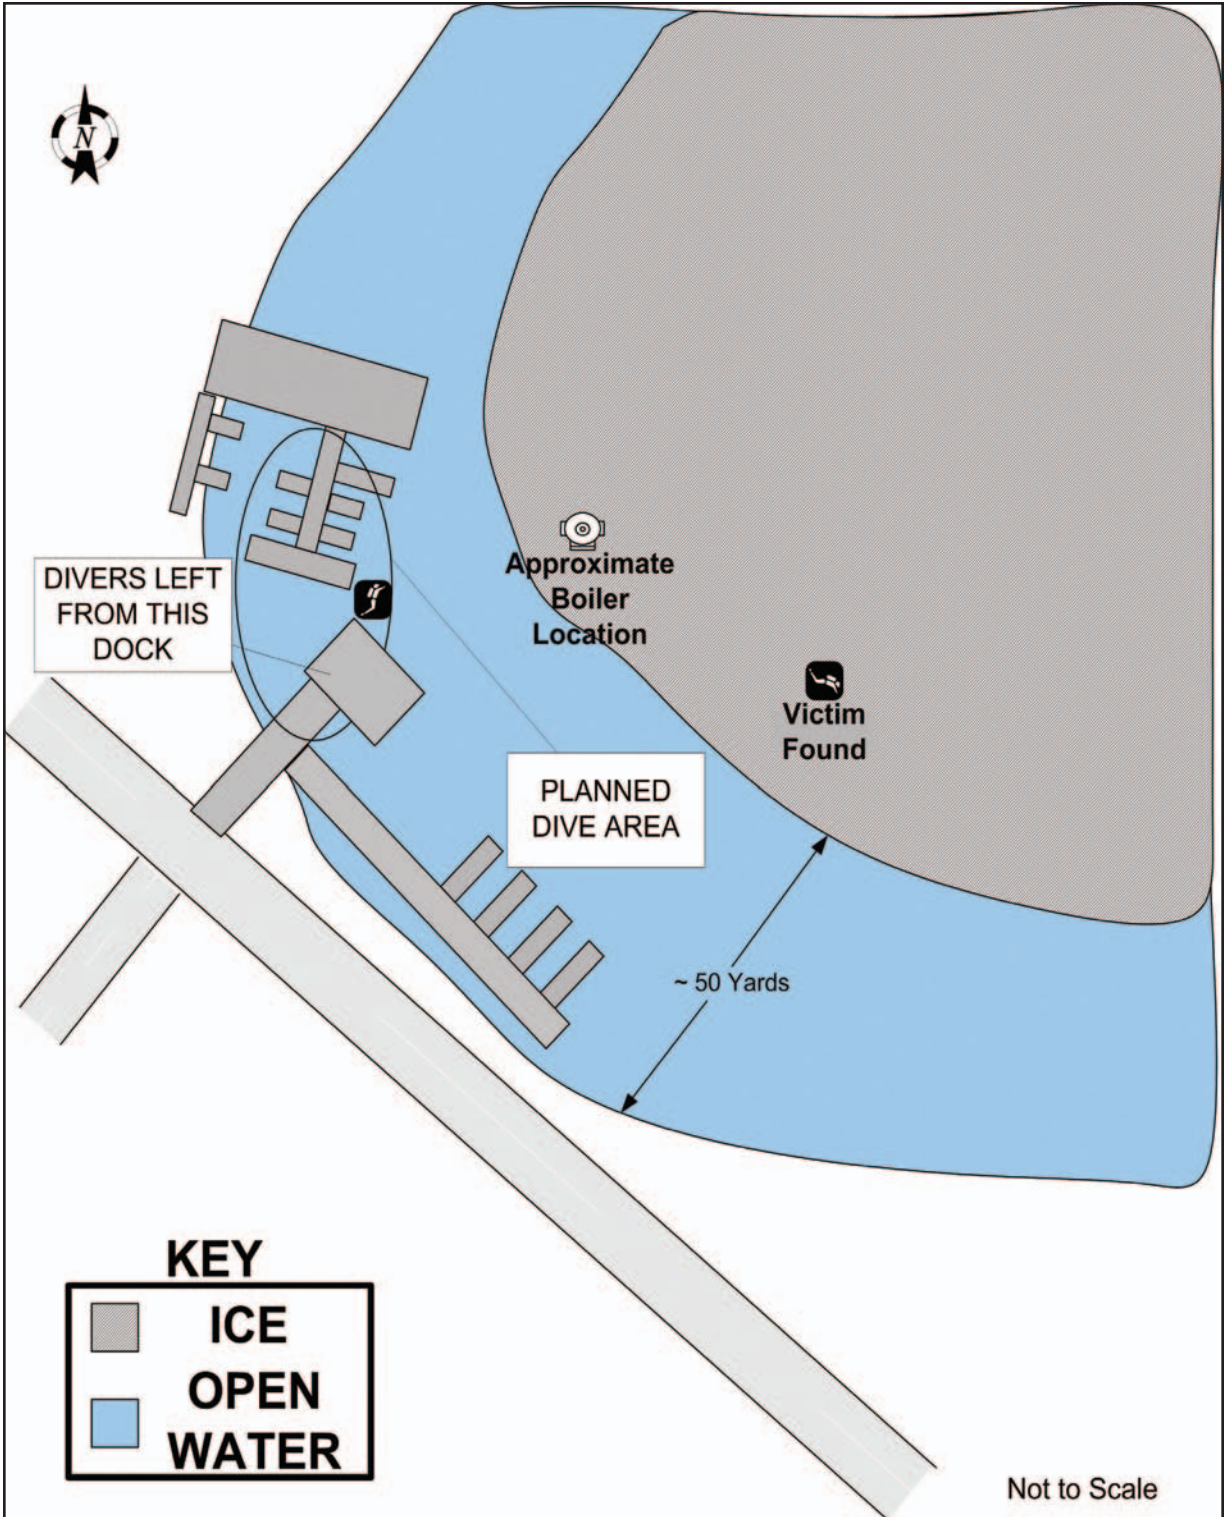
Diagram. Aerial view of dive area

dock in case he needed to use it later. The divers' general plan was to stay in open water along the docks to observe the area around the pier pilings for hazards (Diagram). They specifically decided to stay away from the iced over area of the lake which was prevalent to about 50 feet away from the docks. Two large water circulators, which helped control ice build-up around the docks from the piers, were effective and running at the time of the incident.
