## **One Probationary Career Firefighter Dies and Four Career Firefighters are Injured at a Two - Alarm Residential Structure Fire - Texas**

*This report was revised on January 5, 2007.*

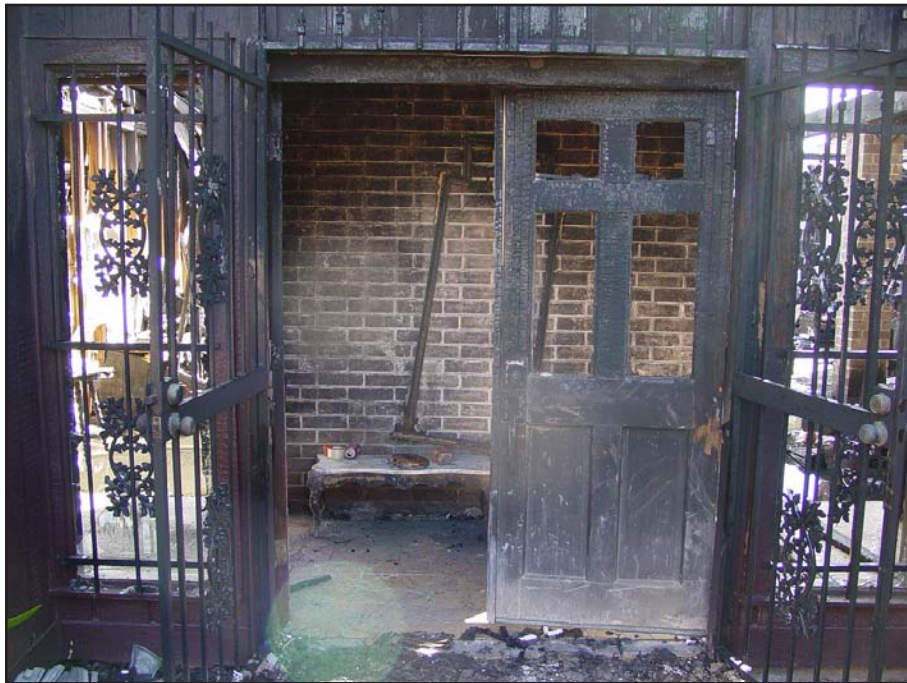
The crew from E-5 (staged at the front door, side-A) (Photo 1) stated that only minutes after entry was made, they heard muffled yelling and firefighters began crawling and running out of the structure. The E-5 crew began assisting the firefighters, as their gear was either smoking, or on fire. At this time, the E-3 (RIT) crew was approaching the front door. The time was approximately 1523 hours, less than four minutes after initial entry was made. The E-5 Lt. stated that he ran over to the IC command post and informed him that they had firefighters down, and to call for additional EMS units. The IC immediately called for a second alarm *(Note: the second alarm for this department is a single engine (E-4) and the dispatch of a volunteer fire department, which reportedly had an approximate 30-minute response time.)* The IC also called for additional EMS units (2 additional) and a PAR. E-2 reported that they had a PAR. EL-1 also initially reported they had a PAR, but then immediately radioed

*Photo 1. Illustrates the front door (side-A) and the burglar bars restricting entry. Note that this security measure was on every access door and window of the structure*

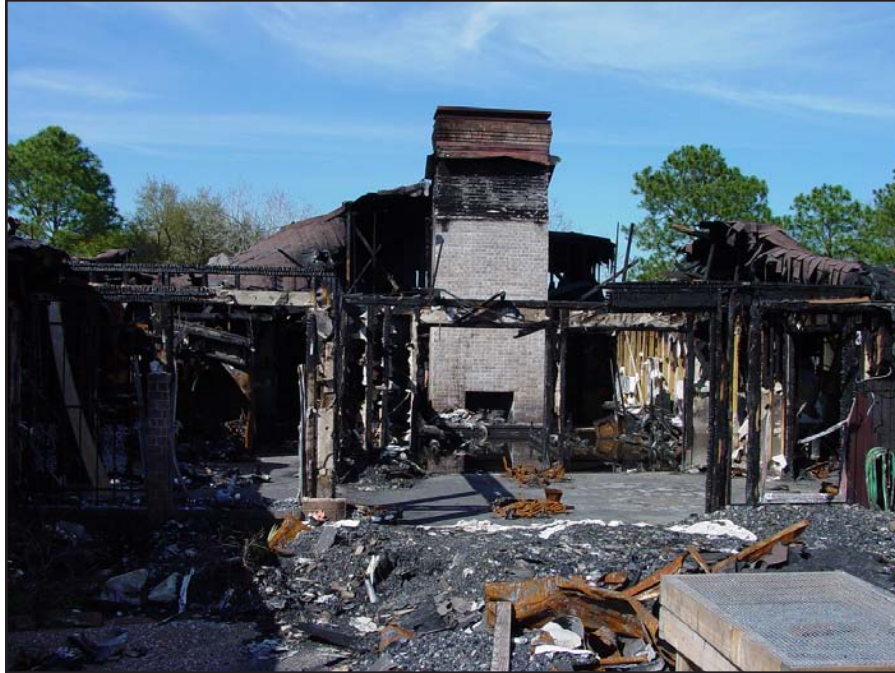
up to the chimney (Photo 2). The victim's SCBA face piece was in place. His gear and SCBA was badly damaged by the heat of the fire, and it was noted by rescuers that the PASS device was not sounding.

*Photo 2. Depicts the rear (side-C) of the structure. Note the collapse area included the majority of the structure, including around the chimney near where the victim was found.*

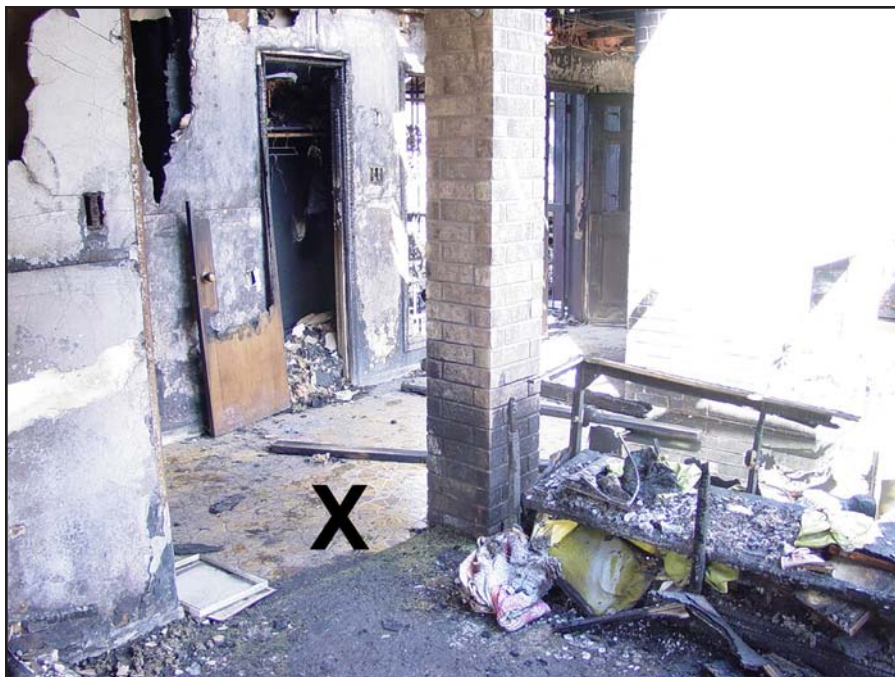
statements verified that the hose line had been advanced through the approximate 4’ space between the wall and a brick pillar (photo 3 and diagram 3), where the victim was found.

*Photo 3. This photo shows (X) where the victim was found, facing toward the door. There was an approximate 4 foot distance between the brick column on the right and the corner of the wall on the left. This photo was taken from the interior of the house, looking toward the front door.*

***Recommendation #8: Fire departments should ensure that hose lines are not pulled from the burning structure when it is possible that a missing firefighter is in the structure.***

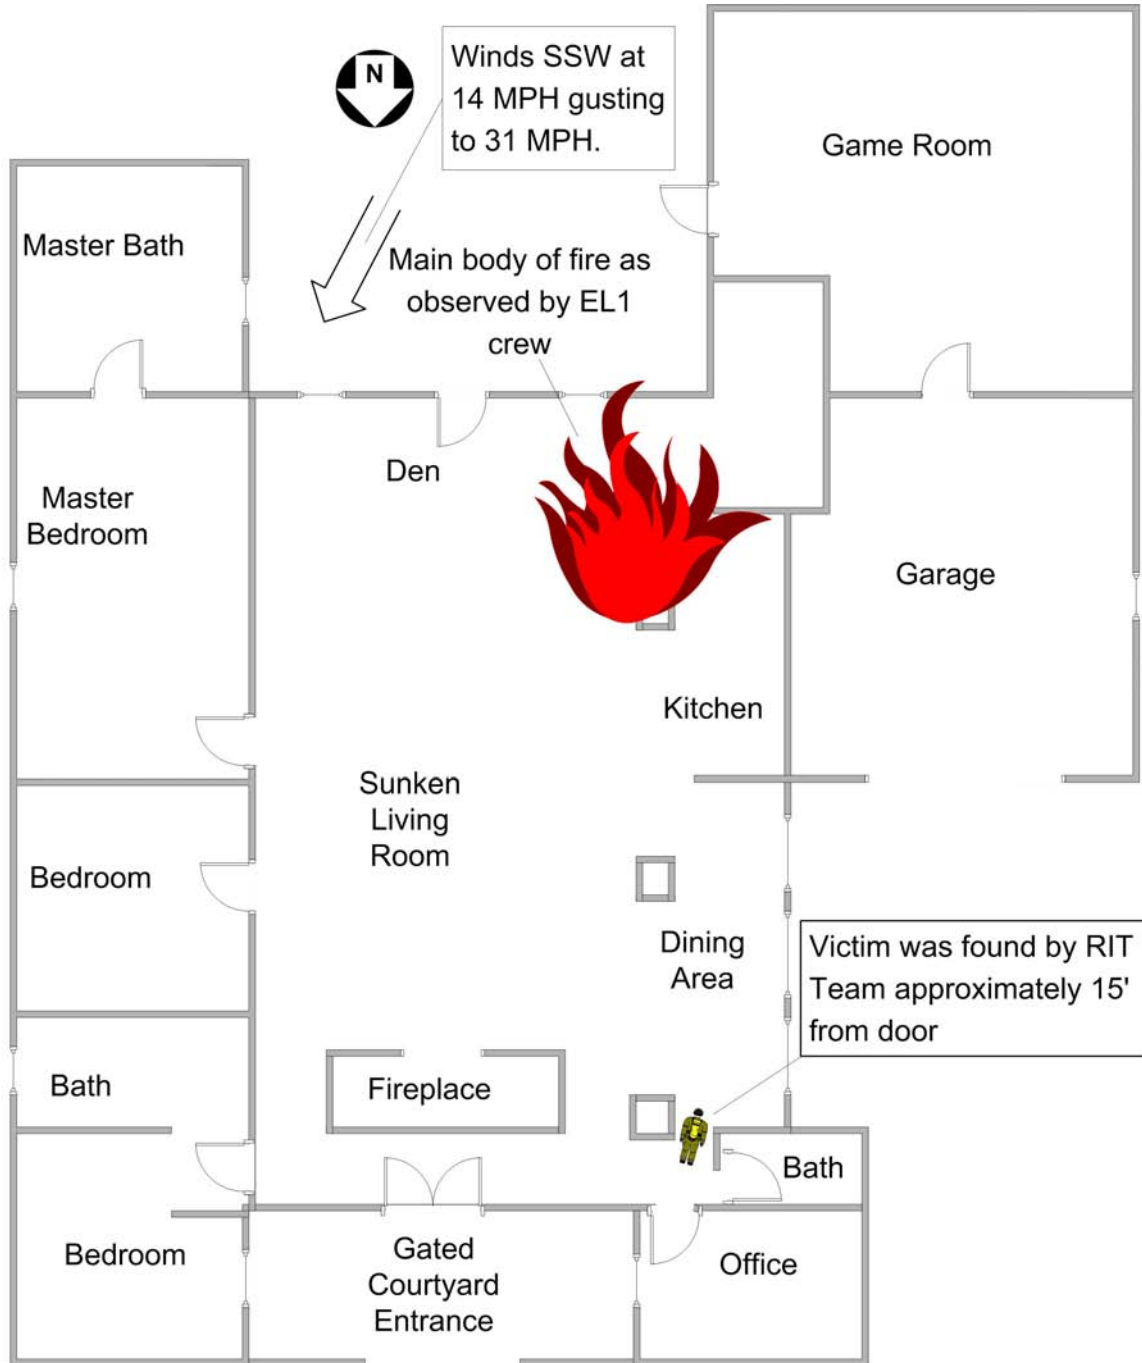
In this incident, a total of six firefighters (and a charged 1 – ¾ inch handline) simultaneously entered the structure through the same door - three firefighters from EL-1 and three firefighters from E-2. The access point and area where firefighters operated in this structure was not conducive to six firefighters operating, in that it was a small area. (Diagram 1).

Diagram 1. Depicts the overall floor plan of the structure, and where the victim was located

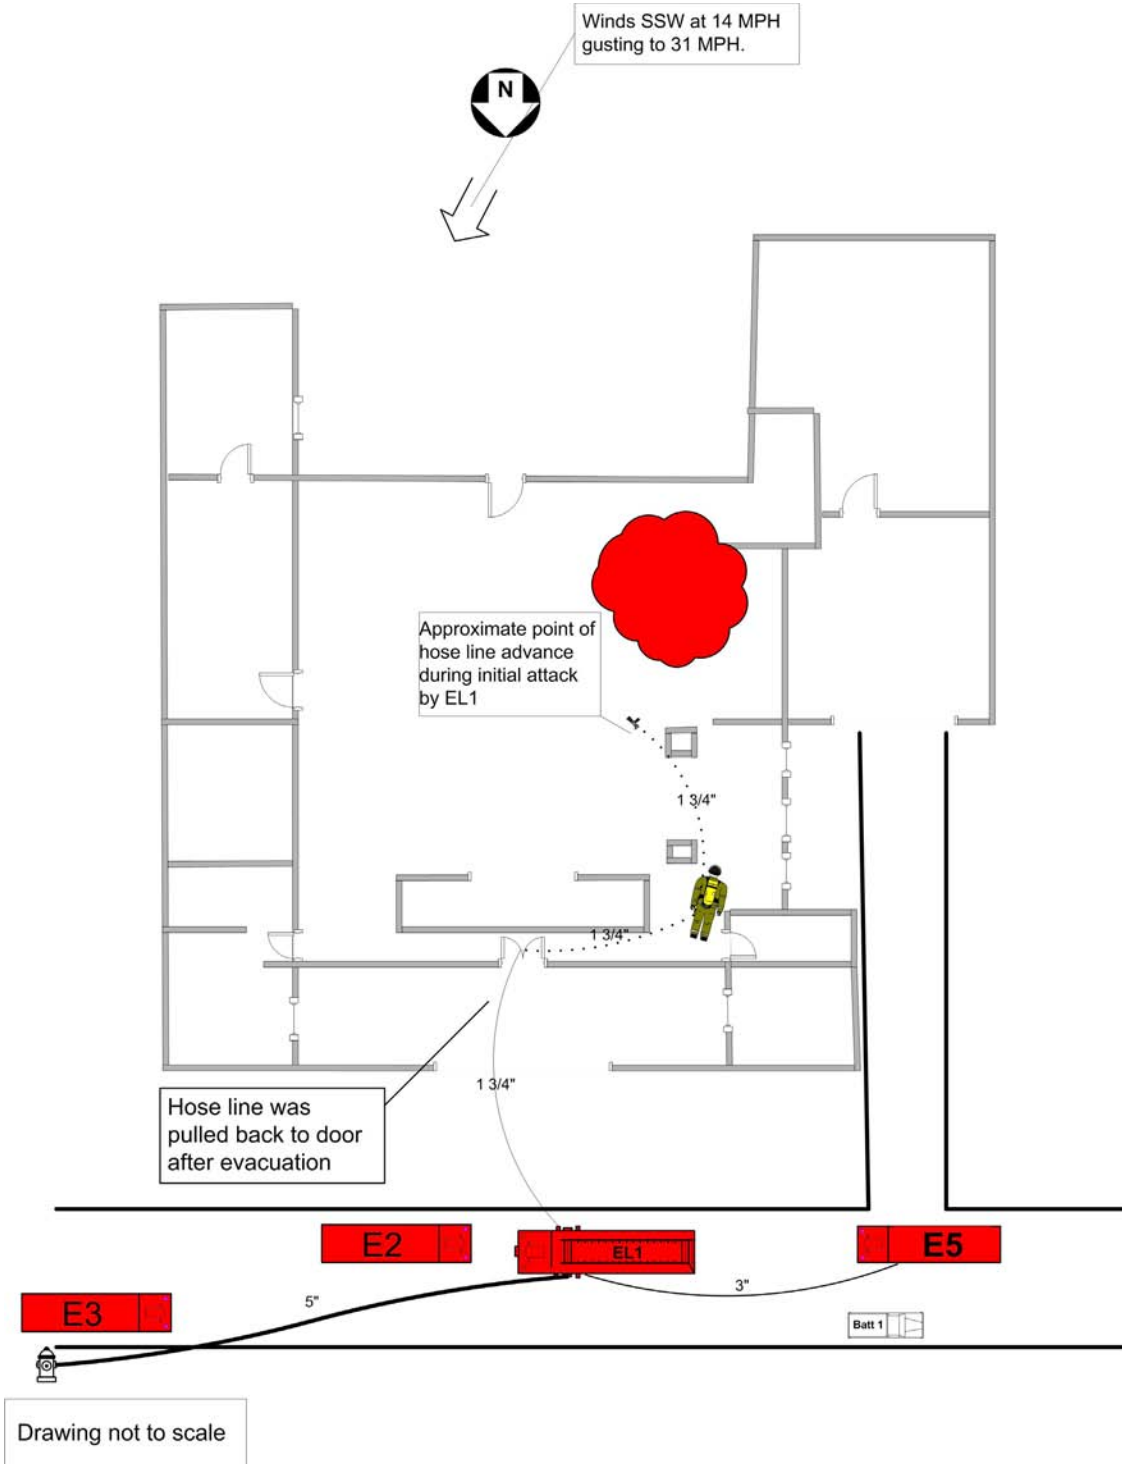
Diagram 3. Depicts the initial hose-line advance. Note the dotted line.

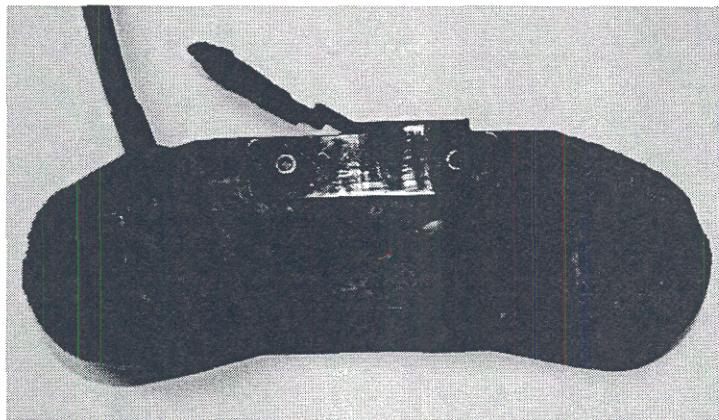
**Visual Inspection** The alarm did show some smoke and heat damage on the outside surfaces. The inspection did not reveal any melt through. Some enclosure deformation was observed on each end.

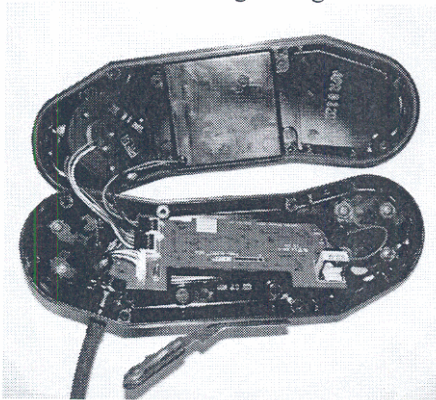
- The product did show some discoloration under the cover plate.
- No physical damage to the PCB was observed.
- No melt through observed.
- No measurable enclosure deformation was observed.
- No internal wiring damage

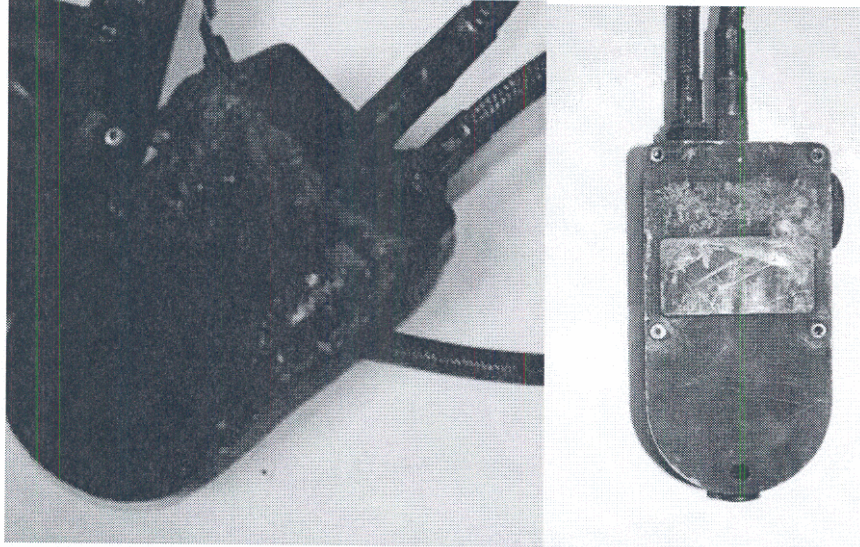
- Smoke discoloration shown over the entire enclosure
- No melt through observed.
- Deformation was observed on the control side of the enclosure.

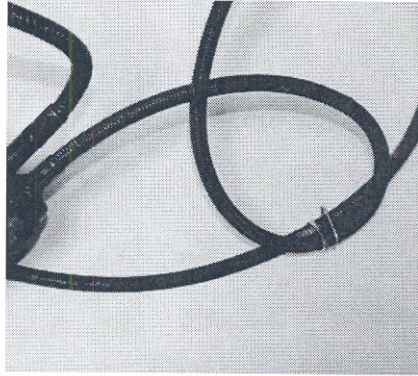
- The metallic outer sheathing was discolored throughout.
- No melt through observed.
- No measurable deformation was observed.

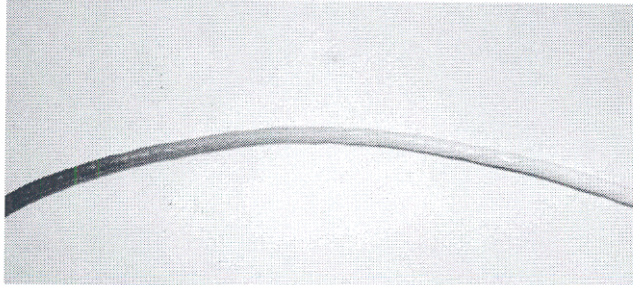
Discolored internal sheathing (Photo to show the difference)

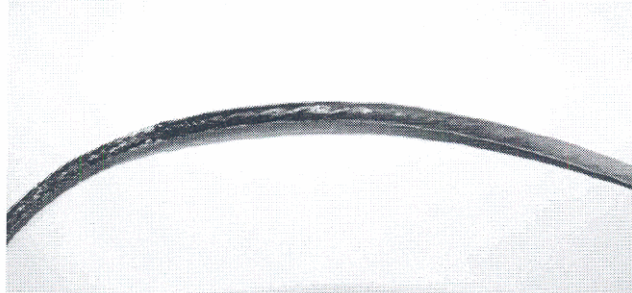
Damaged internal sheathing (left end, no sheathing remaining)

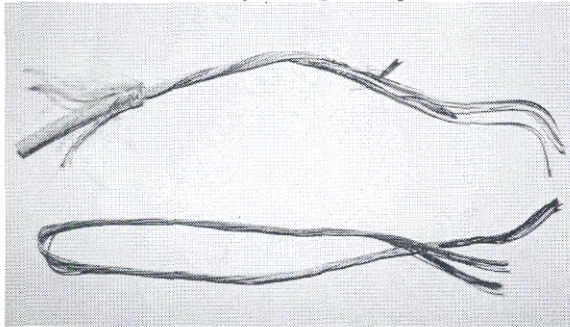
Picture of the internally wiring as inspected

The results of this inspection show that control and alarm enclosures had smoke and heat damage but remained functional. The cable assembly between the alarm and control was damaged by heat to such an extent that inner sheathing and wires insulation was melted away. Without the inner sheathing and insulation the wiring shorted to itself and to the braided metallic outer sheathing.

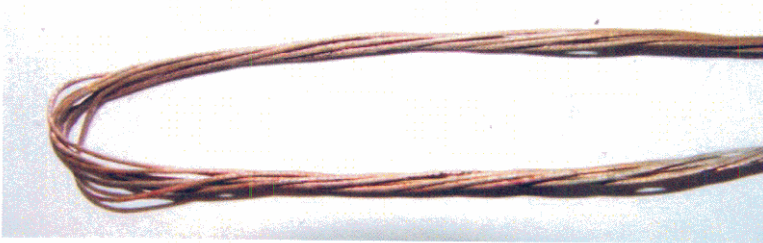
BAD INTERNAL SHEATHING MELTED
