Career Captain Electrocuted at the Scene of a Residential Structure Fire - California

Fatality Assessment and Control Evaluation
Investigative Report #F2005-07

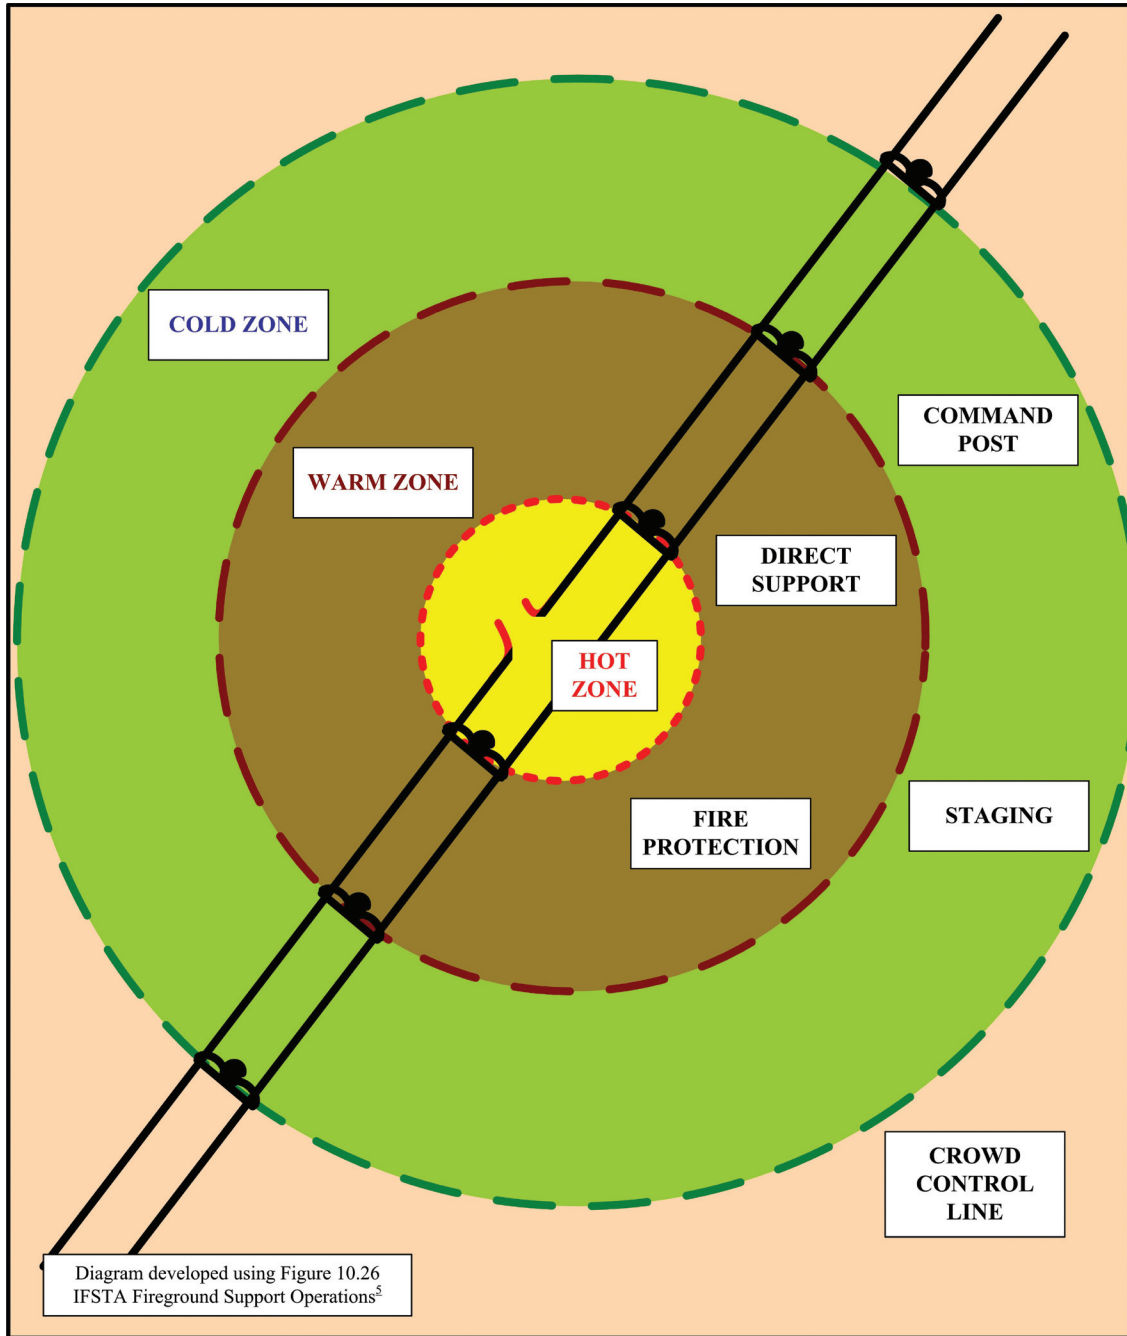
Diagram 2. Perimeter Control

A common error is establishing a safety perimeter that is too small.⁵ The recommended isolation distance is equal to one full span between the adjacent poles or towers in all directions from a break in the wire, or the point of contact with the ground (see Diagram 2). While the aforementioned rule for perimeter placement can be used in most downed wire incidents, in other situations such as following an explosion or structural collapse, it may be necessary to more clearly define the hazard area. For example, if a downed wire is obscured by building debris, smoke, or darkness, it may be necessary for fire fighters to use various forms of technology to identify the hazard area. There are several useful devices available to fire departments for this purpose. Two of the most common are the *alternating current detector* and *thermal imaging camera*.⁵

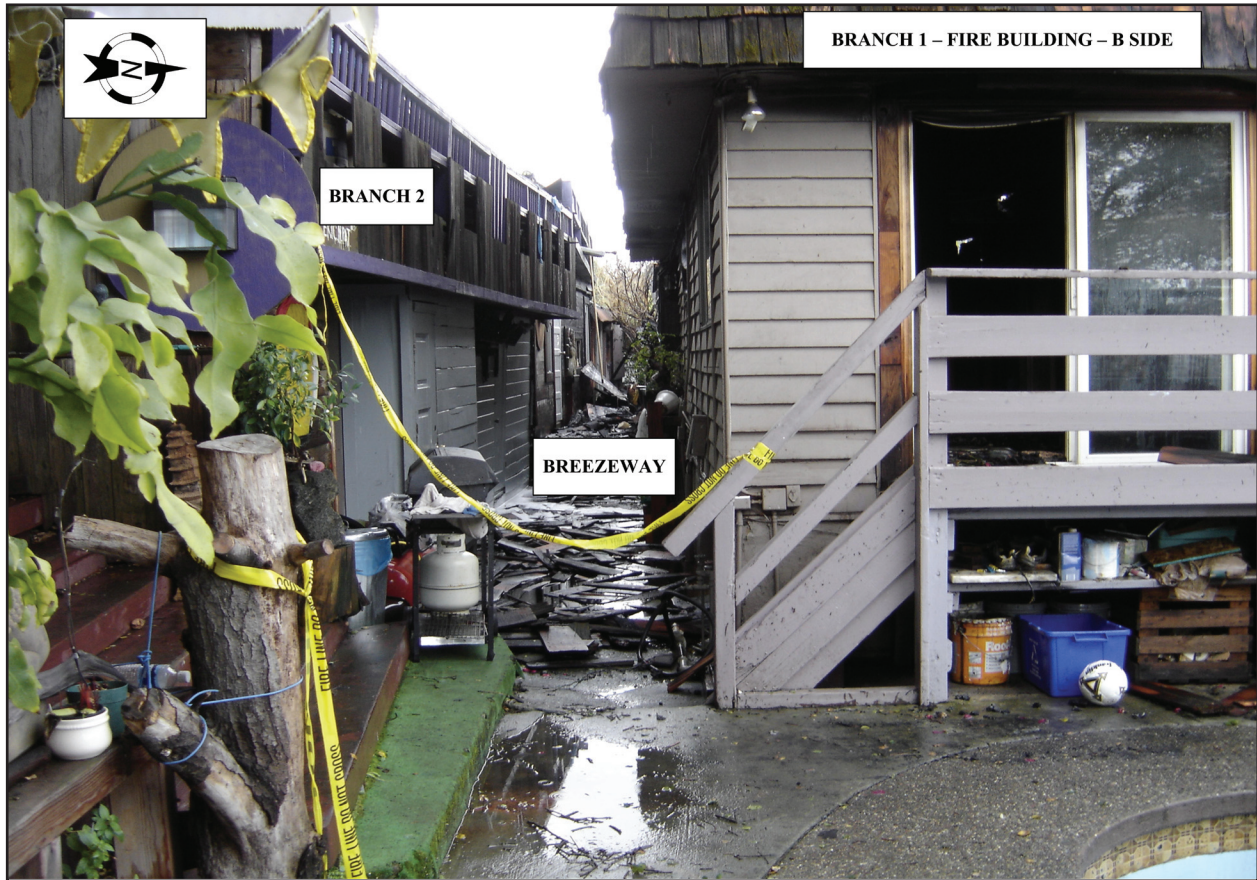
*Photo 1. Photo showing Branch 1 and Branch 2
Photo courtesy of the fire department*

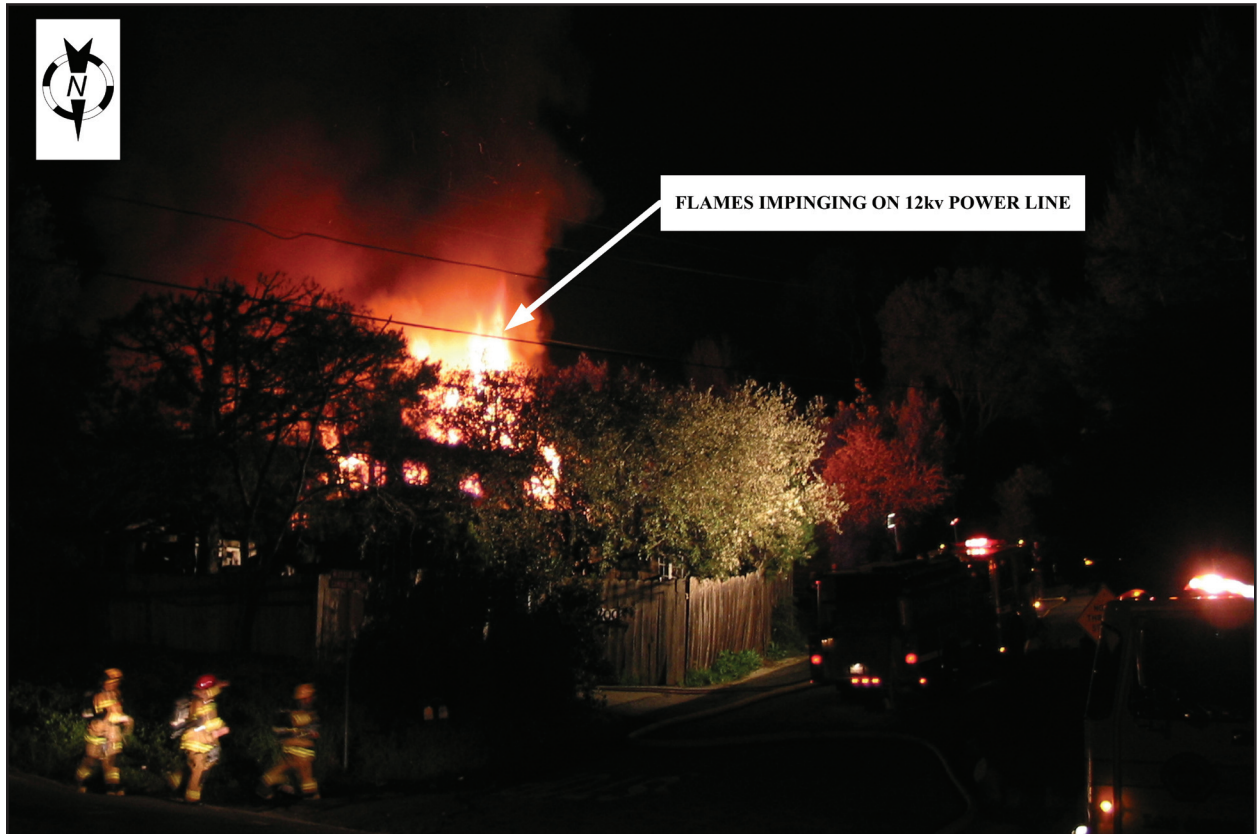
At 0228 hours, IC1 called for a second alarm and requested dispatch to call the power company. He stated "We need (the utility company), the fire is endangering the power line above" (Photo 2). At this point, it appears there was some confusion with the communication as the request was not acknowledged, and when dispatch called for a repeat the IC gave an "all clear". Because of the miscommunication, it is believed that County Command was unaware of the imminent danger created by the fire-impinged power lines and did not relay a sense of urgency to the power company. The call to the electric company was processed as a routine function of the second alarm protocol. At approximately 0228 hours, the officer from R3 reported that he heard an arcing sound and saw a bright flash of light above him as he walked under the tree where the downed power line ultimately lodged. A fire fighter who

*Photo 2. Photo showing flames impinging on power line
Photo courtesy of the fire department*

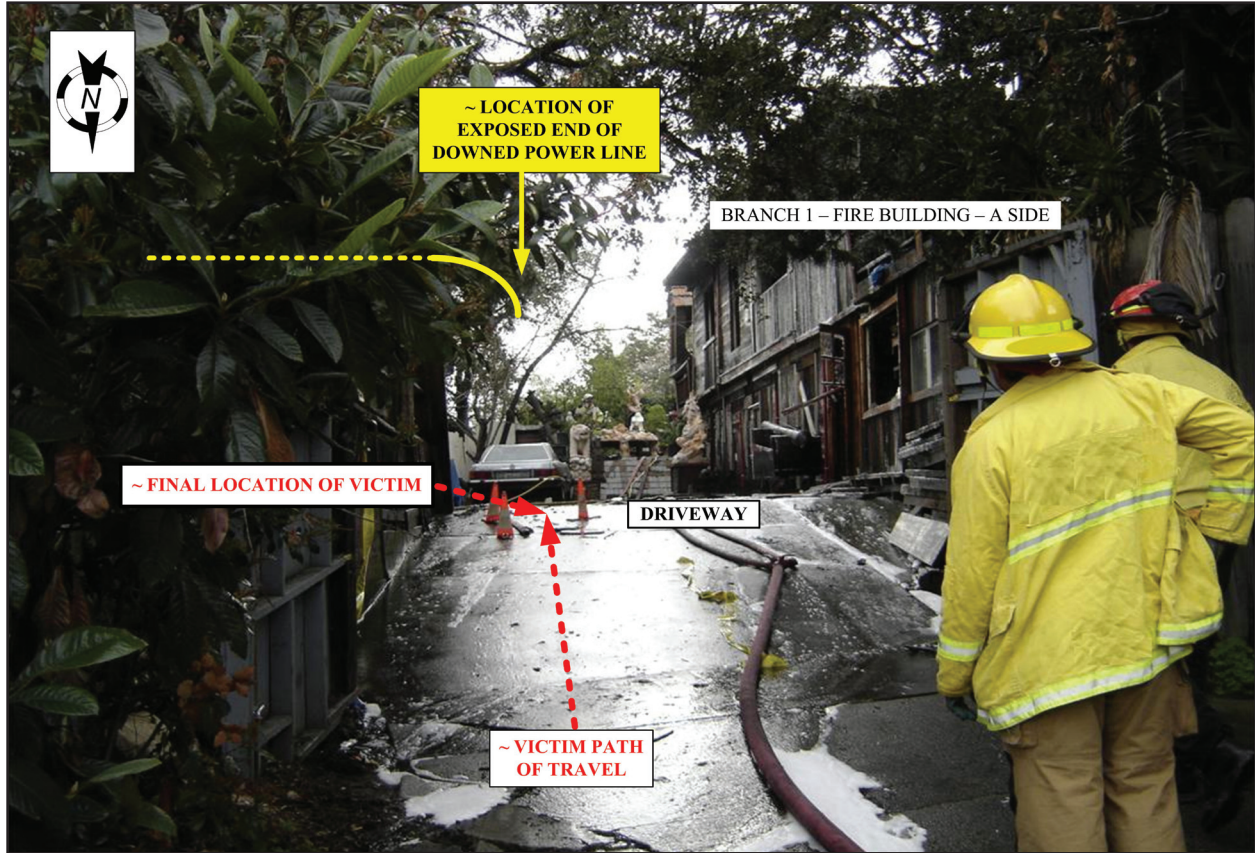
In this incident, attempts were made to warn fire fighters of the downed power line that was hanging in the tree near the driveway by placing yellow caution tape around the area immediately under the tree, and relaying information on the hazard by word-of-mouth. Interviews reveal that the gravity of the situation was not completely understood as fire fighters were permitted to freely traverse the driveway and continue fire suppression activities in proximity to the wire. It also appears that the victim was aware of the downed power line that fell near the C/D corner of Branch 2, and may have considered it the only electrical hazard on the scene. It is believed that he did not see the yellow caution tape, or hear the warning of the fellow fire fighter, before he came in contact with the wire.

*Photo 3. Incident scene
Photo courtesy of the fire department*
