4 Career Fire Fighters Killed and 16 Fire Fighters Injured at Commercial Structure Fire - Texas

Executive Summary

A summary of a NIOSH fire fighter fatality investigation

July 15, 2015

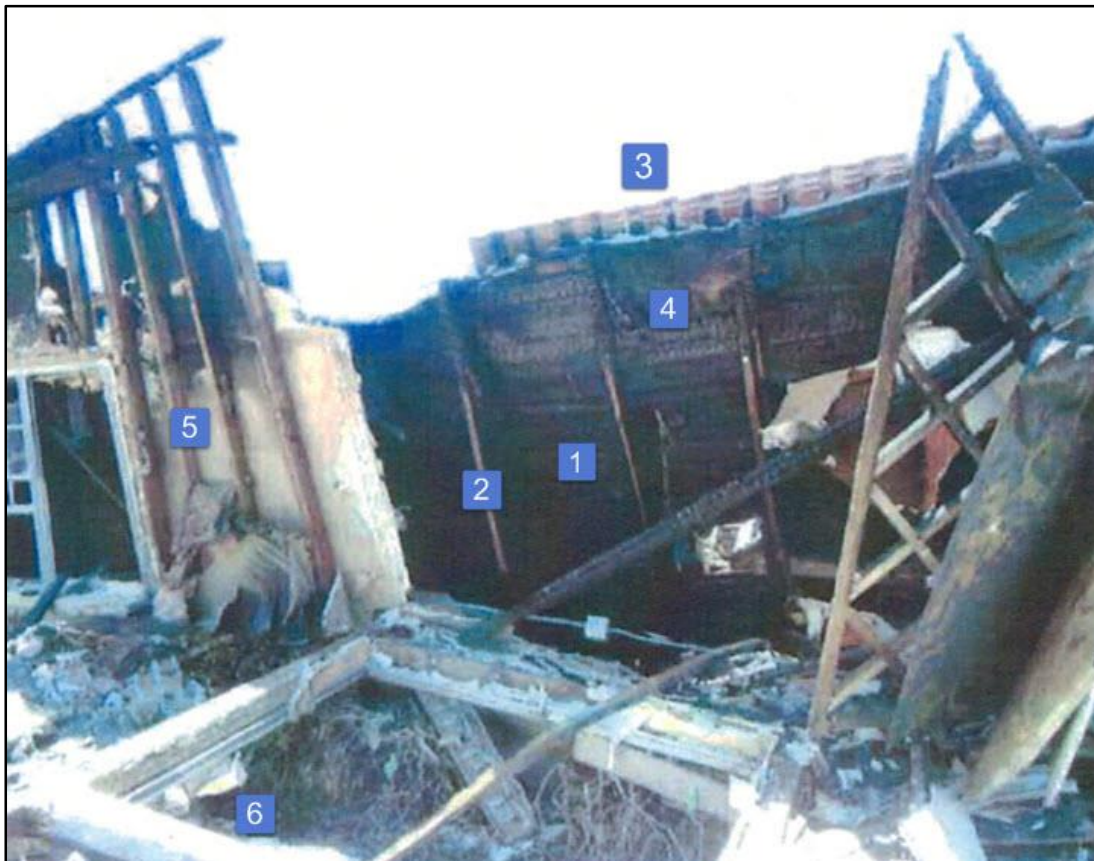
Photo 1. View of Division Alpha Perimeter Wall & Lean-To Roof Collapse
(Fire Department Photo/ Diagram Courtesy of Buildingsonfire.com)

The restaurant's perimeter wall (resulting secondary collapse) is visible with the underside of the roof decking and the remnants of roof truss bottom cords. The edge of the roofing tiles can be seen along upper lateral roof edge. (See **Photo 1**.)

- [1] Roof Sheathing-underside
- [2] Edge of Roof Truss Bottom Cords (24 inch on-center)
- [3] Edge of Roofing Tiles
- [4] Charring from flame impingement
- [5] Restaurant Perimeter wall
- [6] Secondary Collapse Management Zone (SCMZ)

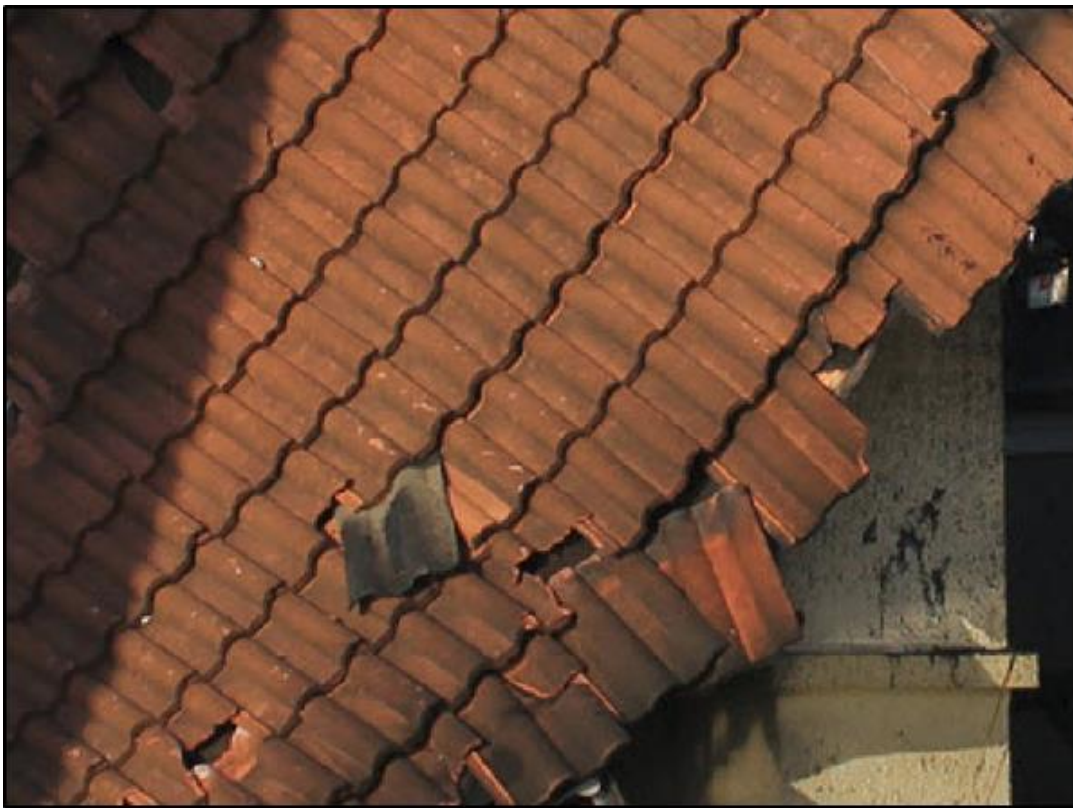
Photo 2. Concrete Roofing Tiles - Post Fire
(NIOSH Photograph)

Interlocking ribs are provided on the longitudinal edges of the tiles to restrict lateral movement and provide a water stop. In addition, transverse bars are provided on the underside to serve as weather checks. Mineral coloring oxides are either applied to the exposed surface in a cementitious material or mixed integrally with the tile mix to produce a through-colored product. Concrete interlocking roof tile profiles and details are provided based on technical literature. [10, 11, 12](#) (See Photo 2 and Diagram 3.)

Due to the absence of historical construction records and specifications, the roofing tile was identified based on the roofing tile manufacturer imprint. This is typically found on the underside of each tile unit. A likely tile unit style was identified, which is consistent with the figures developed and specifications.

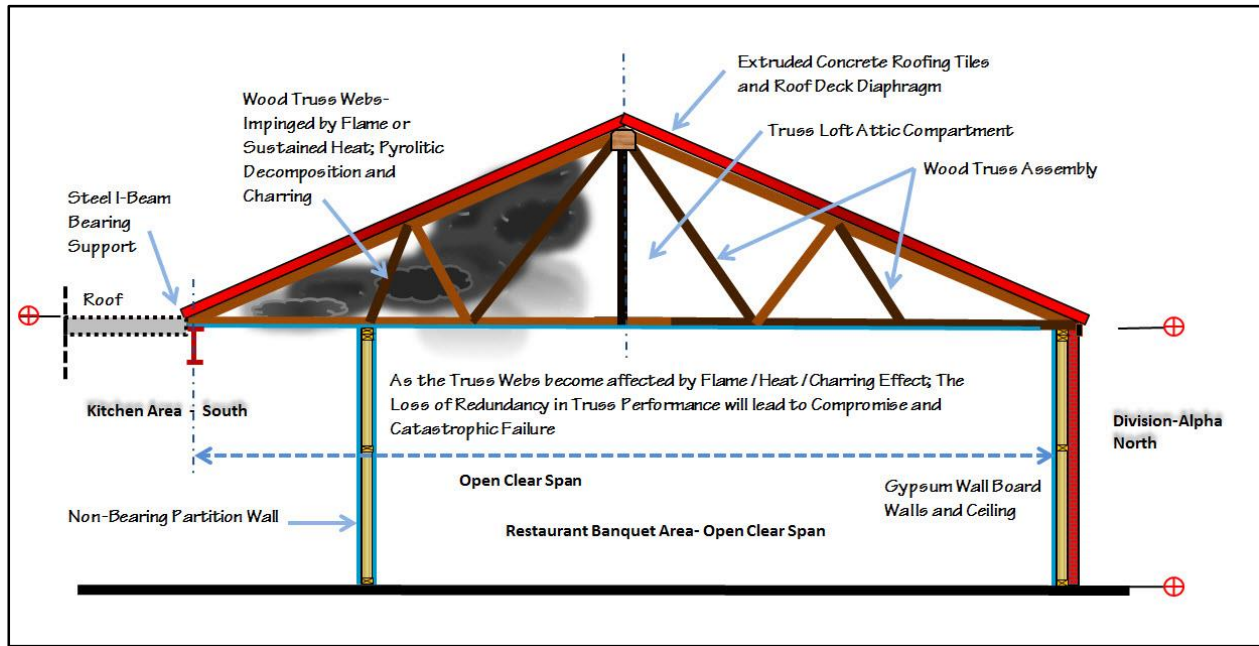
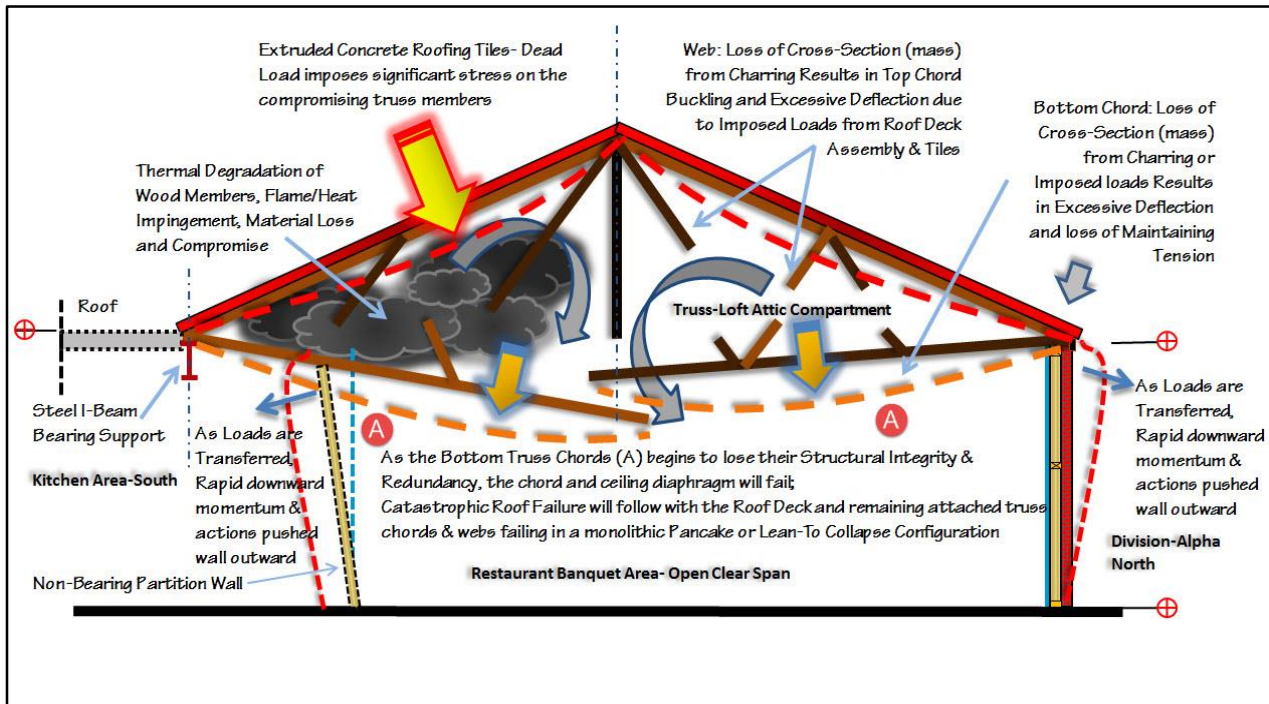
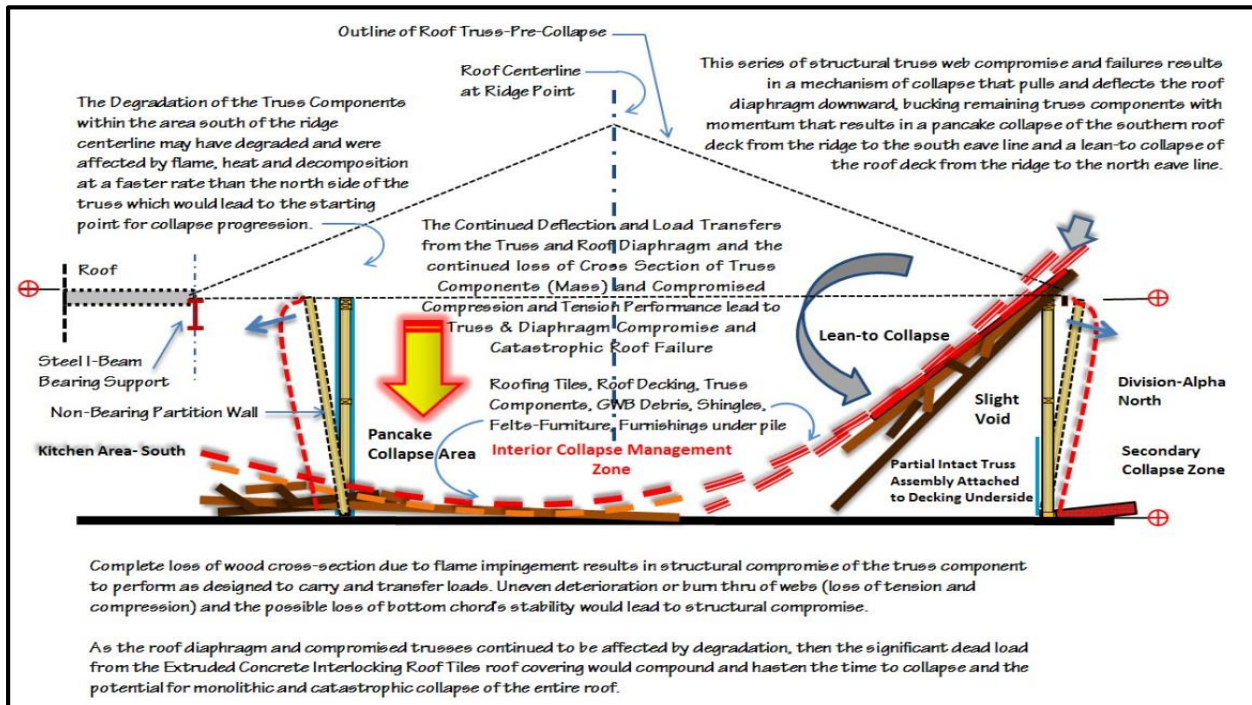
- Based on the postulated mechanism of collapse and the resulting lean-to collapse configuration of the partial roof diaphragm along the Alpha Division (North perimeter wall), the condition of post-fire truss components likely generated uneven burning and increased structural compromise of the truss components occurred along the south perimeter or area of the restaurant roof than did along the north perimeter.

- This increased level of deterioration and/or loss of web performance or materials (due to fire) would cause the wood truss to fold in on its self-downward, and forward toward the front perimeter wall. This series of structural compromise and failure results in a mechanism of collapse that pulls and deflects the roof diaphragm downward, bucking remaining truss components with momentum that results in a pancake collapse of the southern roof deck from the ridge to the south eave line and a lean-to collapse of the roof deck from the ridge to the north eave line. **(See Diagrams 8, 9, 10, and 11.)**

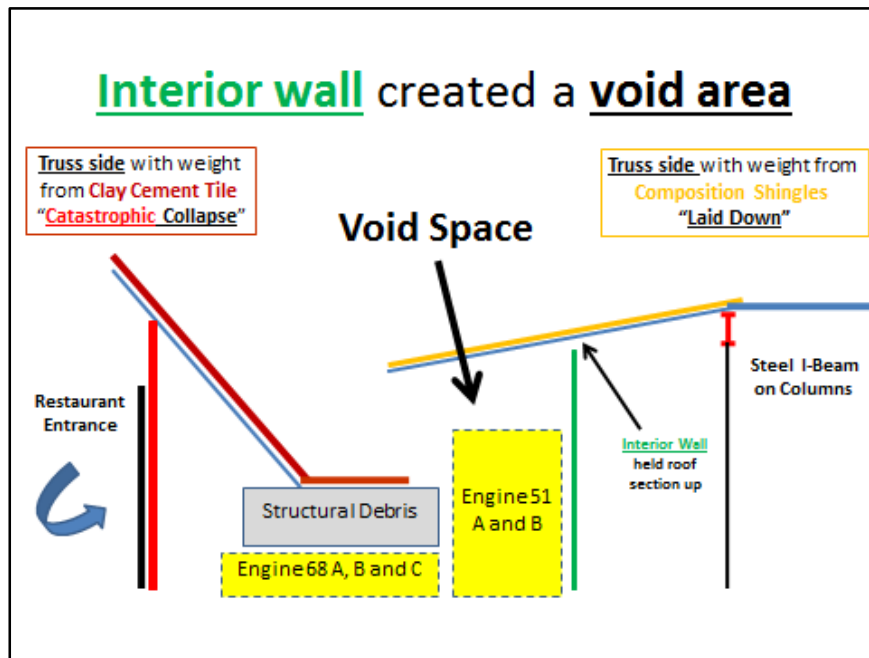
Diagram 11. When the collapse of the roof occurred, it formed a void area trapping fire fighters from E51 and E68
(Diagram courtesy of the fire department)

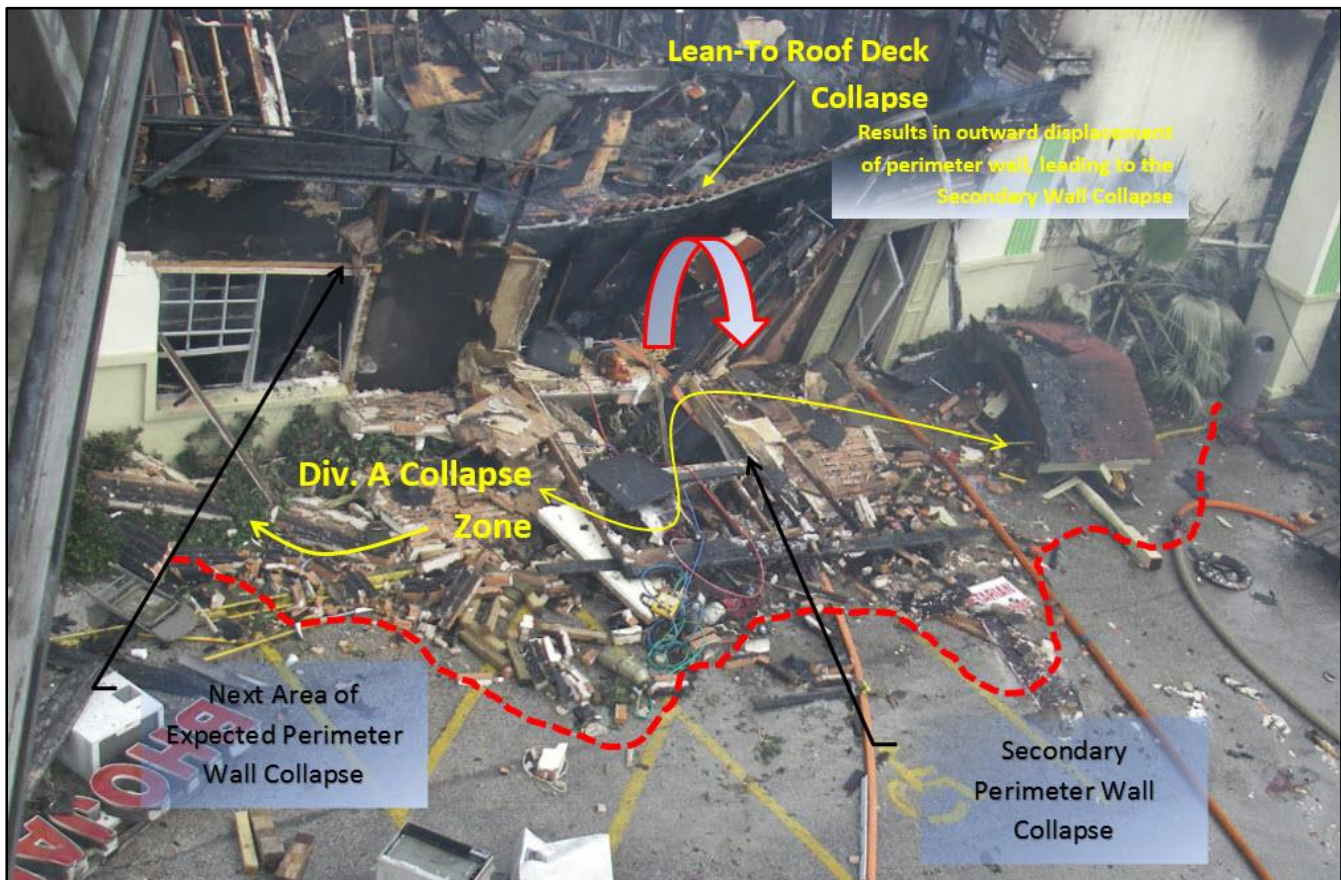
The roof deck came to rest in a slight lean-to configuration creating lateral forces acting upon the outer (north) perimeter wall. This degraded the integrity of the gypsum wall board and wood stud frame wall and caused cracking along the outer wall. Since the primary entry point to the interior of the restaurant was located on the Side Alpha, this was the entry point for the initial handline taken in the building.

Photo 3. Details of the secondary collapse on Side Alpha.
(Photo courtesy of the fire department/Analysis Diagram Courtesy of Buildingsonfire.com)

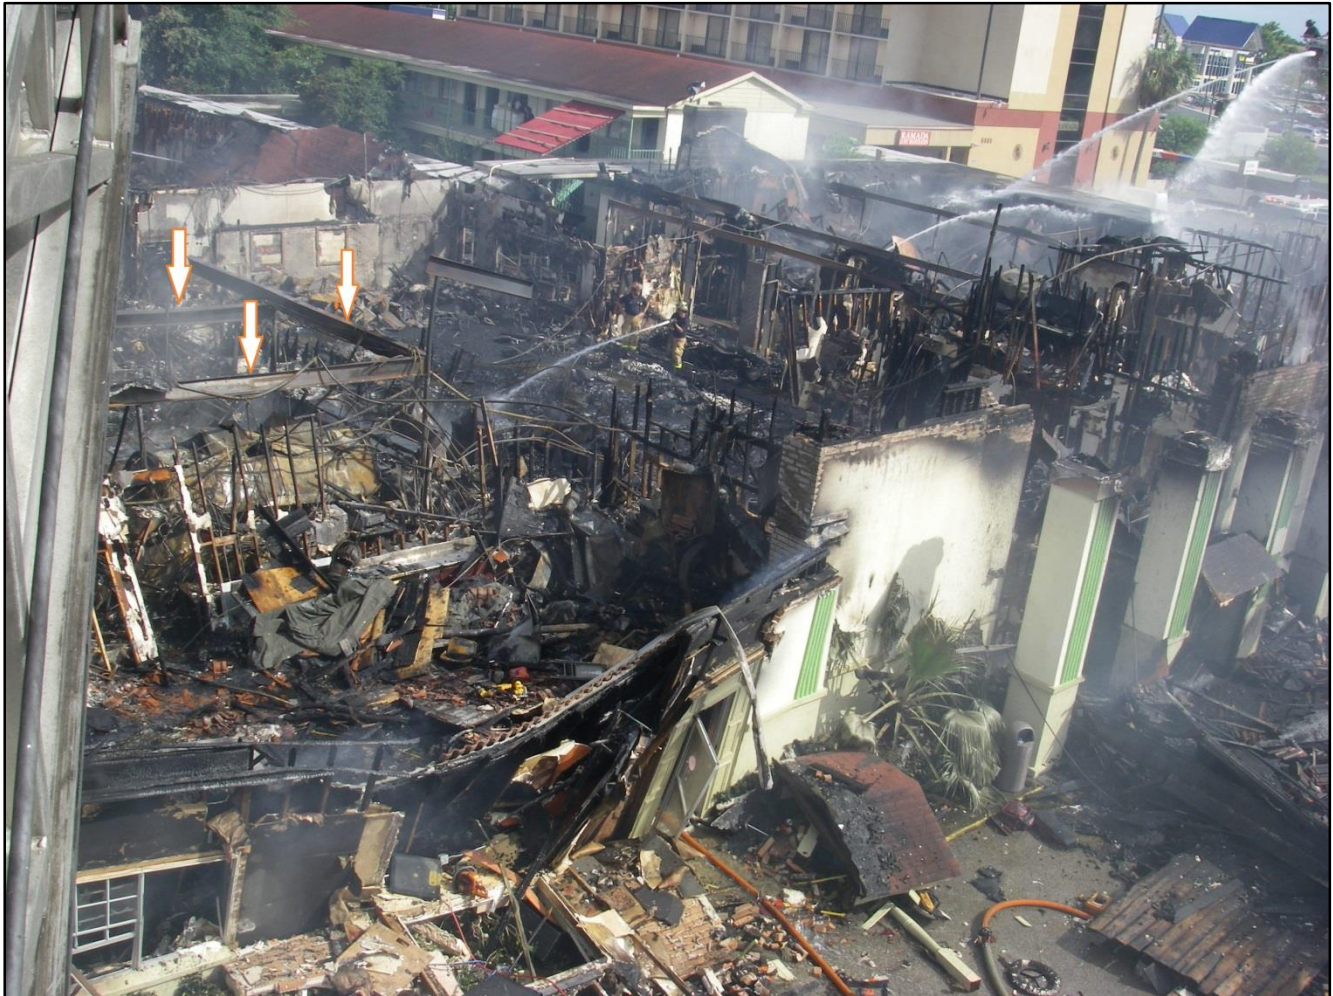
Photo 4. The arrows indicate the support system for the 2nd floor and void space above the restaurant and lobby area of the motel.

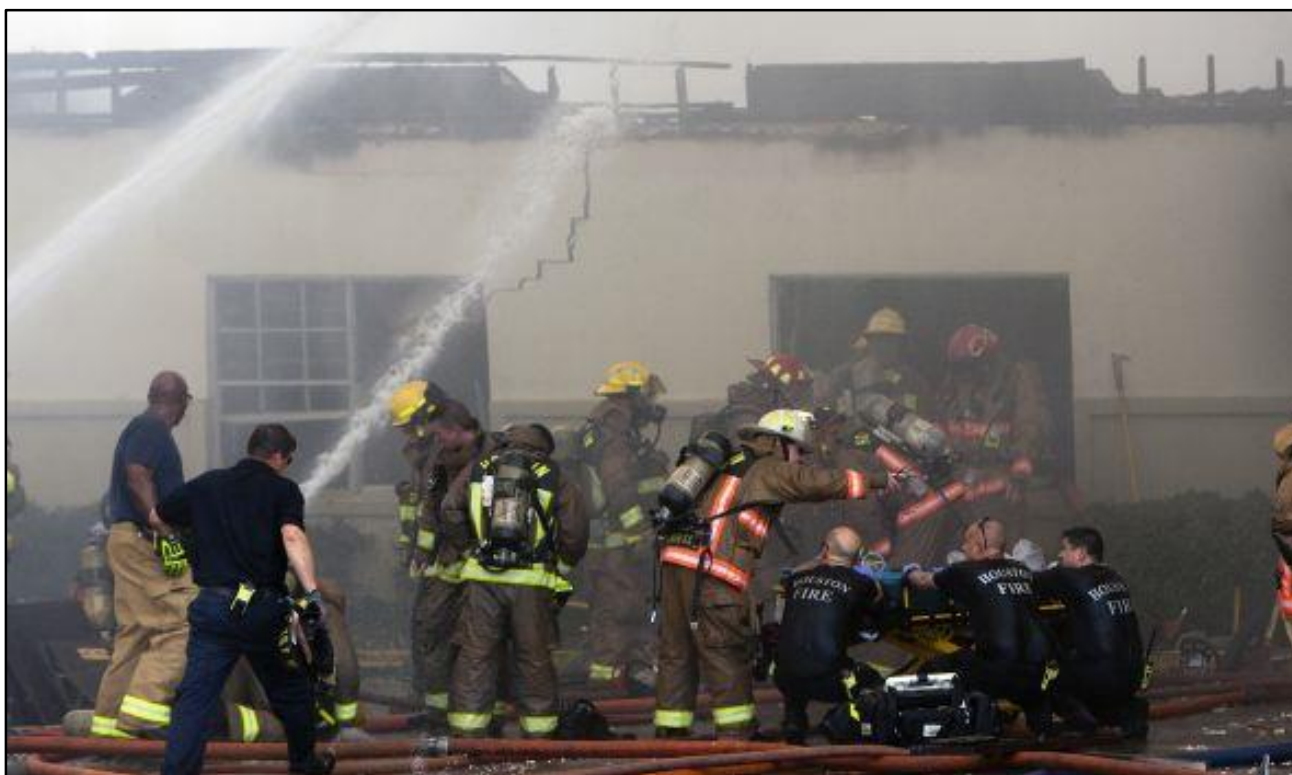
Photo 6. A 20 ft. x 8 ft. foot section (160 SF) of compromised perimeter wall collapse into the immediate area directly in front of the structure. Three members from the Rescue Group became trapped under falling debris that resulted from the secondary collapse. These firefighters were quickly removed by other members in the immediate area and then taken to awaiting EMS crews. The time is approximately 1225 hours.

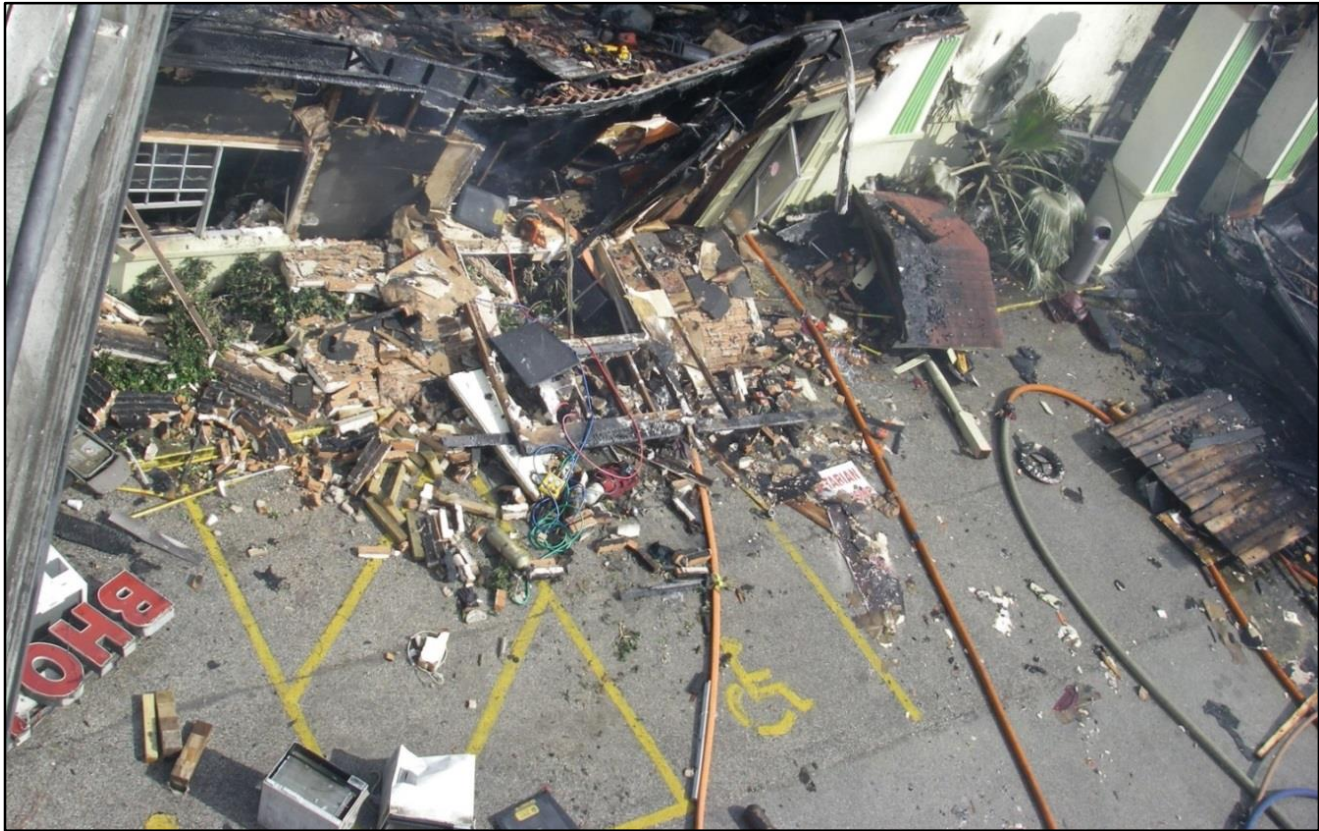
Photo 7. The front façade collapsed at 1303 hours striking fire fighters and officers assigned to the Rescue Group. These members were quickly removed by other fire fighters who picked up the façade and pulled the trapped fire fighters and officers out.
(Photo courtesy of the fire department)

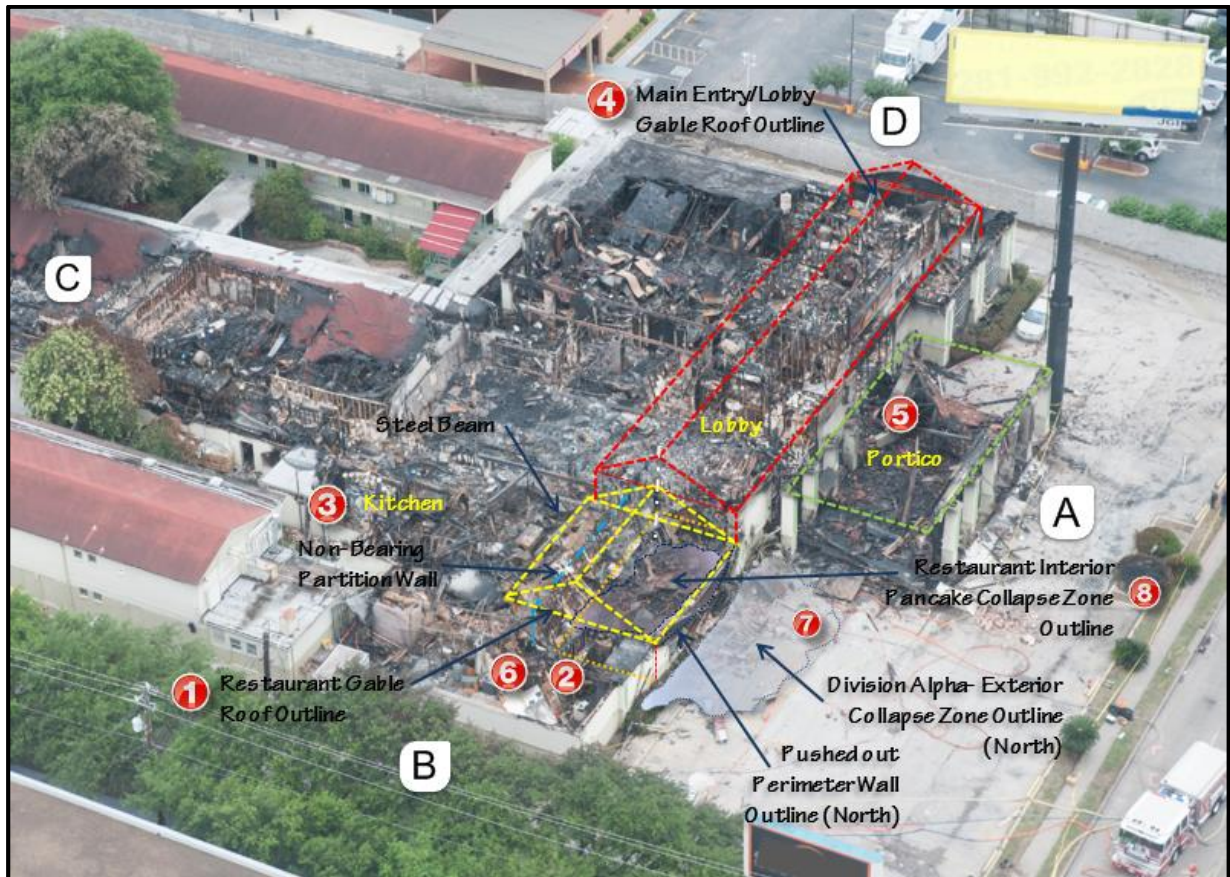
Photo 12. Post Fire-Collapse Aerial View of Building Complex
(Photo courtesy of the fire department/ Diagram Courtesy of Buildingsonfire.com)

The post-fire profile of the complex after the collapse of the roof and walls focusing on Side Alpha and Side Bravo of the structure. (See Photo 12).

- [1] Restaurant Gable Roof - Outline
- [2] Restaurant Floor Outline
- [3] Kitchen Area
- [4] Main Entry and Lobby Gable Roof-Outline
- [5] Main Portico - Canopy Roof Destroyed
- [6] Adjacent Rooms
- [7] Secondary Wall Collapse Zone
- [8] Interior Pancake Collapse Zone
