Status of MIPP RICH

Rajendran Raja Fermilab

15-Mar-2004

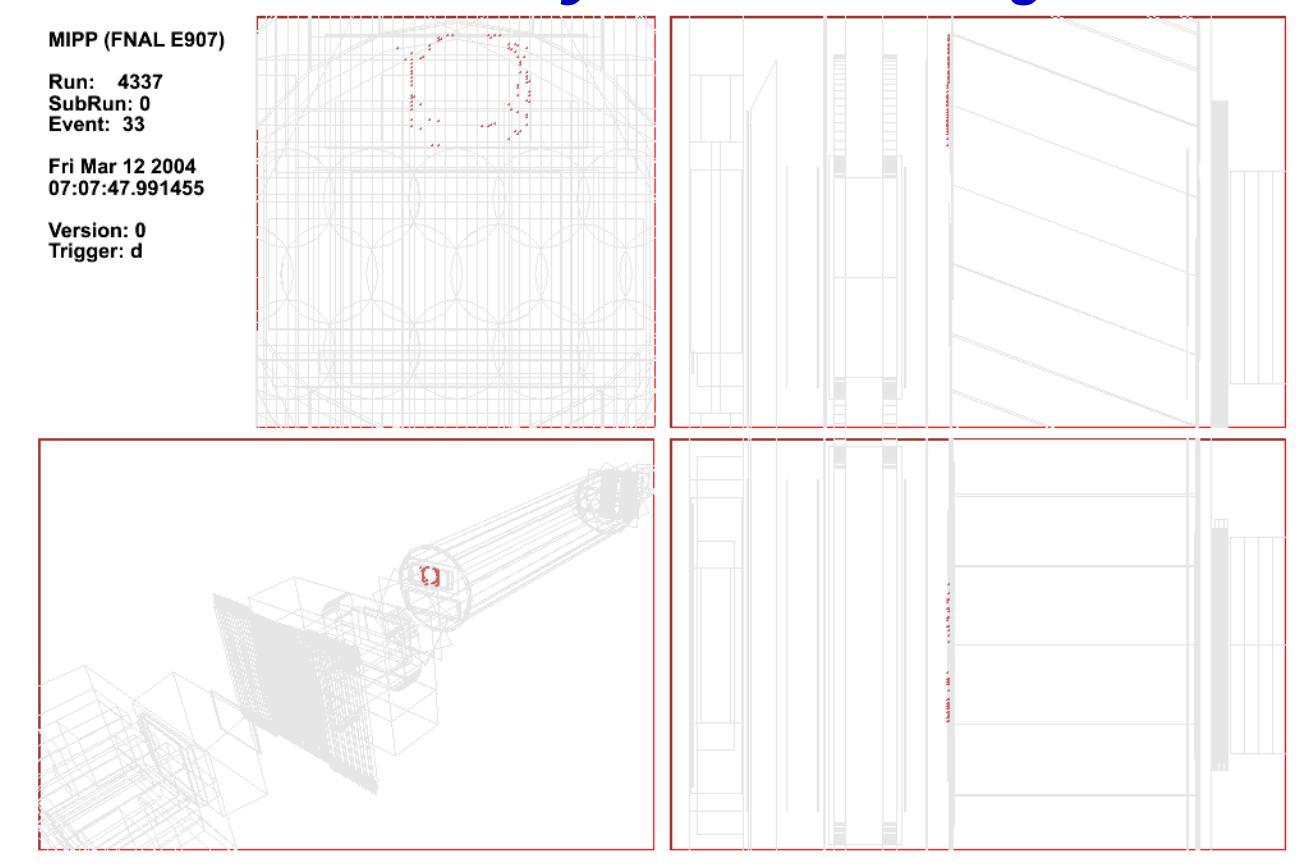
RICH was being read out successfully. We see rings.

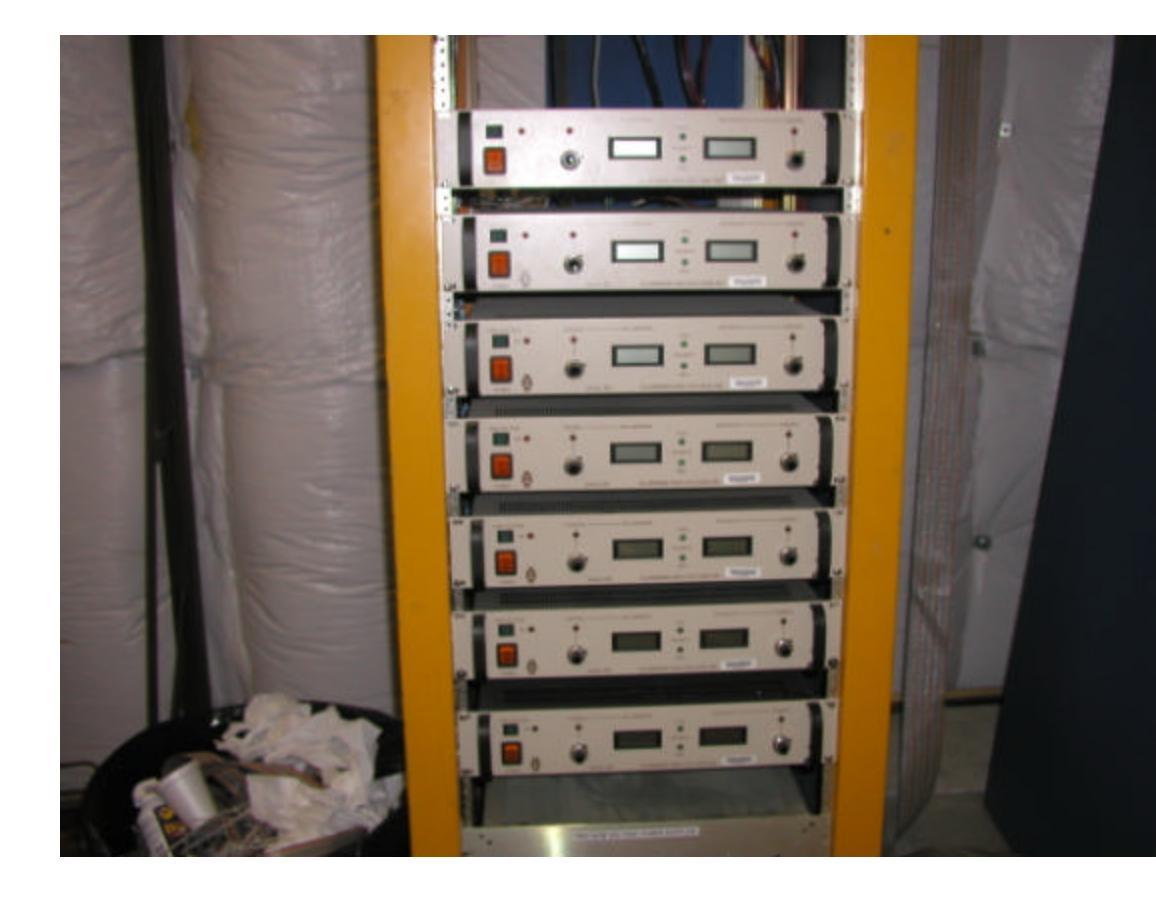
RICH HV supplies

- Current trip limits 3x100mA,2x140 mA. Trips work.
- Interlocked with RICH
- Interlocks work
- Put out
 900Watts for
 ~3000
 phototubes

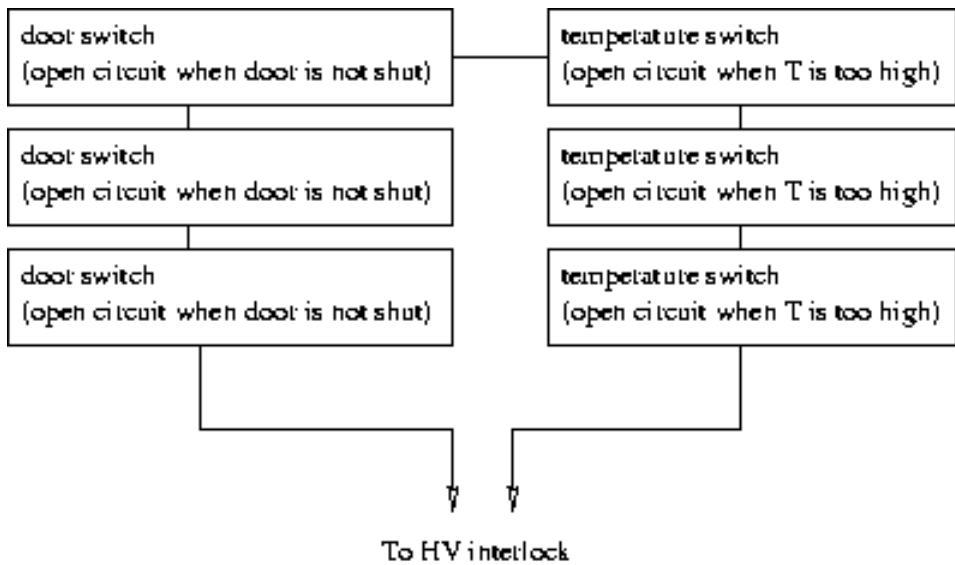
RICH Interlocks

Normally HVPS are powered through HV interlock box, which has two interlock inputs from interlock chain inside PMT box. Chain consists of 3 door switches and 3 thermo-switches hidden somewhere between PMT bases. Chain need to be closed for interlock to operate (You could use 50 Ohm BNC terminators for that). When this chain become open, main circuit breaker on the front of the box will trip.

(HV off if citcuit open)

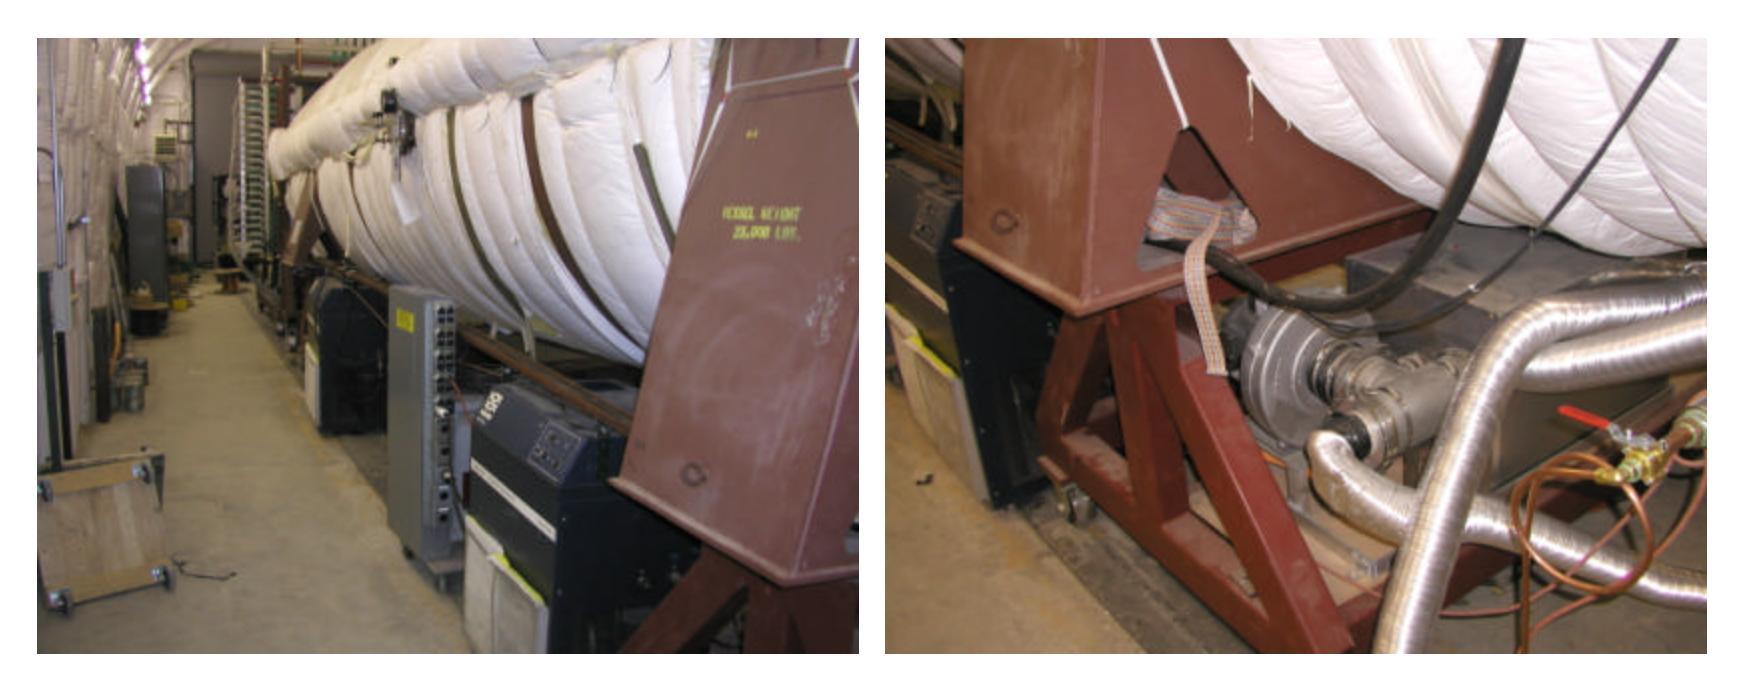
Goes to heat exchanger. Cooling hooked up under guidance of mech engineer. It was redone recently with better hoses. In the process it seems to have been connected in reverse order. Also mixing fans were not connected.

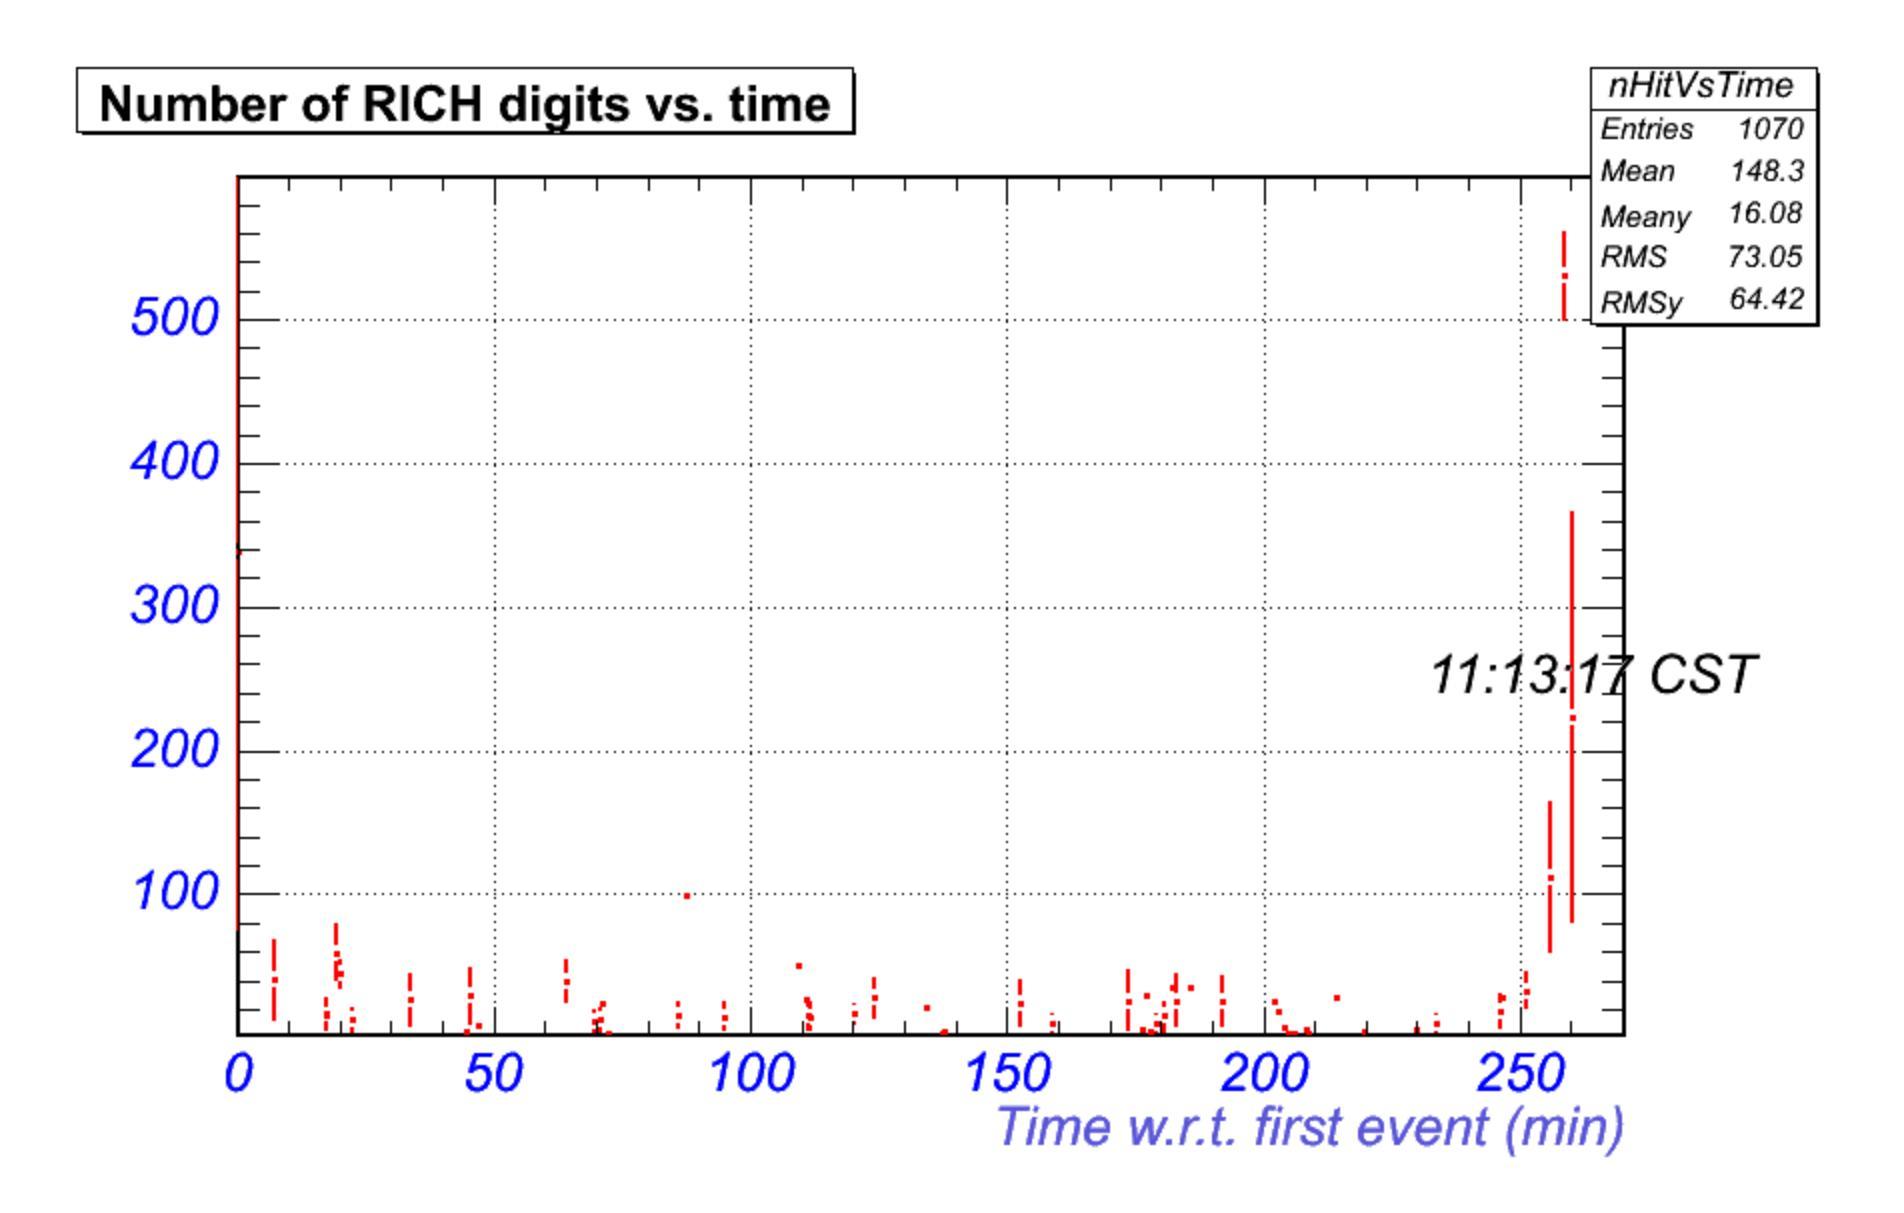
RICH history

- The HV was turned on March 2, 2004. All HV was set at 1400 V to begin with. This was 50-500 V below nominal.
- There was some sort of power glitch a week later. May be unconnected.
- Last event taken on March 14, 2003 at 11:13:11 AM.
