Performance of Physical Structures in
Hurricane Katrina and Hurricane Rita:
A Reconnaissance Report

NIST Technical Note 1476

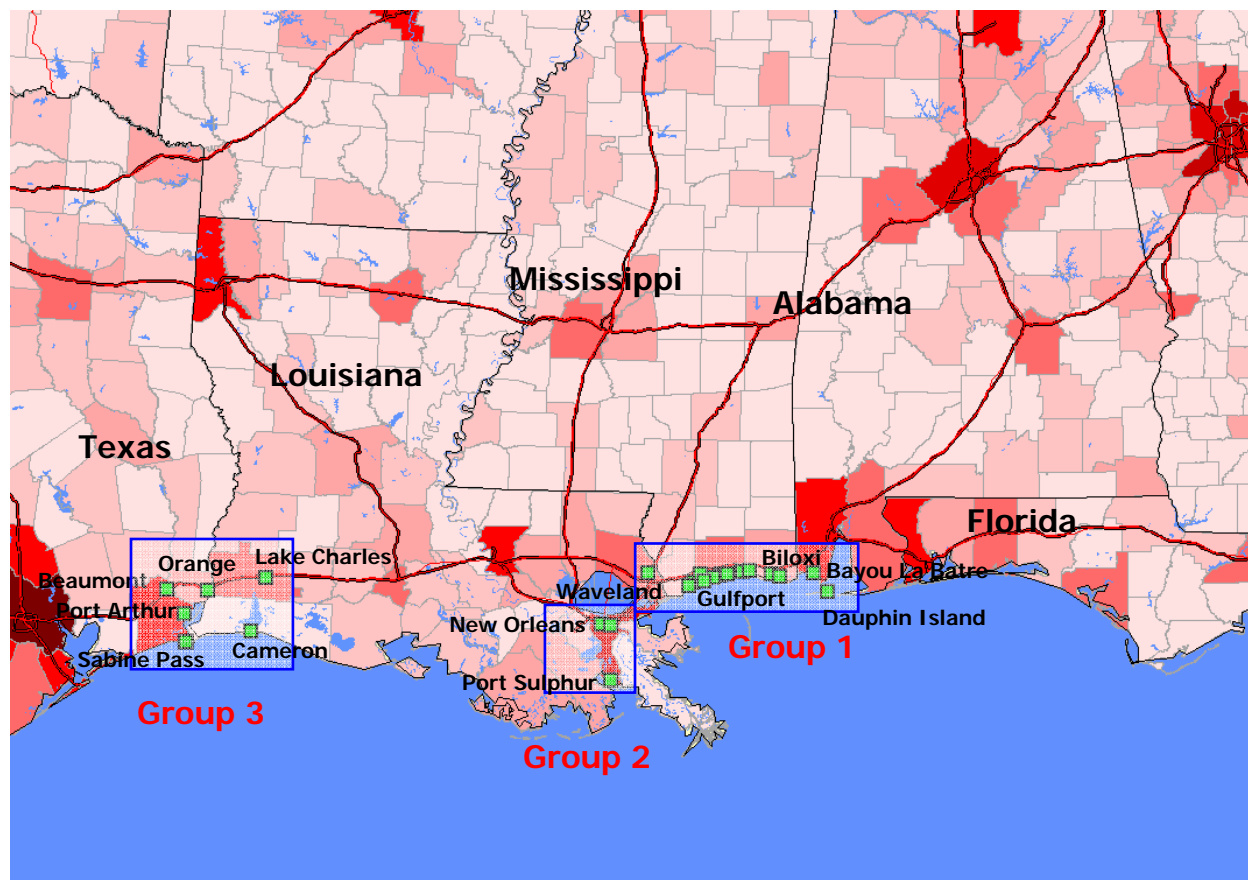
Figure 1-1 NIST-led reconnaissance locations and variation in population density. Darker areas indicate higher population density (Source: Census Bureau [9], enhanced by Ron T. Eguchi, ImageCat).

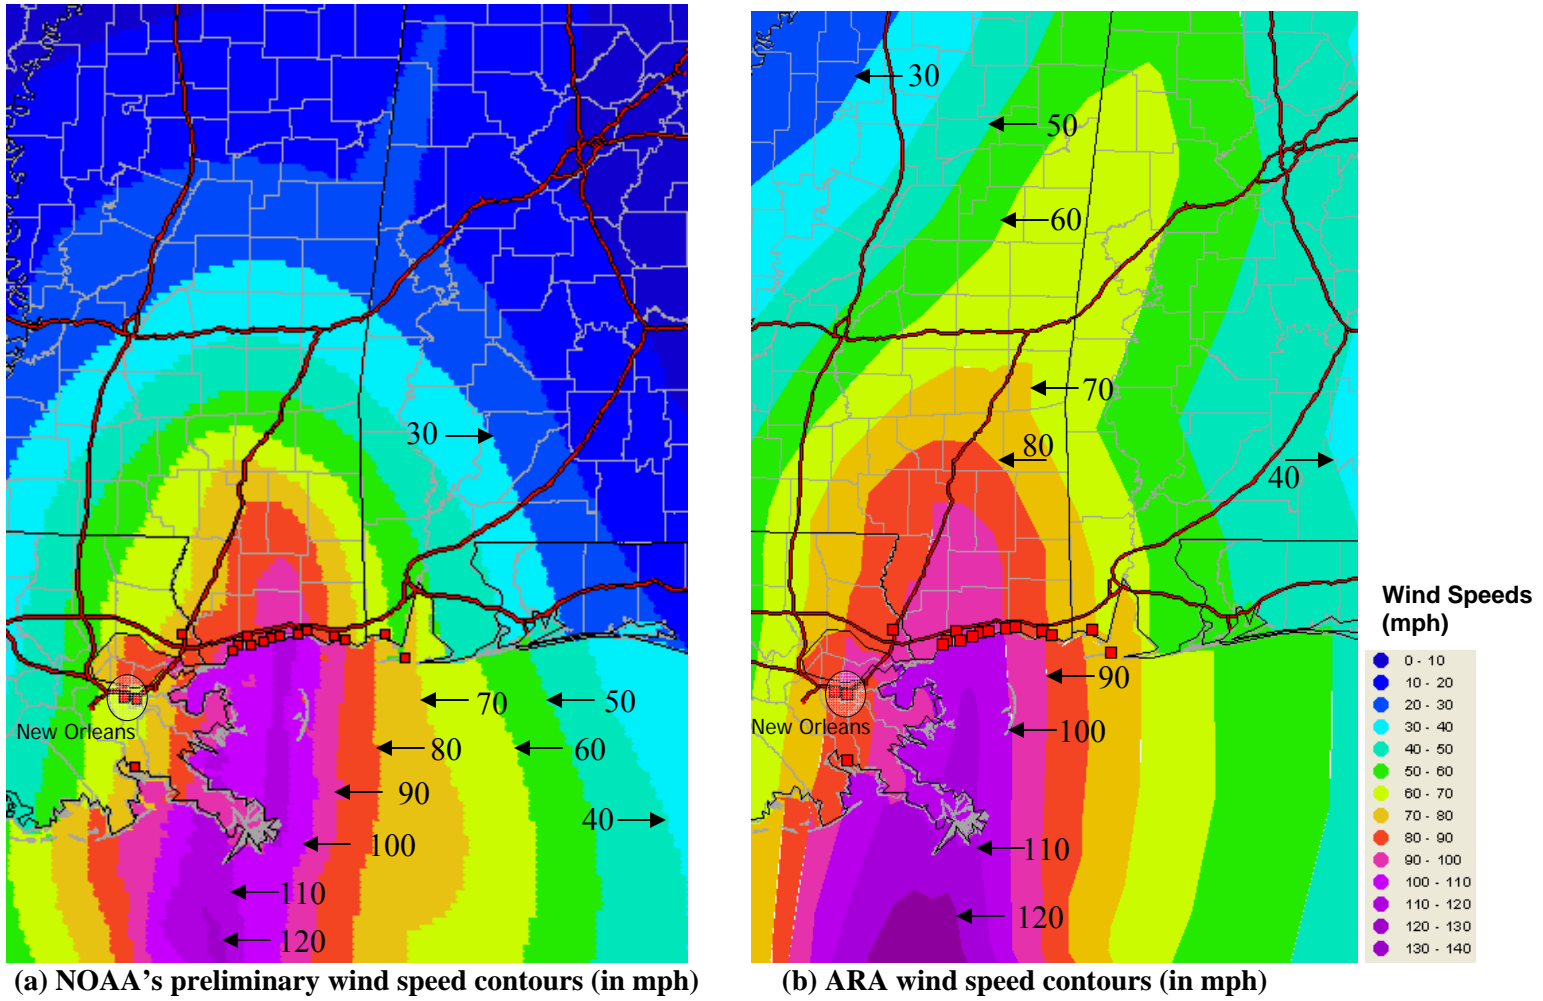
Figure 2-4 Estimated maximum sustained wind speeds (mph) at 10 m above surface for Hurricane Katrina (using the August 29, 1132 UTC landfall analysis). NIST reconnaissance sites are shown as red squares (Source: (a) NOAA; (b) with permission from Peter Vickery, ARA. Enhanced by Ron T. Eguchi, ImageCat)

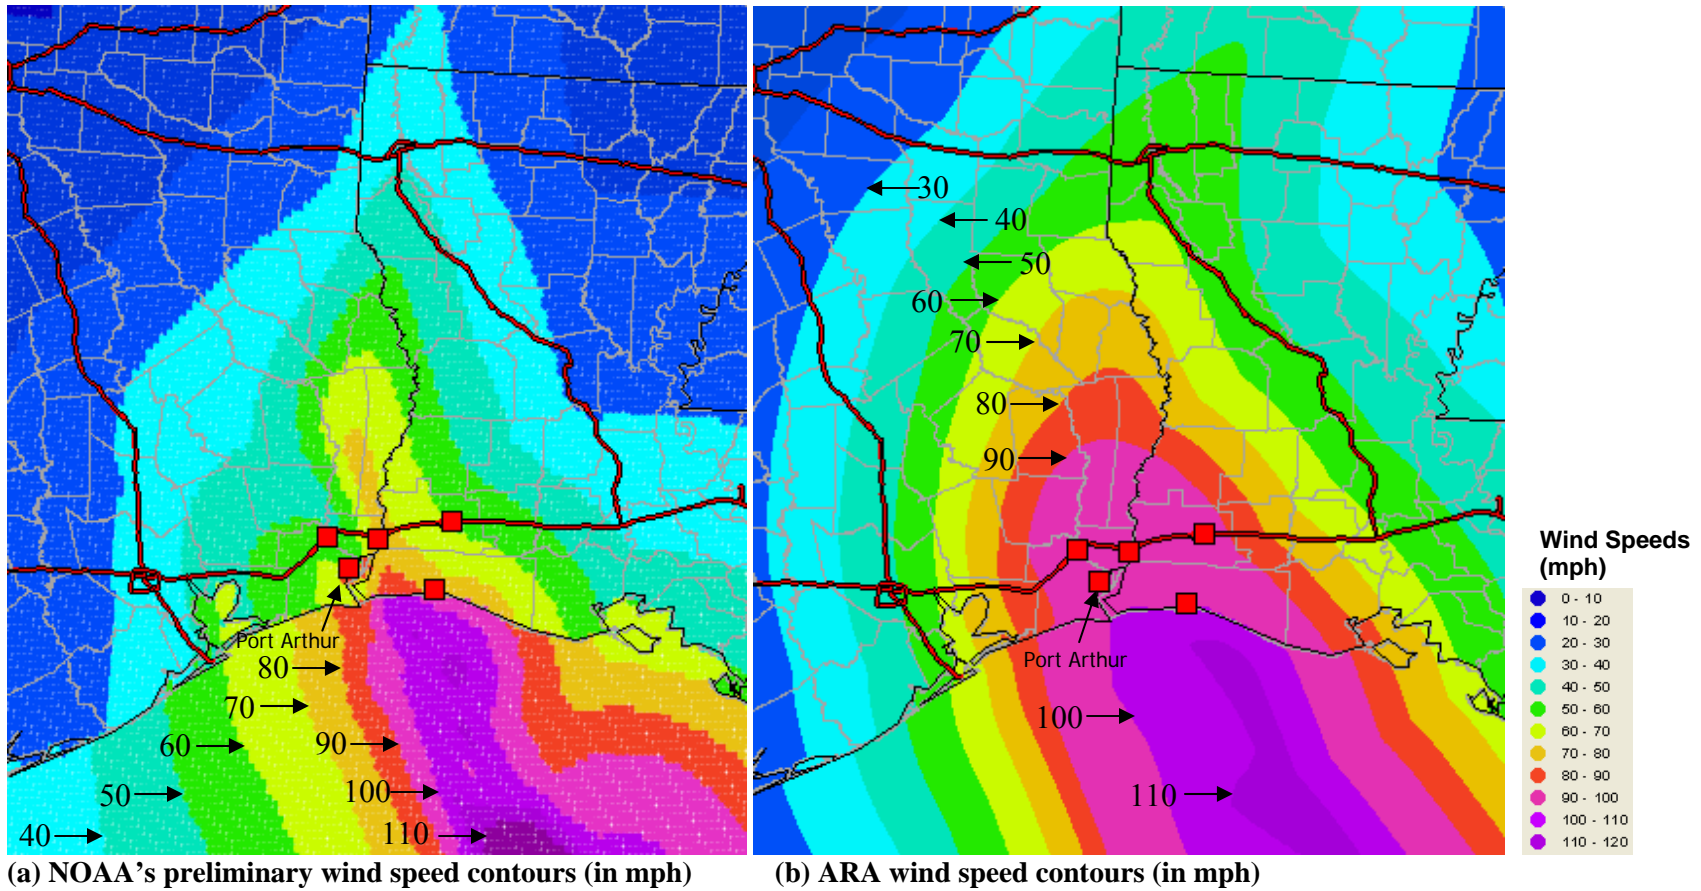
Figure 2-7 Estimated maximum sustained wind speeds (mph) at 10 m above surface for Hurricane Rita (using the September 24, 2005 1030 UTC landfall analysis). NIST reconnaissance sites shown as red squares (Source: (a) NOAA; (b) with permission from Peter Vickery, ARA. Enhanced by Ron T. Eguchi, ImageCat).

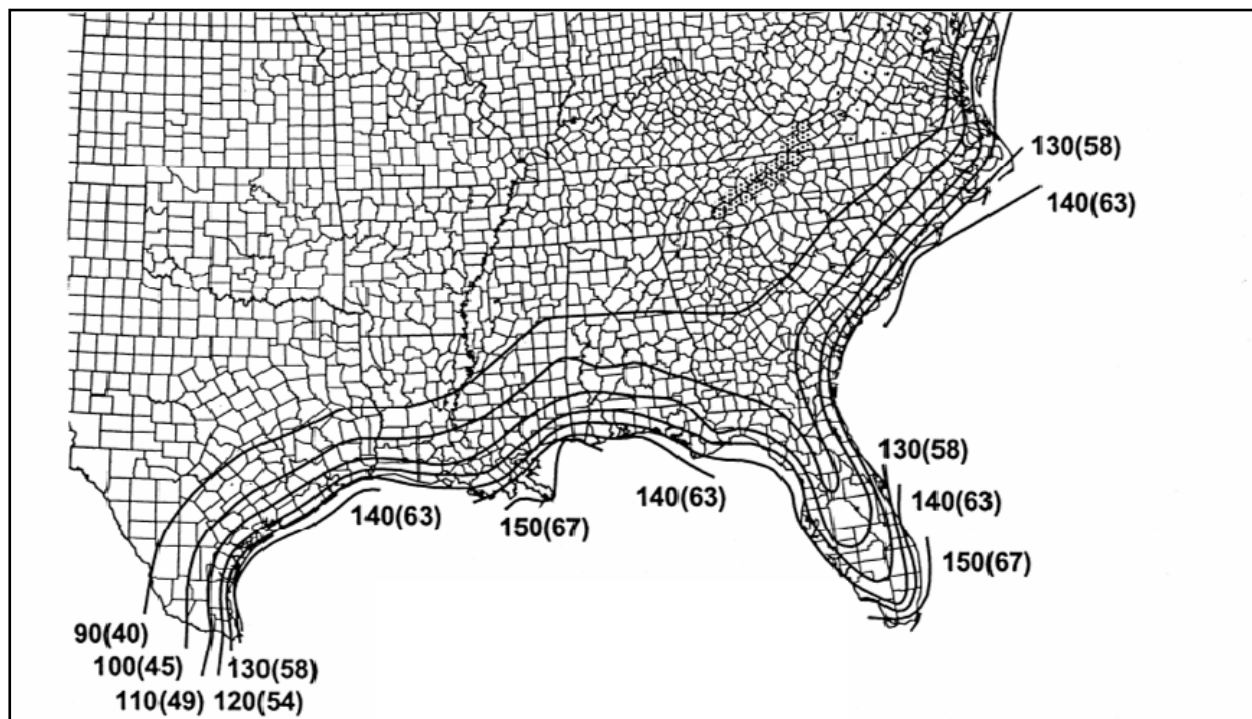
Figure 2-8 ASCE 7-2005 basic wind speed map for the southeastern U.S. hurricane coast. Units are mph or (m/s). (With permission from ASCE [3])

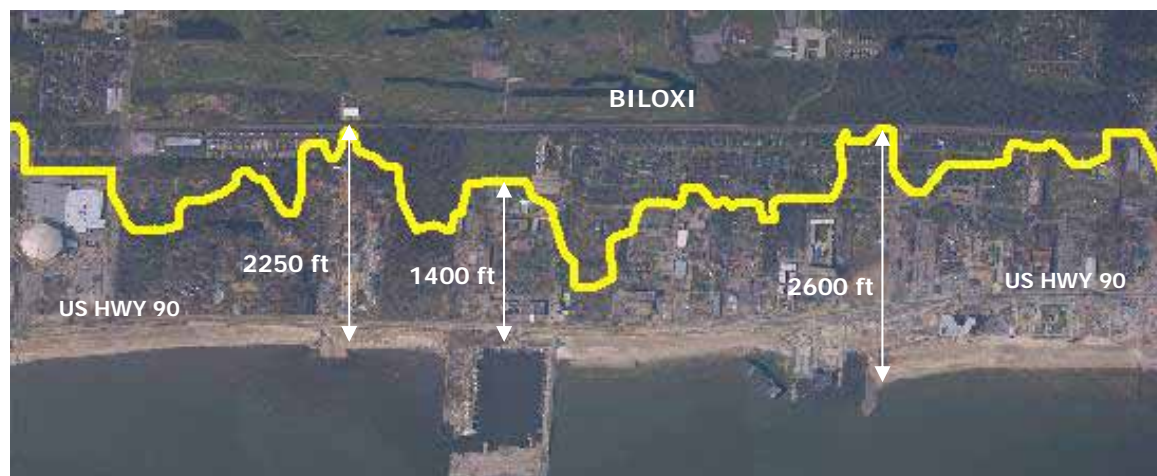
Figure 2-9 NOAA aerial imagery for an area over western Biloxi. Yellow line denotes interpreted debris line. Storm surge heights of between 20 and 24 feet were reported in this area. (Source: NOAA [21]. Enhanced by Ron T. Eguchi, ImageCat).

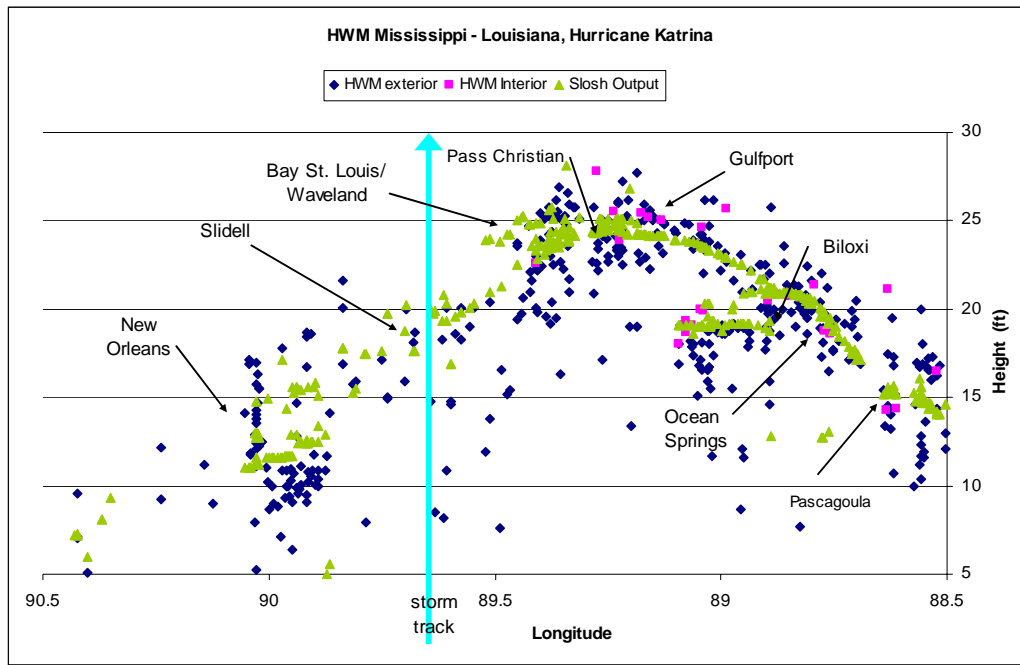
Figure 2-12 (c) Comparison of storm surge predictions using SLOSH with preliminary high water marks observed by FEMA in Mississippi and Louisiana (Source: NOAA)

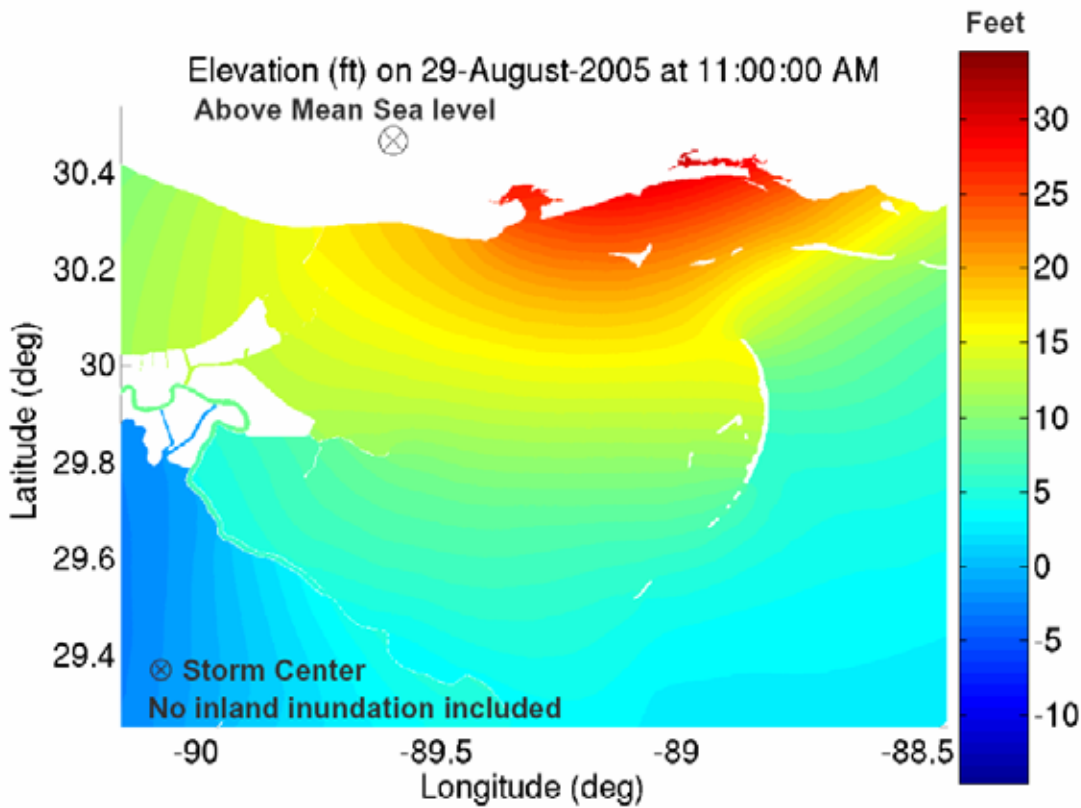
Figure 2-12(d) Preliminary storm surge hindcast results for Hurricane Katrina; inland inundation not included (Source: Commander, Naval Meteorology and Oceanography Command at Stennis Space Center [30])

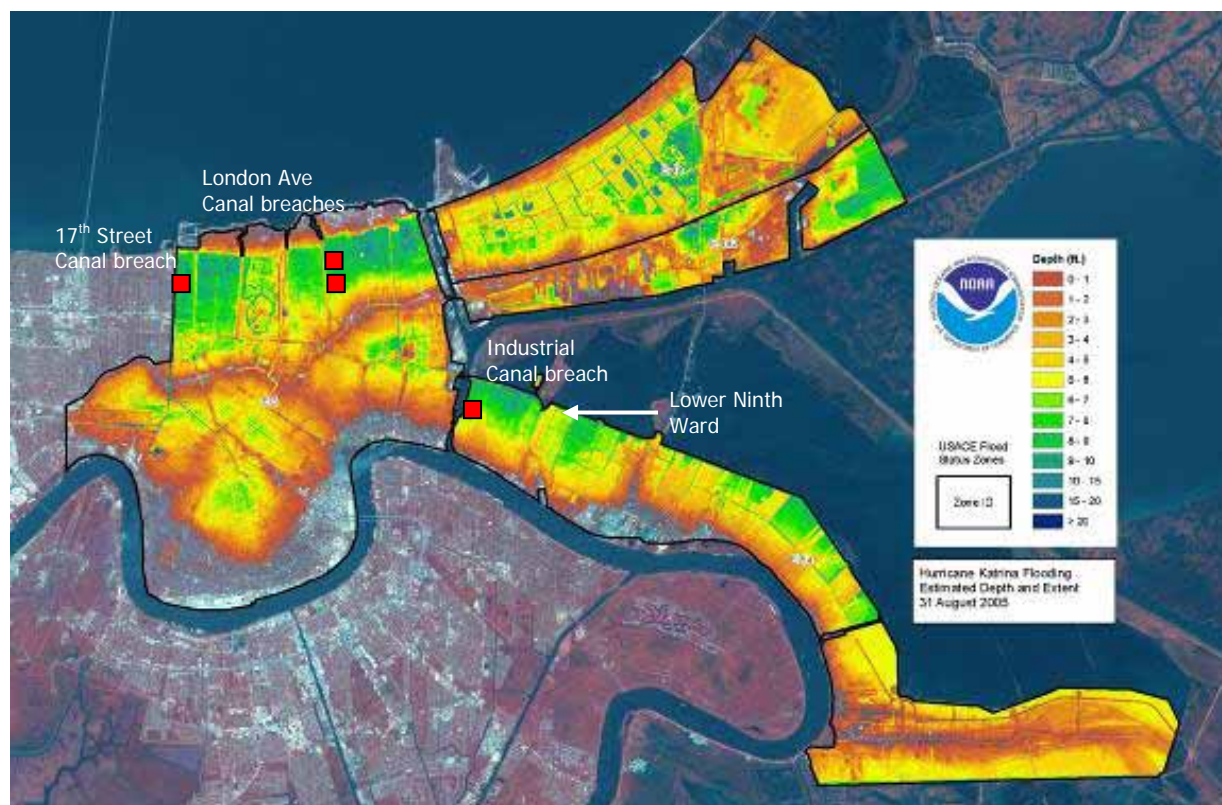
Figure 2-15 Flood depth estimation for New Orleans by NOAA, 31 August 2005 (Source: NOAA [25], enhanced by Ron T. Eguchi, ImageCat).

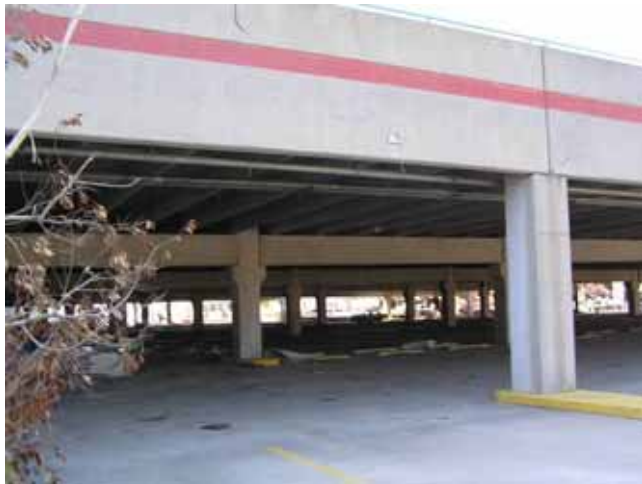
Figure 3-2 Successful performance of a single-story parking structure in Biloxi, MS (Photo credit: NIST).

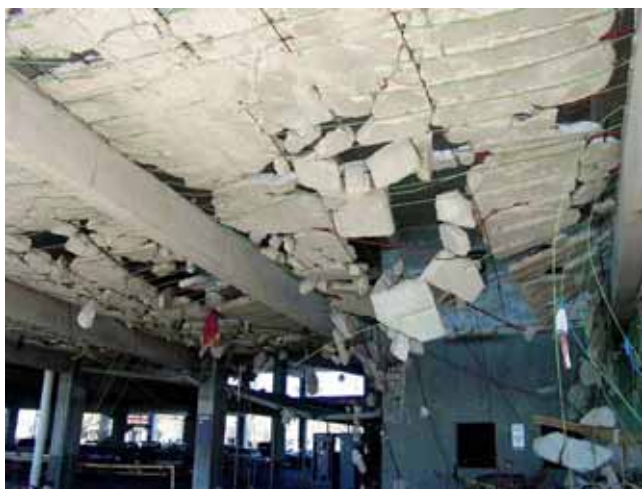
Figure 3-3 Failure of post-tensioned concrete slab exposed to uplift forces due to storm surge (Photo credit: Jack Hayes, USACE)

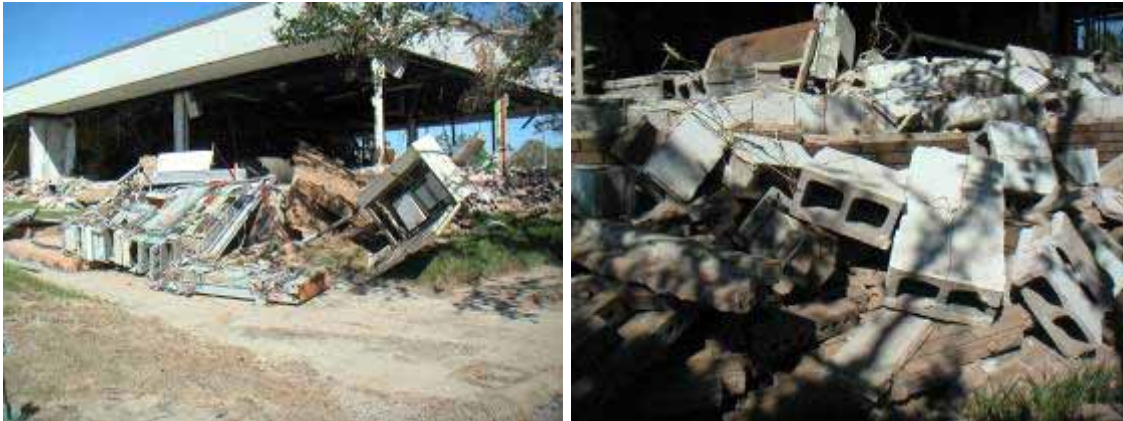
Figure 3-4 Storm-surge-induced collapse of CMU walls at the Venetian Isles Fire Station in New Orleans (Photo credit: Keith Porter, Scawthorn Porter Associates).

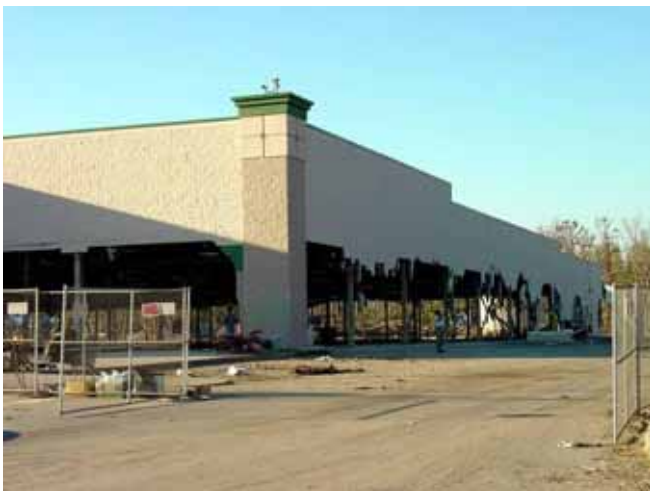
Figure 3-5 Storm-surge-induced collapse of the lower portions to a reinforced CMU wall in Gulfport, MS (Photo credit: Habib Rahman, National Research Council of Canada).

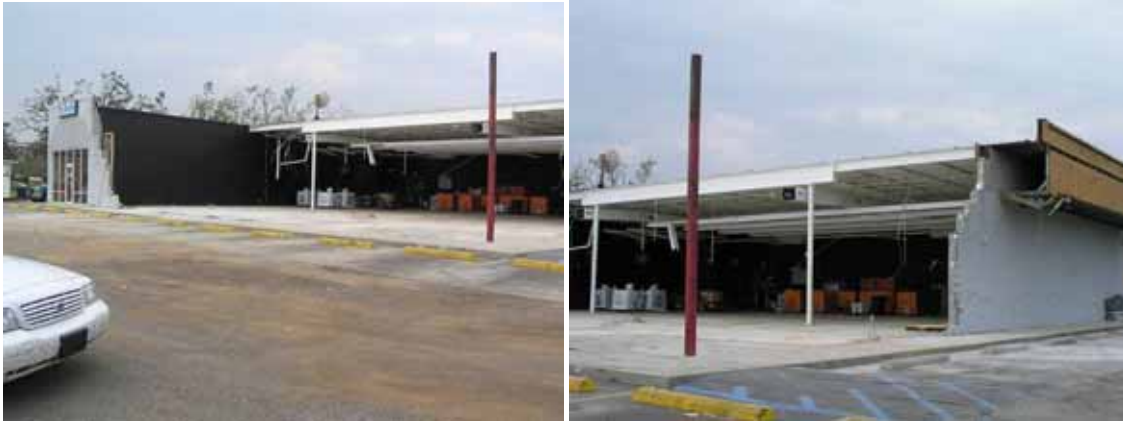
Figure 3-7 Collapse of solid, unreinforced masonry walls in Long Beach, MS (Photo credit: NIST).

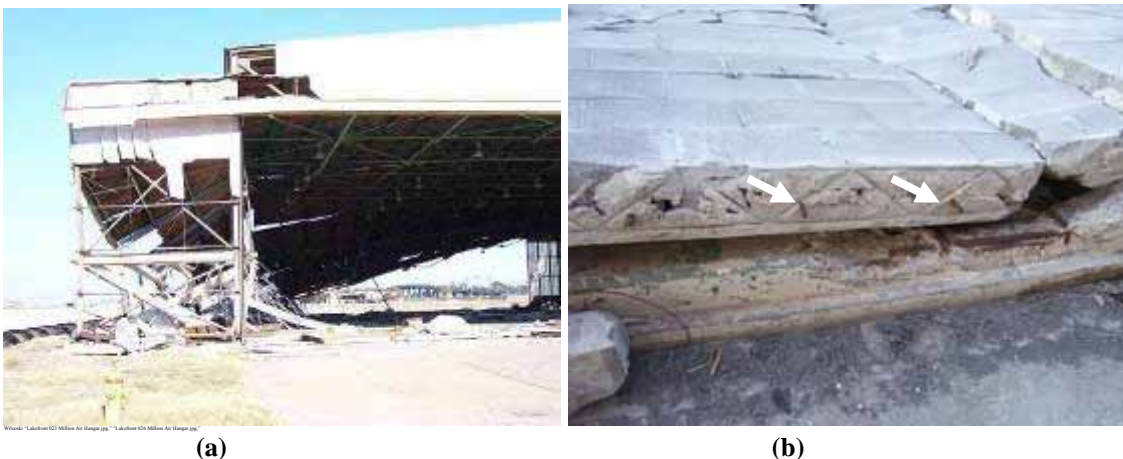
Figure 3-8 (a): Partial collapse of aircraft hangar apparently¹⁵ as a result of the collapse of a CMU infill wall. (b): 3 in lap splice at base of collapsed CMU wall (Photo credit: Ed Huston, Smith and Huston, Inc.)

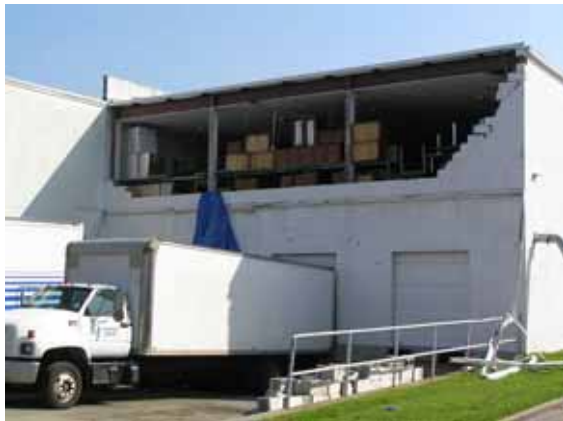
Figure 3-9 Failure of a non-load bearing masonry wall in Beaumont, TX (Photo credit: NIST).

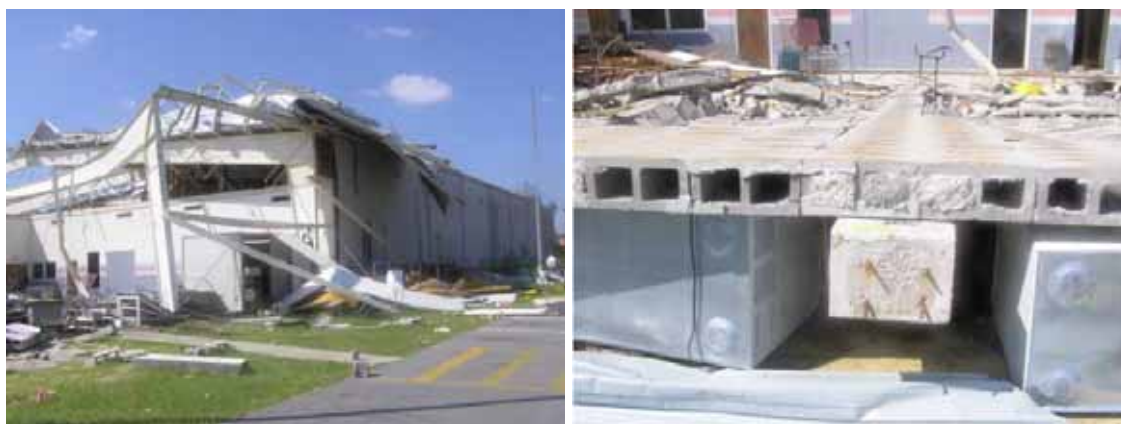
Figure 3-10 Damage to Gaston Hewes Recreation Center in Gulfport, Mississippi (Photo credit: NIST).

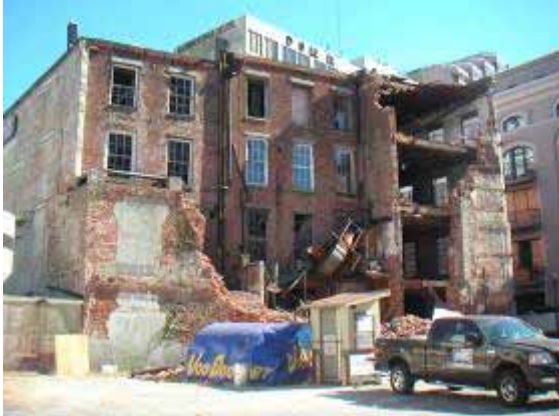
Figure 3-11 Partial failure of a load-bearing masonry wall in New Orleans, LA (Photo credit: NIST).

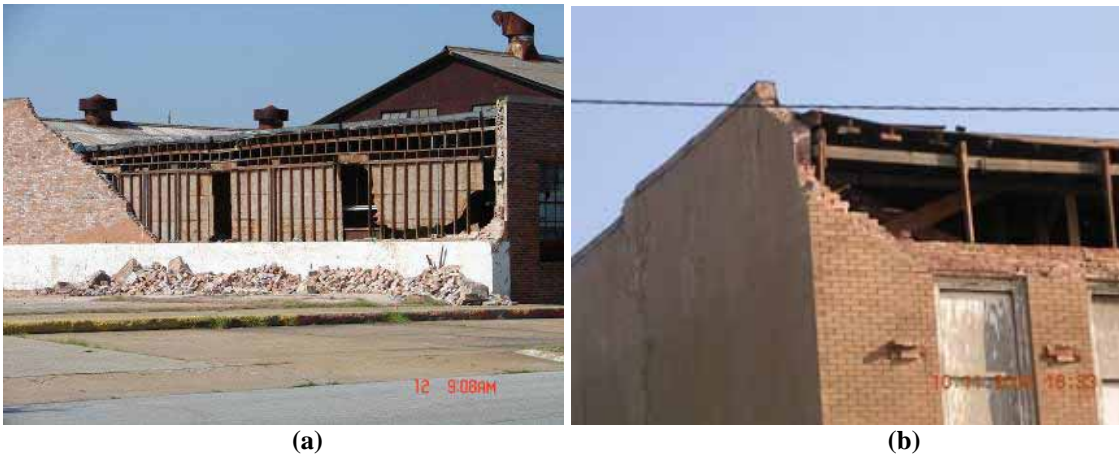
Figure 3-12 Failure of masonry parapet walls along the roof of buildings in Port Arthur, TX, (a) subsequent partial failure of exterior wall, (b) subsequent collapse (Photo credit: Jon Heintz, Applied Technology Council).

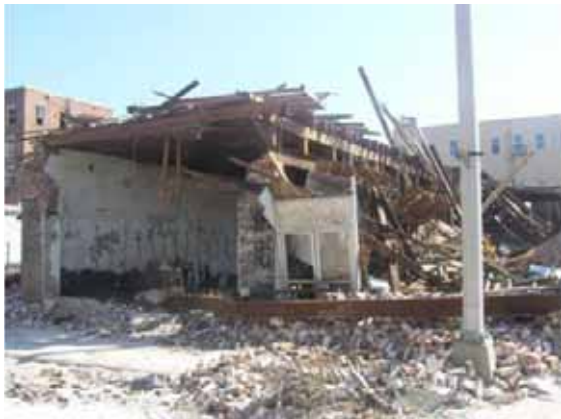
Figure 3-13 Collapsed unreinforced masonry building in downtown Gulfport, MS (Photo credit: NIST).

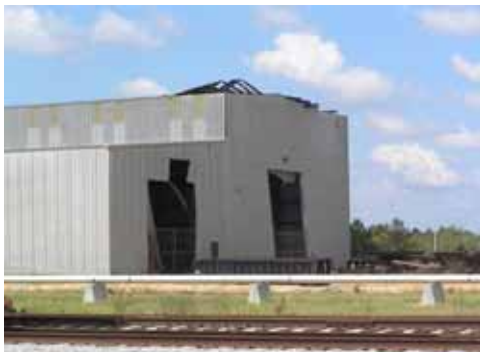
Figure 3-14 Permanent deformation of the windward wall inward and buckled purlins observed at the Port Bienville Industrial Park (Photo credit: NIST).

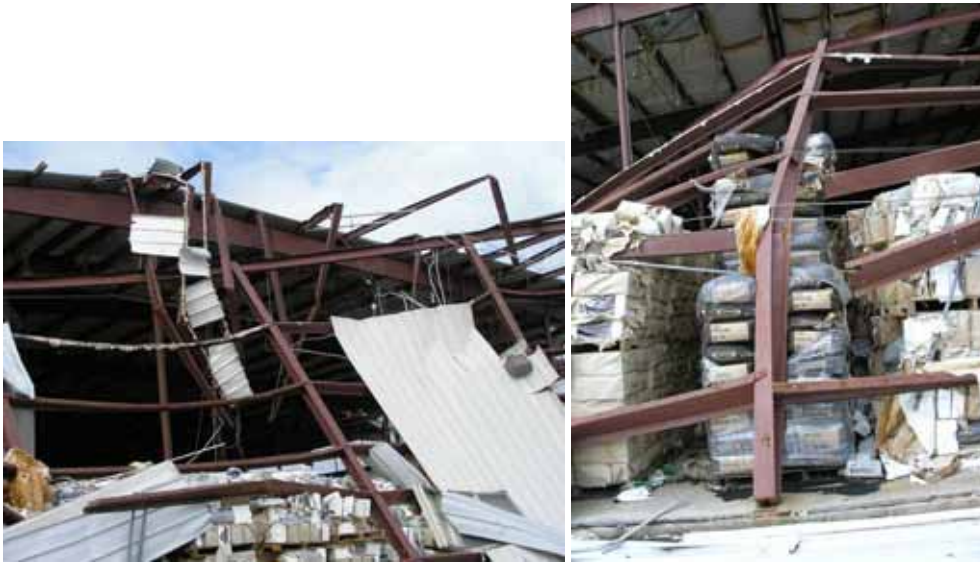
Figure 3-15 Collapse of the entire end bay of a steel-frame warehouse from wind pressure near Long Beach, MS (Photo credit: NIST).

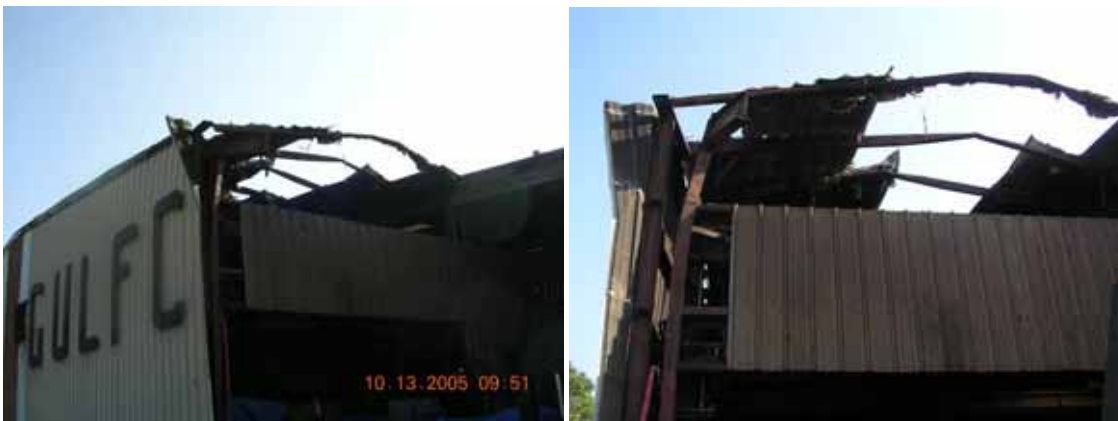
Figure 3-16 Buckled purlins and collapse of a portion of the end bay of a steel-frame warehouse from wind pressure in Beaumont, TX (Photo credit: NIST).

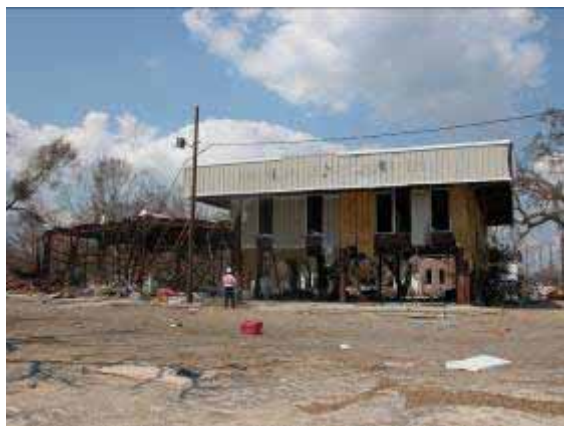
Figure 3-17 Damage to a metal building in Gulfport, Mississippi (Photo credit: Keith Porter, Scawthorn Porter Associates).

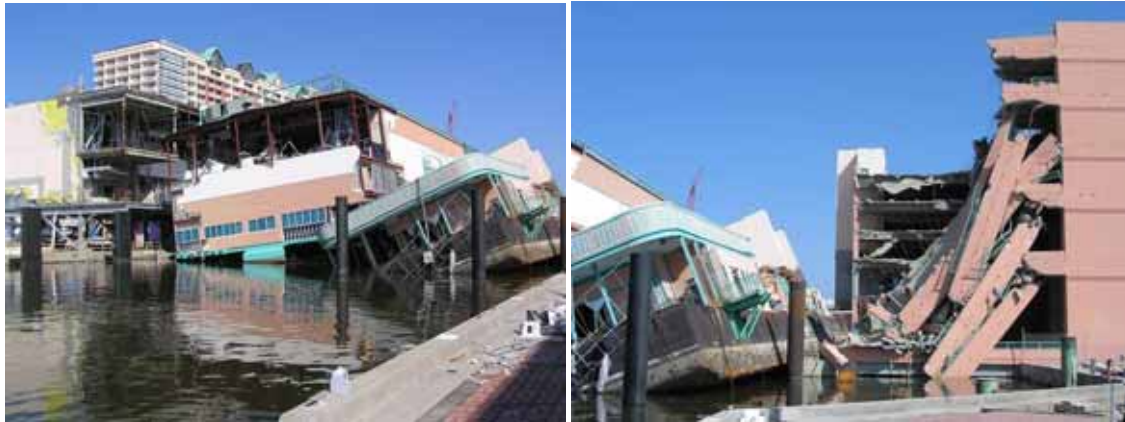
Figure 3-18 Partial collapse of a precast reinforced concrete garage due to impact by a Biloxi, Mississippi casino barge (Photo credit: NIST).

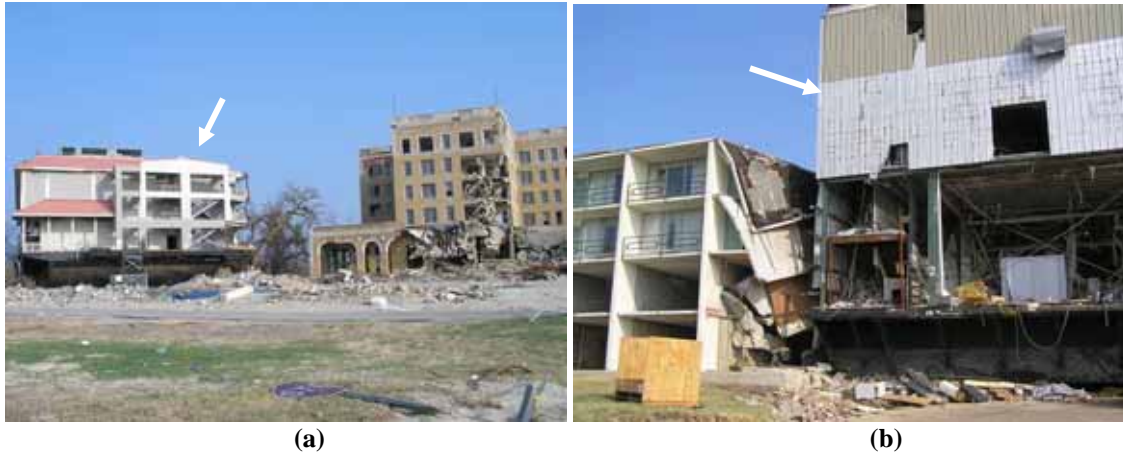
Figure 3-21 Partial collapse of (a) a historic, cast-in-place, reinforced concrete hotel, and (b) a four-story hotel structure caused by two separate casino barges (arrow) that floated inland in Biloxi, MS (Photo credit: NIST).

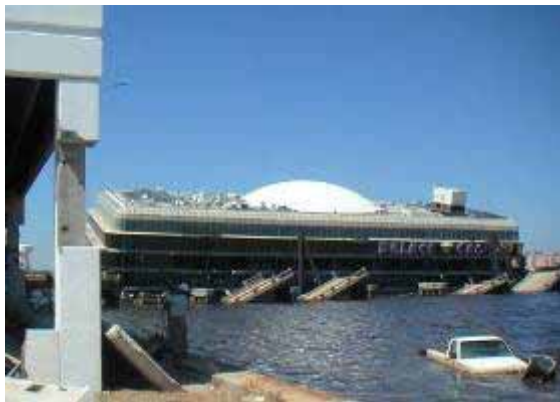
Figure 3-22 A casino barge in Biloxi, Mississippi, that sank in place (Photo credit: Keith Porter, Scawthorn Porter Associates).

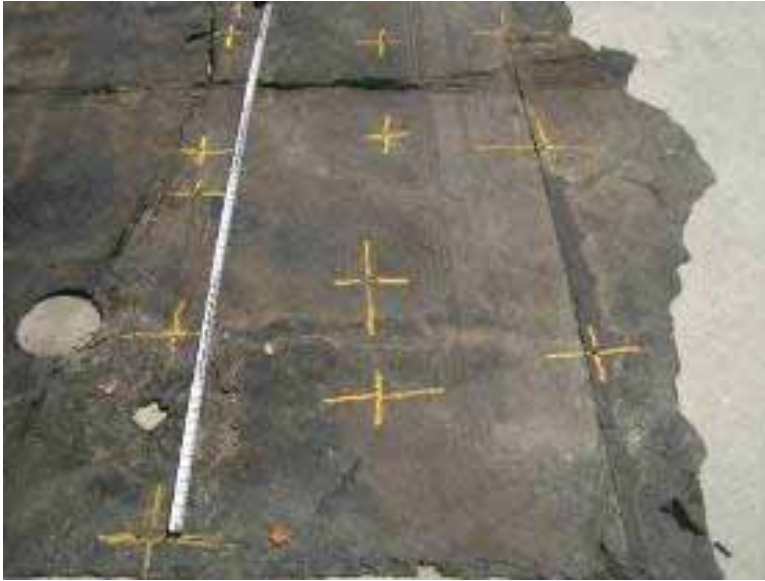
Figure 3-23 Irregularly spaced nailing on this failed hot-applied built-up roofing membrane had approximately 40 percent fewer nails than specified by a typical manufacturer (Photo credit: Robb Smith, Amtech Roofing Consultants).

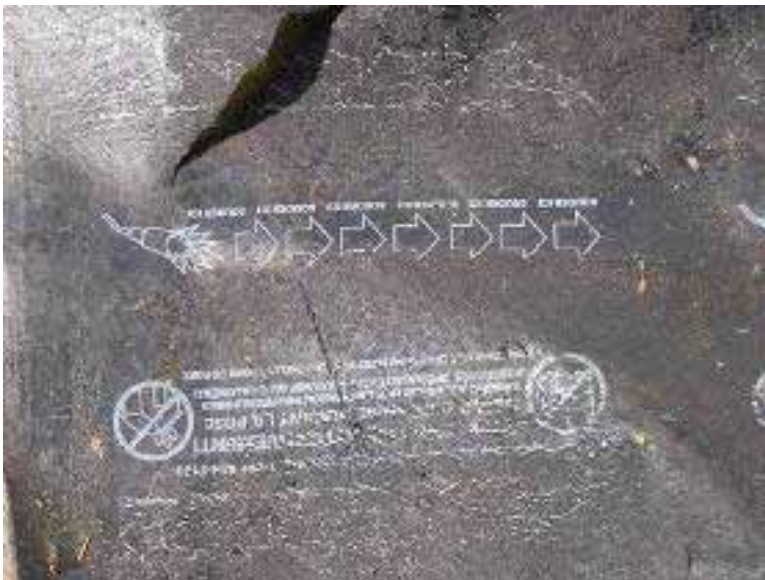
Figure 3-24 Had this failed heat bonded polymer-modified bitumen membrane been heated in accordance with acceptable practice, the plastic film and white markings would not be present (Photo credit: Robb Smith, Amtech Roofing Consultants).

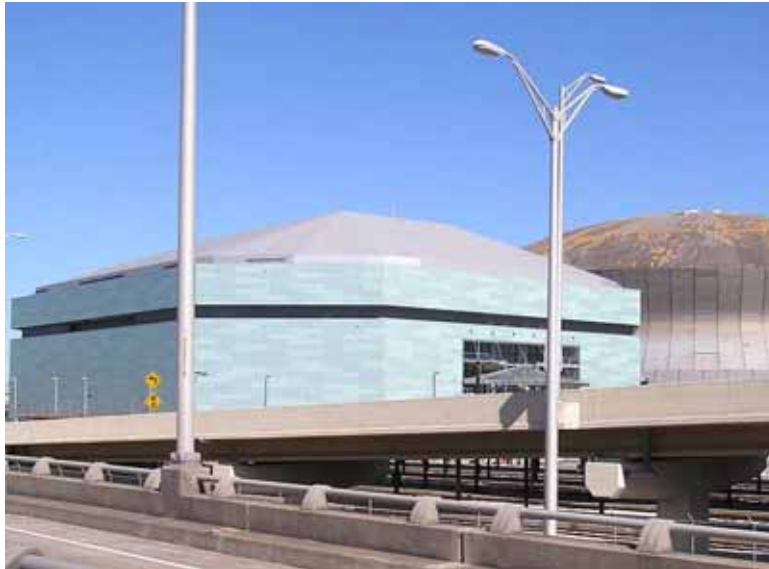
Figure 3-25 The New Orleans Arena, which has an SBS modified bitumen membrane, withstood the Hurricane Katrina winds without damage. (Photo credit: Robb Smith, Amtech Roofing Consultants).

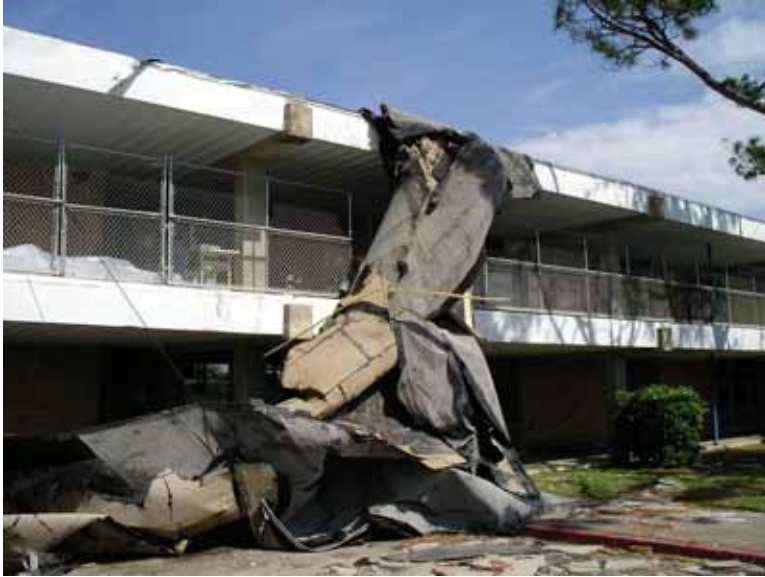
Figure 3-26 Blow-off of a bituminous roofing membrane where failure was precipitated at the edge metal flashing, Port Arthur, TX (Photo credit: NIST).

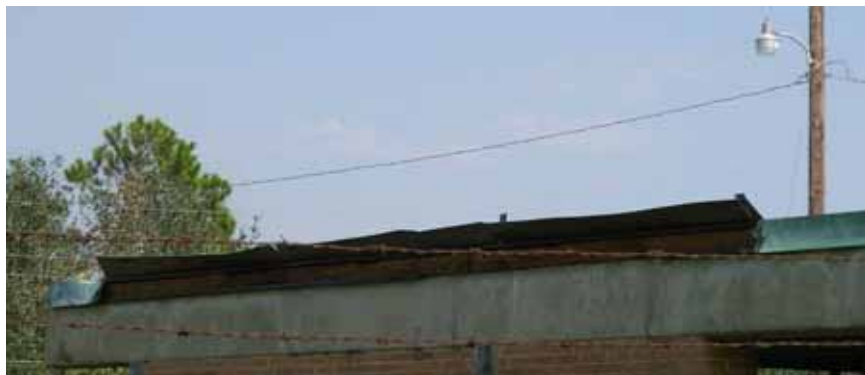
Figure 3-27 Example of perimeter metal flashing that was bent up and back from the building but without damage to the membrane, Port Arthur, TX (Photo credit: NIST).

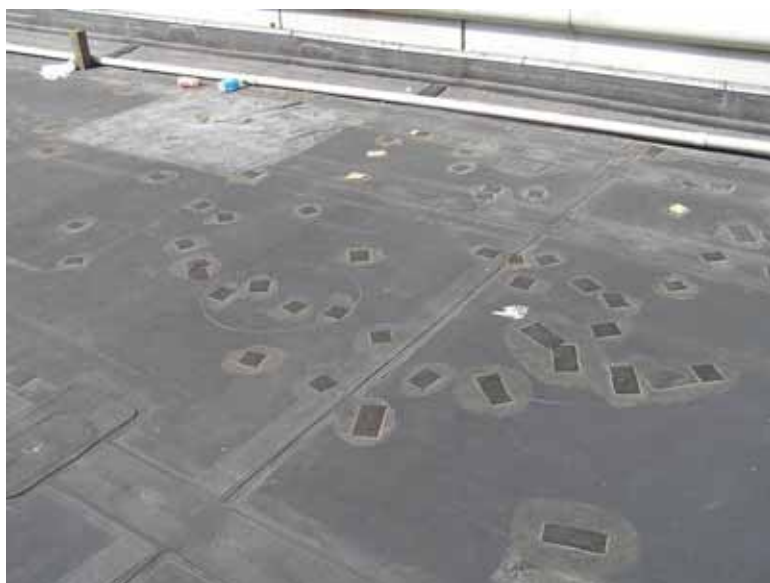
Figure 3-30 Adhered EPDM membrane system in New Orleans. The membrane was punctured by unknown wind-borne debris (Photo credit: Robb Smith, Amtech Roofing Consultants).

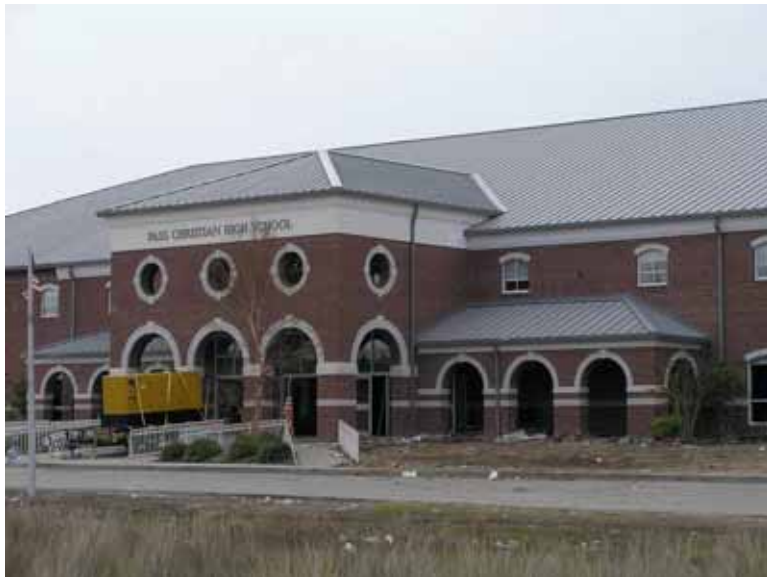
Figure 3-33 Standing seam metal roof in the coastal region of Pass Christian, MS, that sustained Hurricane Katrina without damage (Photo credit: NIST).

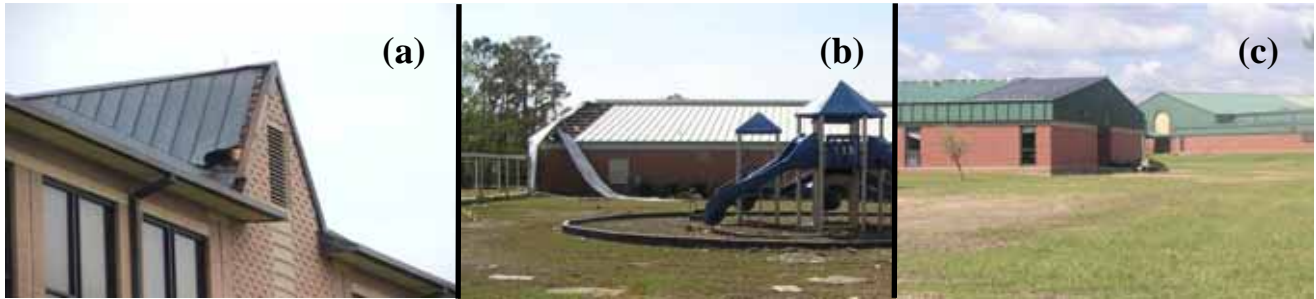
Figure 3-34 Limited damage to standing seam metal roofs at (a) Lamar State University in Orange, TX (Photo credit: Dominic Sims), (b) at Gulfview Elementary School near Waveland, MS (Photo credit: NIST), and at (c) Hancock High School in Kiln, MS . Damage occurred at the edge of the roofs along the windward sides of the buildings (Photo credit: Robb Smith, Amtech Roofing Consultants).

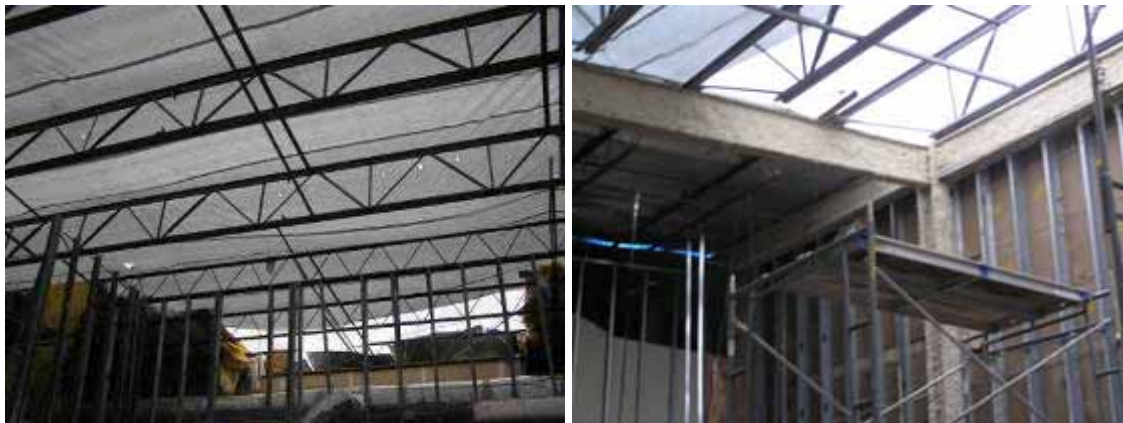
Figure 3-35 Loss of open-web roof trusses and metal-paneled roof deck at Anderson Elementary School in Orange, TX. Note the pictures show the replacement trusses and the temporary plastic covering (Photo credit: NIST).

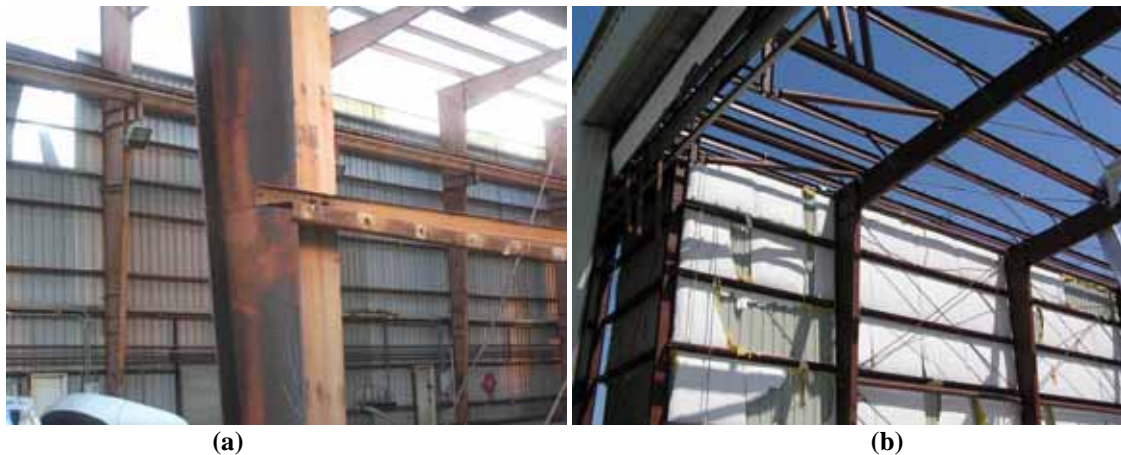
Figure 3-36 Loss of corrugated-metal roofing structures on large, metal buildings in a) Pass Christian, MS, and b) Port Arthur, TX (Photo credit: NIST).

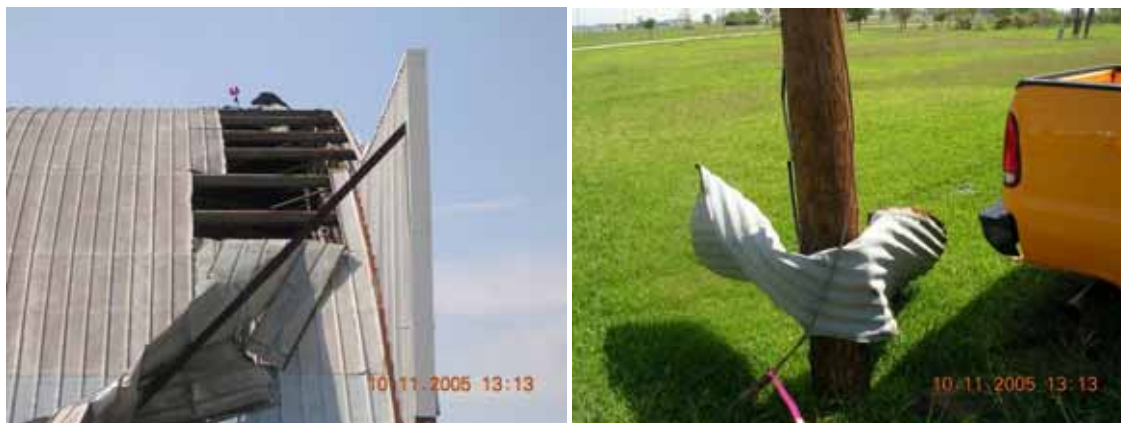
Figure 3-37 Damaged metal panels on a barrel roof at the Southeast Texas Regional Airport, Port Arthur, TX (Photo credit: NIST).

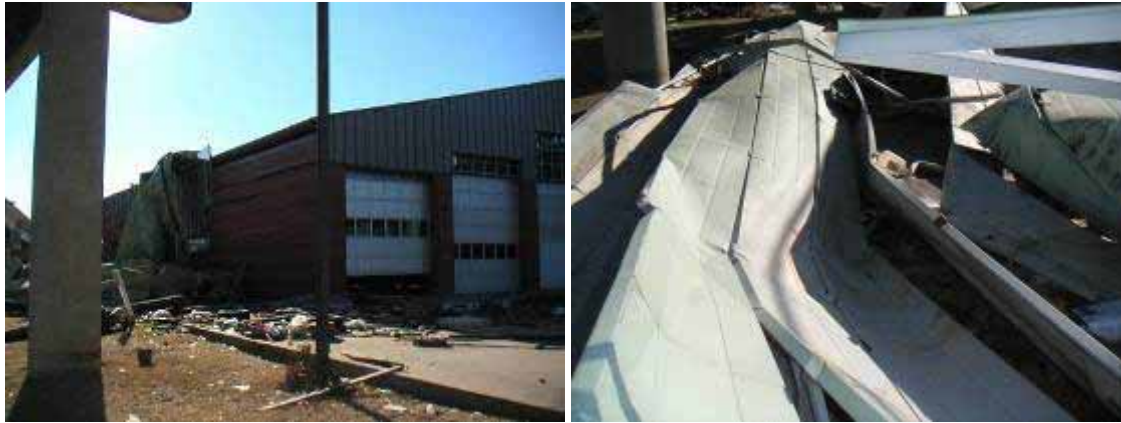
(a) (b)
Figure 3-38 New Orleans Third District Fire Headquarters. (a): roof damage. (b): apparent lack of fasteners (Photo credit: Keith Porter, Scawthorn Porter Associates).

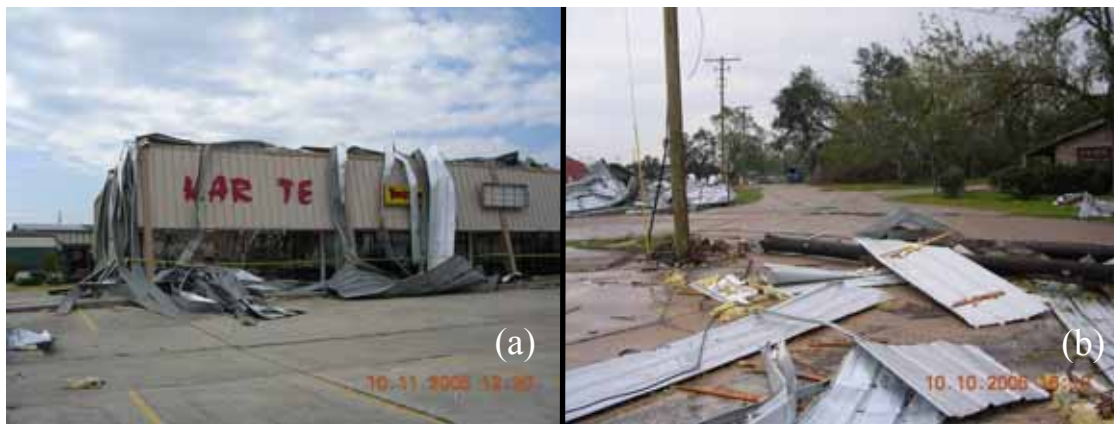
Figure 3-39 Failure of metal roofs in (a) Port Arthur, TX, and (b) West Orange, TX (Photo credit: NIST).

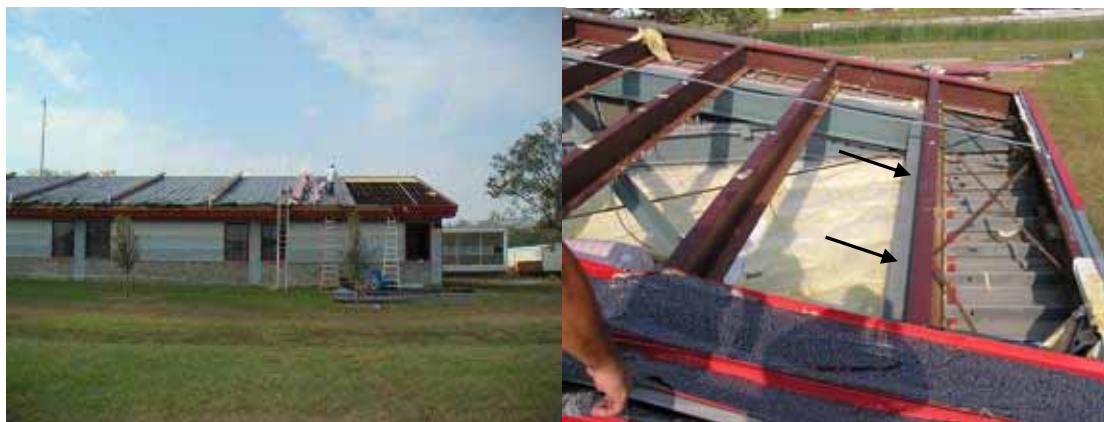
Figure 3-40 Missing roof clips (arrows) at the right eave of the Belle Chasse Middle School in Belle Chasse, LA. No evidence was seen that the clips had ever been installed (Photo credit: Robb Smith, Amtech Roofing Consultants).
