Performance of Physical Structures in
Hurricane Katrina and Hurricane Rita:
A Reconnaissance Report

NIST Technical Note 1476

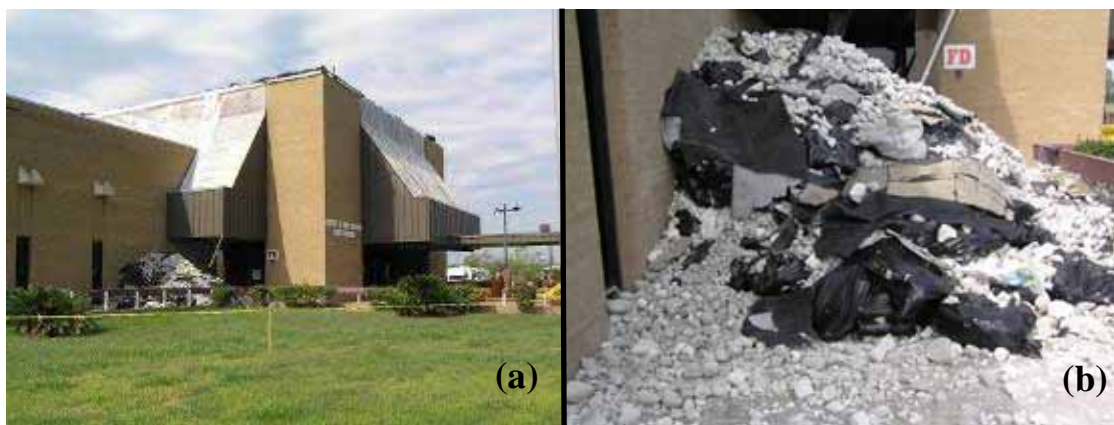
Figure 3-41 Failure of low-sloped bituminous membrane roof along with a metal panel mansard roof at Robert A. “Bob” Bowers Civic Center in Port Arthur, TX (a). The low-sloped roof construction included a lightweight concrete fill that may have been damaged during Hurricane Rita (b) (Photo credit: NIST).

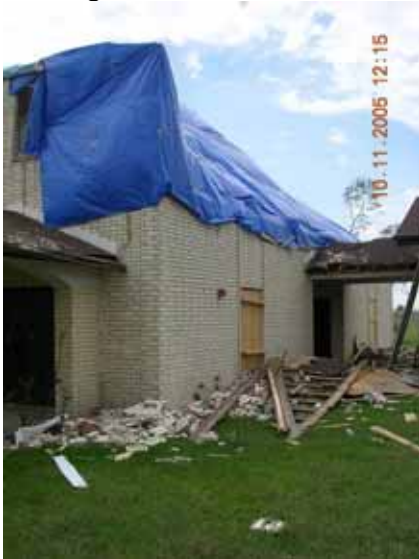
Figure 3-42 Failure of the windward, wooden truss in a recreation center in Port Arthur, TX (Photo credit: NIST).

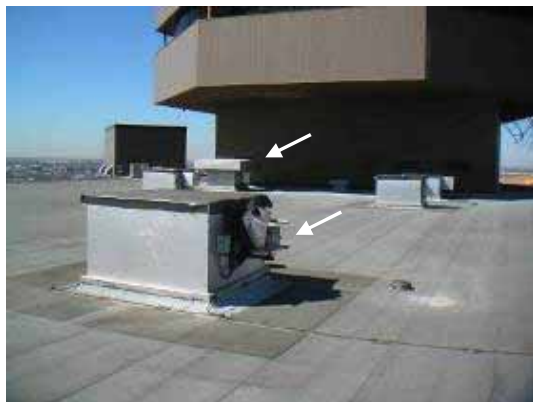
Figure 3-43 Five of six vents on the roof of the New Orleans Hyatt Regency were missing their hoods. Note the remaining hood in the background (arrow) and the missing cover of the fan motor of the vent in the foreground (arrow) (Photo credit: Keith Porter, Scawthorn Porter Associates).

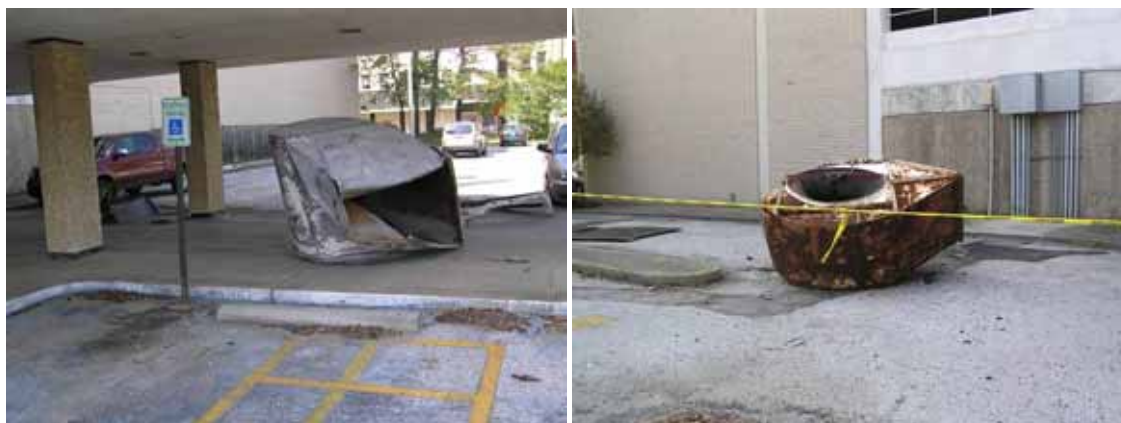
Figure 3-44 Rooftop equipment blown off a neighboring structure in Beaumont, TX (Photo credit: NIST).

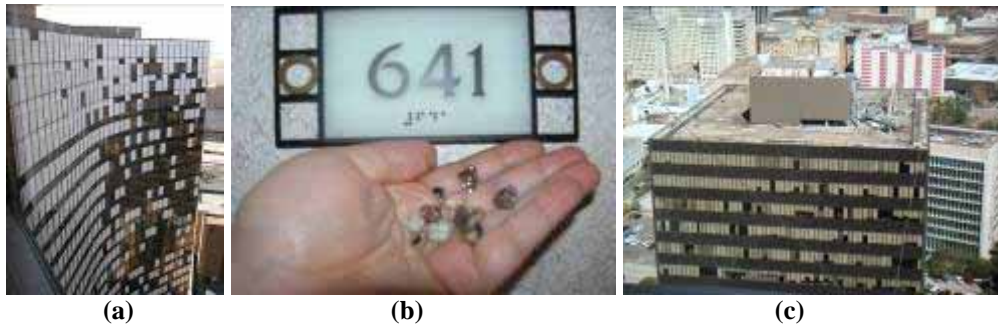
Figure 3-45 Window system damage from wind-borne roof aggregate: (a) New Orleans Hyatt Regency, (b) the aggregate mixed with glass found in rooms, (c) upwind highrise building (Photo credit: Keith Porter, Scawthorn Porter Associates).

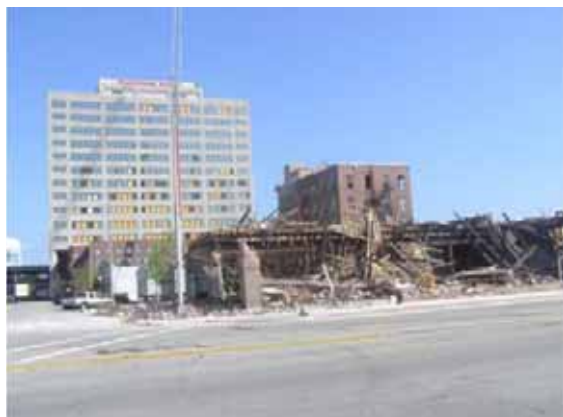
Figure 3-46 Hancock Bank building (background) in downtown Gulfport, Mississippi, downwind (north) of partially collapsed unreinforced masonry building (Photo credit: NIST).

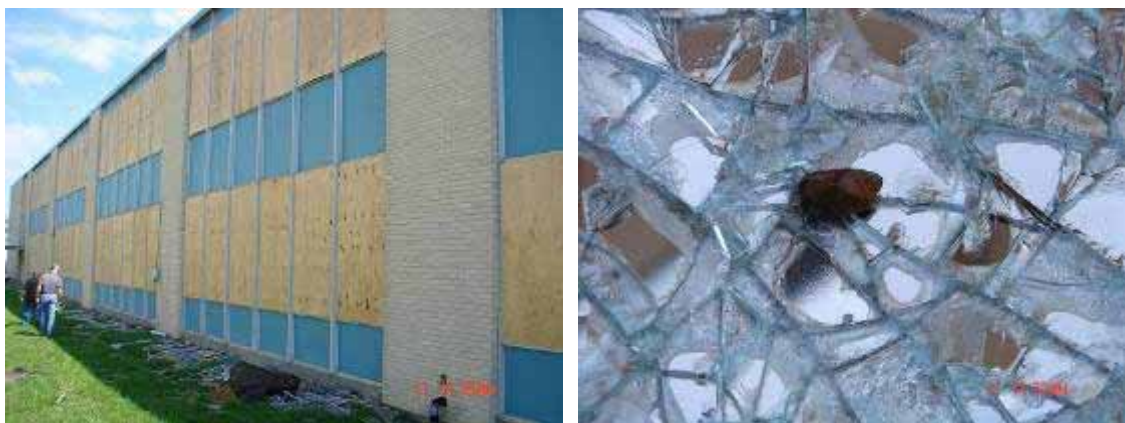
Figure 3-47 Broken glass at Memorial Ninth Grade School in Port Arthur, TX. The gravel among the broken glass was consistent with that on the aggregate-surfaced roof adjacent to this school (Photo credit: Jon Heintz, Applied Technology Council).

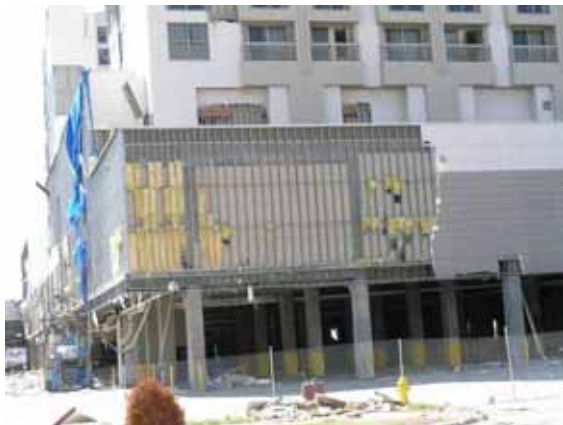
The EIFS was blown off the leeward sides of buildings in Biloxi, MS, New Orleans, LA, and Orange, TX. A few incidences of the damage were at an elevation subjected to storm surge, so water may have also contributed to the EIFS failure (Figure 3-48a). Commercial buildings in New Orleans also experienced damage to their EIFS, e.g., the AMC Palace Shopping Mall (Figure 3-48b). Similar damage to EIFS was observed at Lamar State University in Orange, TX. Many of these EIFS walls did not appear to be subject to substantial wind- or water-borne debris, suggesting that wind pressure alone caused the damage.

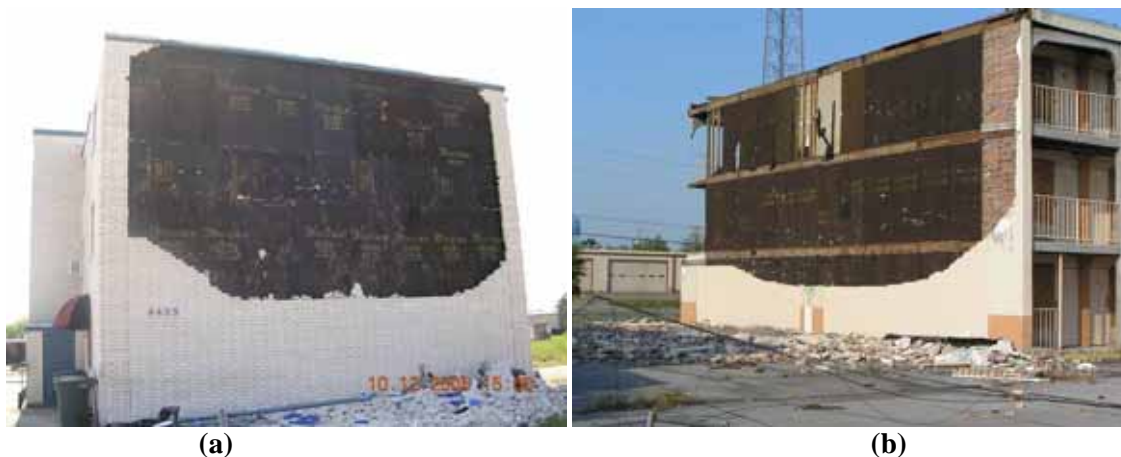
Figure 3-50 Wind-induced collapse of (a) a roughly 40 ft wide by 30 ft high and (b) a roughly 60 ft wide by 25 ft high, poorly anchored brick masonry cladding in Beaumont, TX (Photo credit: NIST).

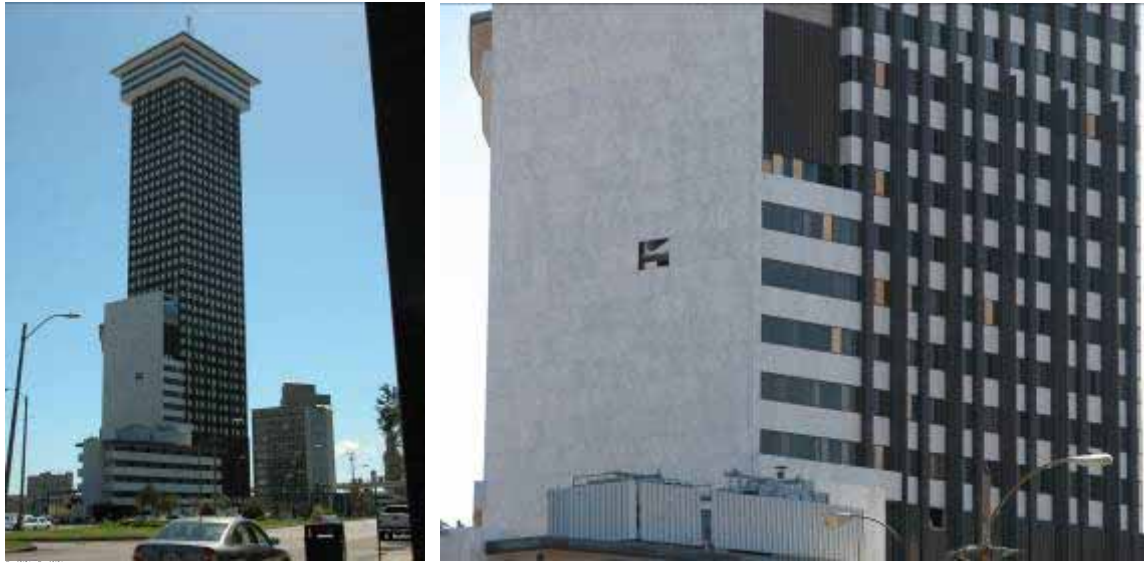
Figure 3-51 Unusual instance of damage to stone cladding due to wind pressure (Photo credit: Keith Porter, Scawthorn Porter Associates).

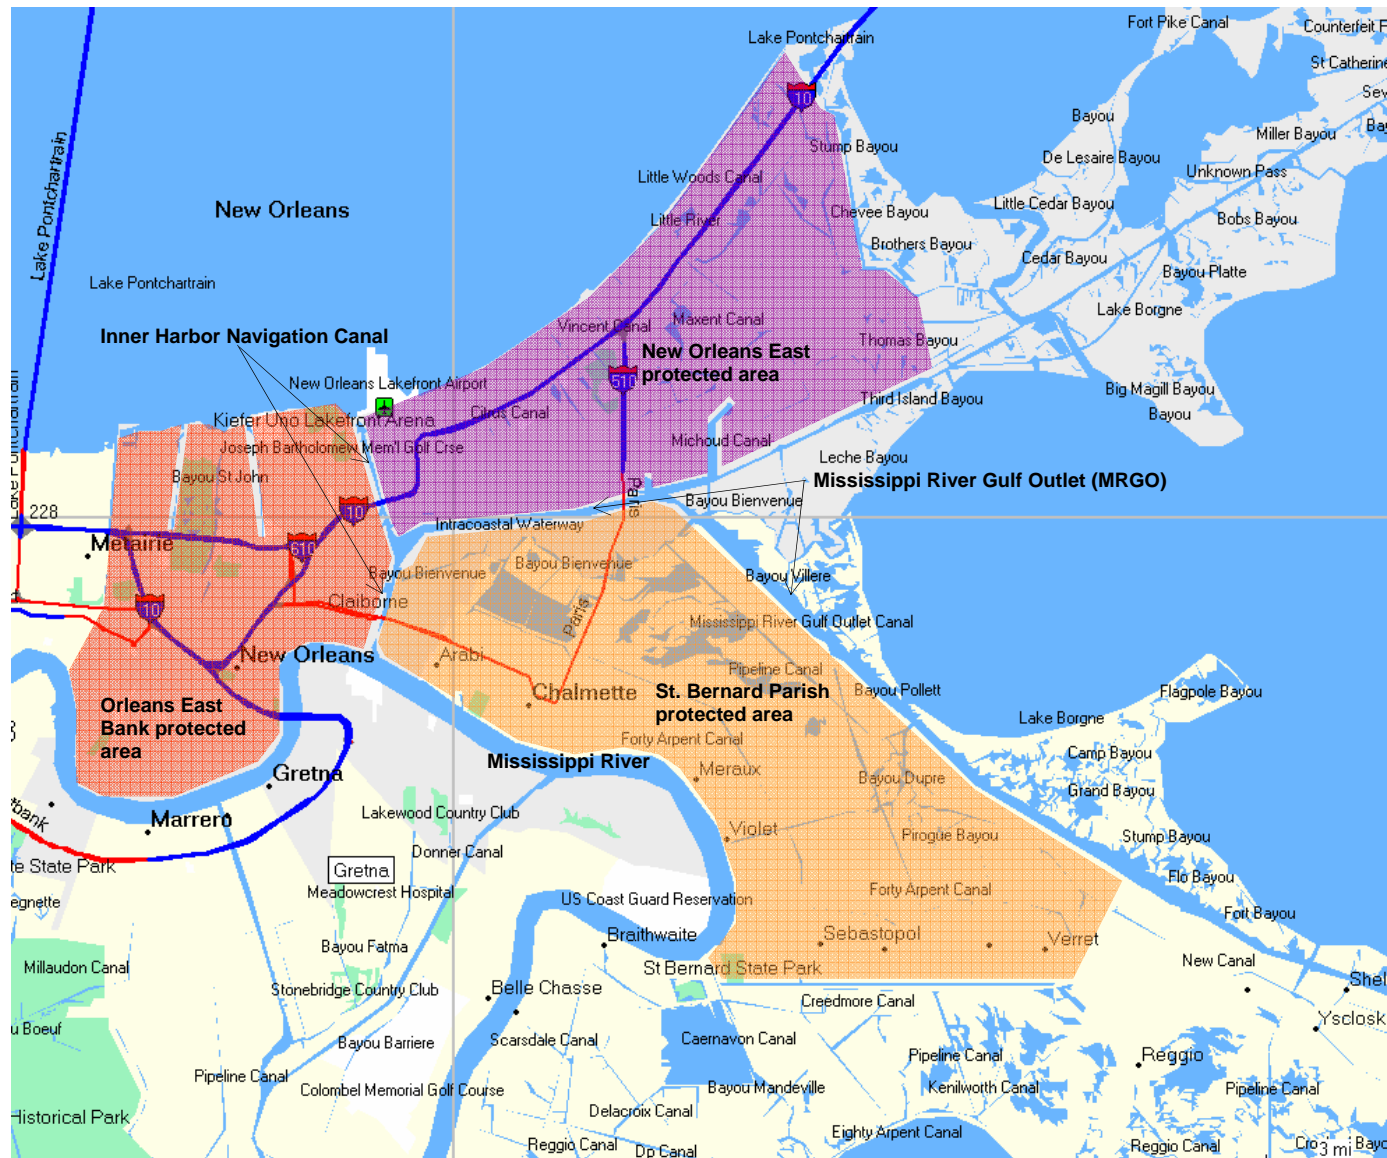
Figure 4-1 Approximate areas and boundaries of the Orleans East Bank, New Orleans East, and St. Bernard Parish protected areas. (© Copyright 2006 Garmin Ltd. or its subsidiaries. All rights reserved. Map data © 2002 NAVTEQ. All rights reserved. Enhancement by NIST)

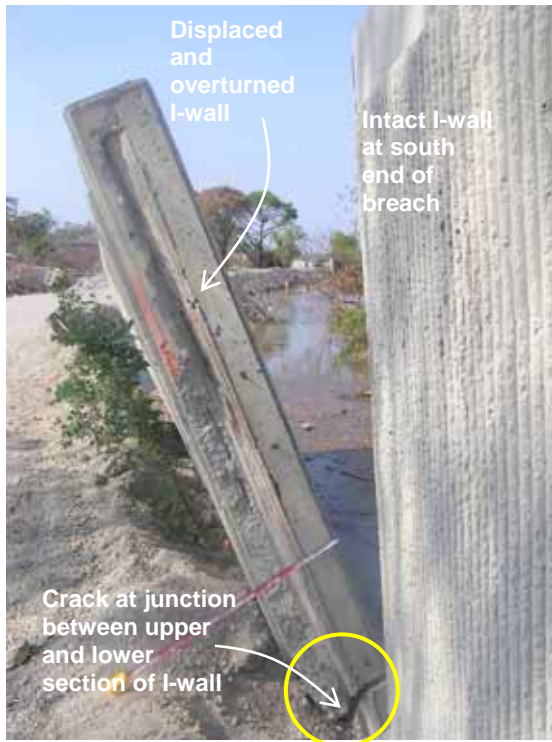
Figure 4-9 Cracked I-wall (photo credit: NIST)

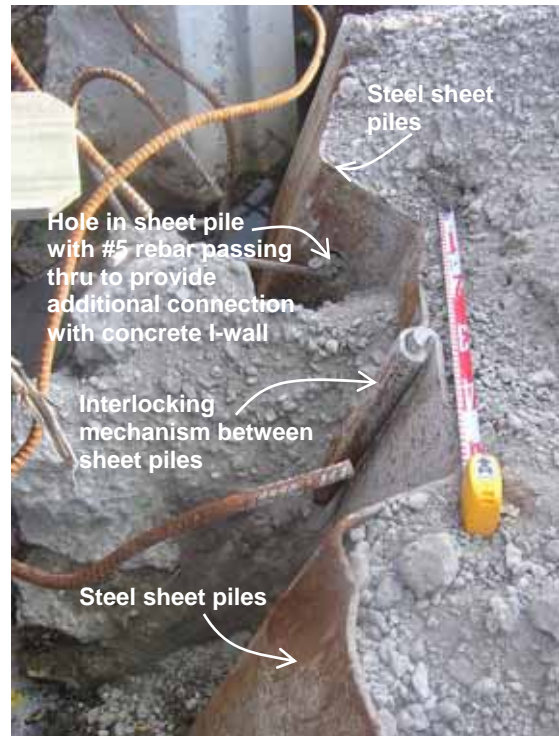
Figure 4-10 Sheet piles details (photo credit: NIST)

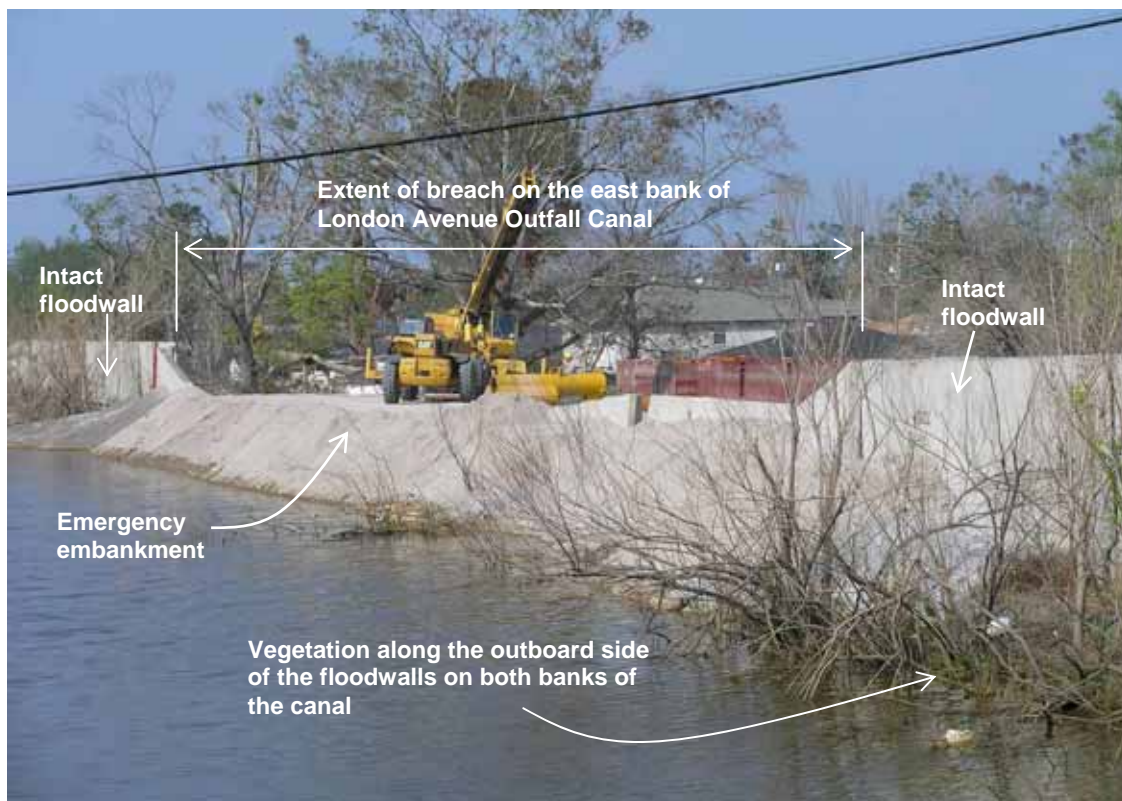
Figure 4-11 View looking north from Mirabeau Road bridge toward the breach on the east bank of the London Avenue Outfall Canal (photo credit: NIST)

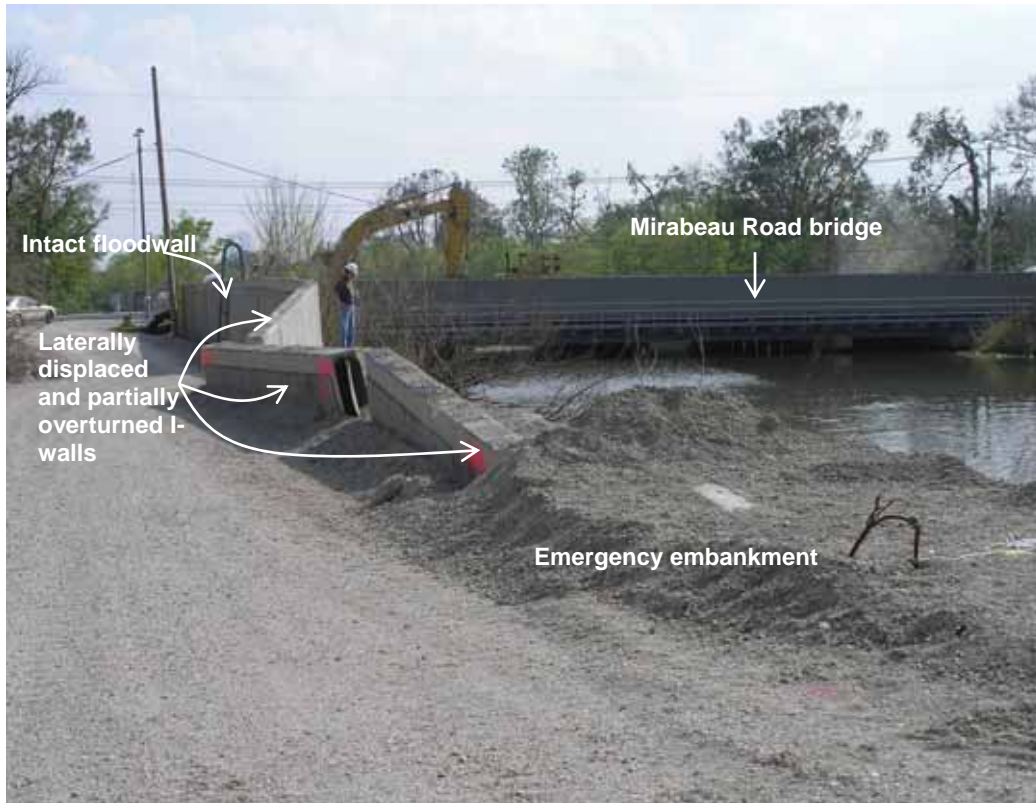
Figure 4-12 View looking south from the breach on the east bank of the London Avenue Outfall Canal toward Mirabeau Road bridge (photo credit: NIST)

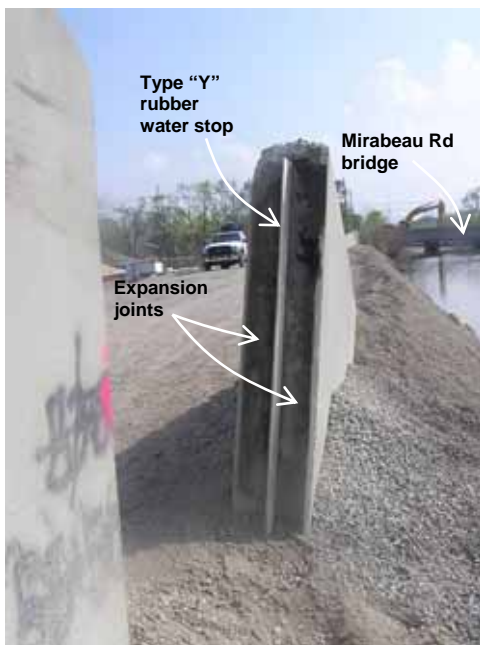
Figure 4-13 I-walls of failed floodwall section separated along water stop joint (photo credit: NIST)

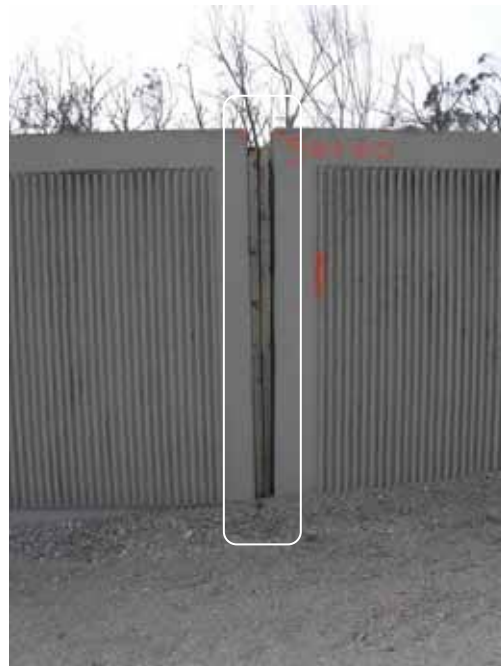
Figure 4-14 Partial separation of adjacent I-walls along water stop joint (photo credit: NIST)

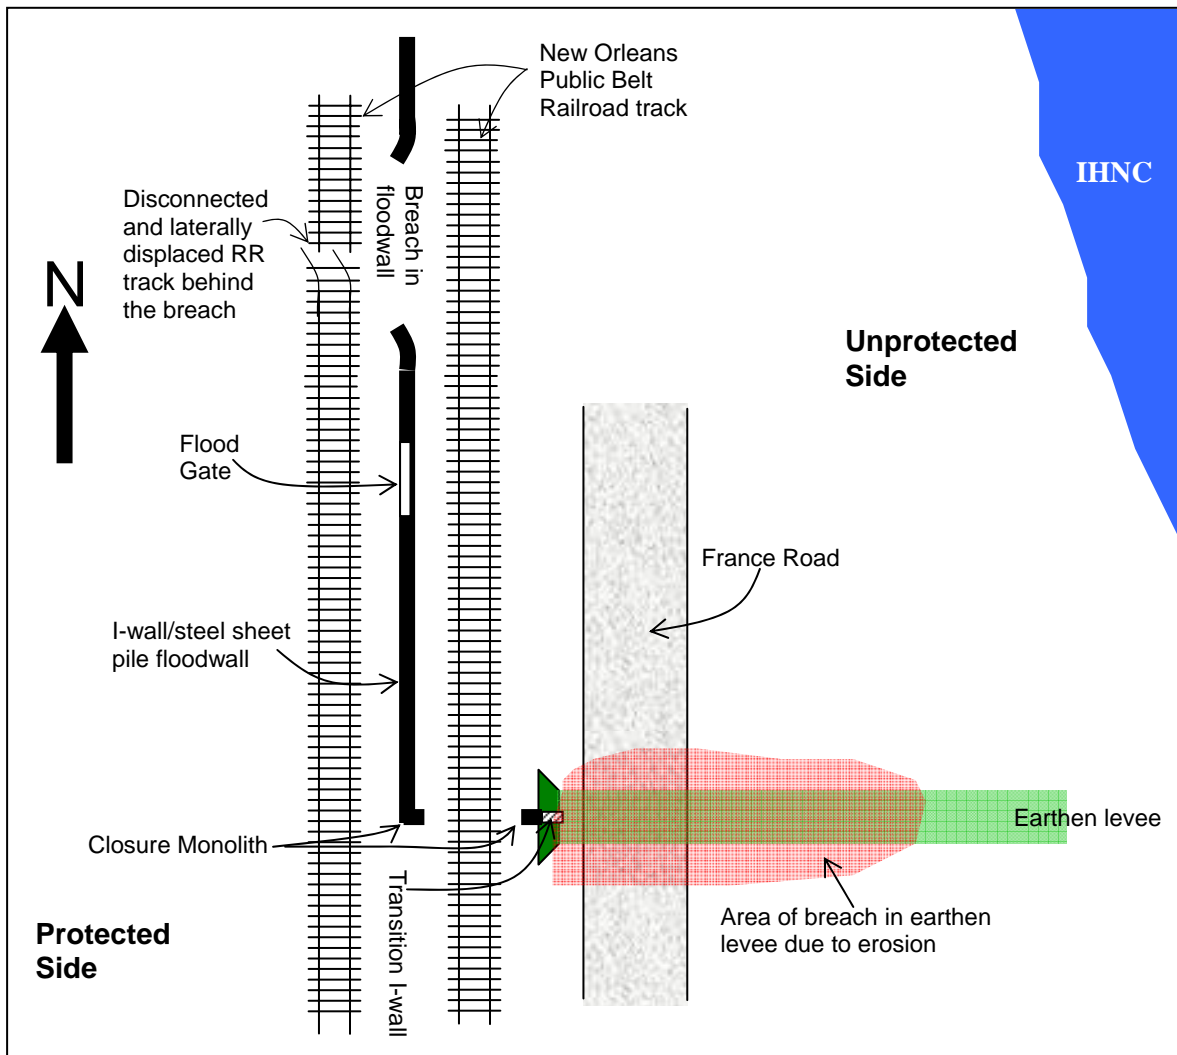
Figure 4-15 General locations of the IHNC breaches at France Road (drawing credit: NIST)

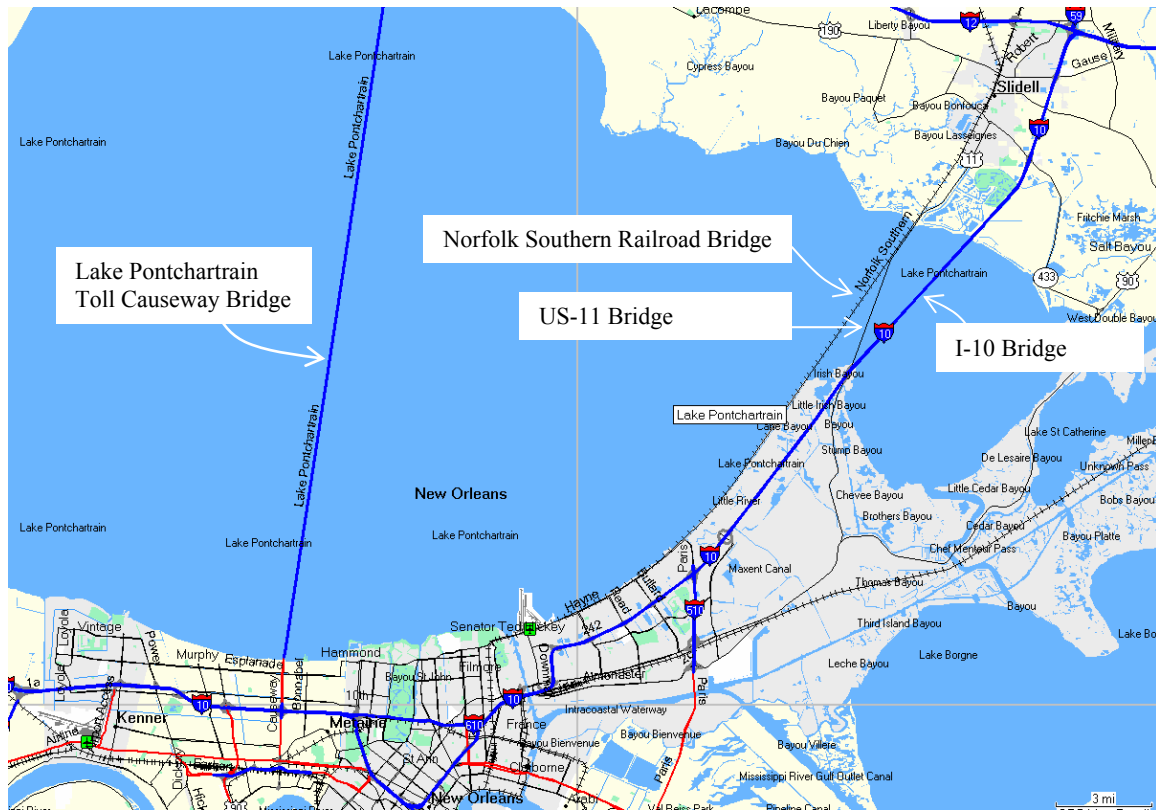
Figure 4-30 Major bridges over Lake Pontchartrain in Louisiana (© Copyright 2006 Garmin Ltd. or its subsidiaries. All rights reserved. Map data © 2002 NAVTEQ. All rights reserved. Enhancement by NIST)

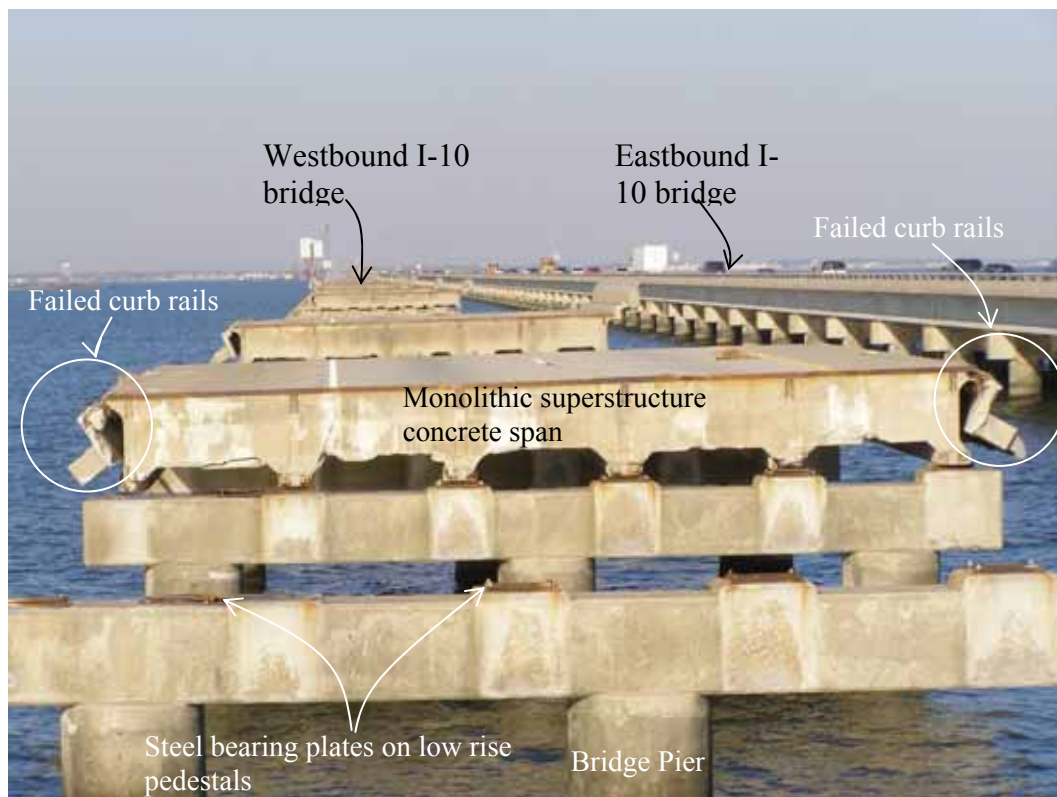
Figure 4-31 View looking north from west abutment of I-10 twin span bridges over Lake Pontchartrain (photo credit: NIST).

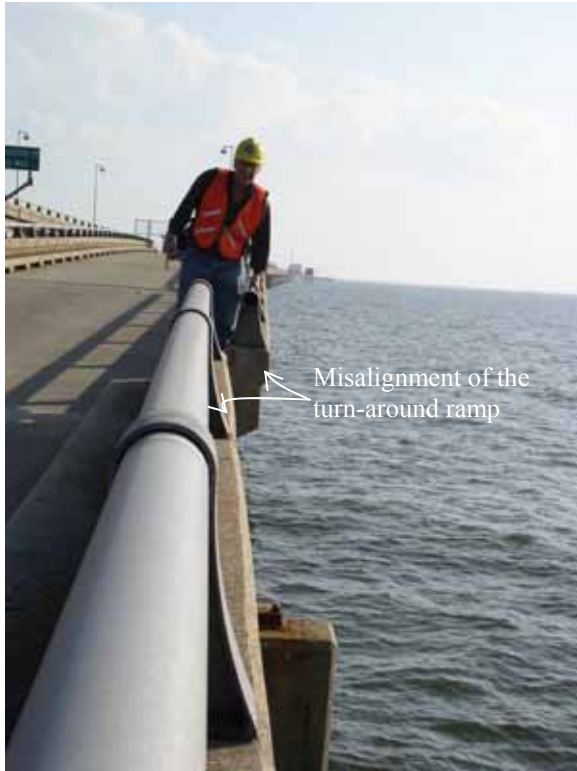
Figure 4-35 Misaligned spans of the Toll Causeway's turn around ramp (photo credit: Ron T. Eguchi, ImageCat).

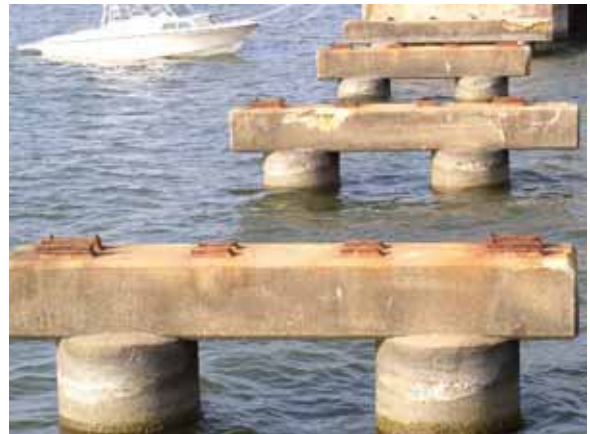
Figure 4-36 Steel Bearing Plates/Shear Keys connection between the superstructure and the bridge piers (photo credit: Ron T. Eguchi, ImageCat)

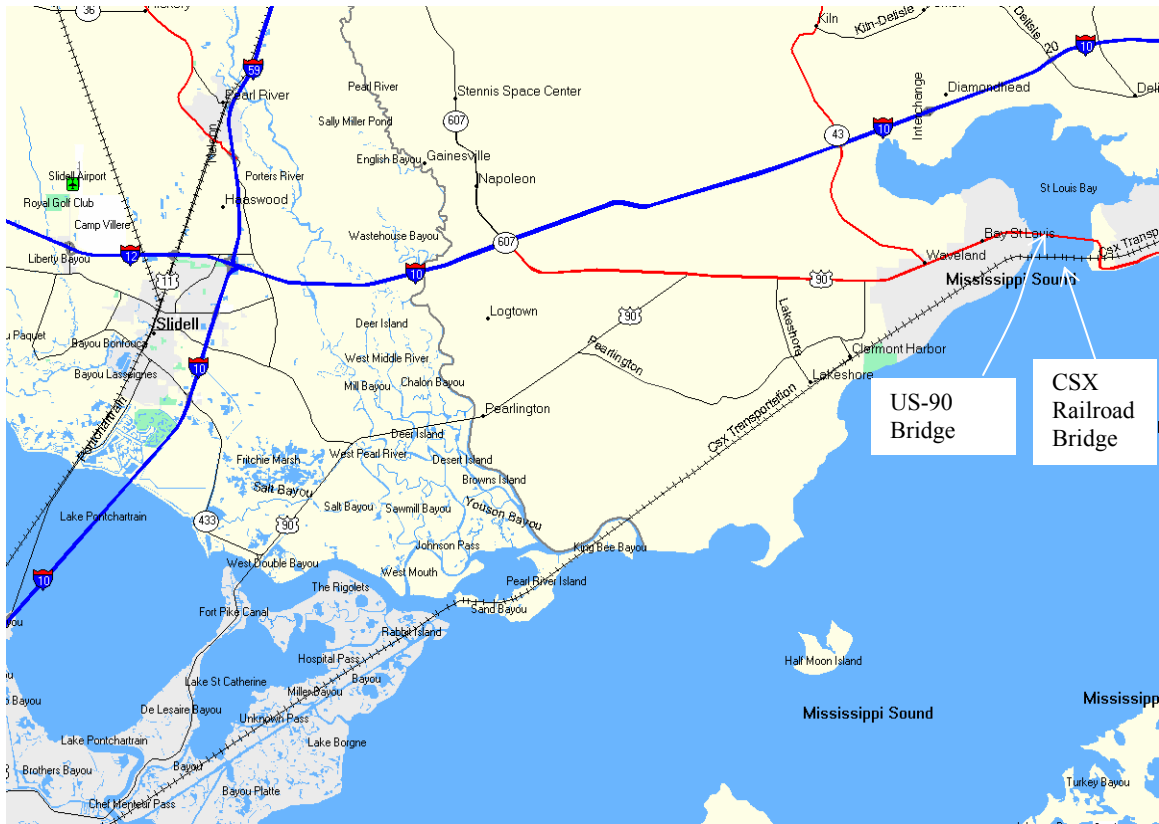
Figure 4-37 Bridges over St. Louis Bay (© Copyright 2006 Garmin Ltd. or its subsidiaries. All rights reserved. Map data © 2002 NAVTEQ. All rights reserved. Enhancement by NIST)

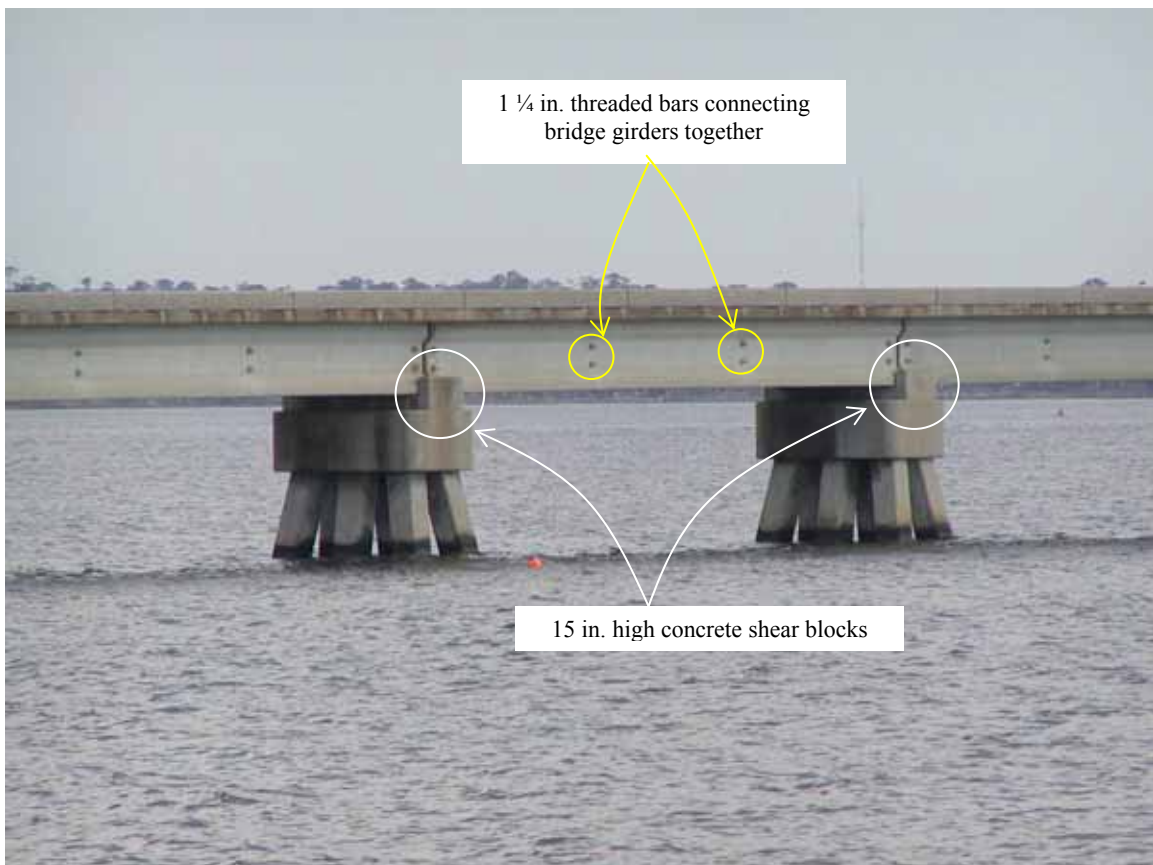
Figure 4-44 The CSX railroad bridge survived with minor damage, most likely¹⁵ due to the presence of high shear blocks (photo credit: LA DOTD).

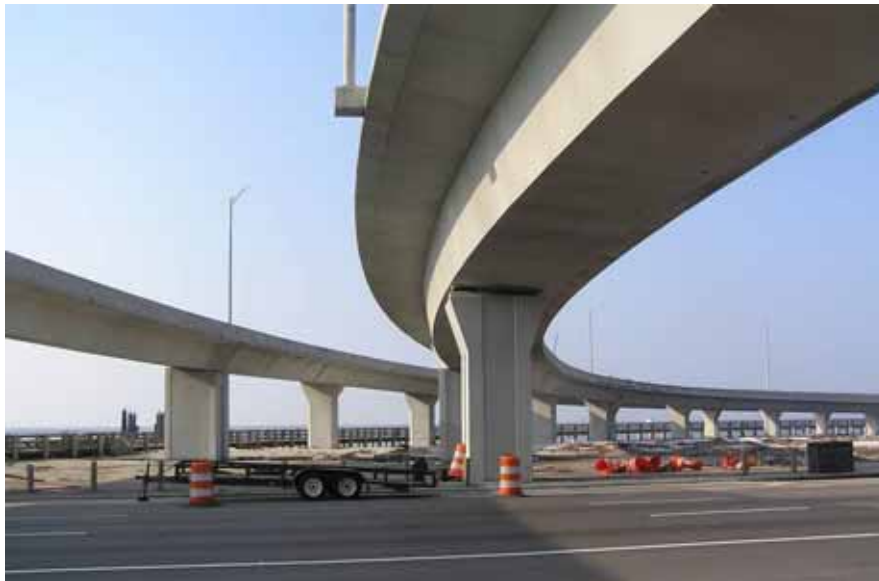
Figure 4-45 I-110 bridge ramps with cast-in-place, continuous box girder superstructure positively connected to bridge piers (photo credit: NIST)

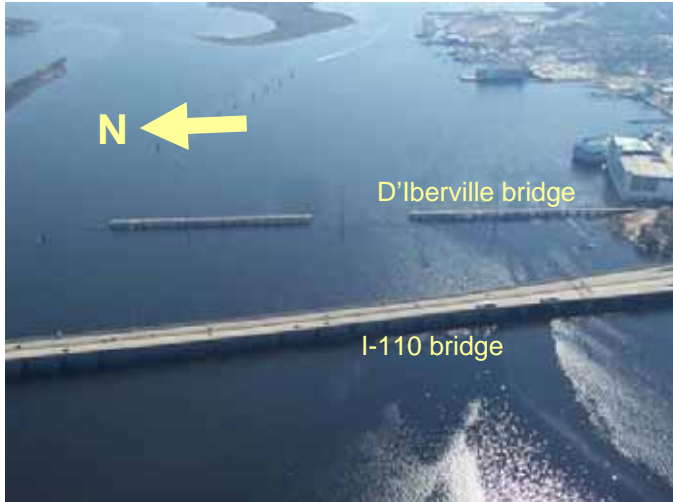
Figure 4-46 Back Bay facing southeast. D'Iberville bridge lost several spans and piers. I-110 bridge was hit by a barge, damaging some of the supporting piers (photo credit: MSDOT, provided by J. O'Connor, MCEER).

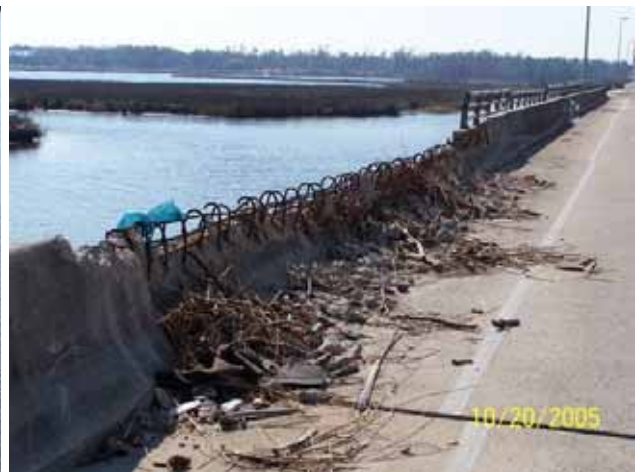
Figure 4-48 Broken curb rail, Popps Ferry bridge (photo credit: J. O'Connor, MCEER)

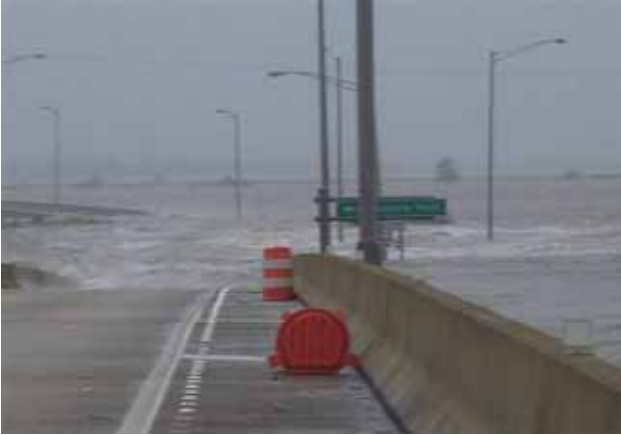
Figure 4-50 Surge waters overtopped US I-10 bridge ramp over Mobile Bay. View is eastbound, taken on the same day Hurricane Katrina hit (8/29/06). (Photo credit: George Conner, MSDOT)

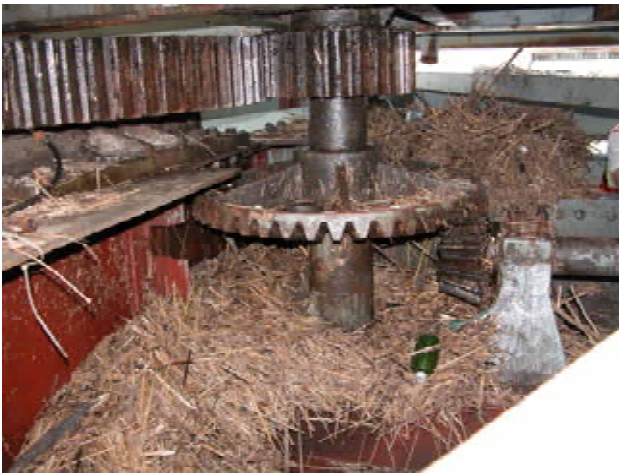
Figure 4-53 Typical debris buildup in the gear mechanism of a moveable bridge (photo credit: LA DOTD, provided by J. O'Connor, MCEER).

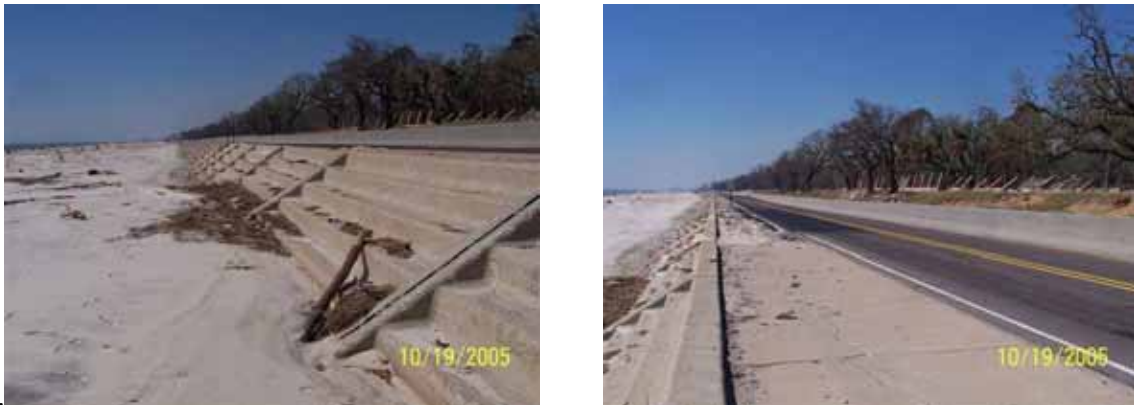
Figure 4-55 Seawall along US-90 protected much of the pavement from being undermined and washed out (photos credit: J. O'Connor, MCEER).

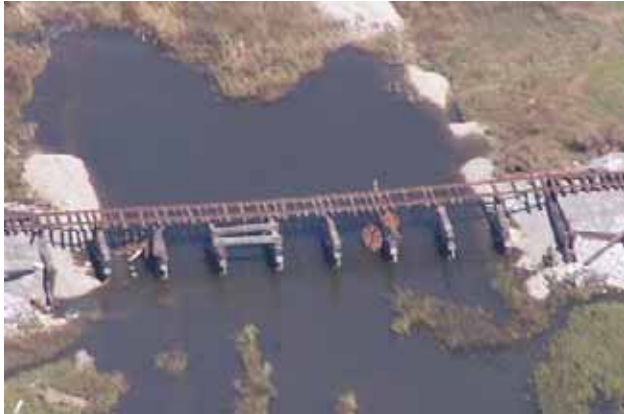
Figure 4-56 The superstructure was lost on this railroad bridge along the Mississippi coast, leaving only the dangling tracks and the substructure units (photo credit: J. O'Connor, MCEER).

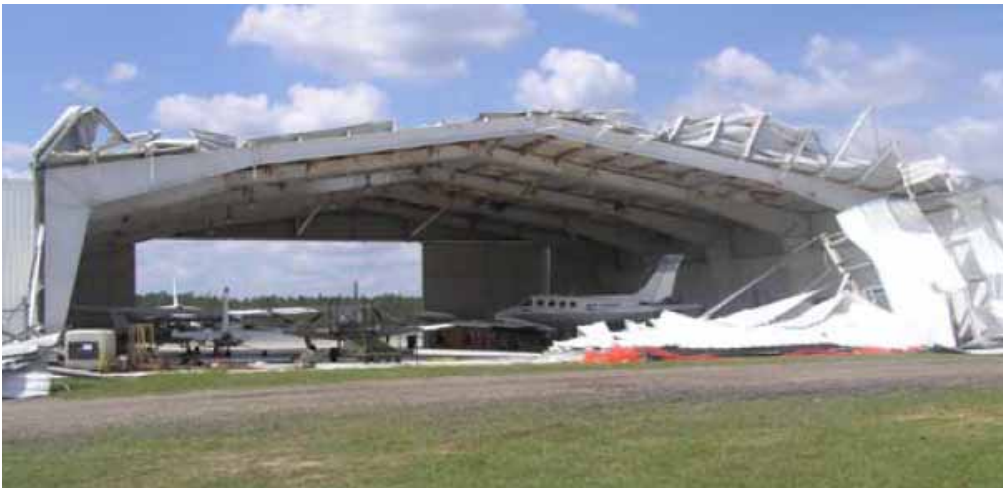
Figure 4-58 Hangar damage at Stennis Airport, Mississippi (photo credit: NIST)

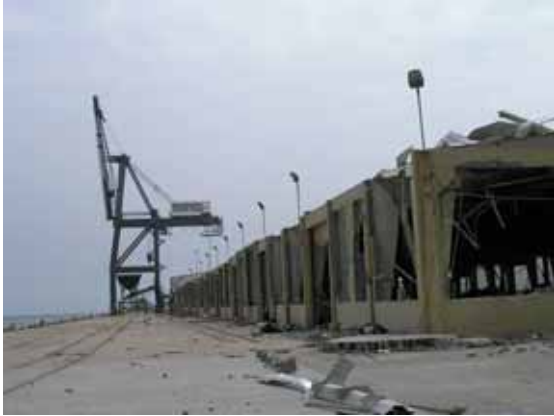
Figure 4-59 Damaged warehouse at Port of Gulfport (photo credit: NIST)

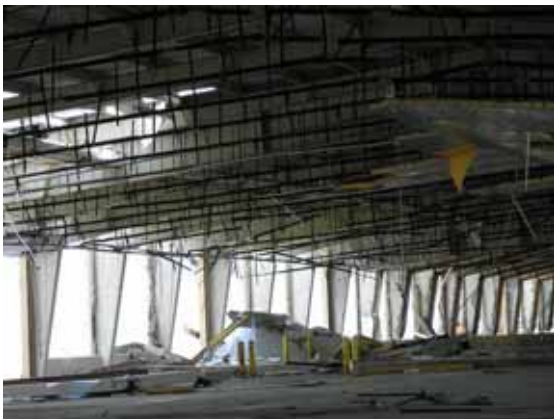
Figure 4-60 Damaged warehouse at Port of Gulfport, with steel frames still standing (photo credit: NIST)

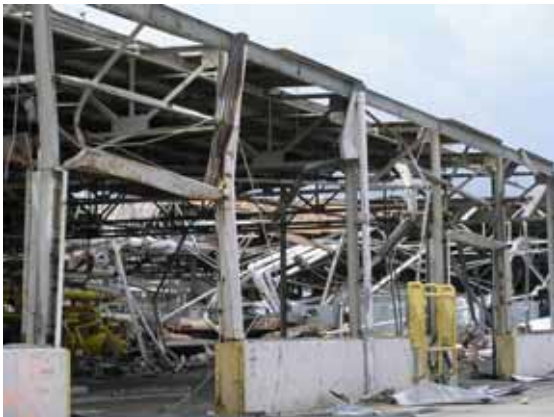
Figure 4-61 Damaged warehouse at Port of Gulfport, collapsed steel members (photo credit: NIST)

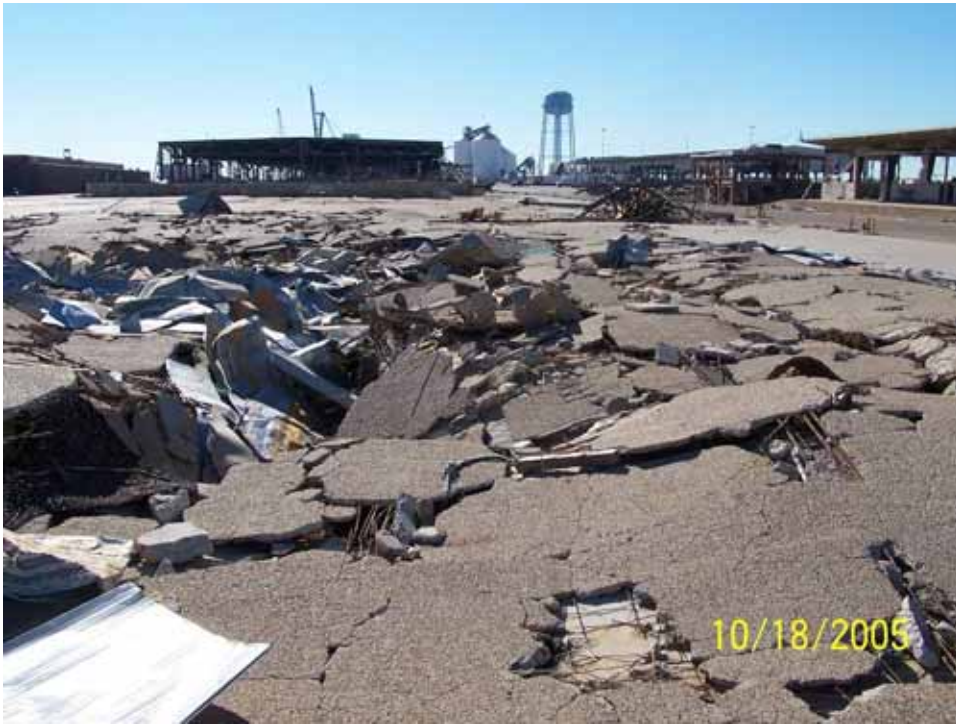
Figure 4-62 West Pier, showing collapse of wharf structure due to pile failure (photo credit: Thomas B. Rodino, Shiner Moseley and Associates, Inc.)

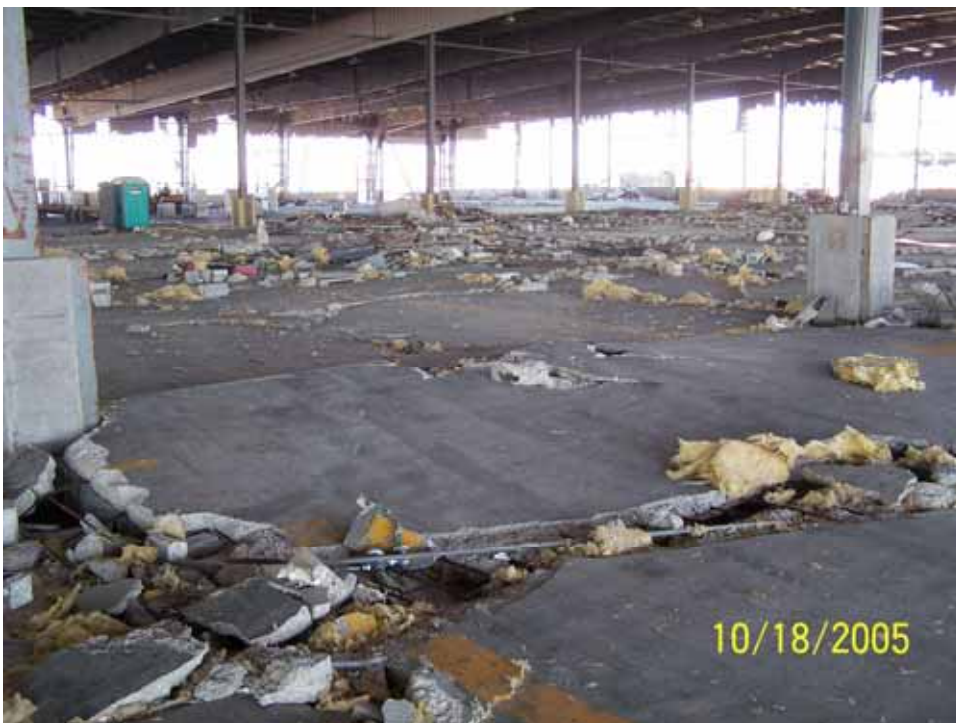
Figure 4-63 East Pier, showing damage to cargo shed deck and sheet metal siding (photo credit: Thomas B. Rodino, Shiner Moseley and Associates, Inc.)

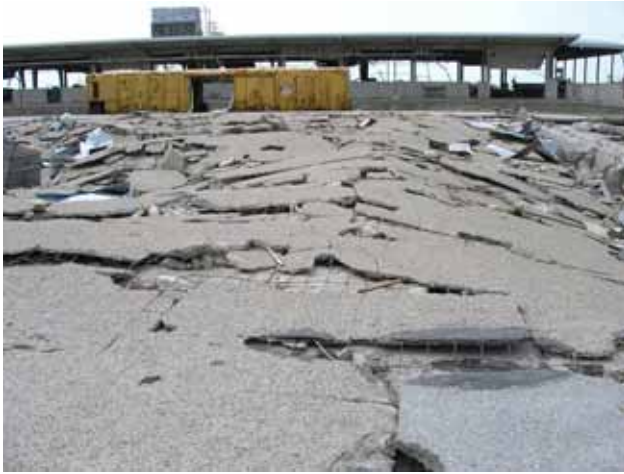
Figure 4-64 Wharf buckled upward due to storm surge pressure (photo credit: Thomas B. Rodino, Shiner Moseley and Associates, Inc.)

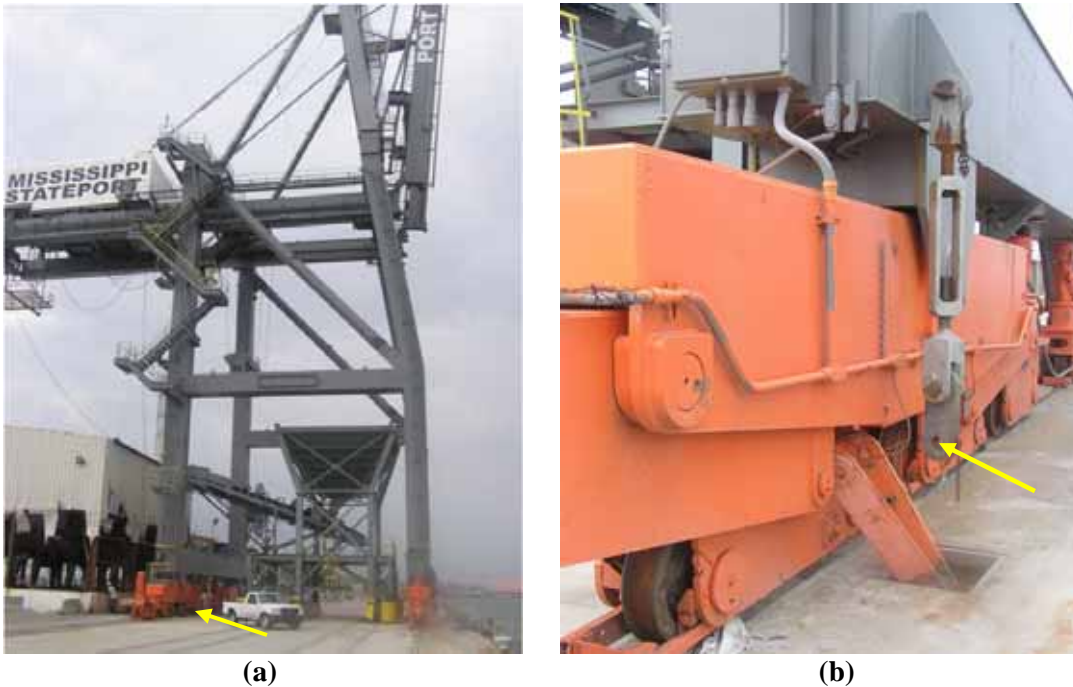
Figure 4-65 (a) Container crane with tie-down damage at Port of Gulfport, Mississippi and (b) Broken restraint (photo credit: NIST)

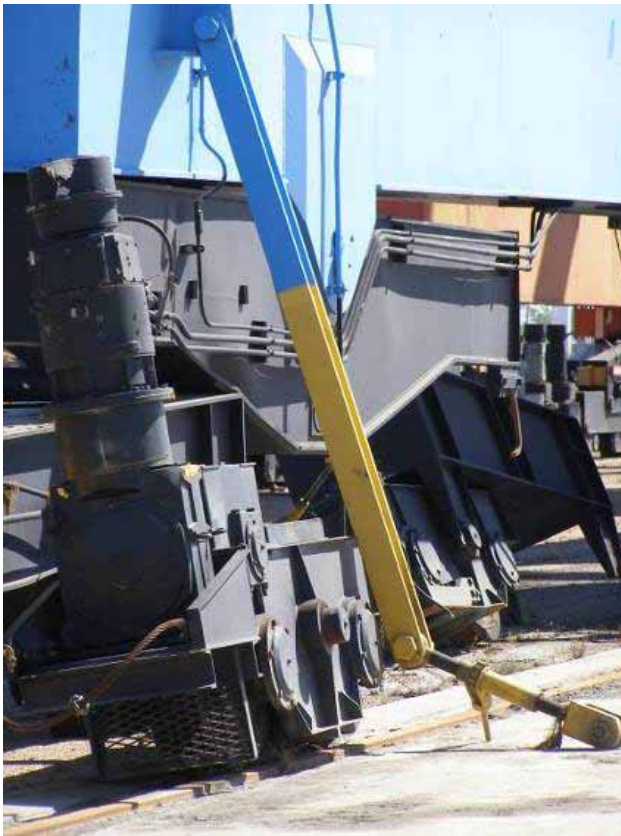
The Port of New Orleans is one of the busiest in the country and, together with the Port of Gulfport, accounts for approximately 25 percent of U.S. shipping. Container cranes are critical to the operation of such facilities, and three container cranes were damaged in Hurricane Katrina. Each was secured with four hurricane tie-down connections designed for hurricane winds (Figures 4-66a and b). The tie-downs were overstressed, resulting in tension failure of several of the 2 in. threaded rods. All three cranes were pushed as far as 50 feet, ending up together at the end of wharf. One crane was also pushed off track and had a wheel carriage broken. Replacement or repair of this equipment can be problematic because it is not easily transported and has long lead times for assembly and delivery.
