Performance of Physical Structures in
Hurricane Katrina and Hurricane Rita:
A Reconnaissance Report

NIST Technical Note 1476

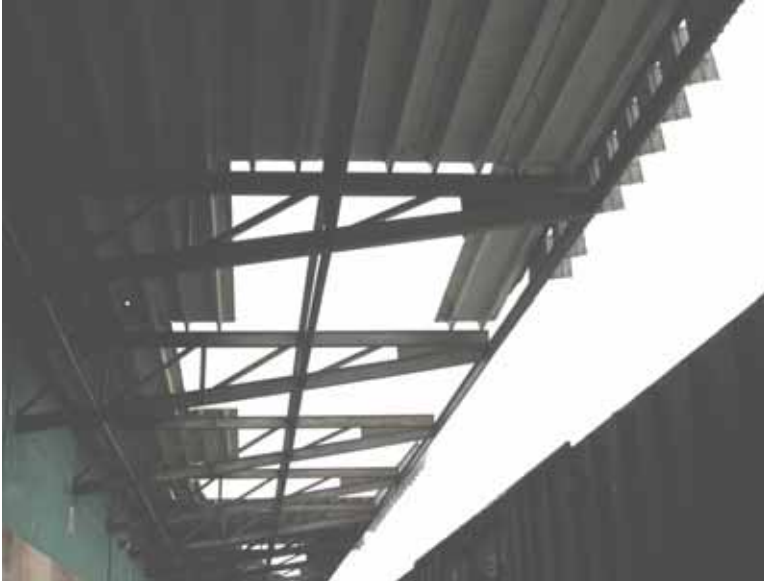
Figure 4-67 Concrete double-T beam blow-off on warehouse overhang, Port of Port Arthur, Texas (photo credit: NIST)

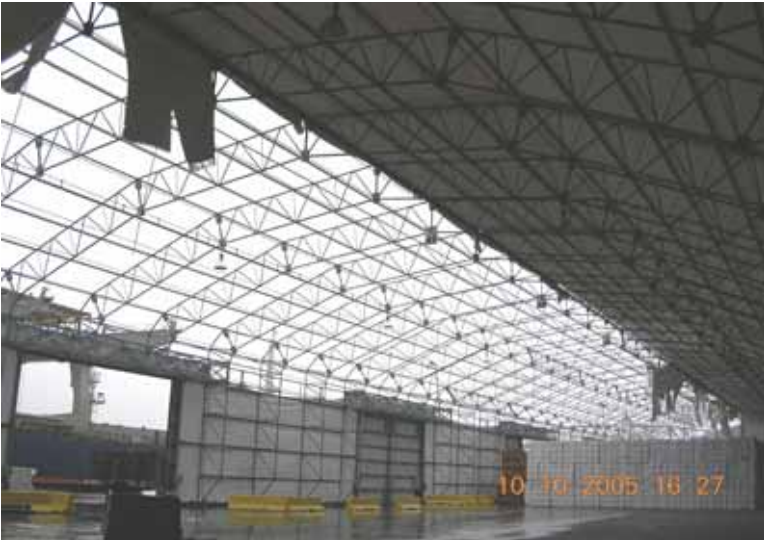
Figure 4-68 Fabric roof failure on warehouse, Port of Port Arthur, Texas (photo credit: NIST)

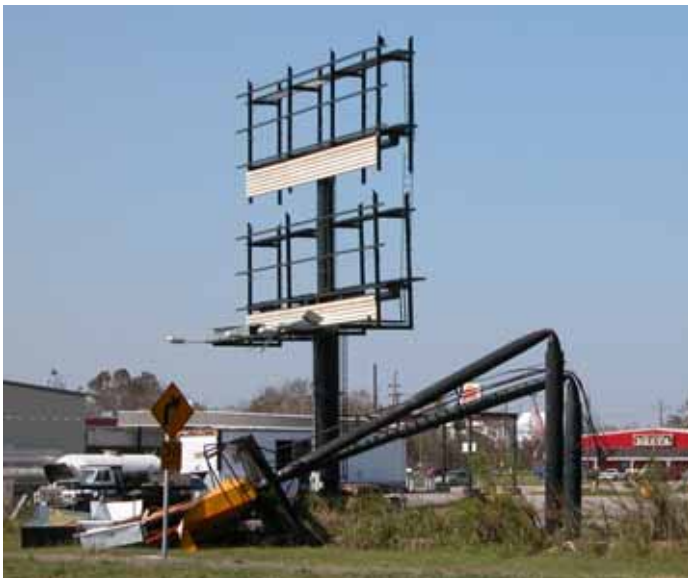
Figure 4-69 Typical billboard failures along US Interstate 10 near Beaumont, Texas (photo credit: NIST)

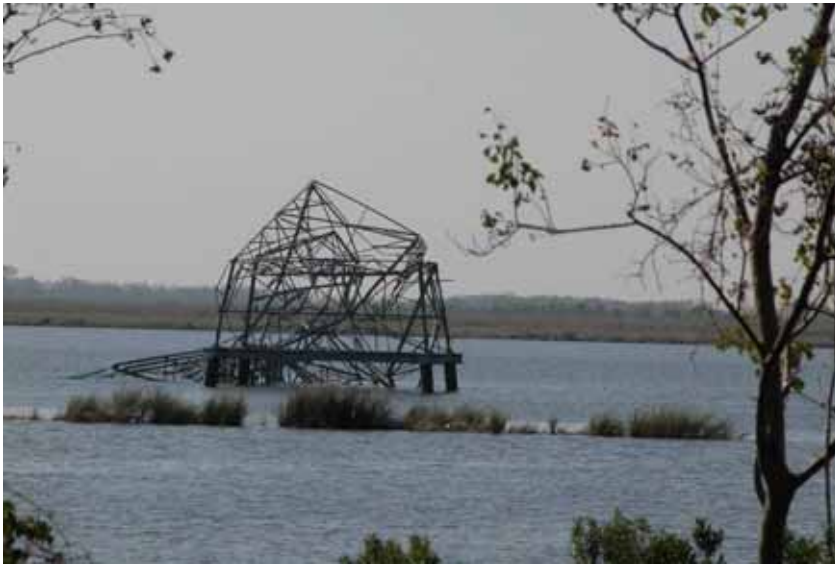
Figure 4-70 Failure of transmission line lattice tower on the Neches River (Ocean Springs to Moss Point) near Bridge City, Texas following Hurricane Rita (photo credit: NIST)

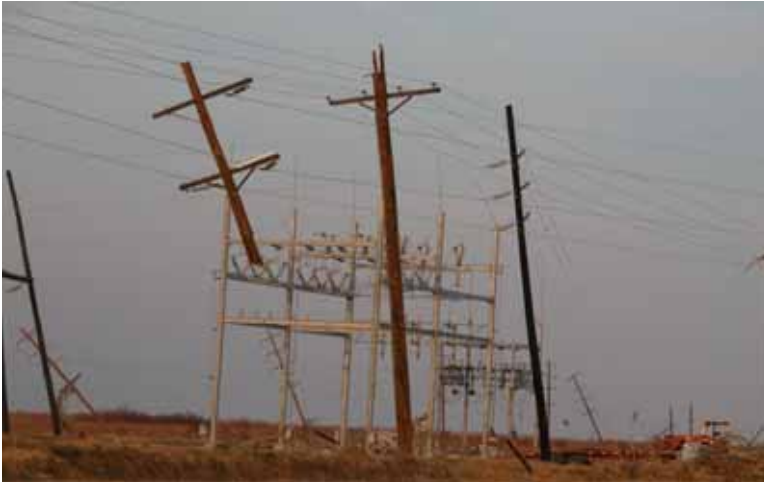
Figure 4-71 Distribution lines on US Route 82 in Louisiana damaged by Hurricane Rita (photo credit: NIST)

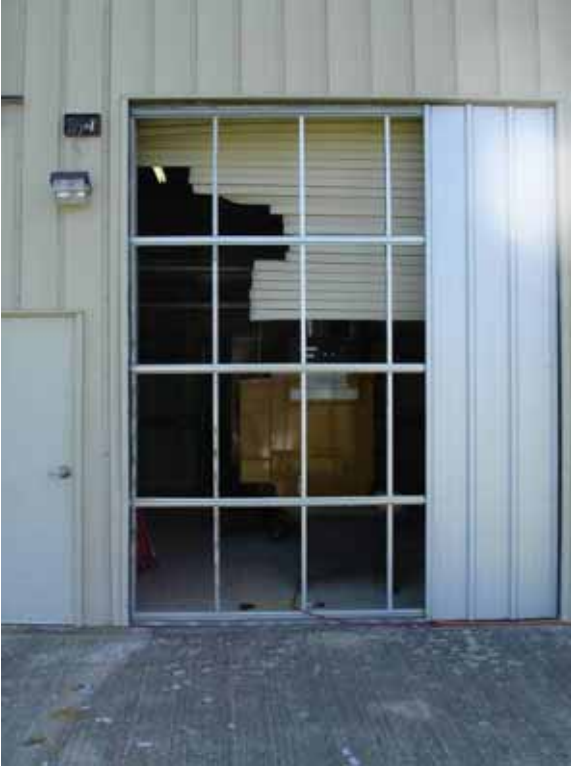
Figure 4-73 Roller door failure (with temporary framing and cladding) that led to auxiliary generator shutdown at Central Water Treatment Plant in Beaumont, Texas (photo credit: Christopher Letchford, Texas Tech University)

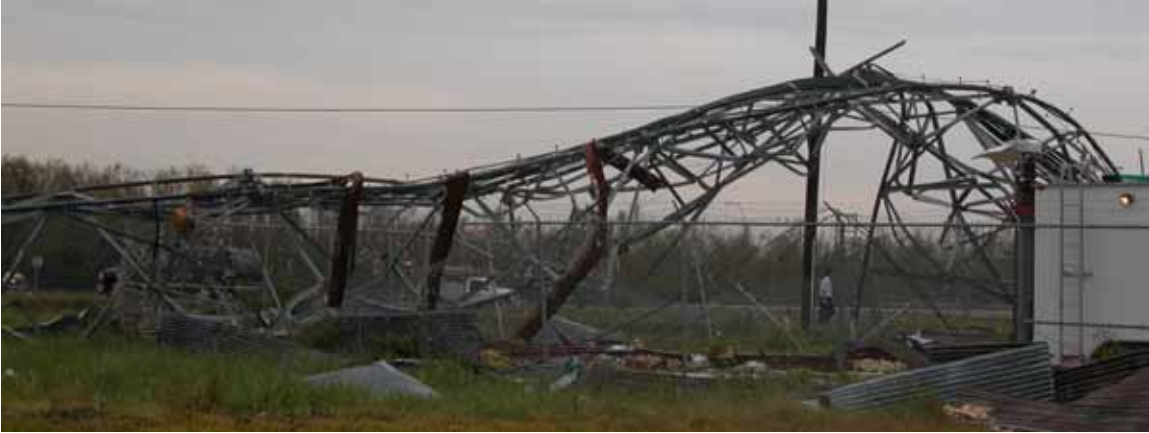
Figure 4-76 Cell tower downed by Hurricane Rita, in Orange, Texas (photo credit: NIST)

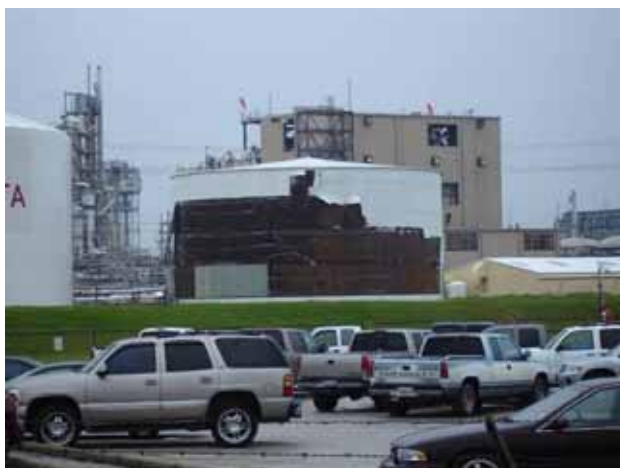
Figure 4-78 This tank at the Dupont Sabine River Plant in Orange, Texas, lost its wall insulation in Hurricane Rita (photo credit: NIST)

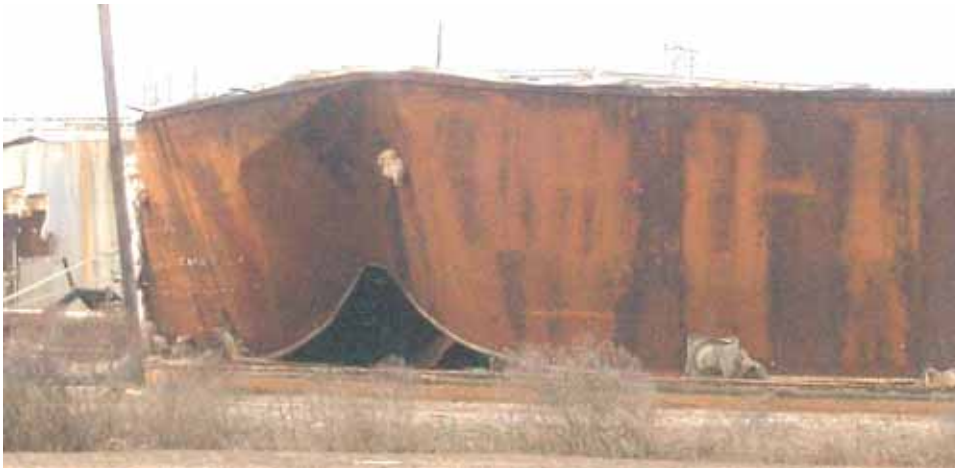
Figure 4-79 Buckled oil storage tank in Port Sulphur, LA (photo credit: Keith Porter, Scawthorn Porter Associates)

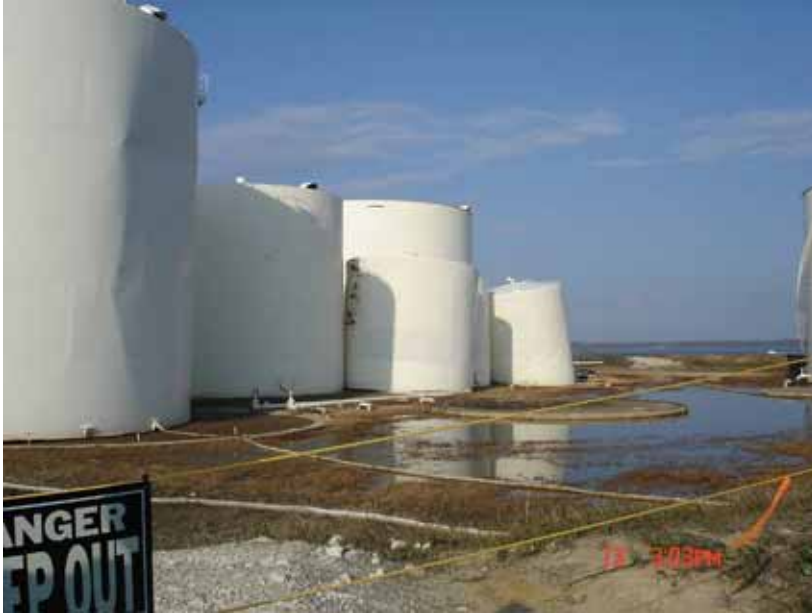
Figure 4-80 Shifting of oil storage tanks, Monroe Petroleum plant, Biloxi, MS. (photo credit: D. Fratta, U. of Milwaukee)

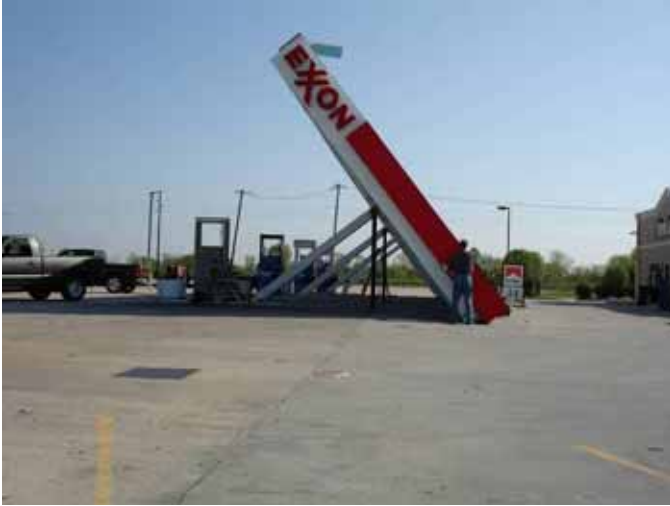
Figure 4-81 Gas station near Port Arthur, Texas with column failure (photo credit: NIST)

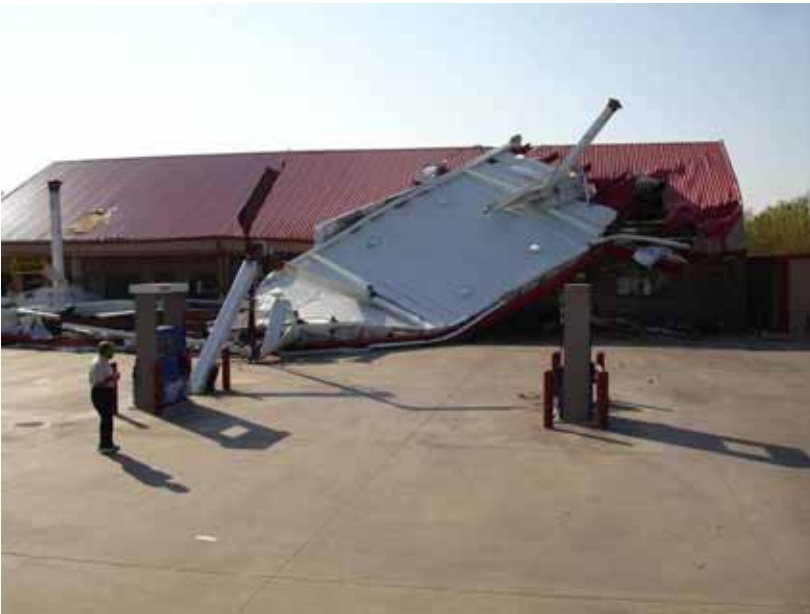
Figure 4-82 Gas station canopy near Port Arthur, Texas pulled out of its foundation (photo credit: NIST)

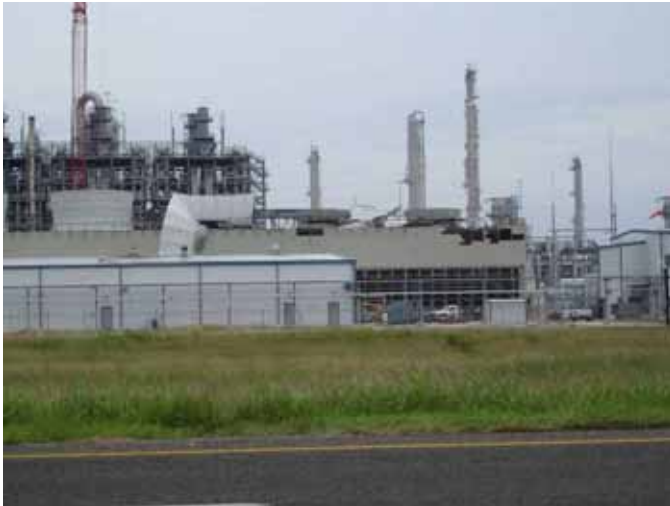
Figure 4-83 Cooling tower failures at the BASF Fina Plant in Port Arthur/Groves, Texas (photo credit: Christopher Letchford, Texas Tech University)

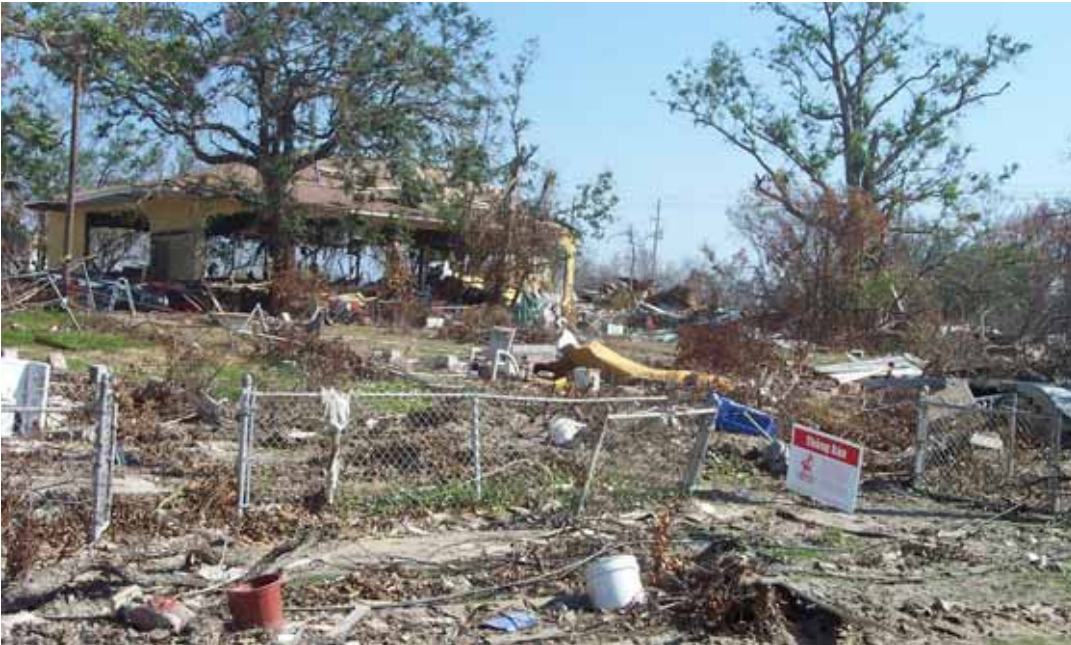
Figure 5-3 Residential damage in Biloxi, Mississippi. Masonry components survived. (Photo credit: Thomas B. Rodino, Shiner Moseley and Associates, Inc.)

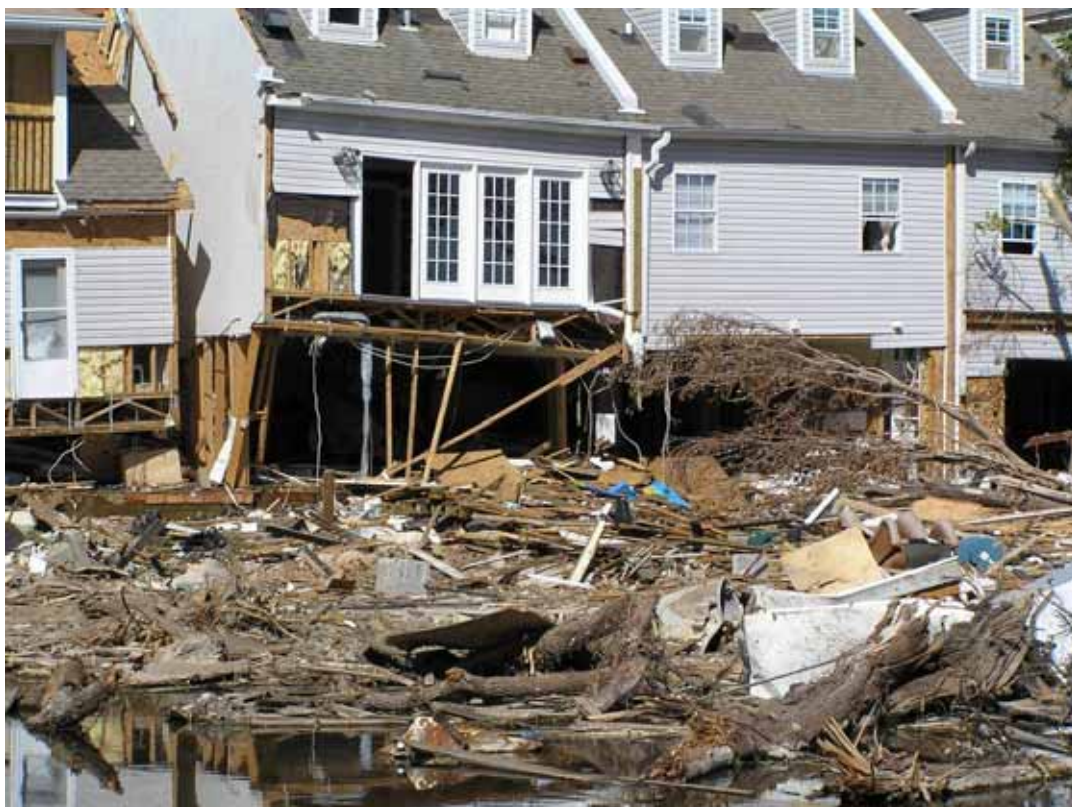
Figure 5-4 Severe damage and destruction to townhomes in Gulfport, Mississippi. (Photo credit: NIST)

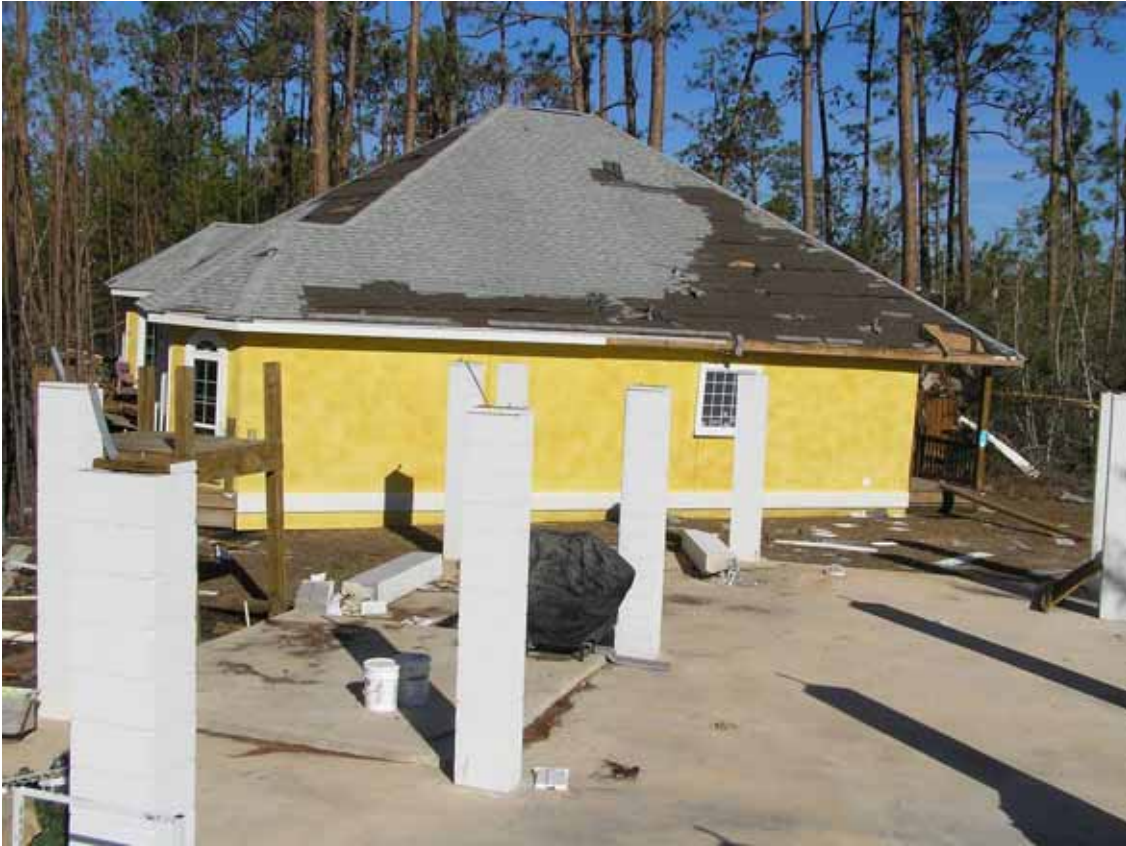
structure survival, but infill wood framing was completely destroyed in many cases where storm surge elevation exceeded first floor elevation. One such example is shown in Figure 5-8.

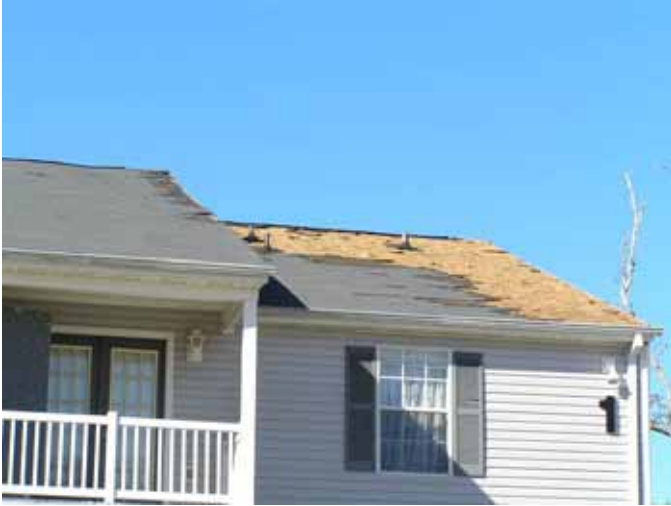
Figure 5-18 Loss of three-tab asphalt shingles where the underlayment was lost along with the shingles in New Orleans. Note the bare deck on the right. For many of the homes having damaged shingles, the underlayment or a previously installed shingle layer was in place, which may provide secondary backup against water penetration (photo credit: NIST).

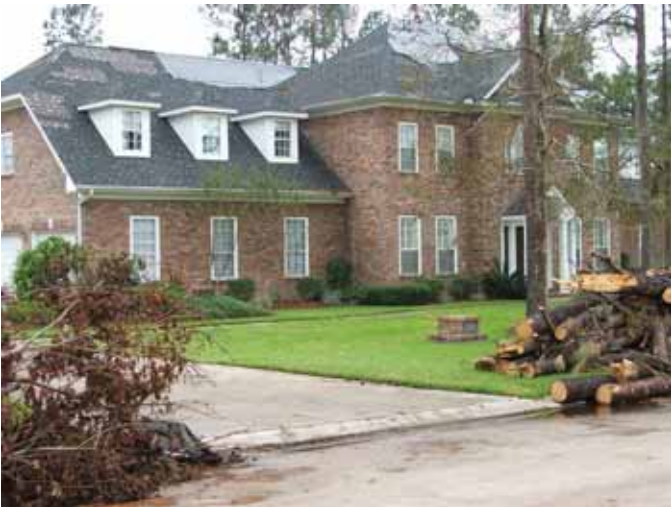
Figure 5-19 Damage to laminated asphalt shingles in Orange, TX. Shingles were temporarily repaired with tarps and roofing felt. No shingle debris was found throughout this and many other neighborhoods. (Photo credit: Dominic Sims, International Code Council)

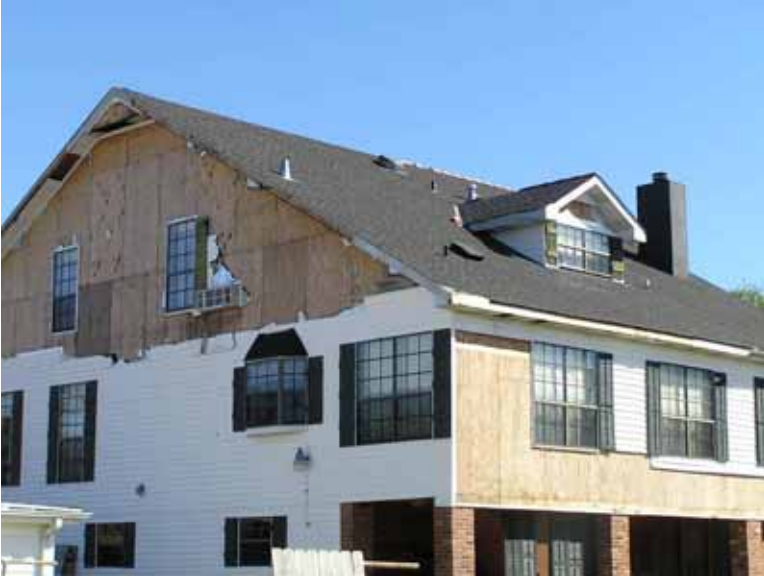
Figure 5-20 Damaged home where laminated asphalt shingles were intact; in contrast, considerable damage to vinyl siding and fascia boards occurred. This observation was not typical. In many cases and particularly in the Hurricane Rita impacted areas, homes not damaged by fallen trees, storm surge, or flooding often only sustained loss of roof coverings. Wall claddings, doors, and windows were often undamaged. (Photo credit: Robb Smith, Amtech Roofing Consultants)

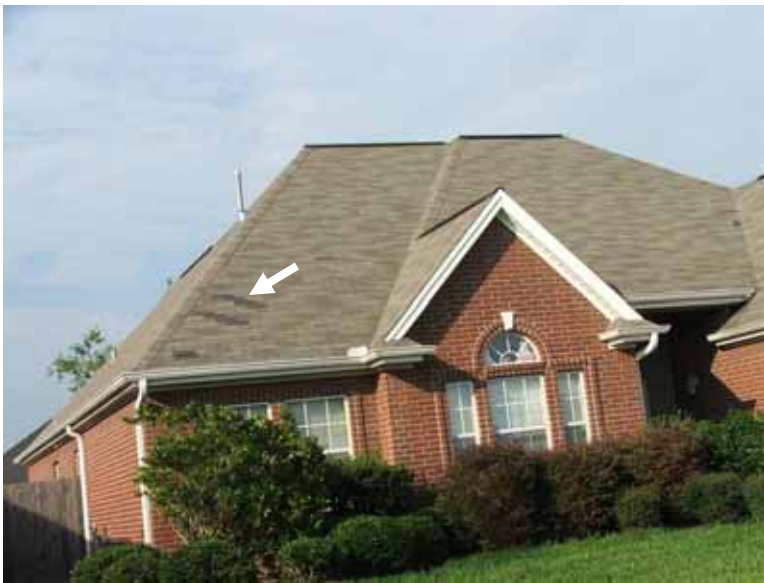
Figure 5-21 Limited damage (arrow) to relatively new three-tab asphalt shingles in Port Arthur, TX. (Photo credit: Dominic Sims, International Code Council)

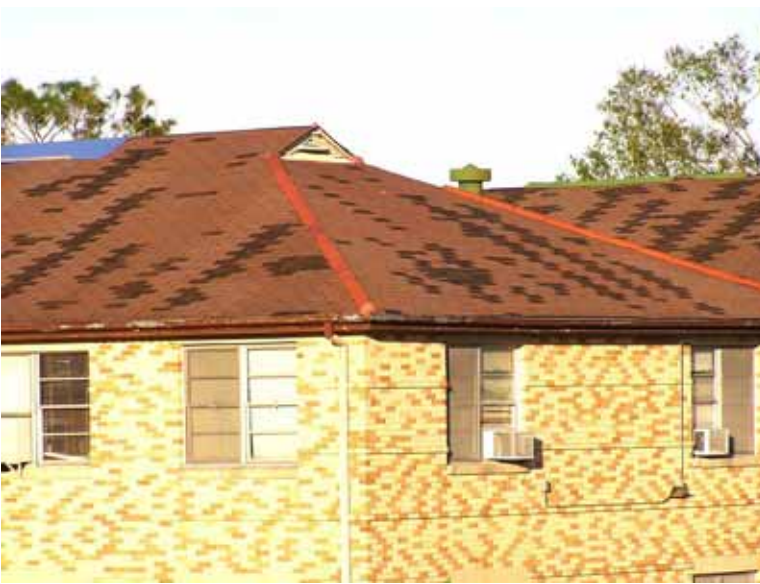
Figure 5-22 Damage to older three-tab asphalt shingles wherein approximately 40 percent to 50 percent of the shingles were blown off the front side of the home in New Orleans. Note the vertical strips of blown-off shingles. This failure pattern is associated with applying the shingles in a process known as “racking” in which shingle are applied vertically or straight up the roof. Racked–applied shingles are susceptible to blow-off as illustrated here, and the process should not be carried out in regions susceptible to high winds. (Photo credit: Robb Smith, Amtech Roofing Consultants)

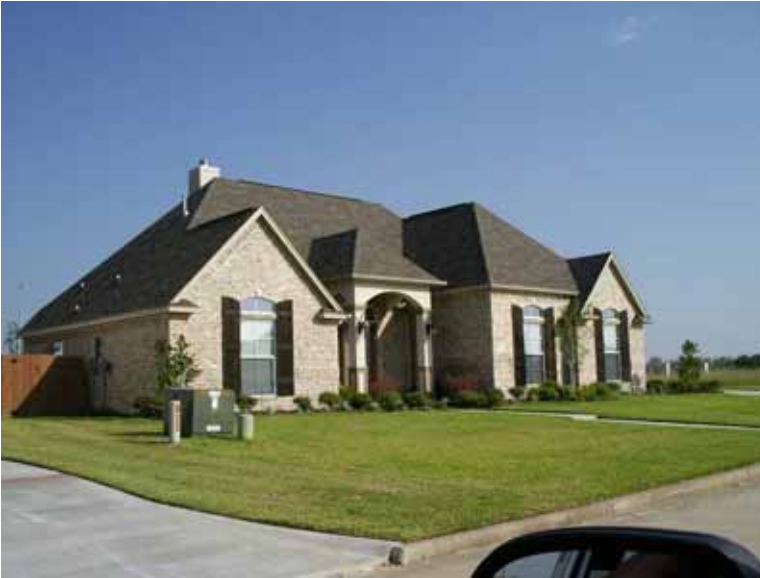
Figure 5-23 Home with undamaged laminated asphalt shingles estimated to be less than 5 years old, Beaumont, TX. (Photo credit: NIST)

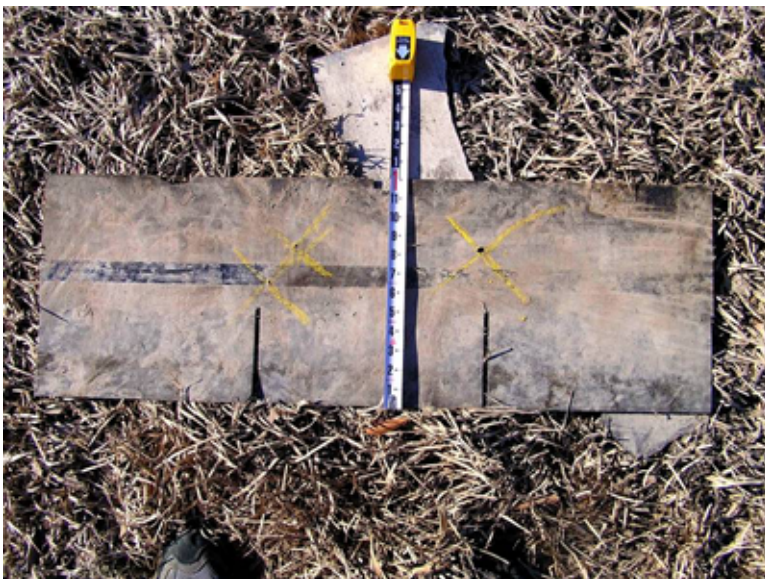
Figure 5-24 Example of a blown-off three-tab asphalt shingle that was clearly misapplied. The yellow Xs mark locations where the shingle was nailed in place. (Photo credit: Robb Smith, Amtech Roofing Consultants)

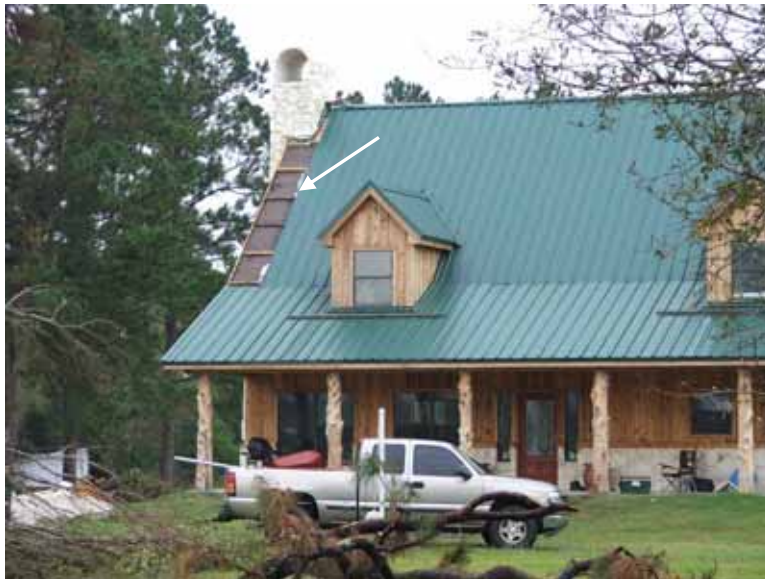
Figure 5-25 Damage to metal roofing (arrow), Orange, TX. Overall, little damage was seen to metal roofing; where seen, it was limited to a relatively small area of the covering and often along an edge of the roof. (Photo credit: Dominic Sims, International Code Council)

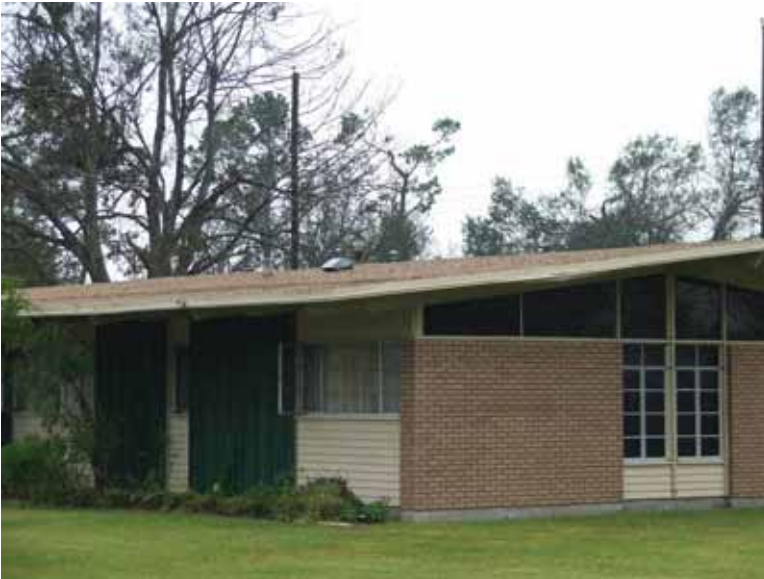
Figure 5-26 A small number of single-family, single-story homes having built-up bituminous membrane roofing (BUR) were seen. Those observed were undamaged as was the case for this house in Orange, Texas. (Photo credit: Dominic Sims, International Code Council)

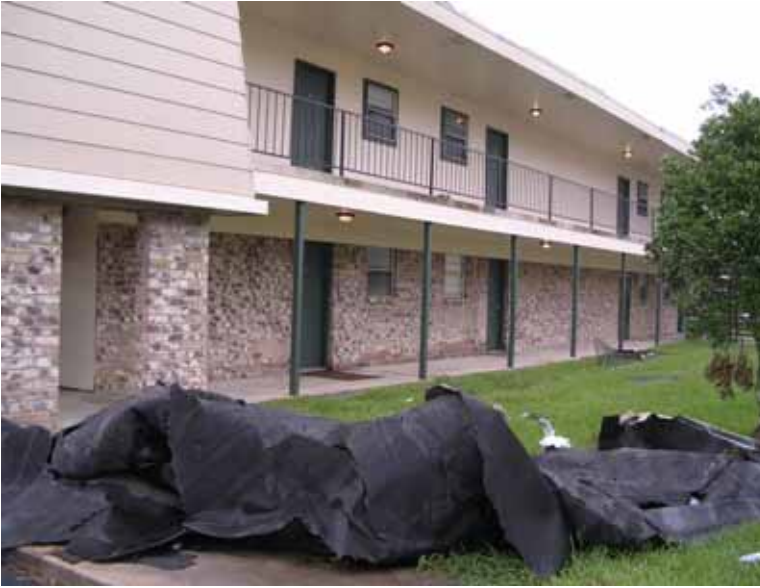
Figure 5-27 Blown-off polymer-modified bituminous membrane at an apartment complex in Orange, TX. (Photo credit: Hua He, Texas Tech University)

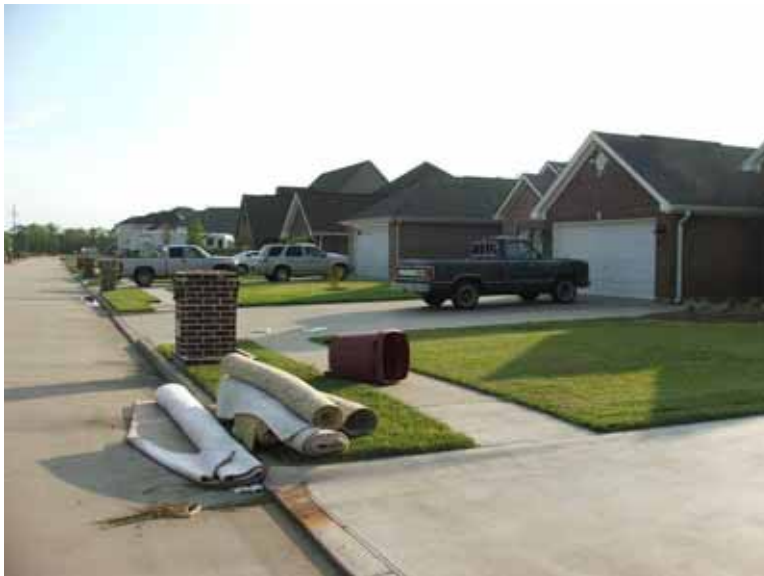
Figure 5-30 Example of water-damaged carpeting that a resident of the neighborhood reported was due to window leaks during Hurricane Rita, Port Arthur, TX. None of the houses in the neighborhood displayed damage to the exterior envelope components. (Photo credit: Dominic Sims, International Code Council)
