Reducing the Potential for Vehicle/Pedestrian Deviations (V/PD) and Runway Incursions

Federal Aviation
Administration

Office of Airport
Safety and
Standards

August 2007

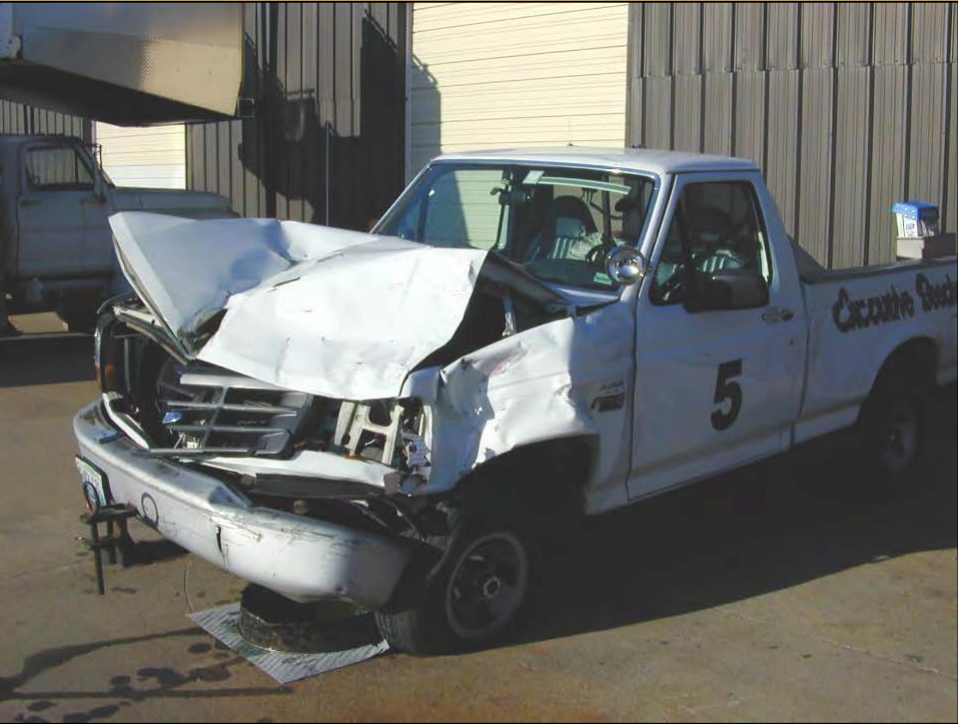
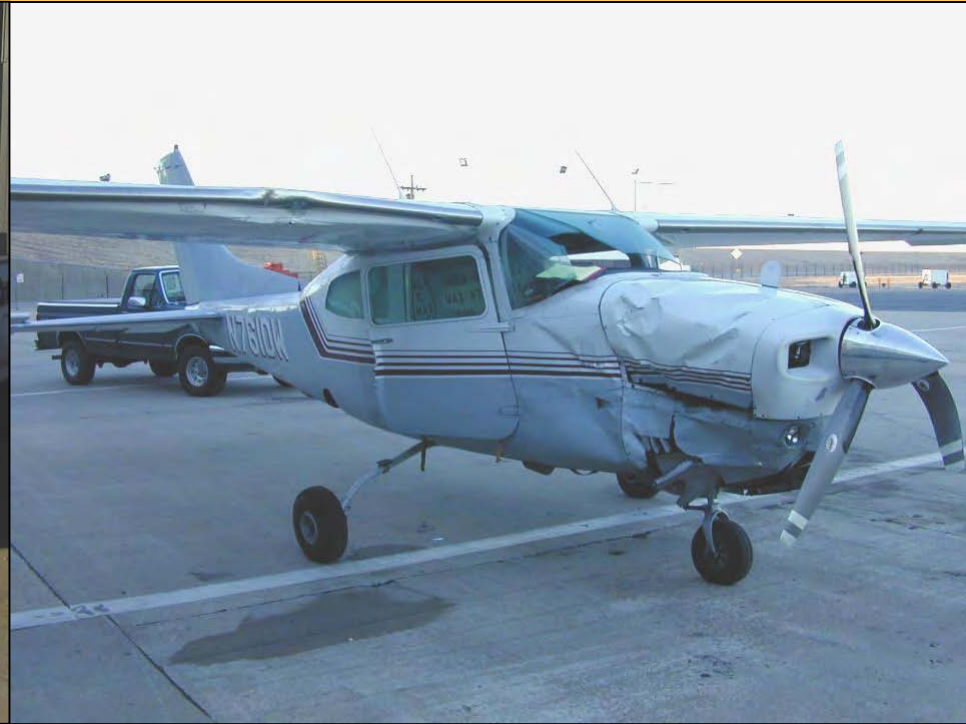
Probable speeding and lack of attention by the operator of this FBO vehicle resulted in a collision with a taxiing Cessna. This accident occurred on the apron at night

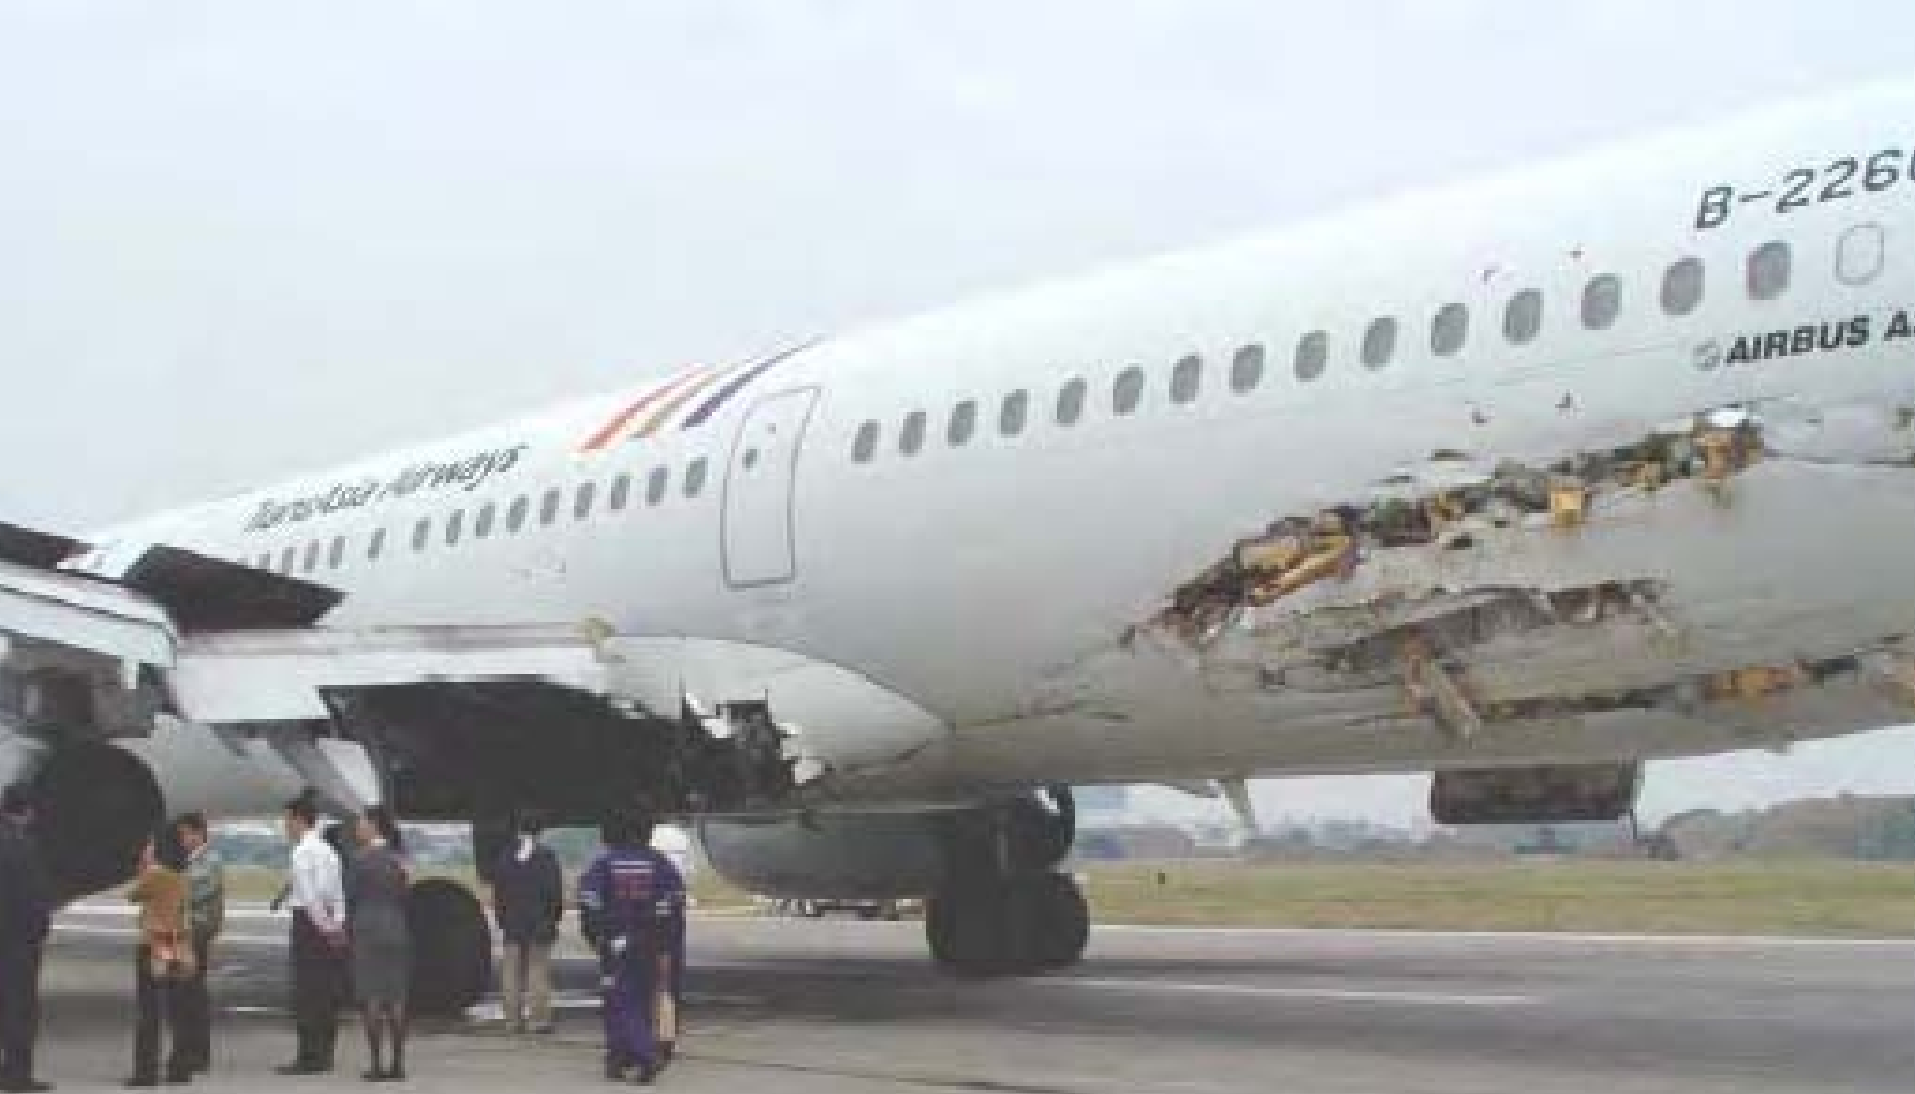
March 2003 - Taiwan. A TransAsia Airbus landed on Runway 36 at Tainan Airport and hit a maintenance vehicle on the runway. There were no injuries to the passengers and crew. The flight was late and ATC cleared the aircraft to land on the runway shortly after it was closed for maintenance activity.

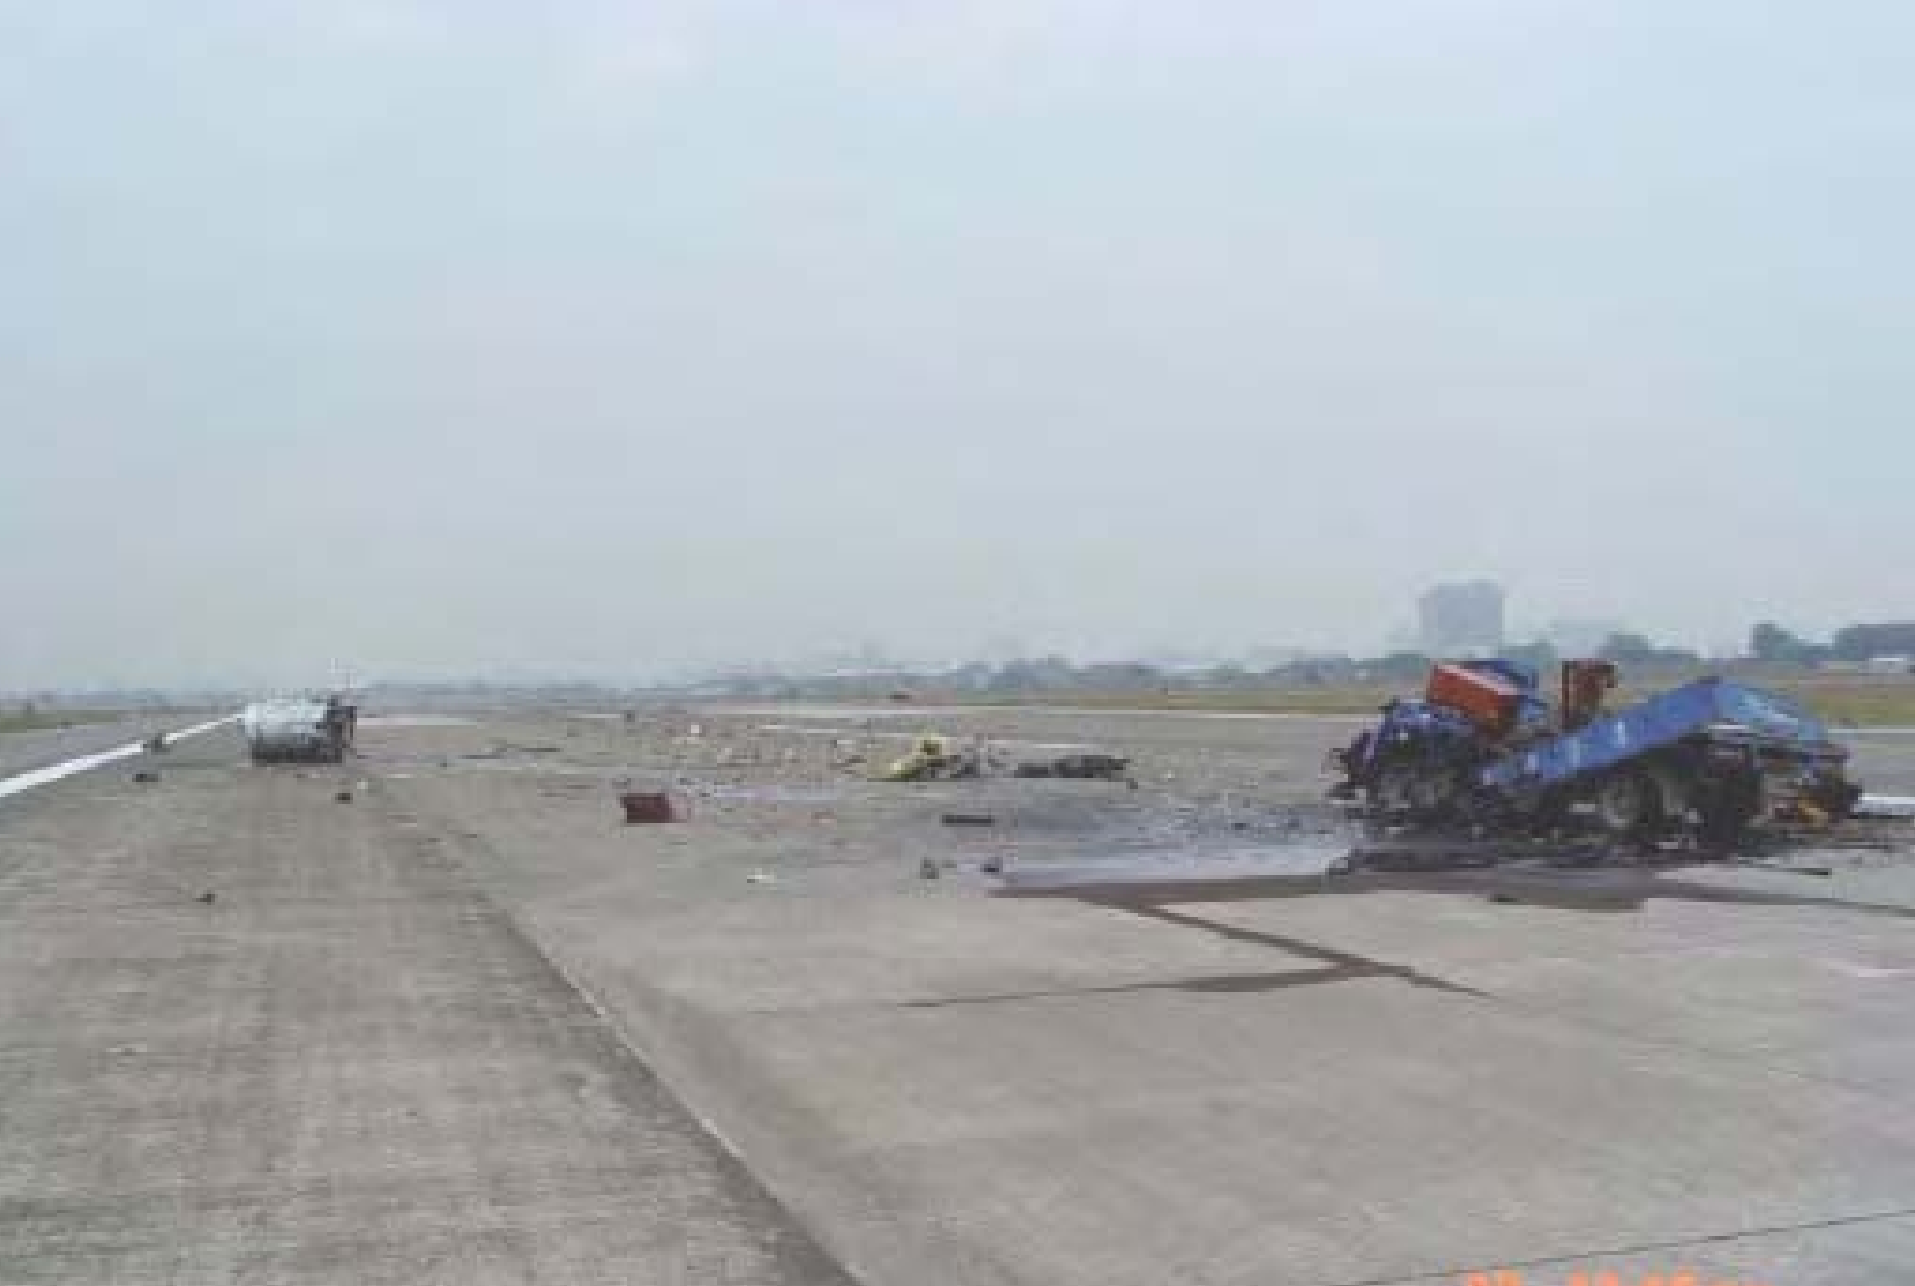
The maintenance vehicle was traveling in the direction of landing traffic and the two occupants in the vehicle failed to see the landing airliner.

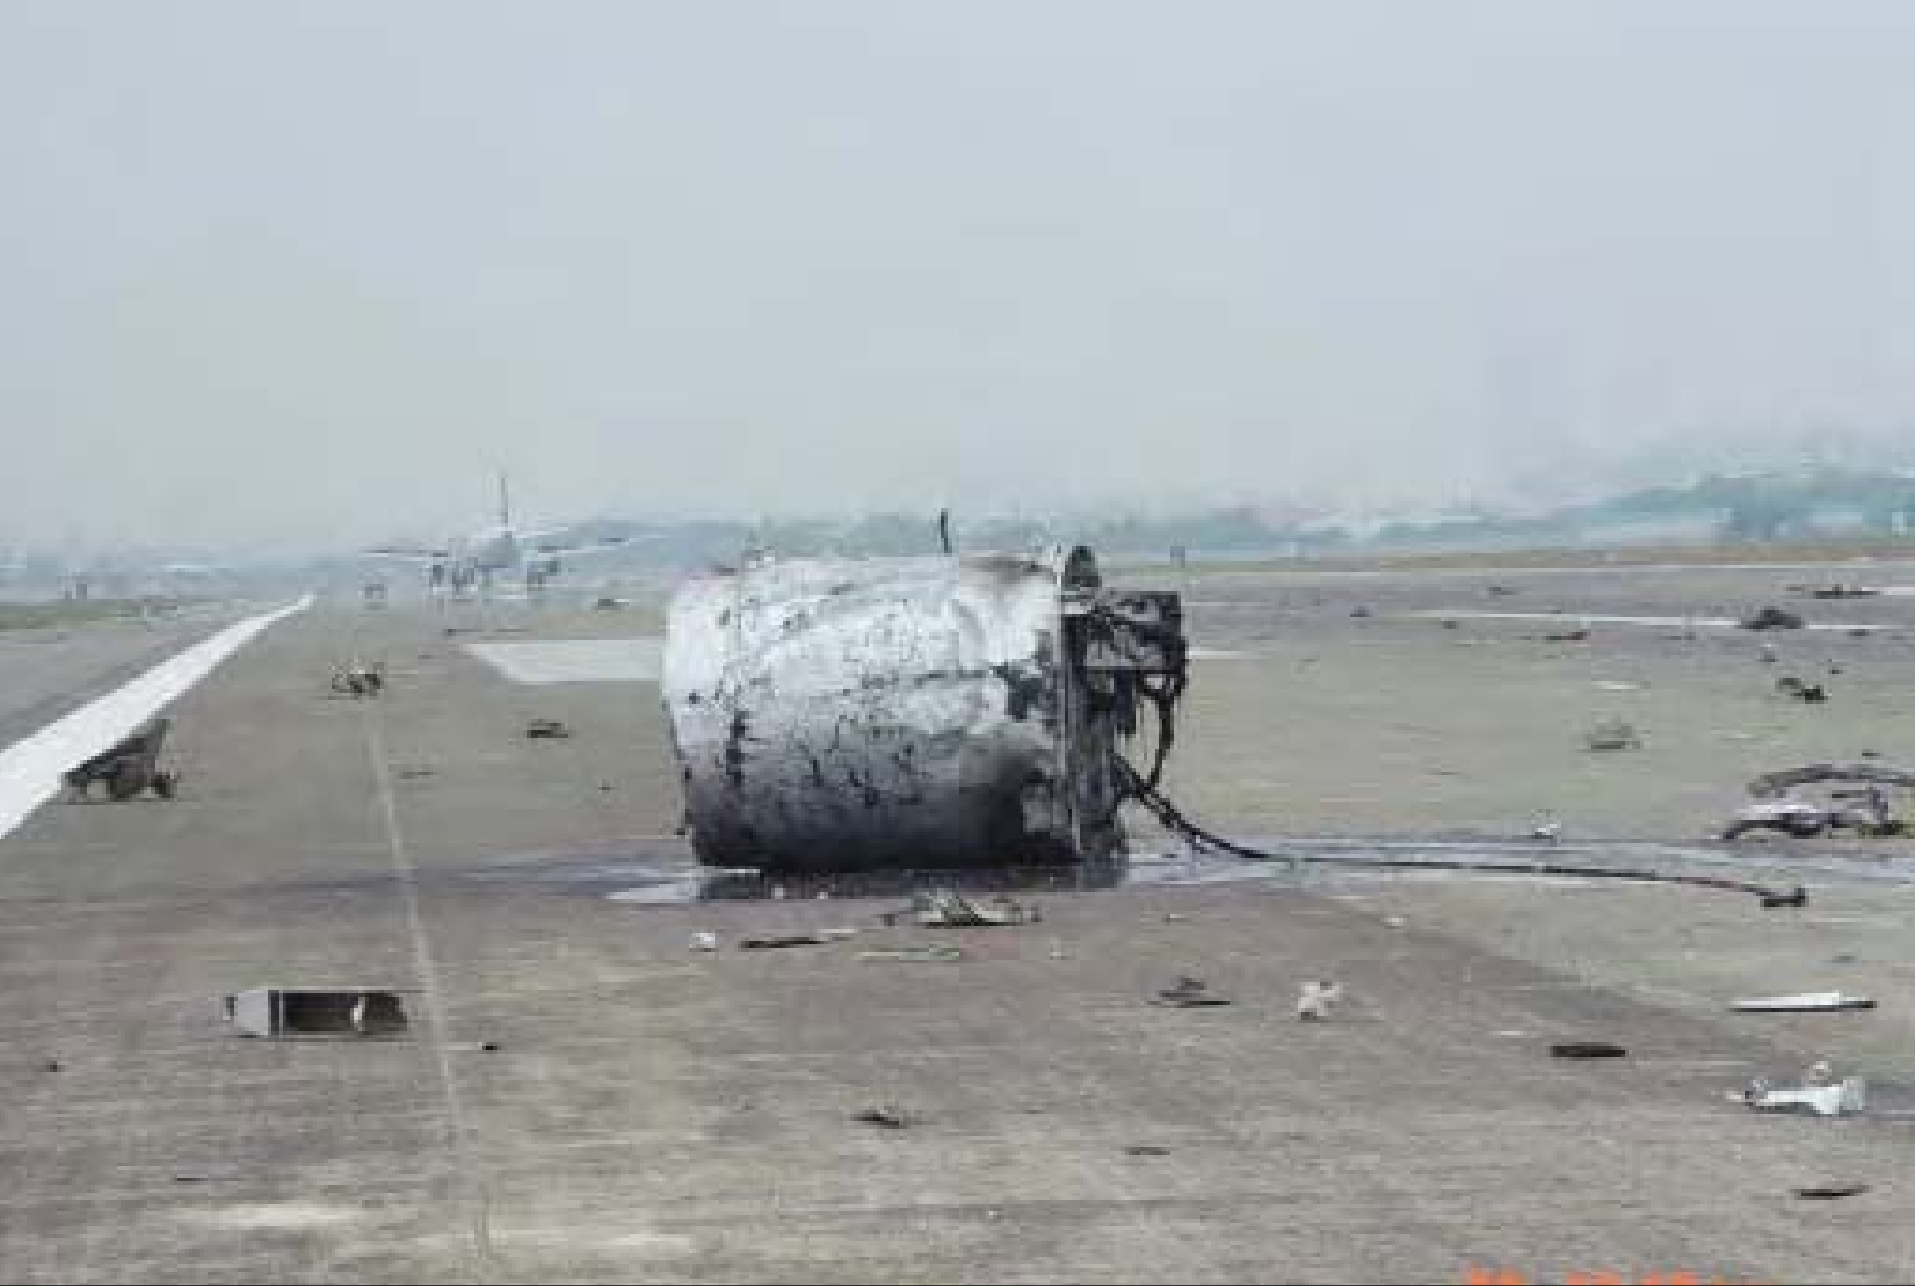
Two other vehicles were also on the runway traveling towards the landing traffic and veered off the runway to avoid a collision with the aircraft.

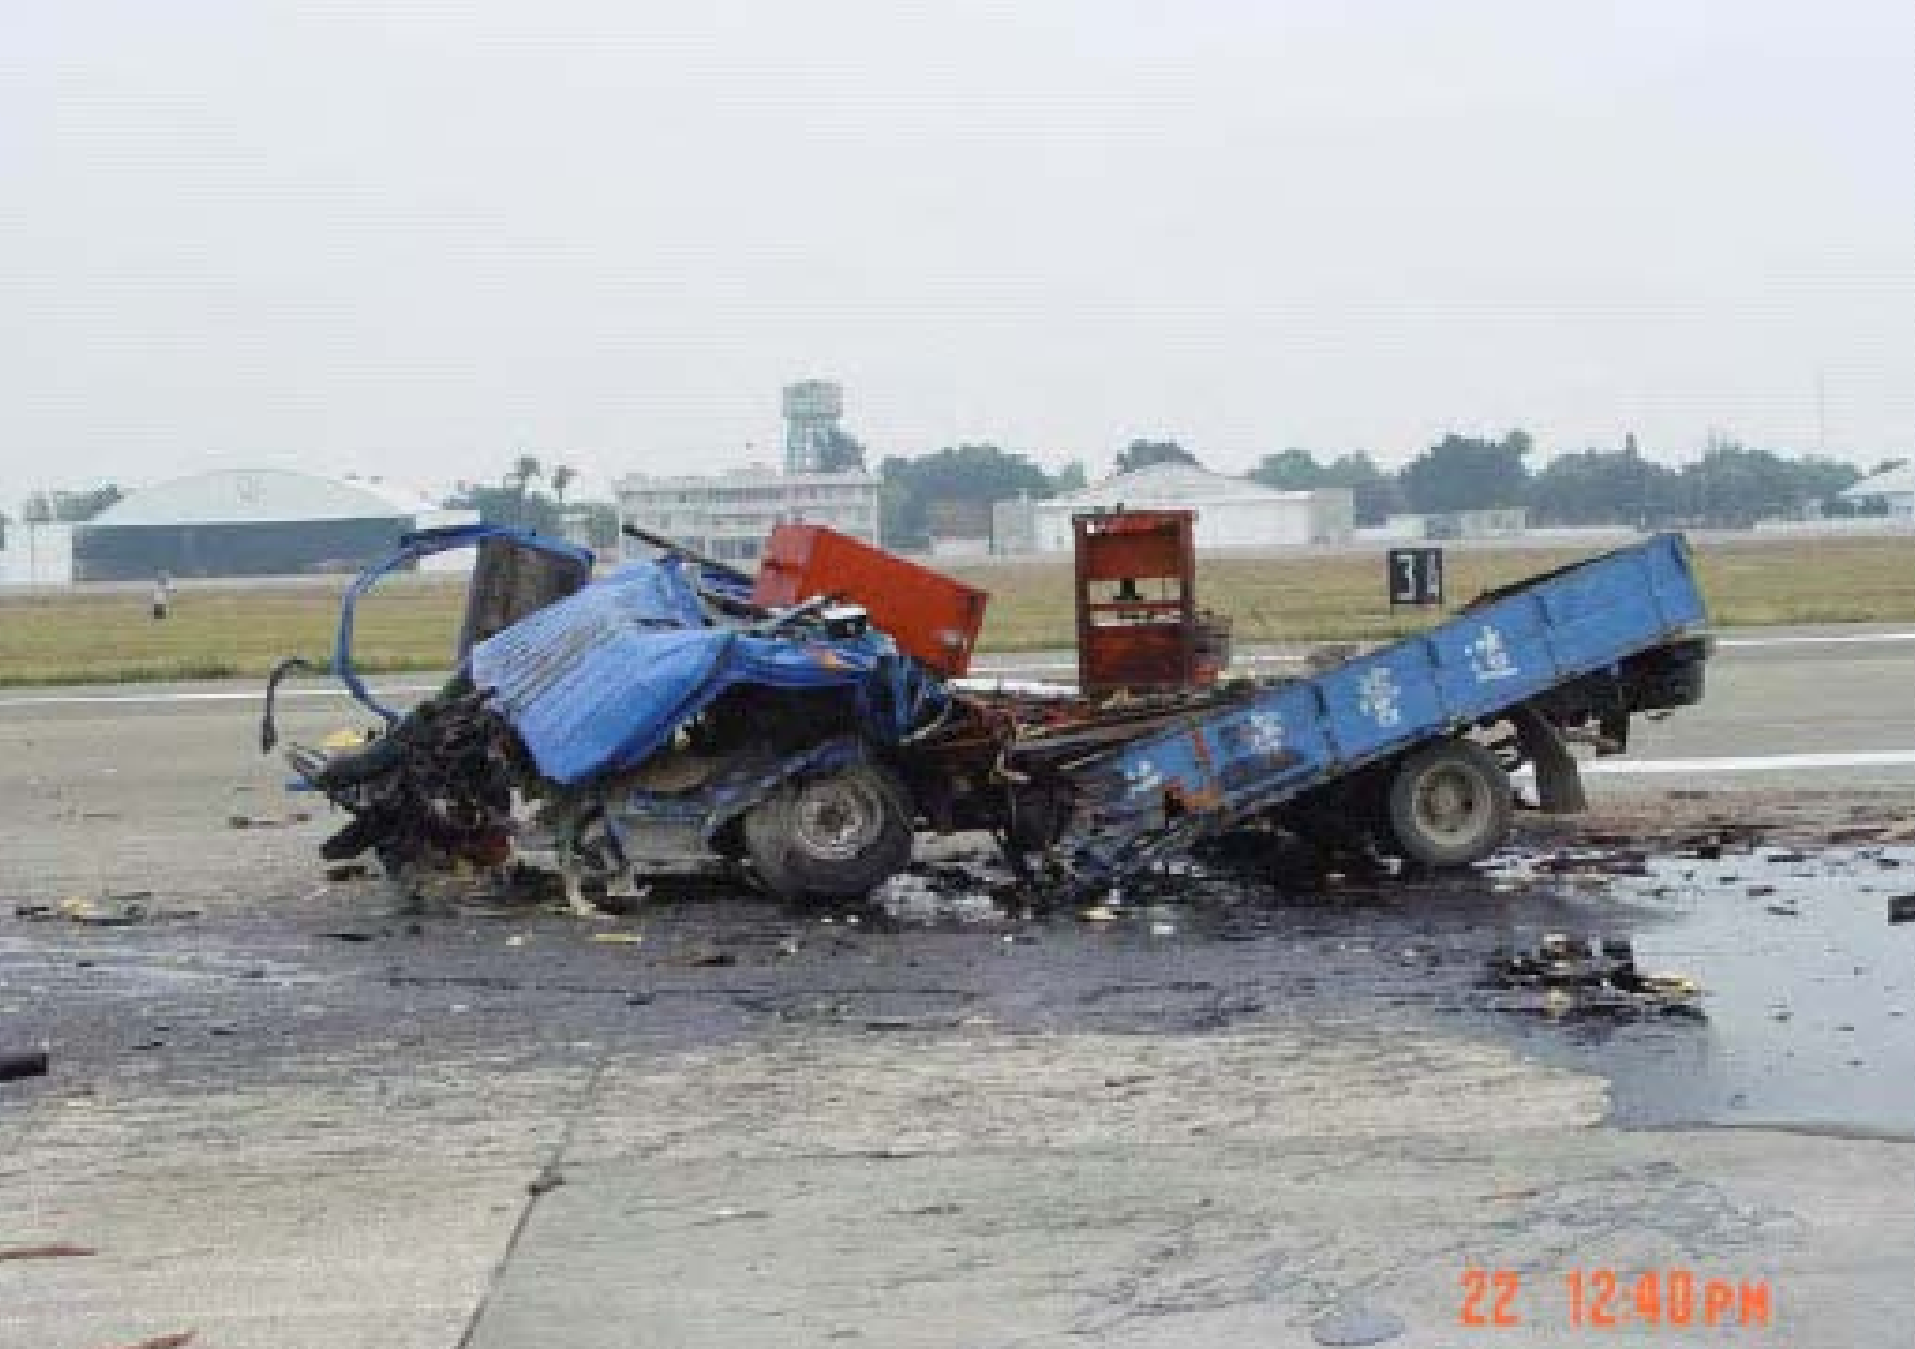
The two people in the maintenance vehicle were injured but survived.

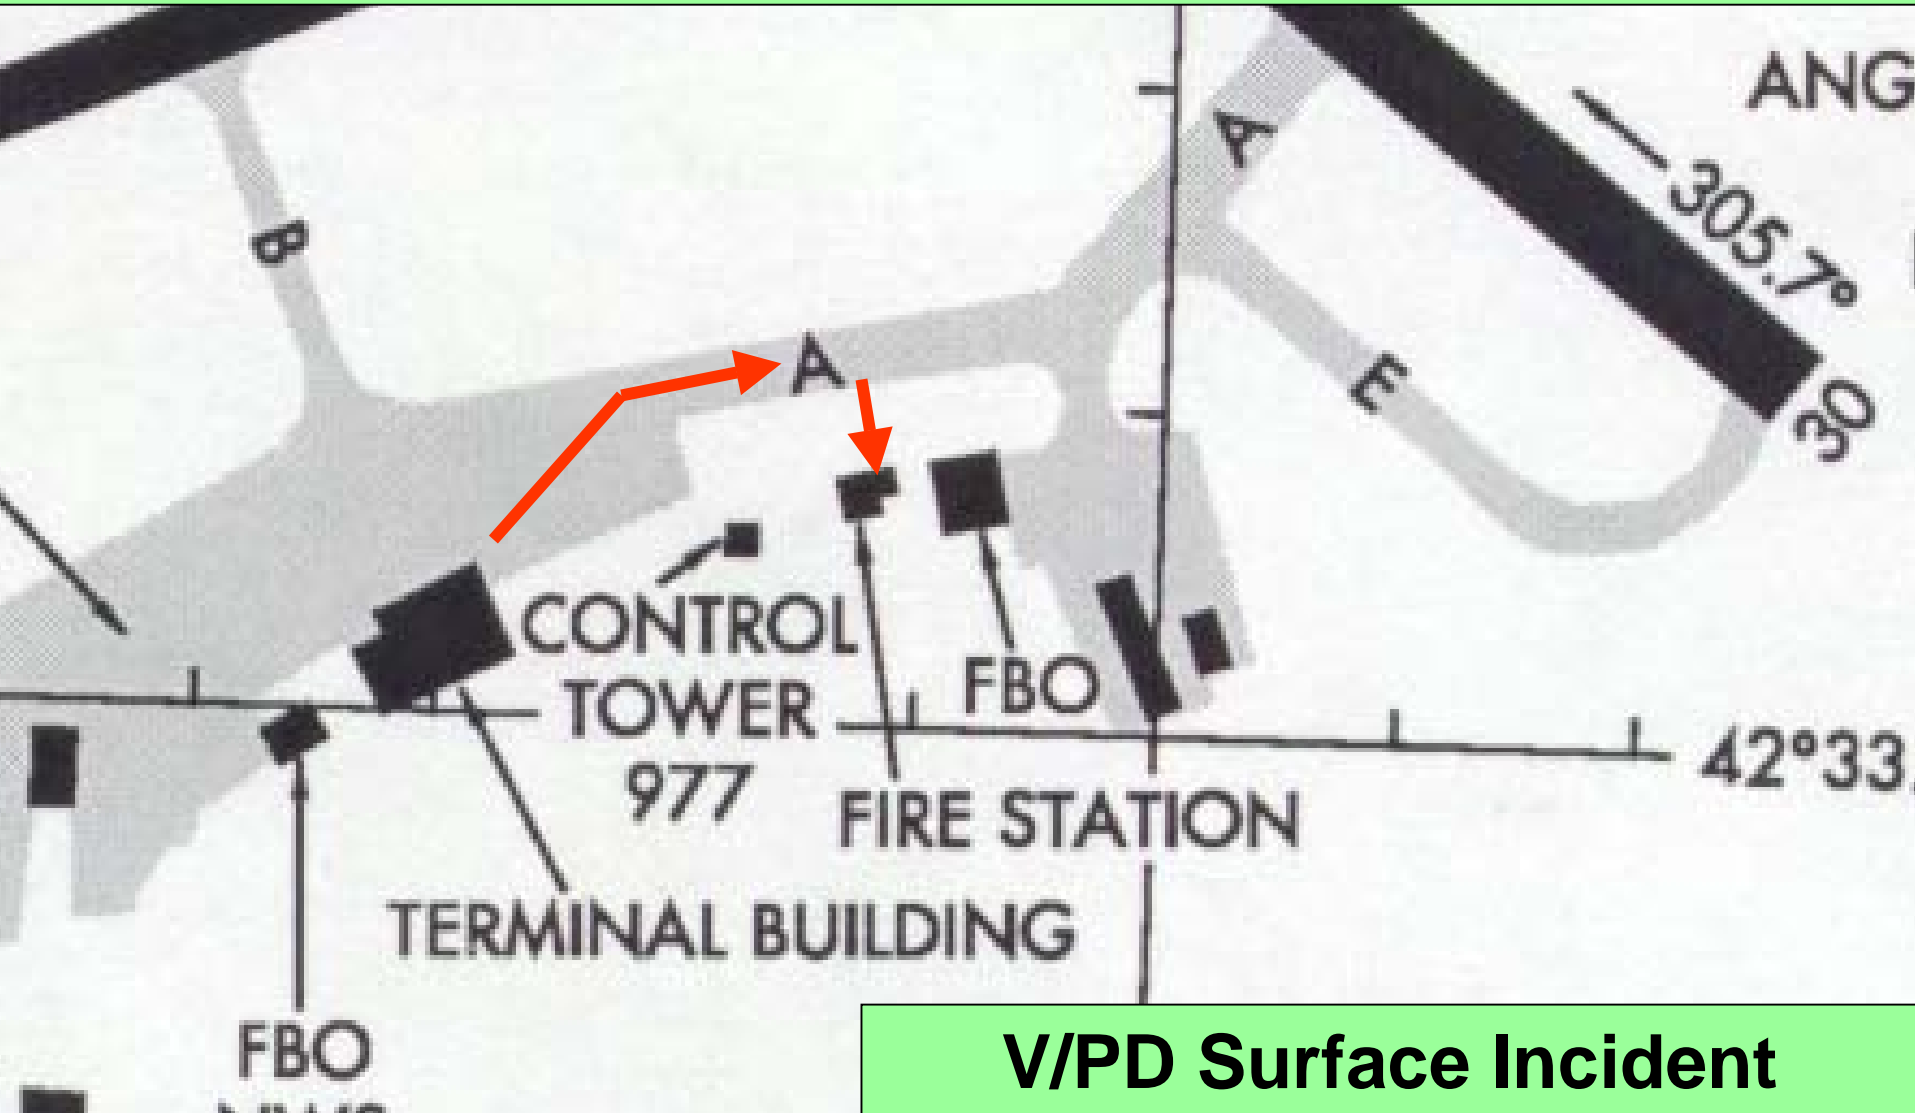
V/PD Surface Incident

Vehicle Deviation - Taxiway An airline tug and mobile stair vehicle entered Taxiway Alpha from the apron without ATCT clearance. The vehicles proceeded eastbound on Taxiway Alpha a short distance and exited at the Fire Station to pick up a handicap lift device being stored there. The tug operator stated that she did not know that she could not drive on the taxiway without ATCT clearance and had not received any training on where she could operate a vehicle.

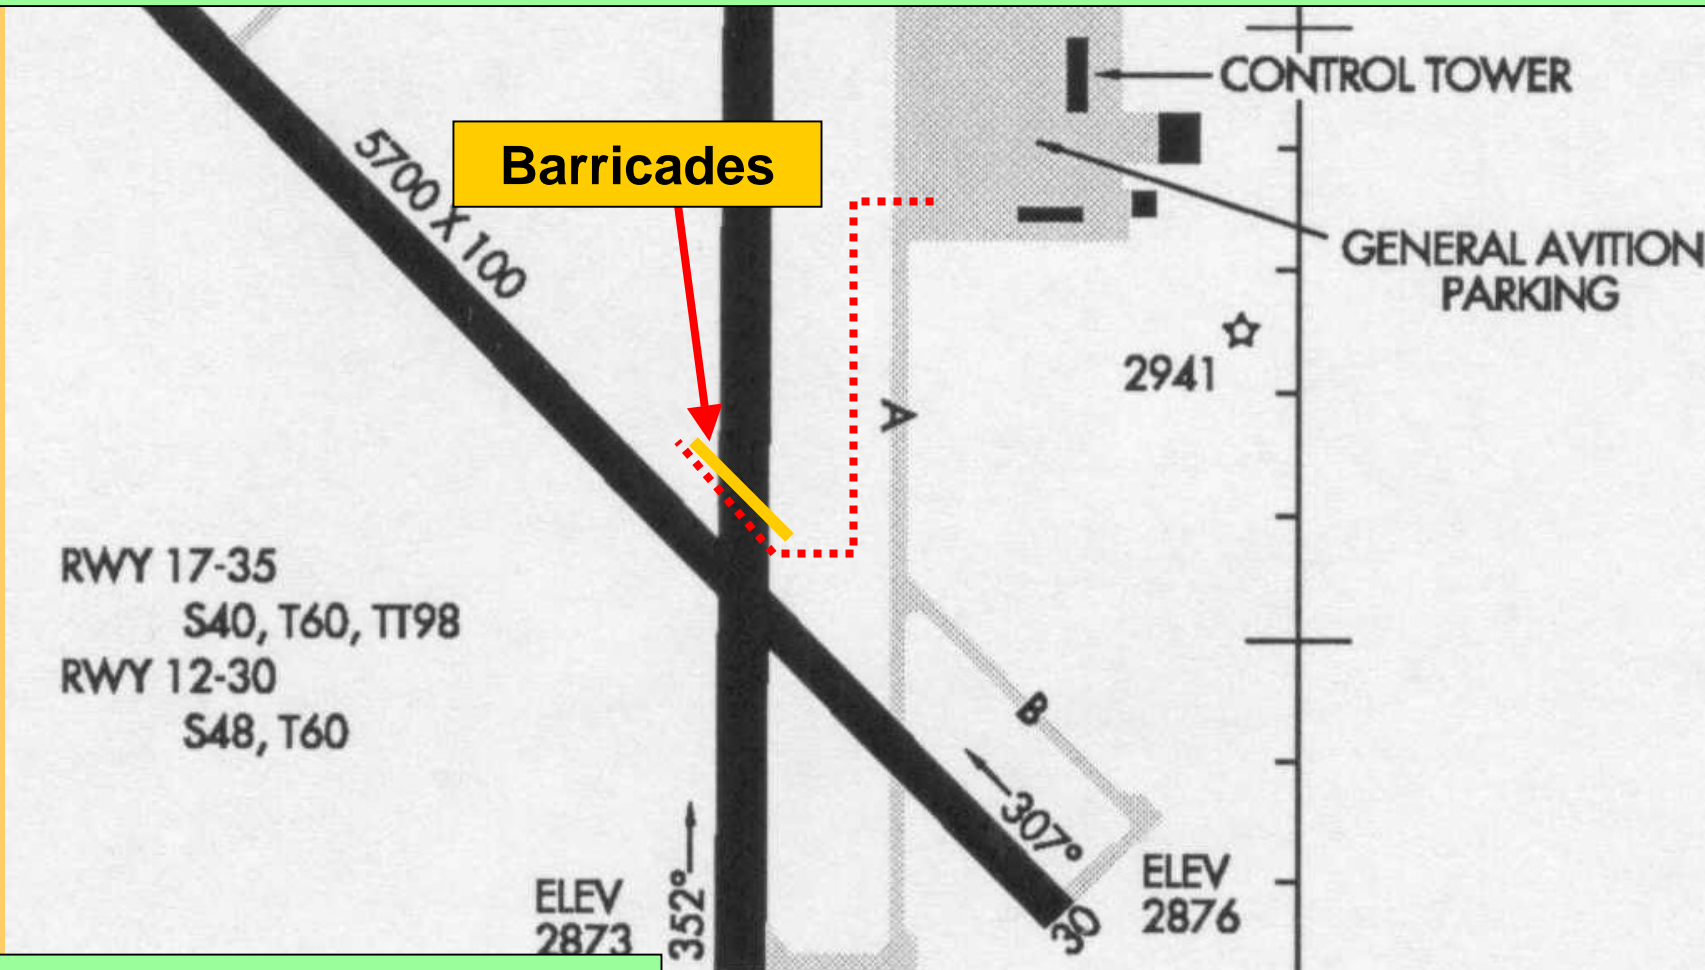
V/PD Surface Incident

Vehicle Deviation – Runway Safety Area The controller observed a black Chevy SUV proceed across the apron onto the grass infield. The vehicle then drove towards the construction area and proceeded across a closed Runway 17-35 on the 12-30 movement side of the barricades without ATCT clearance. The vehicle was an AF vehicle from another airport that was not equipped with a radio. FAA issued a Letter of Correction to the airport for the AF employee not complying with the ACM concerning training and radio equipped vehicles.

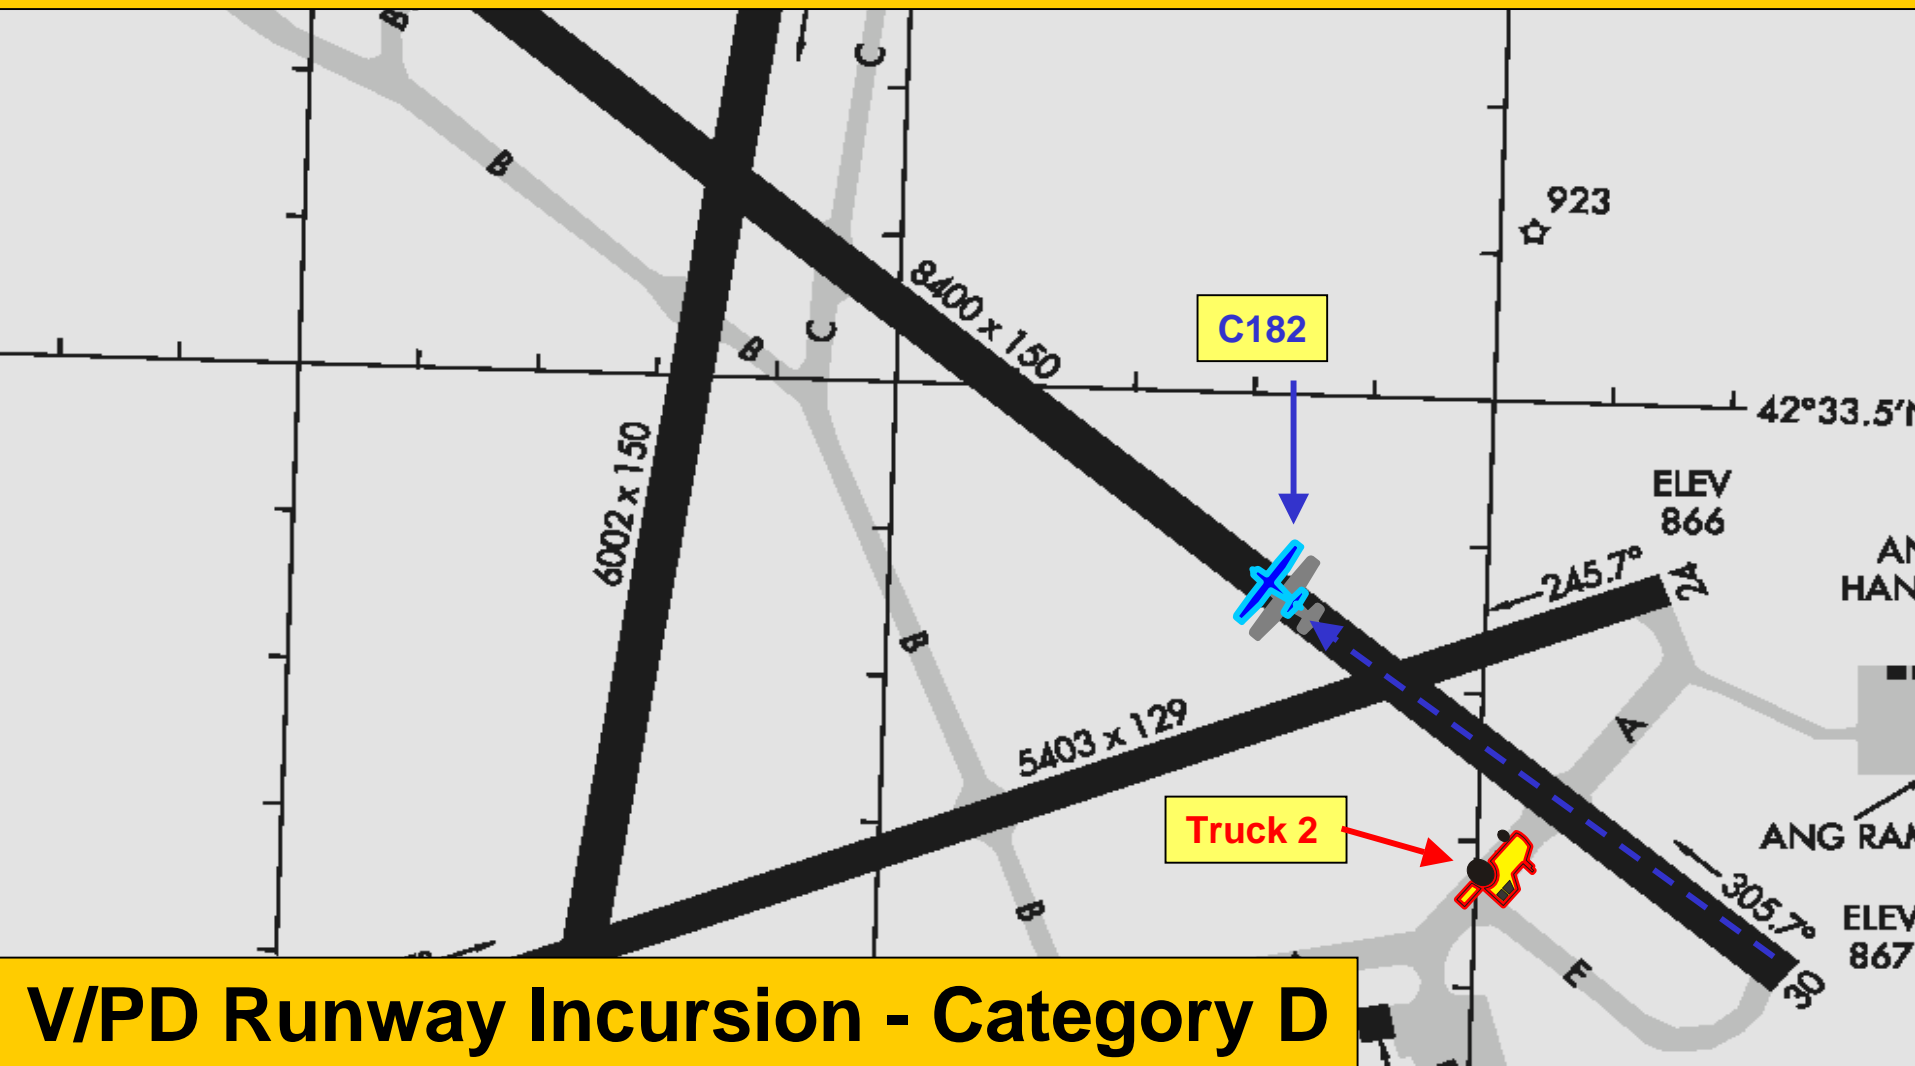
V/PD Surface Incident

Vehicle Deviation – Holdline Violation Airport maintenance Truck 2 was instructed and read back hold short of Runway 30 at Taxiway A. Truck 2 stopped at the holdline and observed a snow bank along the edge of the taxiway that he wanted to remove. The driver turned the vehicle sharply to avoid crossing the holdline and misjudged the location of the holdline, inadvertently crossing the holdline. ATCT observed Truck 2 crossing the holdline and instructed Truck 2 to back up over the hold short line. As Truck 2 was backing up, a Cessna C182, on departure Runway 30, passed abeam Taxiway A.

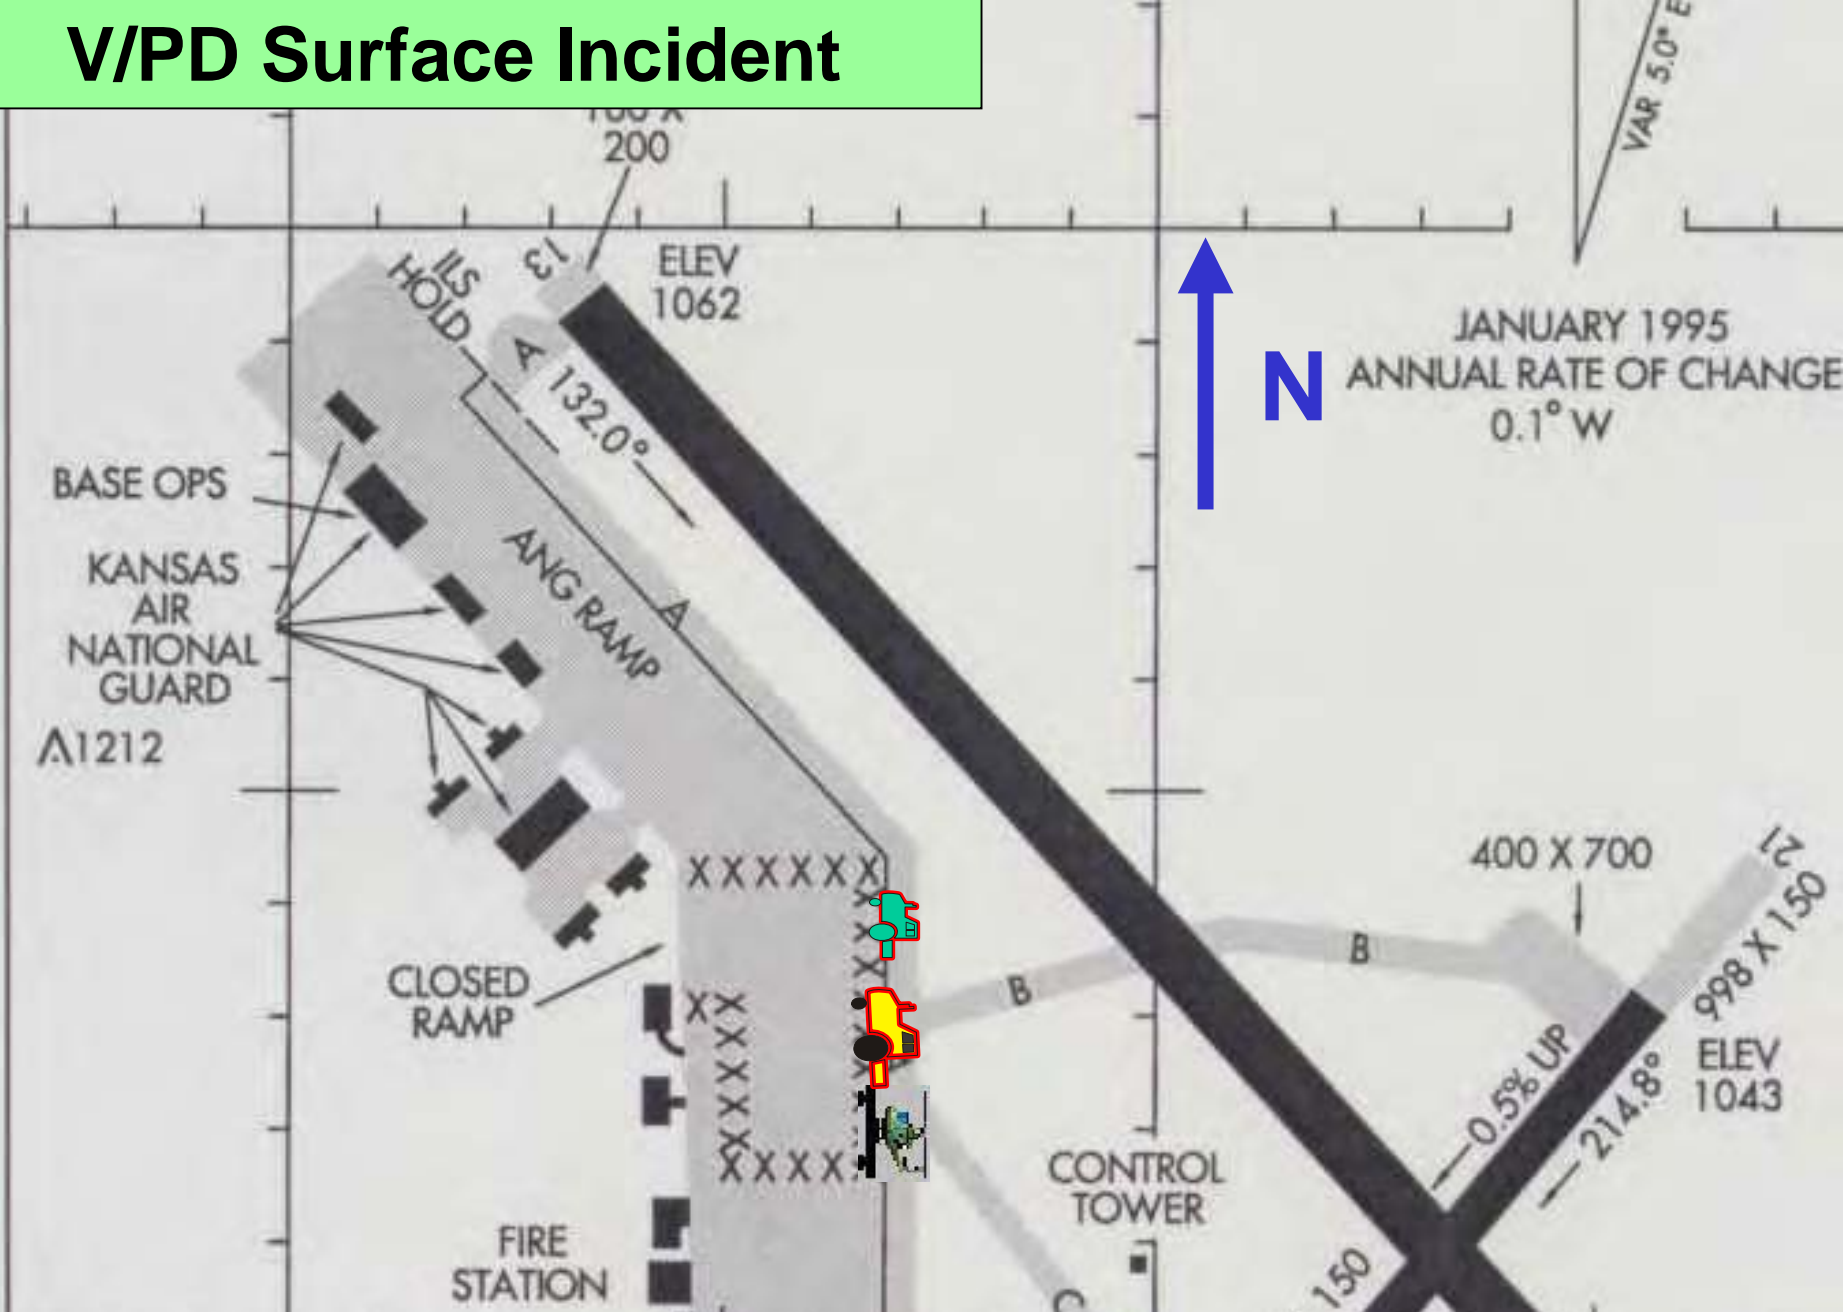
Vehicle Deviation - Taxiway A golf cart and tug towing a UH-60 Blackhawk helicopter entered Taxiway Alpha in front of the tower and proceeded north without ATCT clearance.

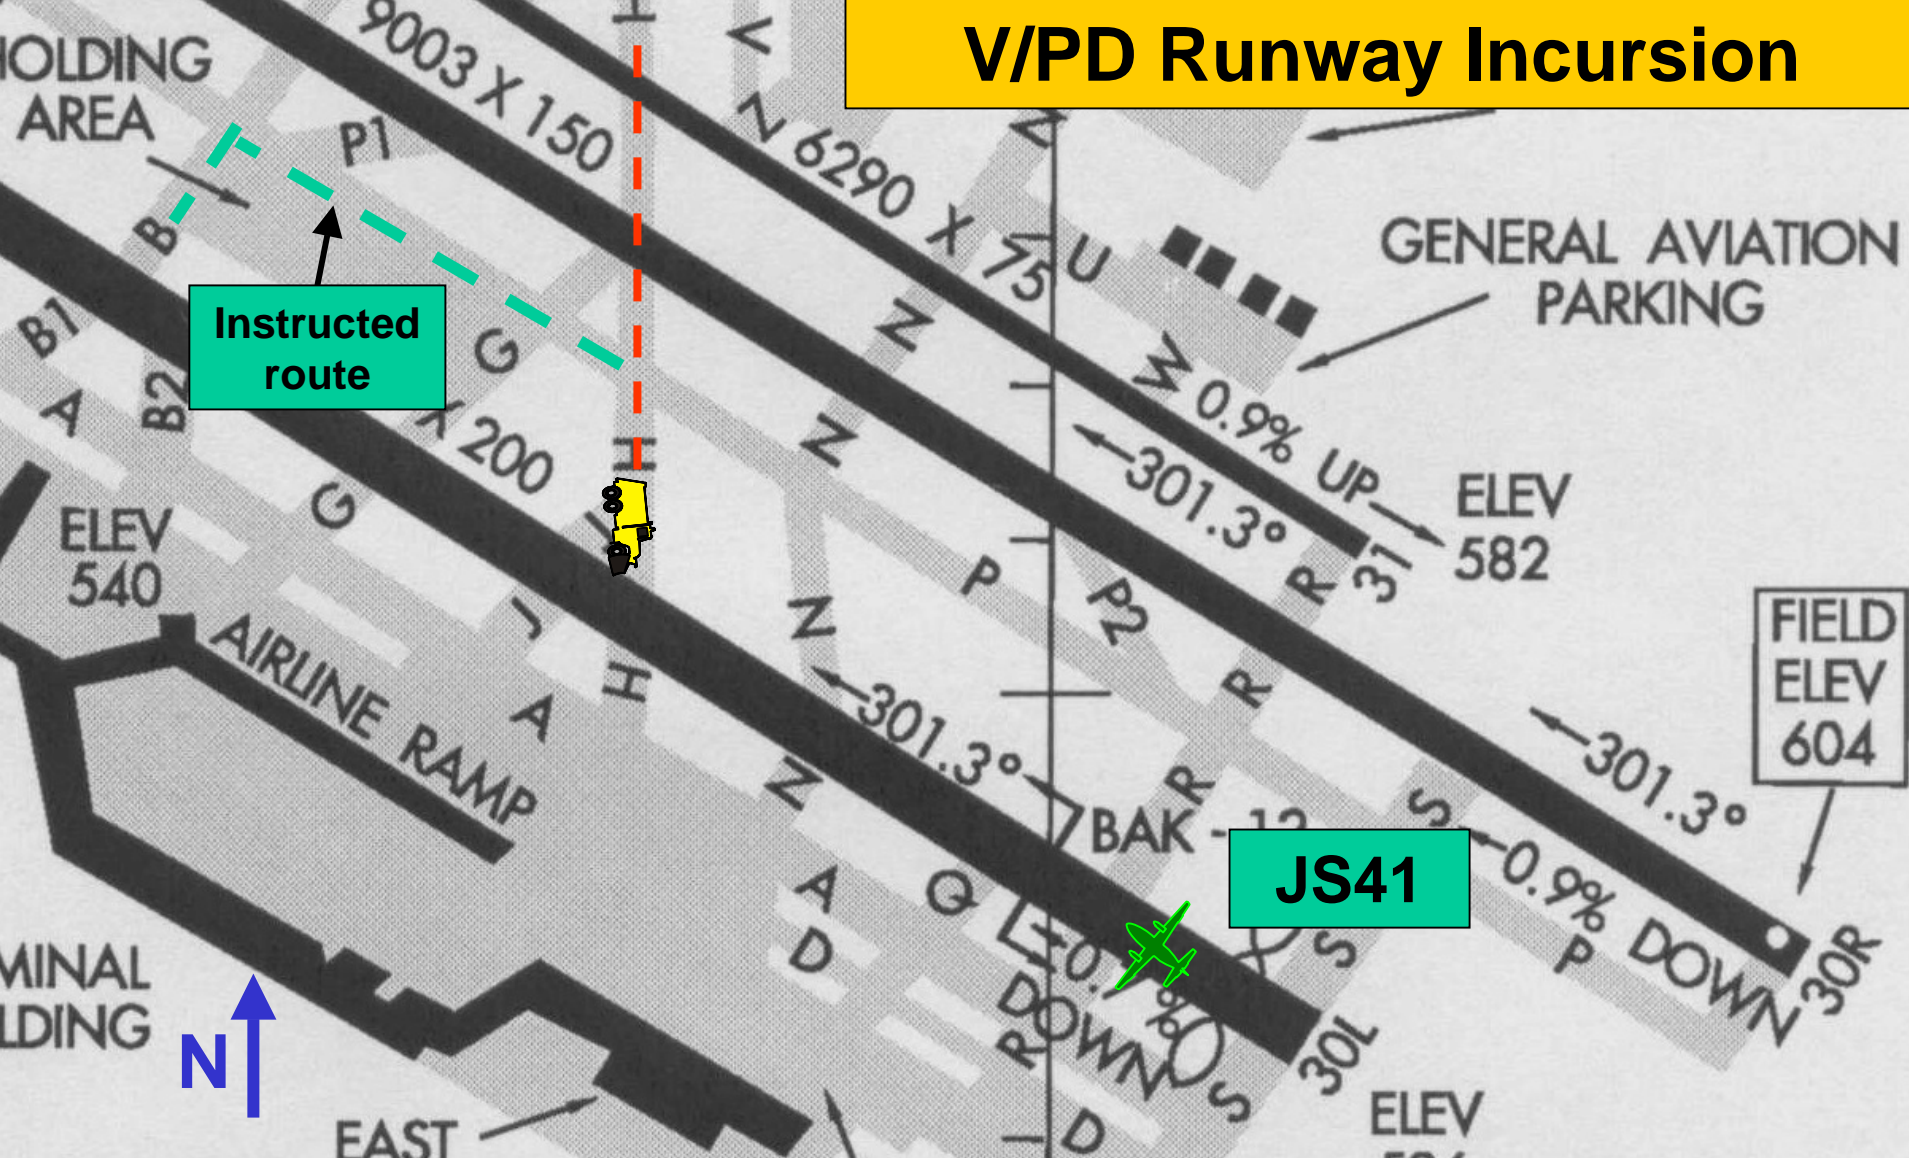
Vehicle Deviation – Holdline Violation Ground Control instructed Truck 46 (ARFF Vehicle) to cross 30R, turn right on Papa and hold short 30L on Taxiway Bravo. Truck 46 crossed 30R but failed to turn right on Papa and crossed the hold short line for Runway 30L at Hotel. A Jetstream 41 cleared for take-off 30L rolled about 2,400 feet and turned off at Romeo after Local Control cancelled take-off clearance.
