Reducing the Potential for Vehicle/Pedestrian Deviations (V/PD) and Runway Incursions

Federal Aviation
Administration

Office of Airport
Safety and
Standards

August 2007

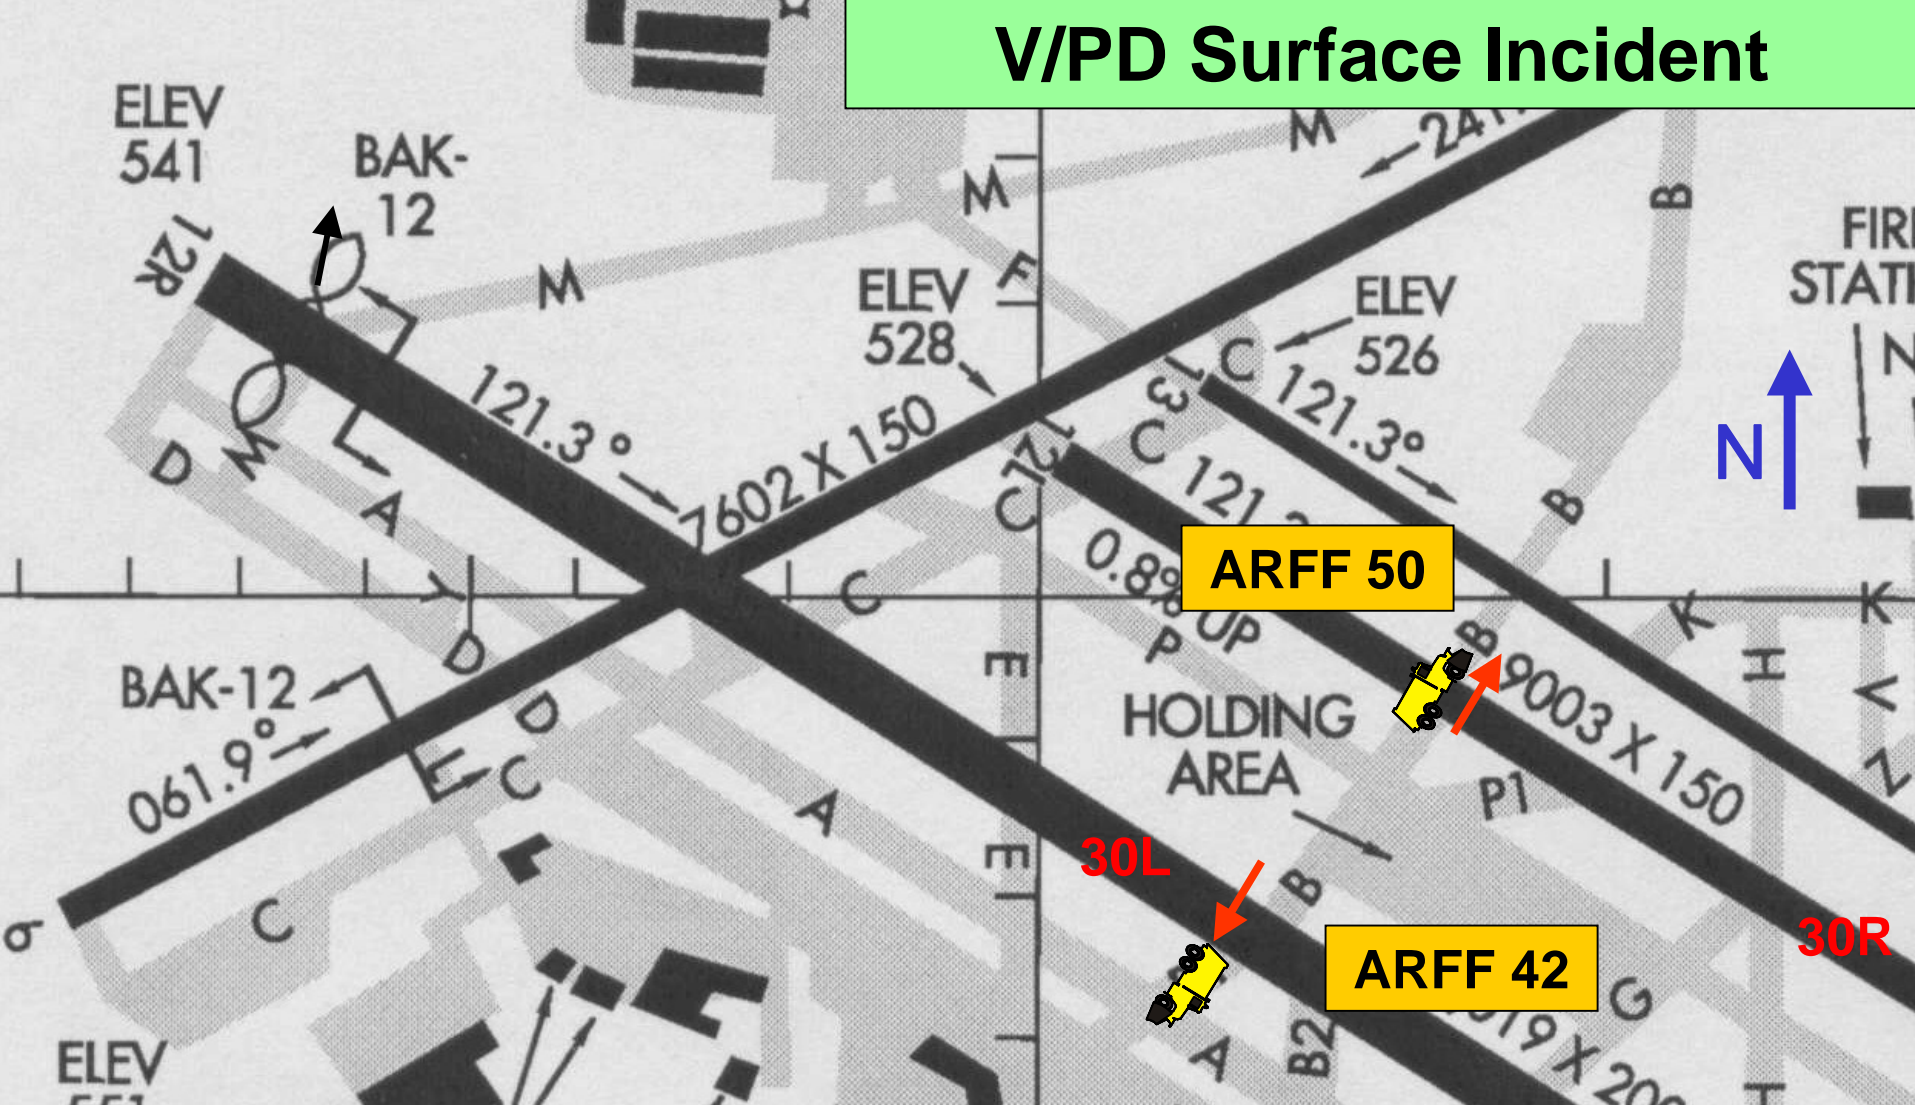
Vehicle Deviation - Runway GC instructed southbound ARFF 42 to hold short 30R at Bravo. ARFF 50 requested to drive from south side to Main Fire House. GC instructed northbound ARFF 50 to cross 30L and hold short 30R at Bravo. GC instructed ARFF 42 to cross 30R. GC then instructed ARFF 42 to cross 30L and 24 to Field Maintenance. ARFF 50 was then observed crossing 30R without ATCT clearance. ARFF 50 was then observed stopping in the middle of 30R and backing up. A C-501 on 1 ½ mile final was sent around.

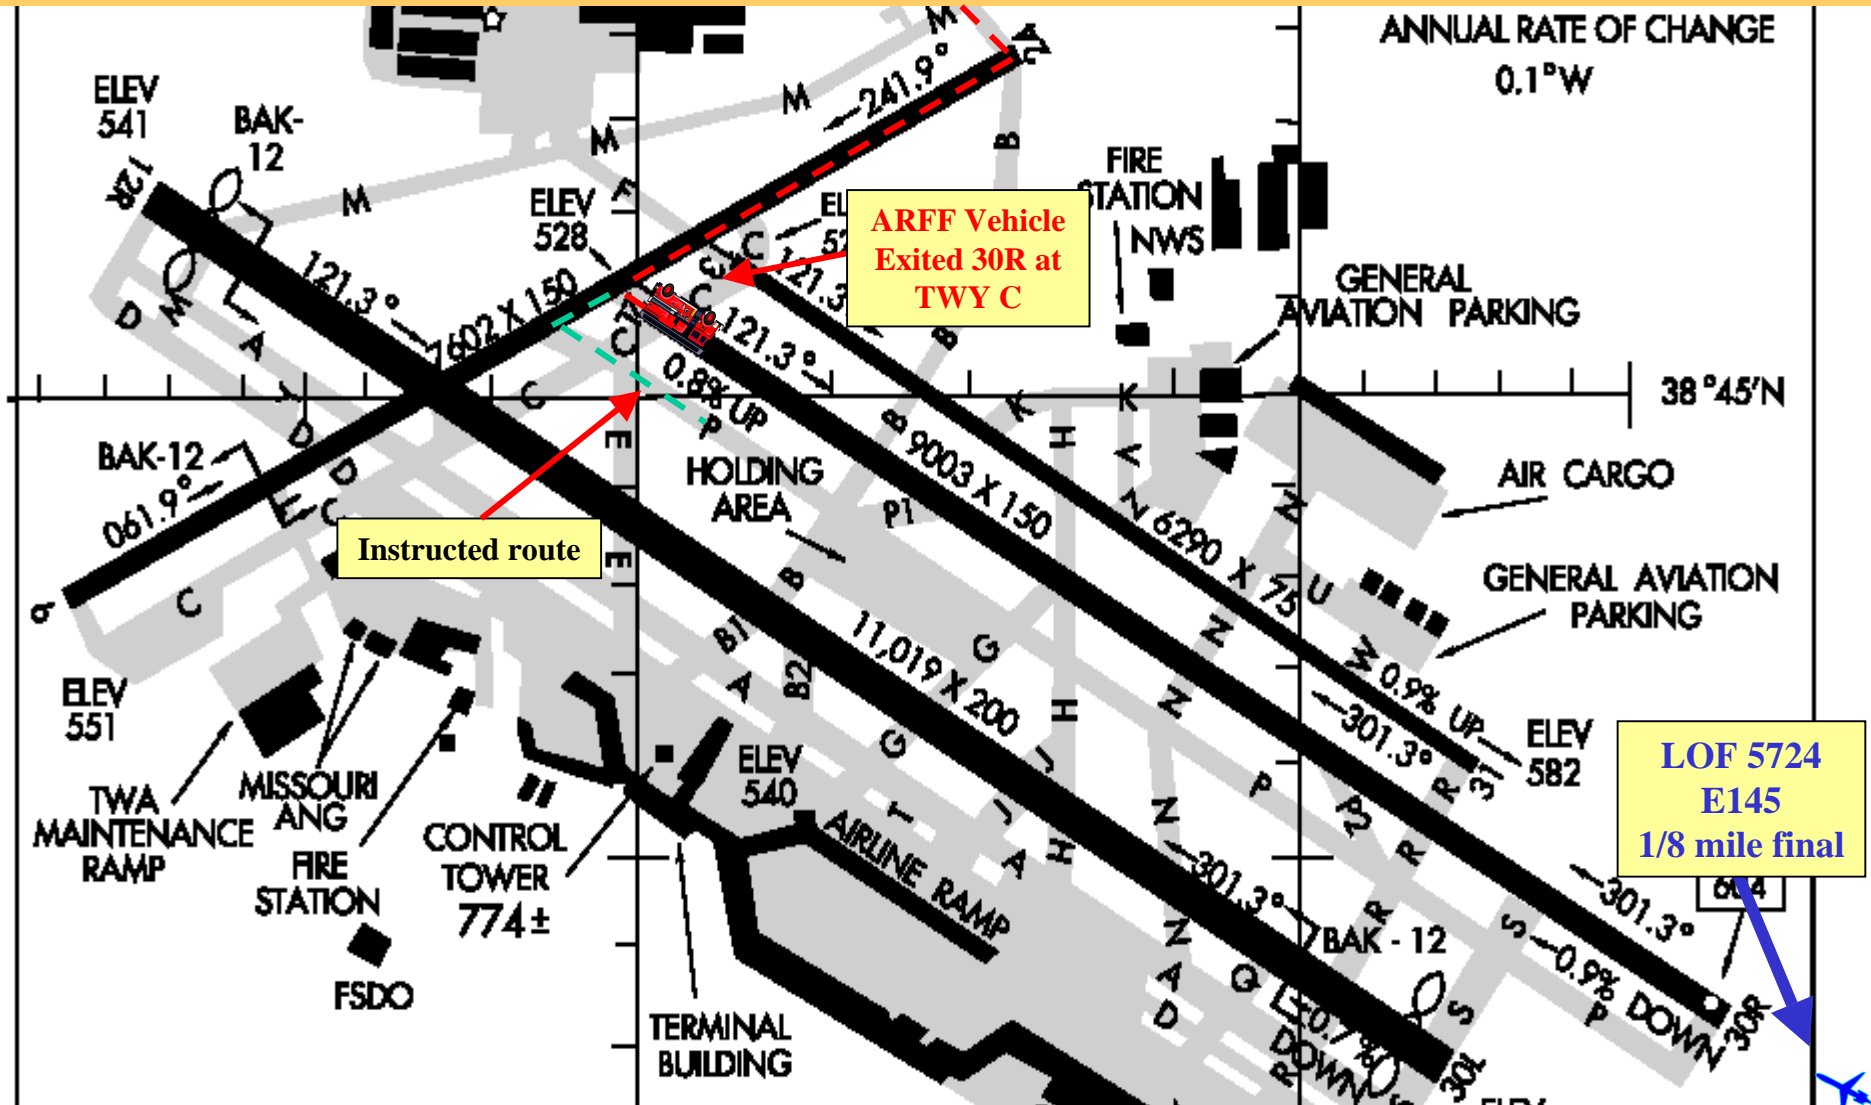
Vehicle Deviation - Runway ARFF 45 was cleared on Rwy 24 and instructed to exit Taxiway Papa. ARFF 45 instead exited onto the departure end of Rwy 30R while E-145 regional jet was on short final. The E-145 was sent around.

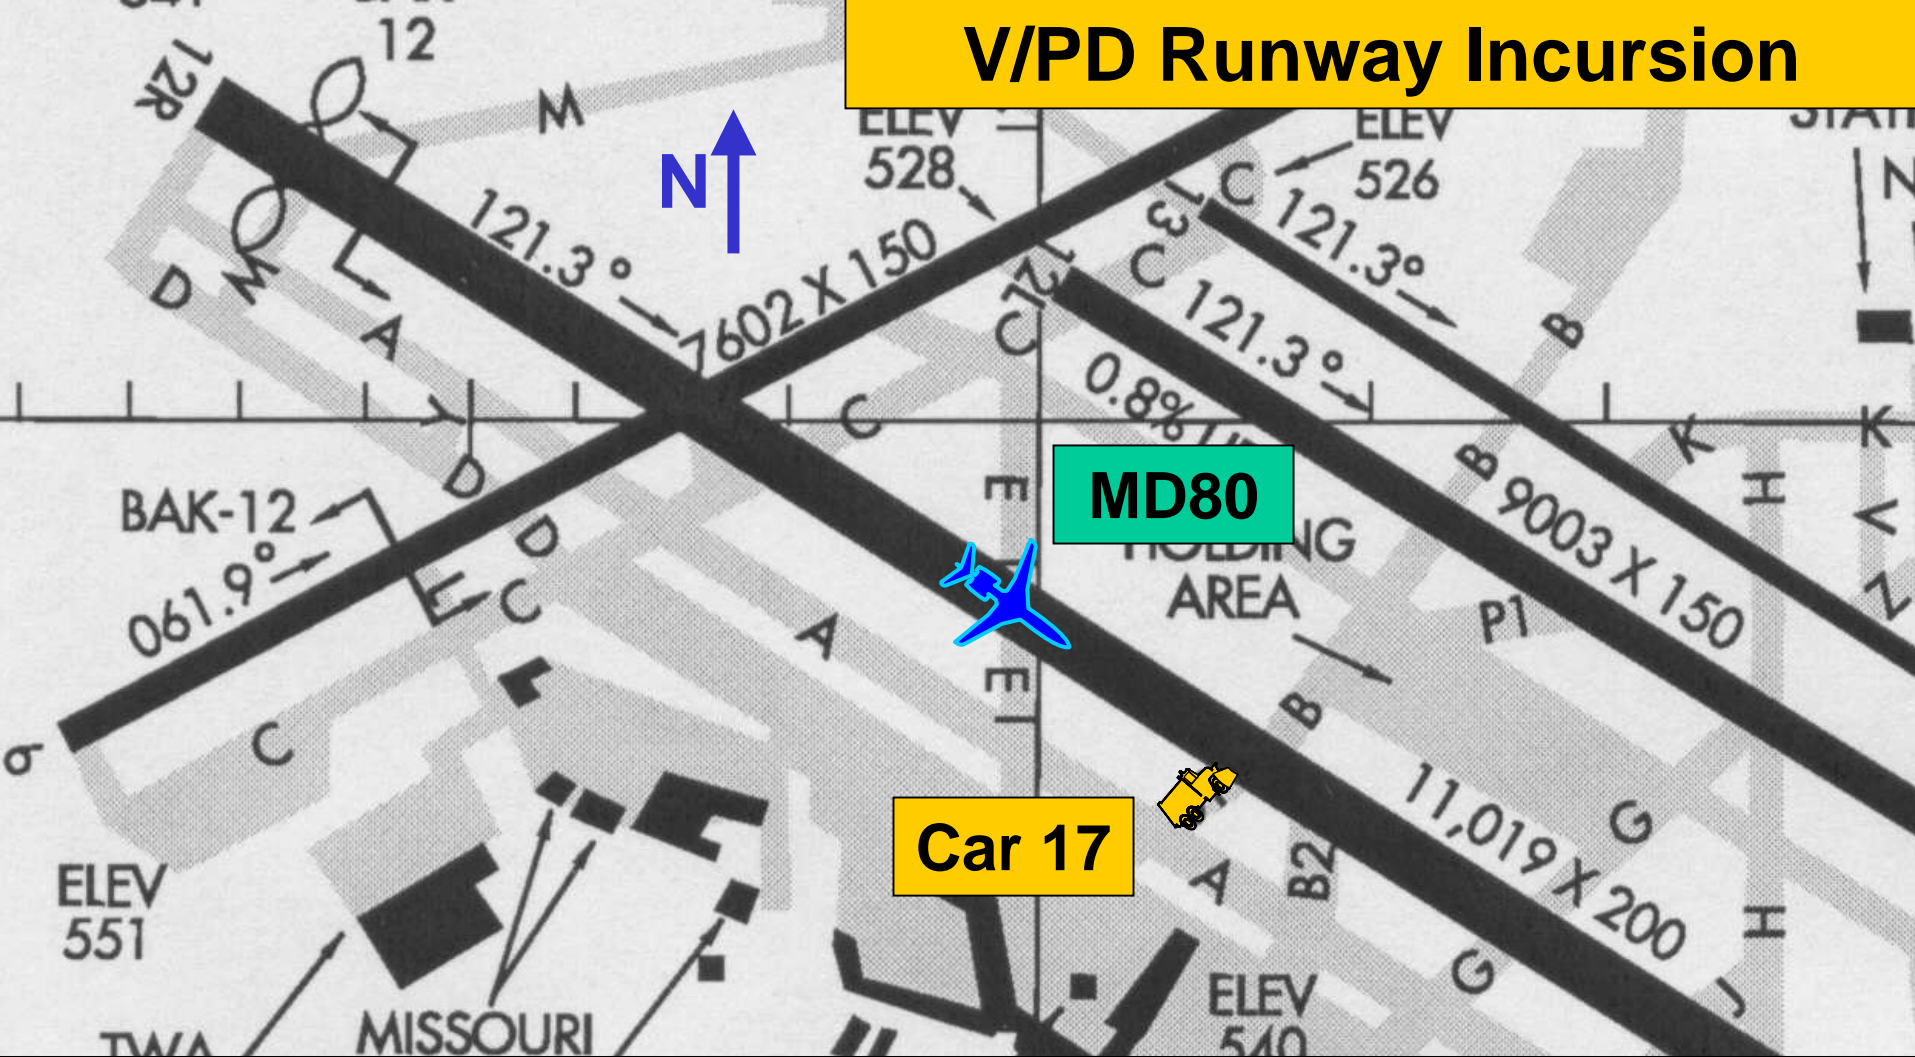
Vehicle Deviation – Holdline Violation. ATC cleared AAL MD80 for takeoff Rwy 12R. GC instructed Car 17 (Ops Vehicle) to hold short Runway 12R at Taxiway B1. Car 17 incorrectly read back hold short Rwy 12L at Twy Bravo. GC immediately corrected Car 17 with no response. GC instructed Car 17 to stop, while Car 17 reported “crossing 12R at Bravo One”. GC yelled at Car 17 a second time to STOP. Car 17 was then observed braking to a stop past the holdline but short of the runway edge as AAL MD80 was accelerating on takeoff at the Echo intersection. AAL MD80 was still on the ground when he passed B1.

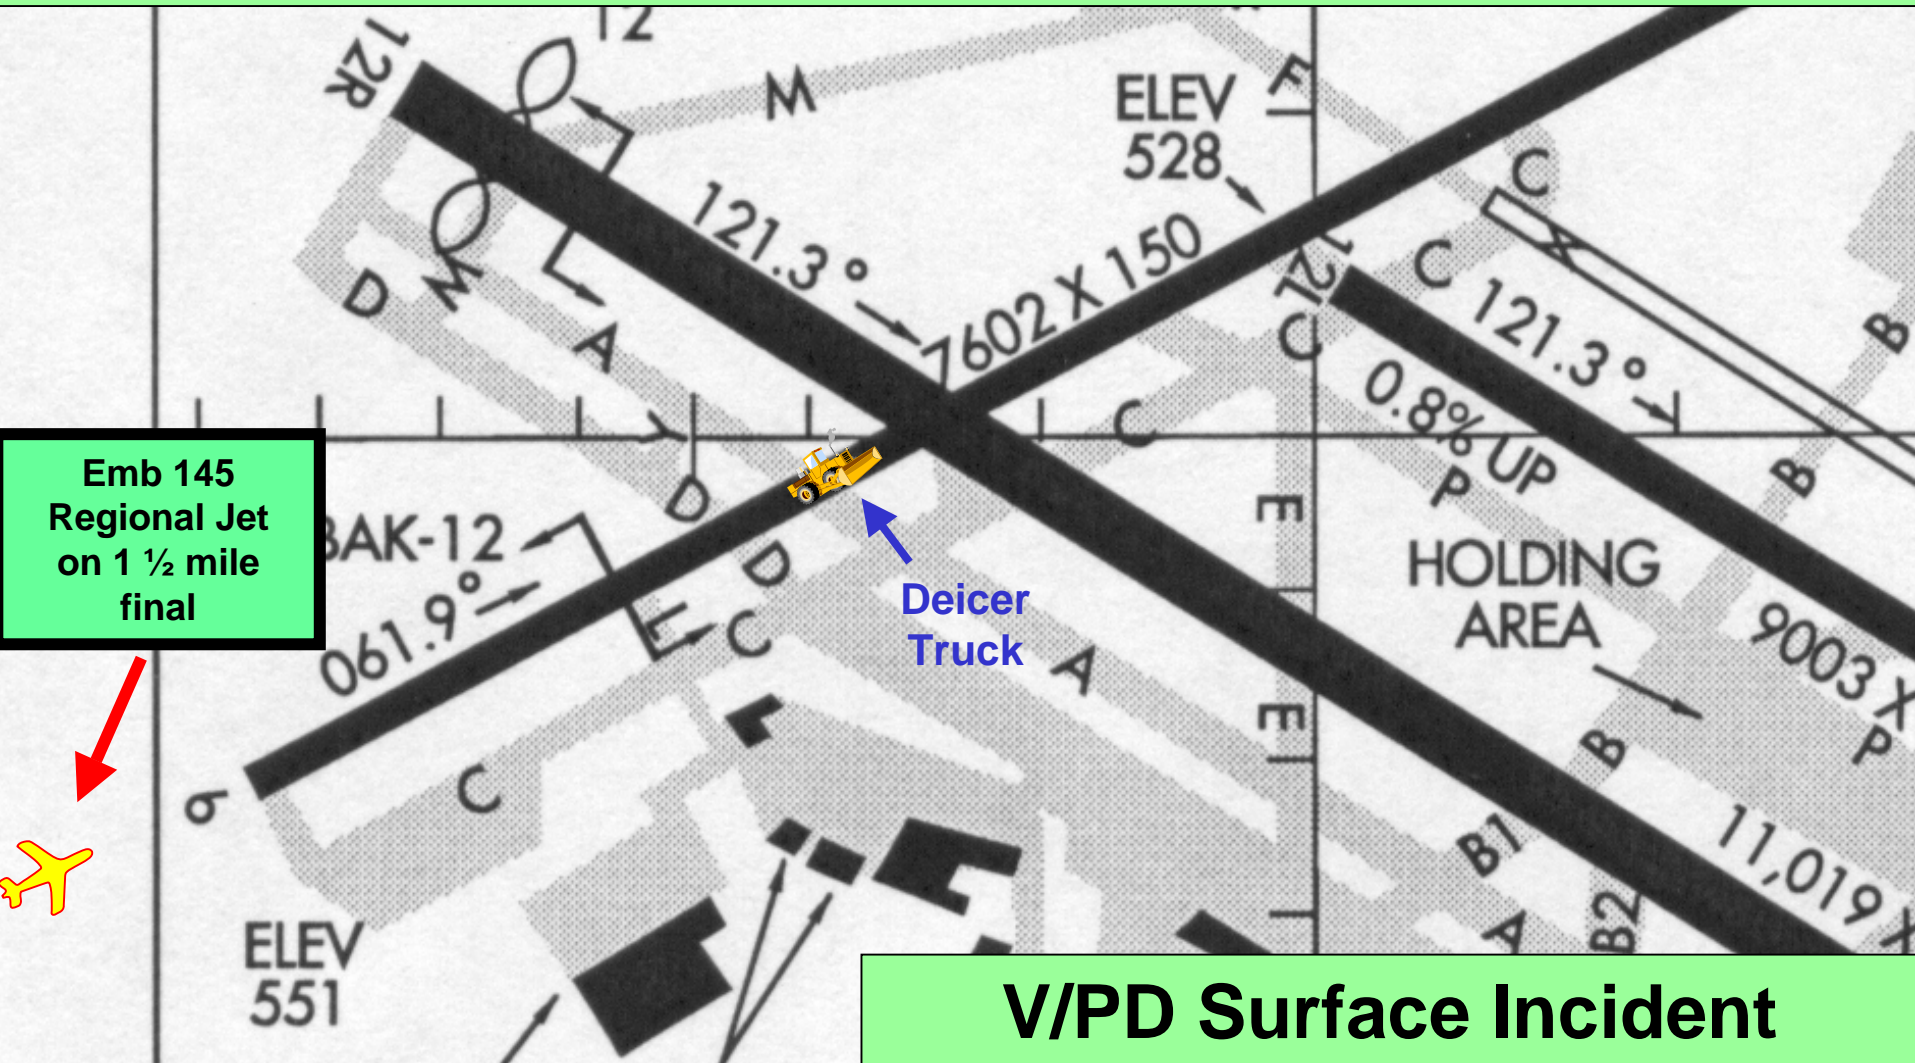
Vehicle Deviation - Runway A deicer truck entered Rwy 6 without clearance and requested to cross 12R. An Emb 145 RJ on 1 ½ mile final was sent around. The deicer truck driver had contacted Operations and was told that Rwy 6 was closed for snow removal. Operations had just faxed NOTAM to ATCT. Operations failed to coordinate the runway closure with ATC and several aircraft were lined up for Rwy 6 when the NOTAM was faxed to ATCT. Deicer truck driver failed to obtain initial approval from ATCT prior to operating on any movement area, as required in Letter of Agreement and Airport Certification Manual.

Emb 145
Regional Jet
on 1 ½ mile
final

Deicer
Truck

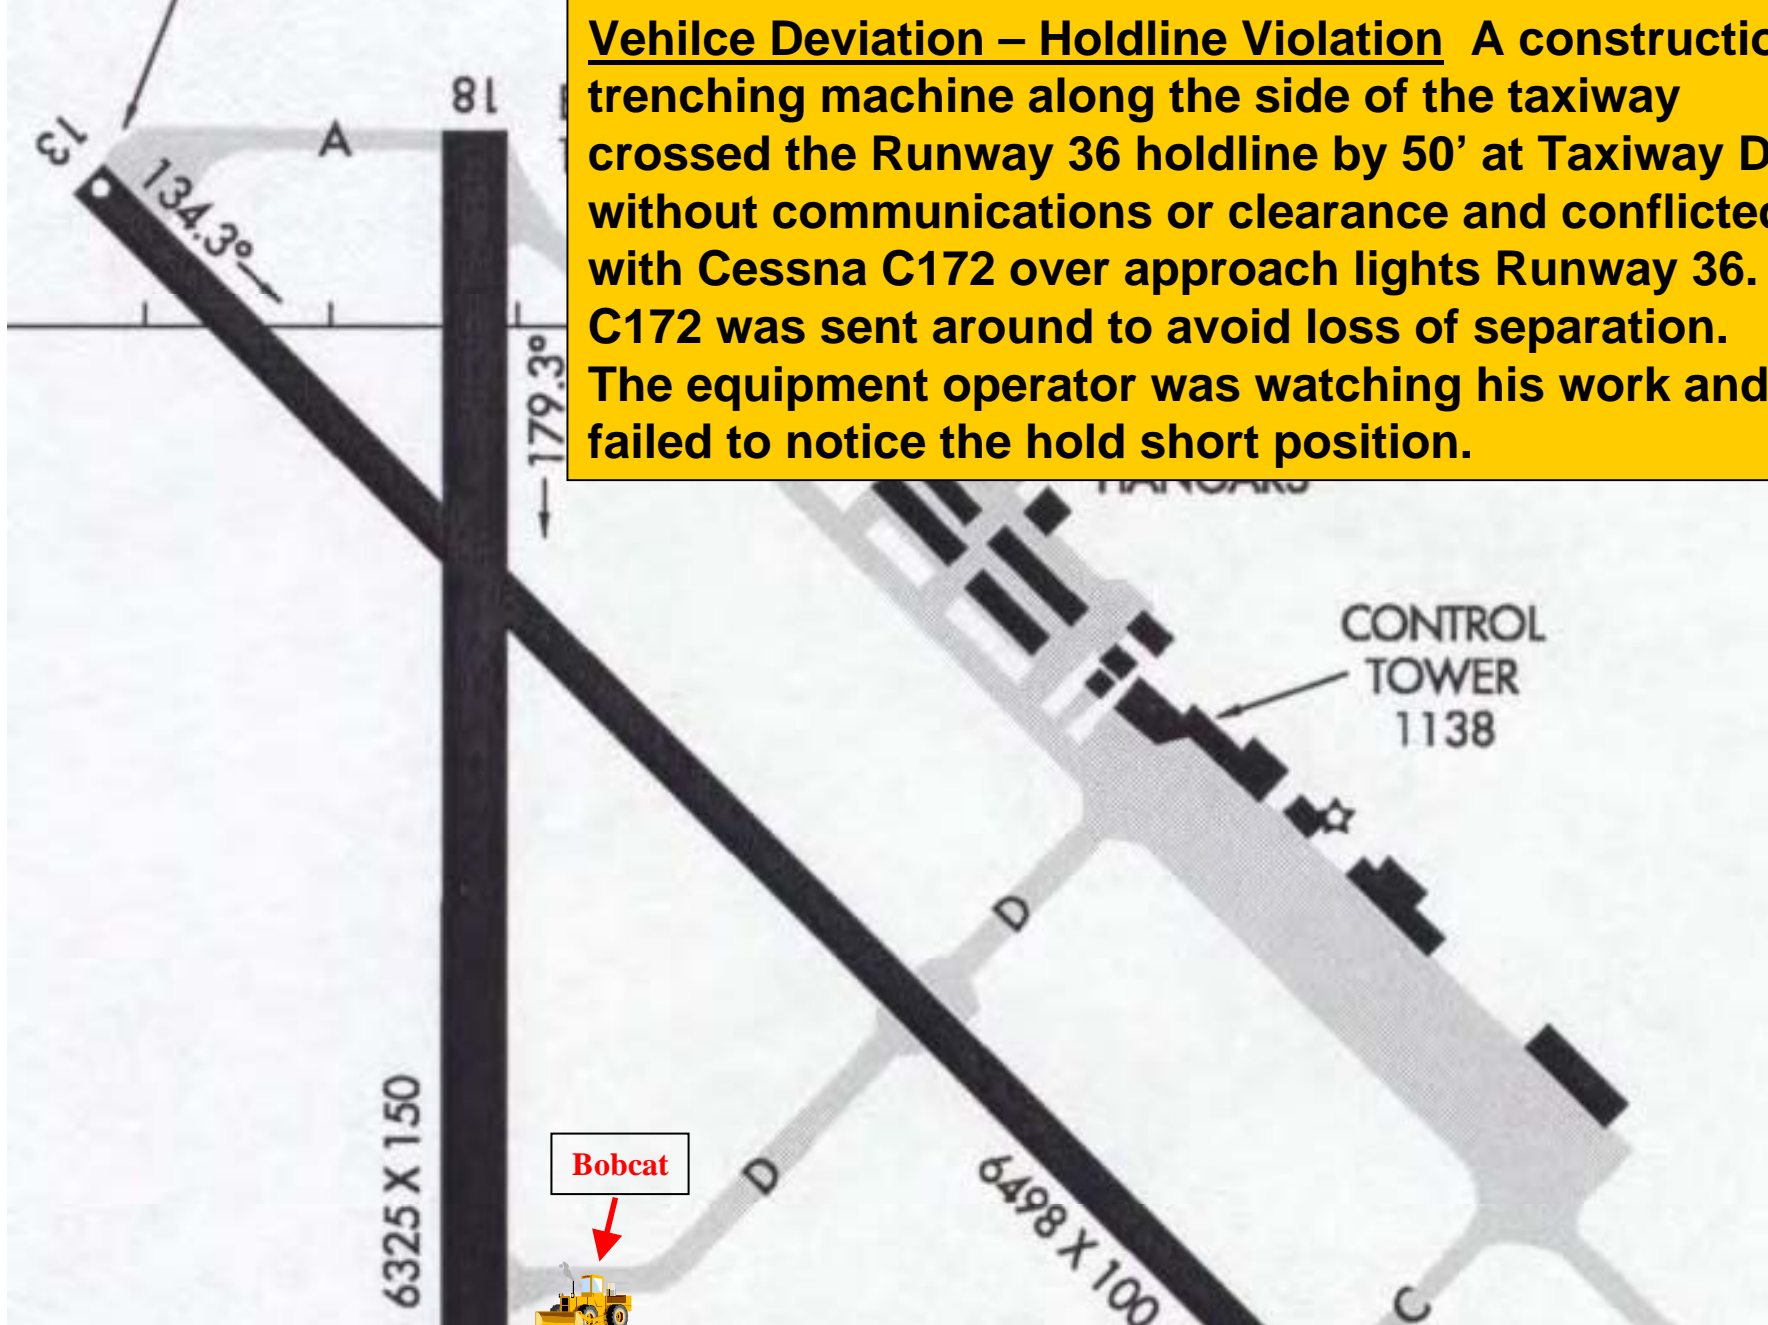
Vehicle Deviation – Holdline Violation A construction trenching machine along the side of the taxiway crossed the Runway 36 holdline by 50' at Taxiway D without communications or clearance and conflicted with Cessna C172 over approach lights Runway 36. C172 was sent around to avoid loss of separation. The equipment operator was watching his work and failed to notice the hold short position.

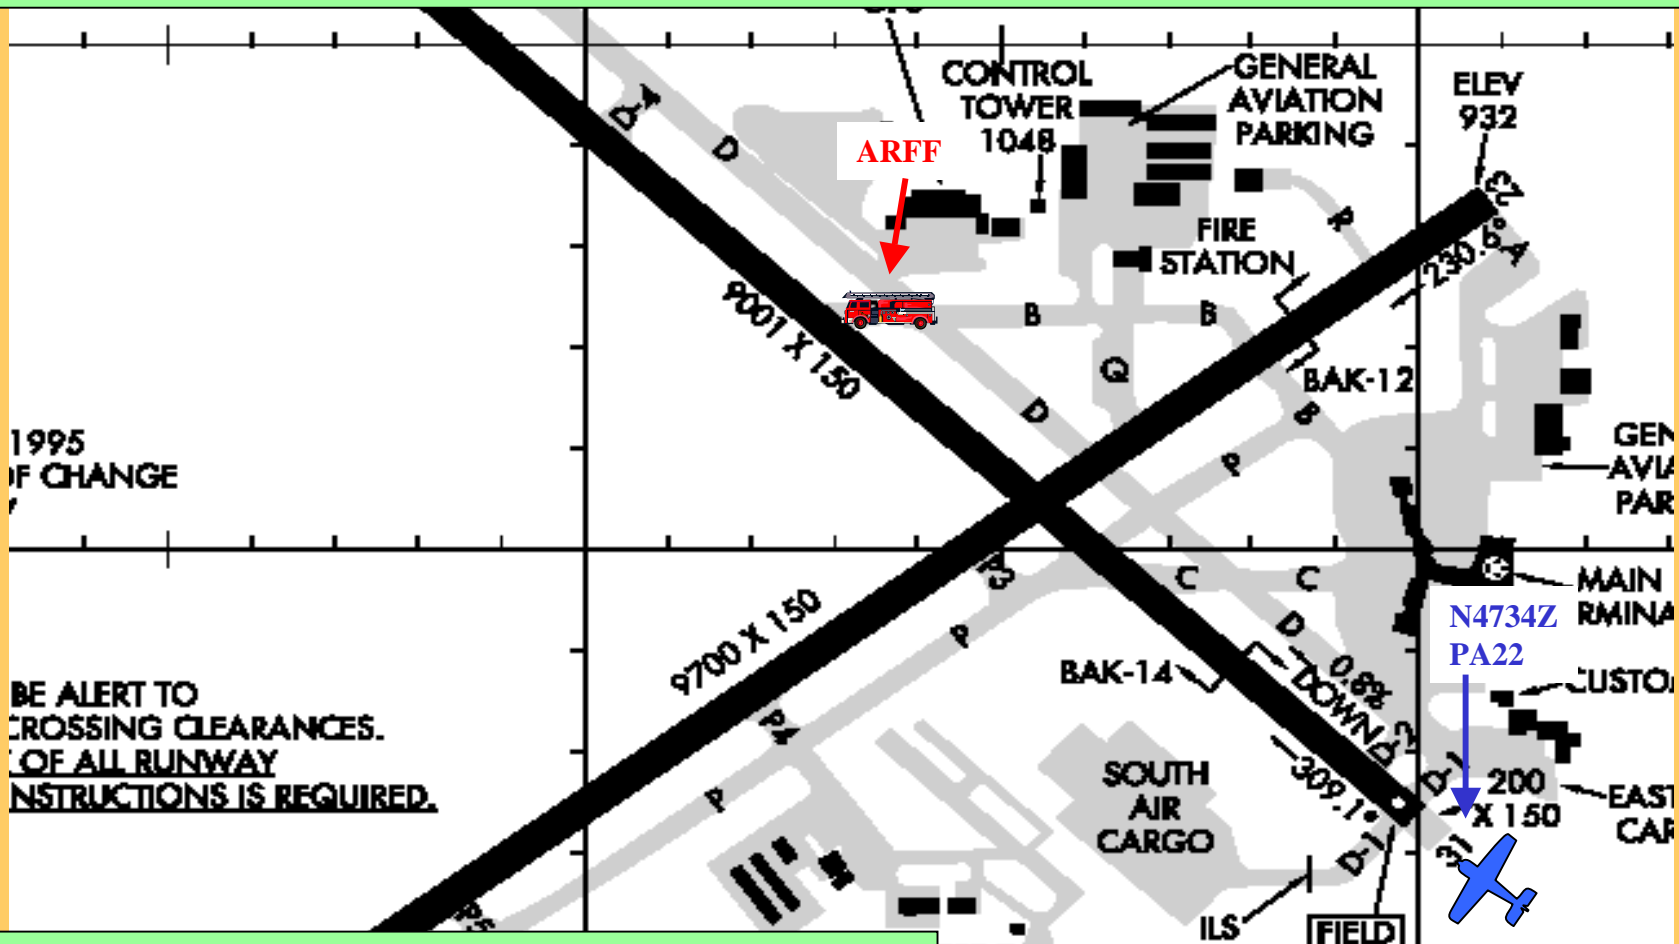
Vehicle Deviation – Holdline Violation An ARFF vehicle, crossed hold line on Taxiway B for Runway 31, but did not enter the runway. Piper PA22, on 1/8 mile final to Runway 31 was sent around. The ARFF vehicle crossed the holdline while turning around on the taxiway to escort a Falcon that had just landed with an emergency. Operations reopened the runway but did not inform ARFF.

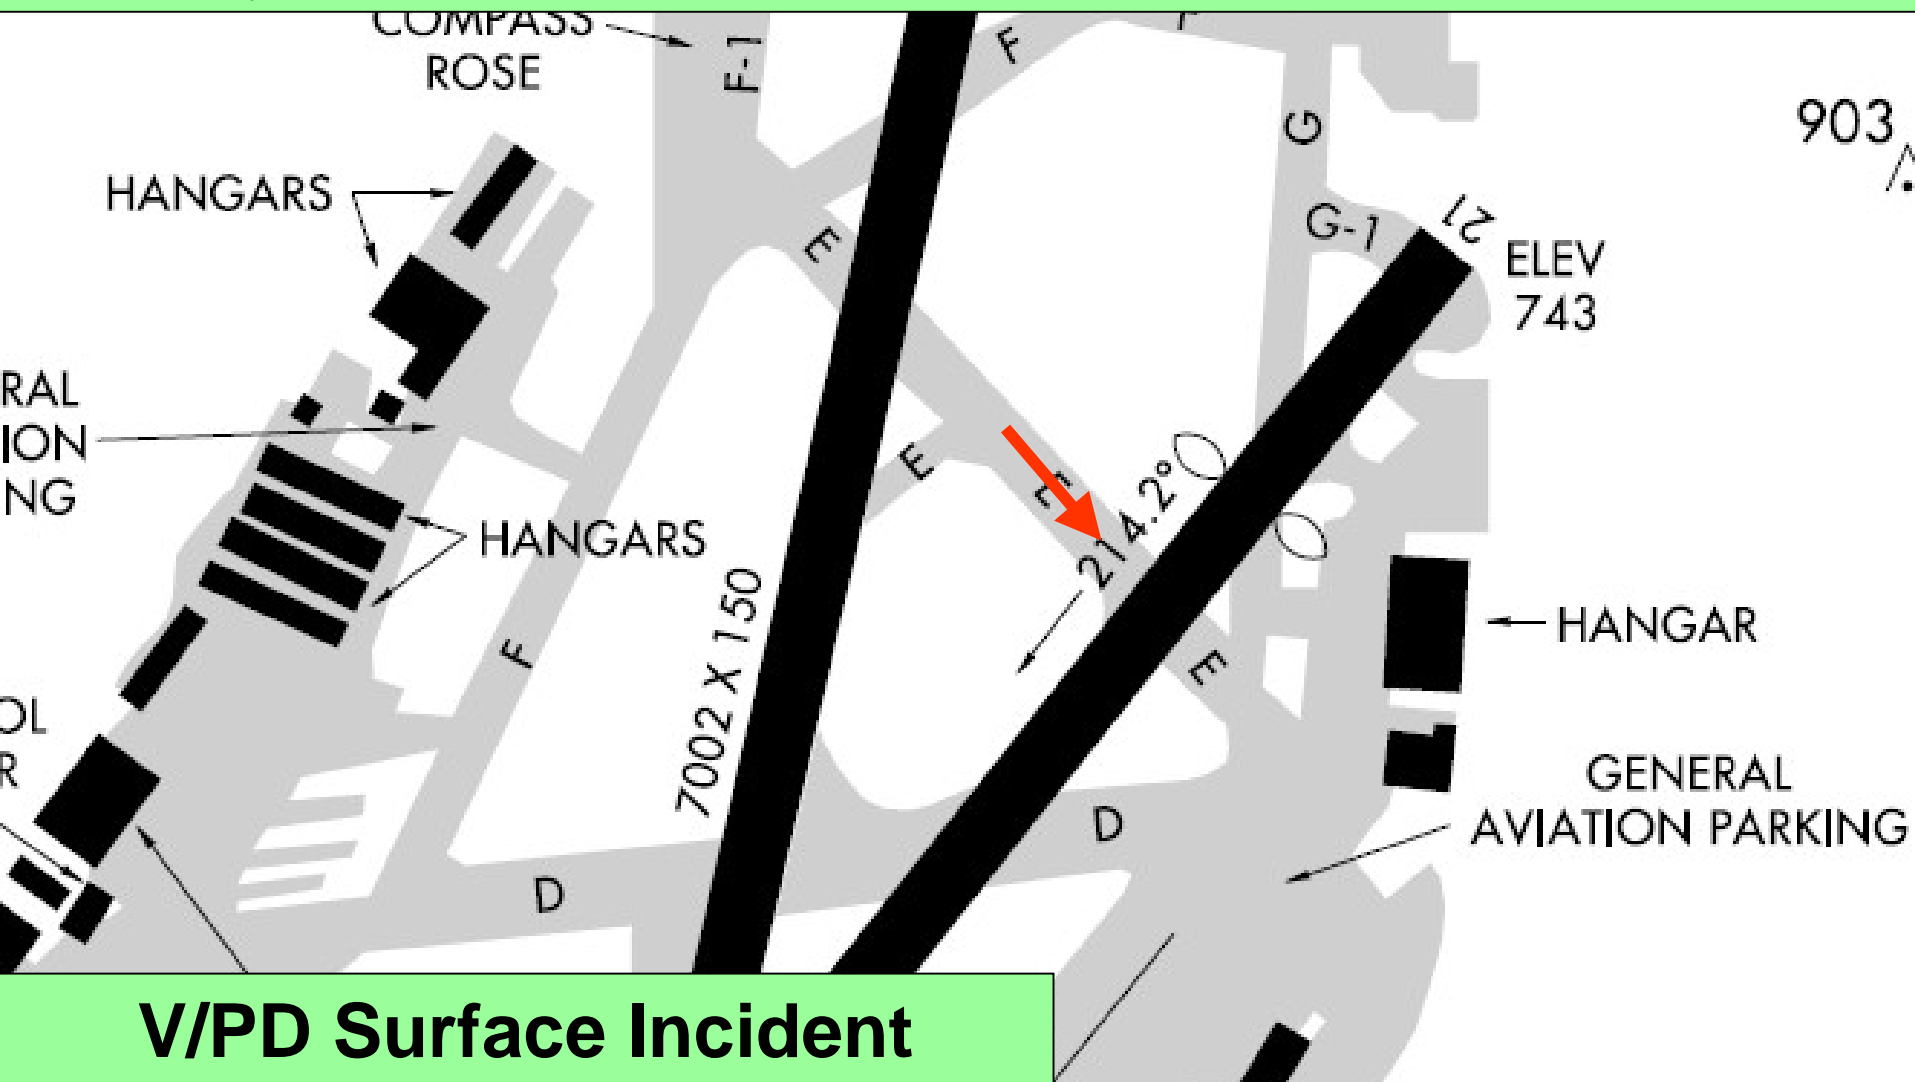
Vehicle Deviation – Holdline Violation A convoy of construction vehicles eastbound on Taxiway Echo were observed approaching the Runway 3-21 hold position faster than normal. When the first construction vehicle crossed the holdline, the takeoff clearance for an aircraft on Rwy 3 was cancelled. The construction vehicles turned around just past the holdline to unload barricades to place on the holdline. The vehicle drivers were not properly trained.

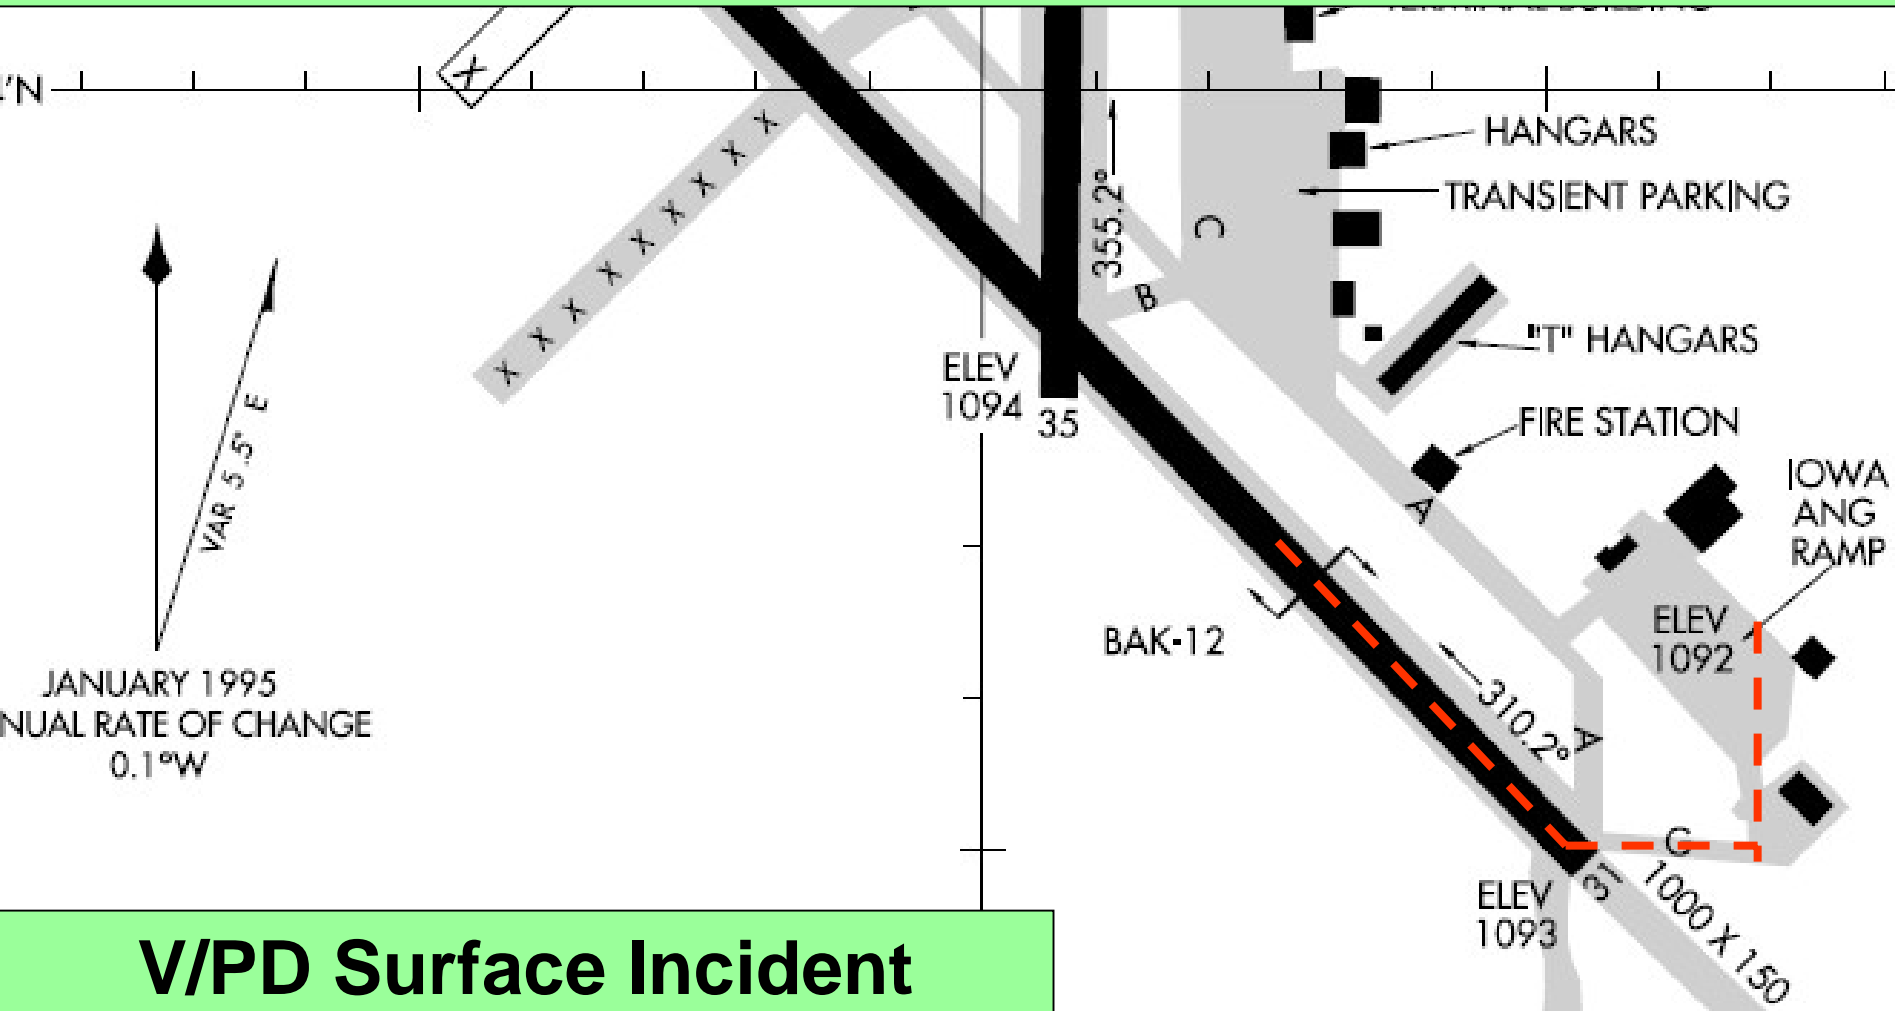
Vehicle & Pedestrian Deviation - Runway The mother of a ANG recruit drove onto the base to pick up her son. After entering the gate she became disoriented and entered the apron. She was not stopped by ANG personnel because she was driving a vehicle similar to the Airport Operations Director. She then drove out onto the taxiway and proceeded north on Rwy 31 where she was observed by ATCT. While driving back on the runway, her son had ran out onto the runway to flag her down and was picked up by the mother. They were then escorted off the movement area by security personnel.

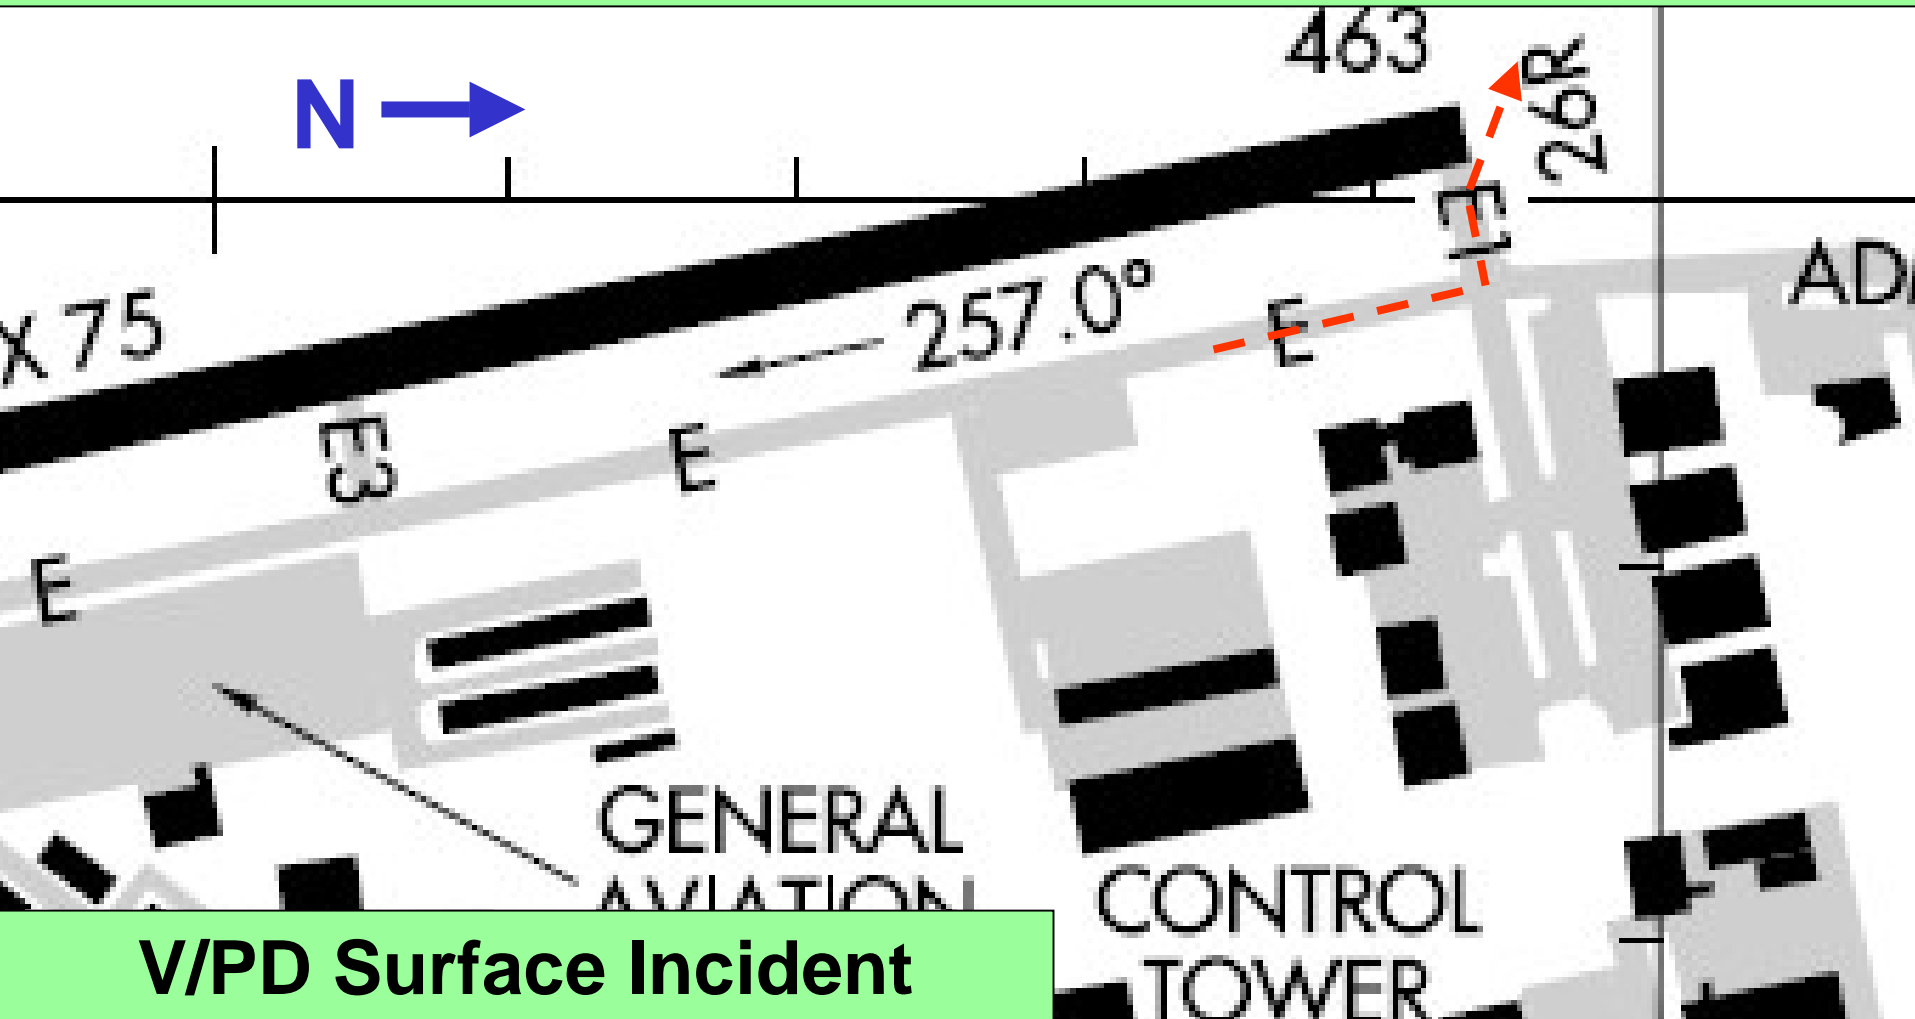
Vehicle Deviation – Holdline/Safety Area Violation A backhoe operator was left alone at a construction site east of Runway 26R. He as instructed to wait for an escort but became impatient and drove north on Echo, west on E1 across the 26R holdline and out into the safety area at the 26R approach without ATCT clearance. This was the route he took on a previous project when 26R was closed. The backhoe operator was barred from further work at the airport. An aircraft was on 1½ final for Runway 26R, however, no loss of separation occurred.

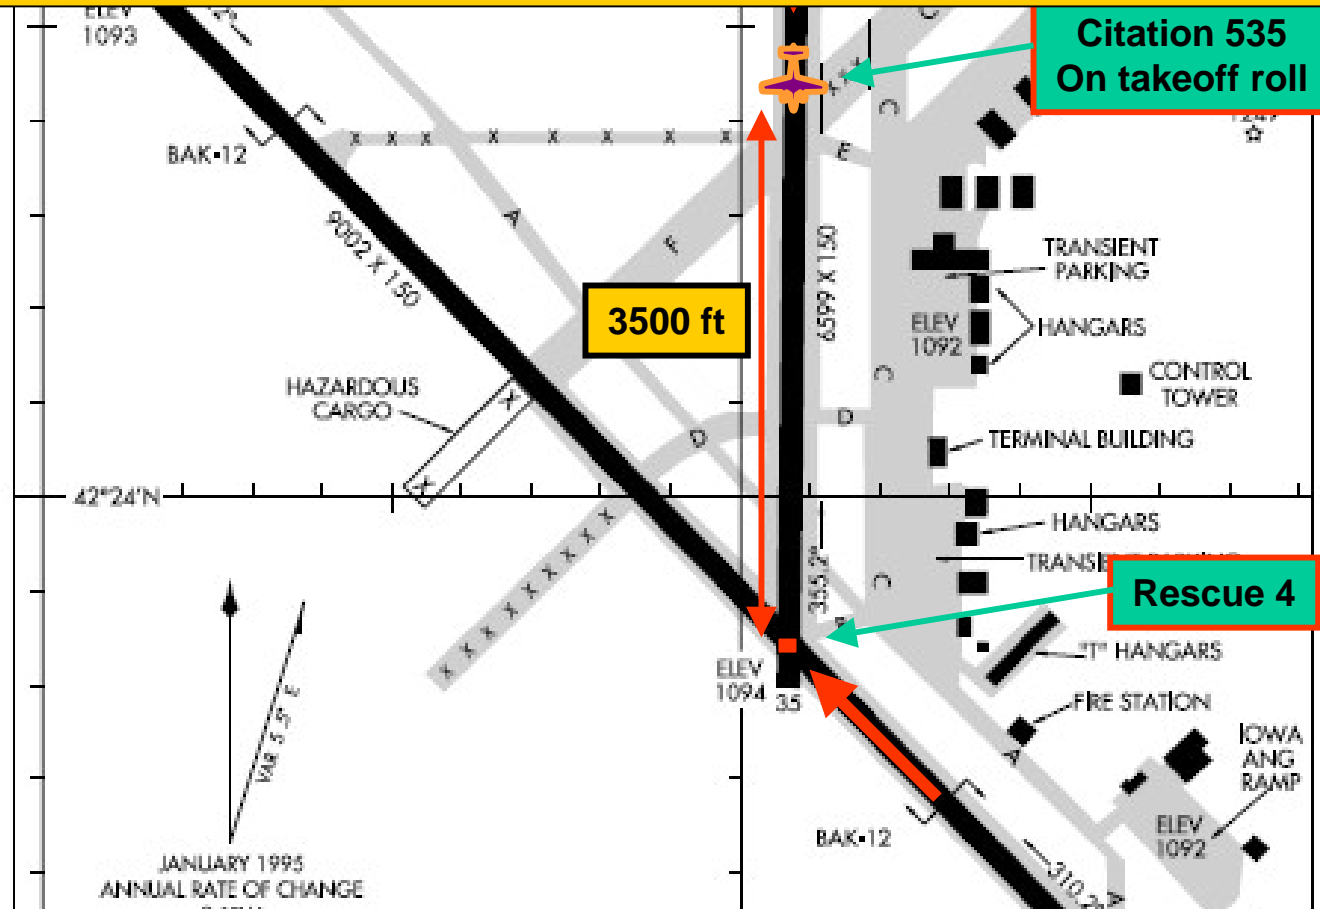
Vehicle Deviation - Runway ATC issued takeoff clearance to C-525 on Rwy 17. Rescue 4 requested clearance north on Rwy 31 and was instructed to proceed on Rwy 31, hold short Rwy 35. Rescue 4 read back hold short instructions. As Rescue 4 approached 35, ATC reissued hold short of 35 but the driver did not reply and entered Rwy 35. ATC instructed Rescue 4 to exit the runway immediately. Rescue 4 saw the LAHSO holdline on the other side of the intersection and mistook that for the hold position for 35.

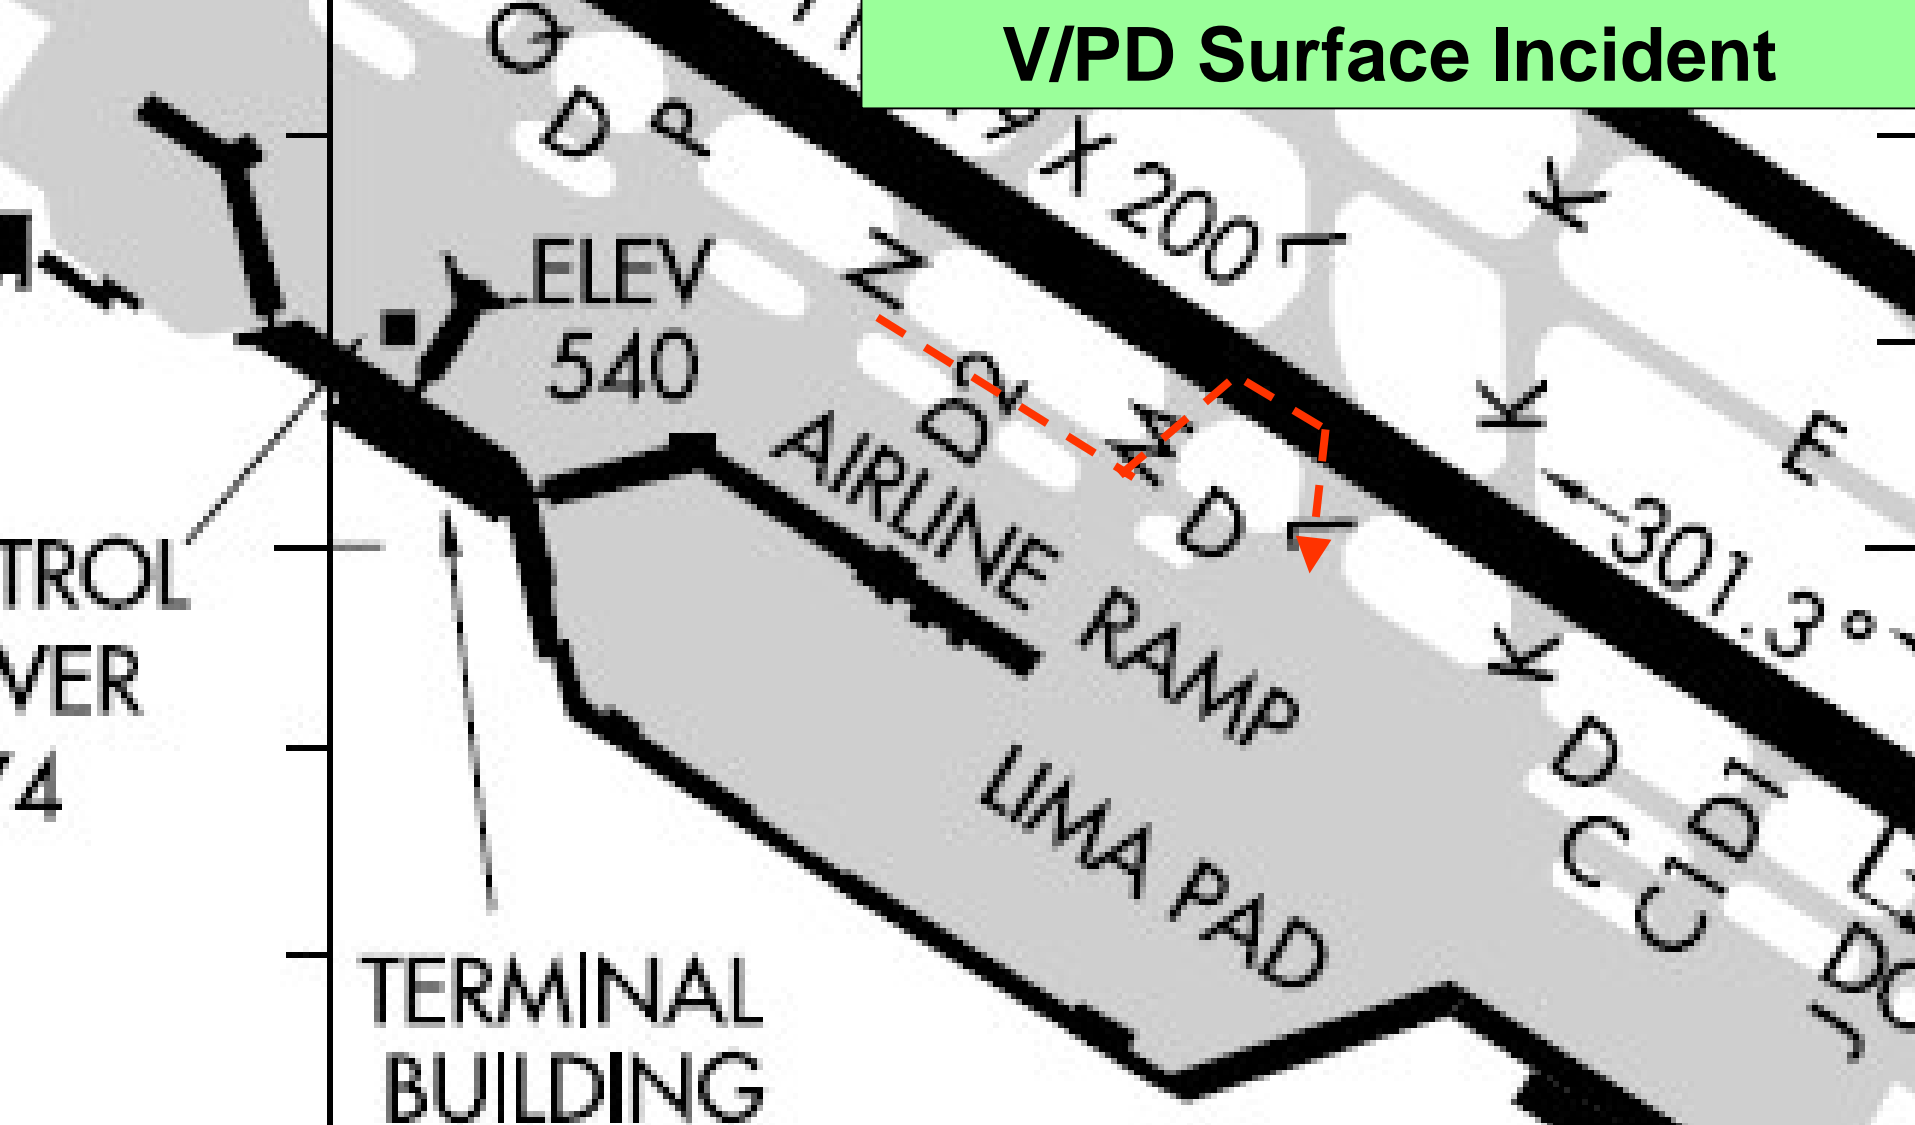
Vehicle Deviation - Runway A pilot reported a baggage truck on Taxiway Delta. The baggage truck was observed turning onto Taxiway Mike and then drove out onto Runway 30L. Airport Operations was cleared onto Runway 30L to escort the vehicle off the runway on Taxiway Lima. The baggage truck was driven by an airline employee who stated that she was lost. No loss of separation occurred.
