Reducing the Potential for Vehicle/Pedestrian Deviations (V/PD) and Runway Incursions

Federal Aviation
Administration

Office of Airport
Safety and
Standards

August 2007

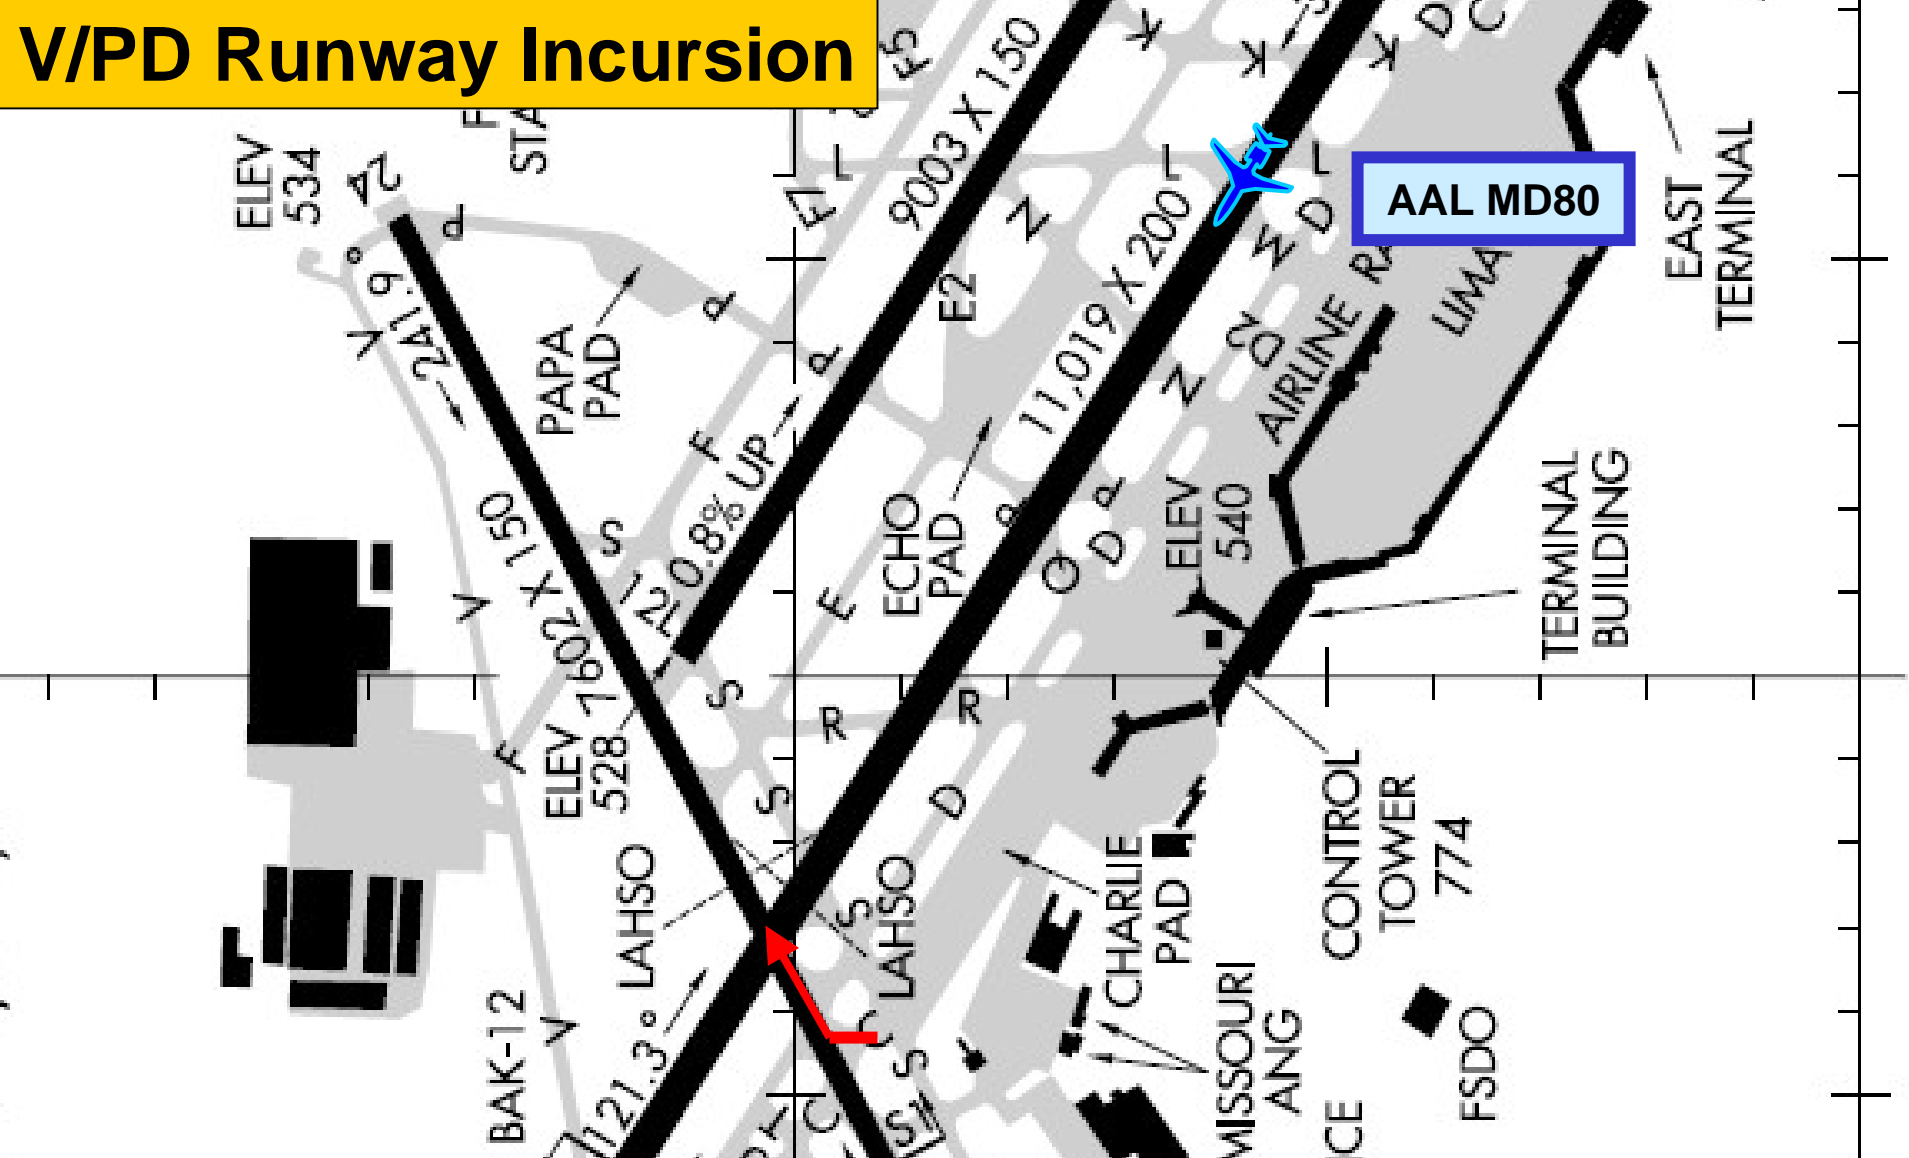
Vehicle Deviation – Runway GC instructed Truck 169 (maintenance vehicle), on Runway 6, to hold short 30L and Truck 169 read back the hold short instruction. AAL MD80 was cleared for take-off 30L. GC observed Truck 169 about to cross 30L and instructed Truck 169 to hold short but the vehicle proceeded onto 30L, chasing a blowing box. AAL MD80 rotated at the Lima intersection as Truck 169 entered Runway 30L. (5,300' separation)

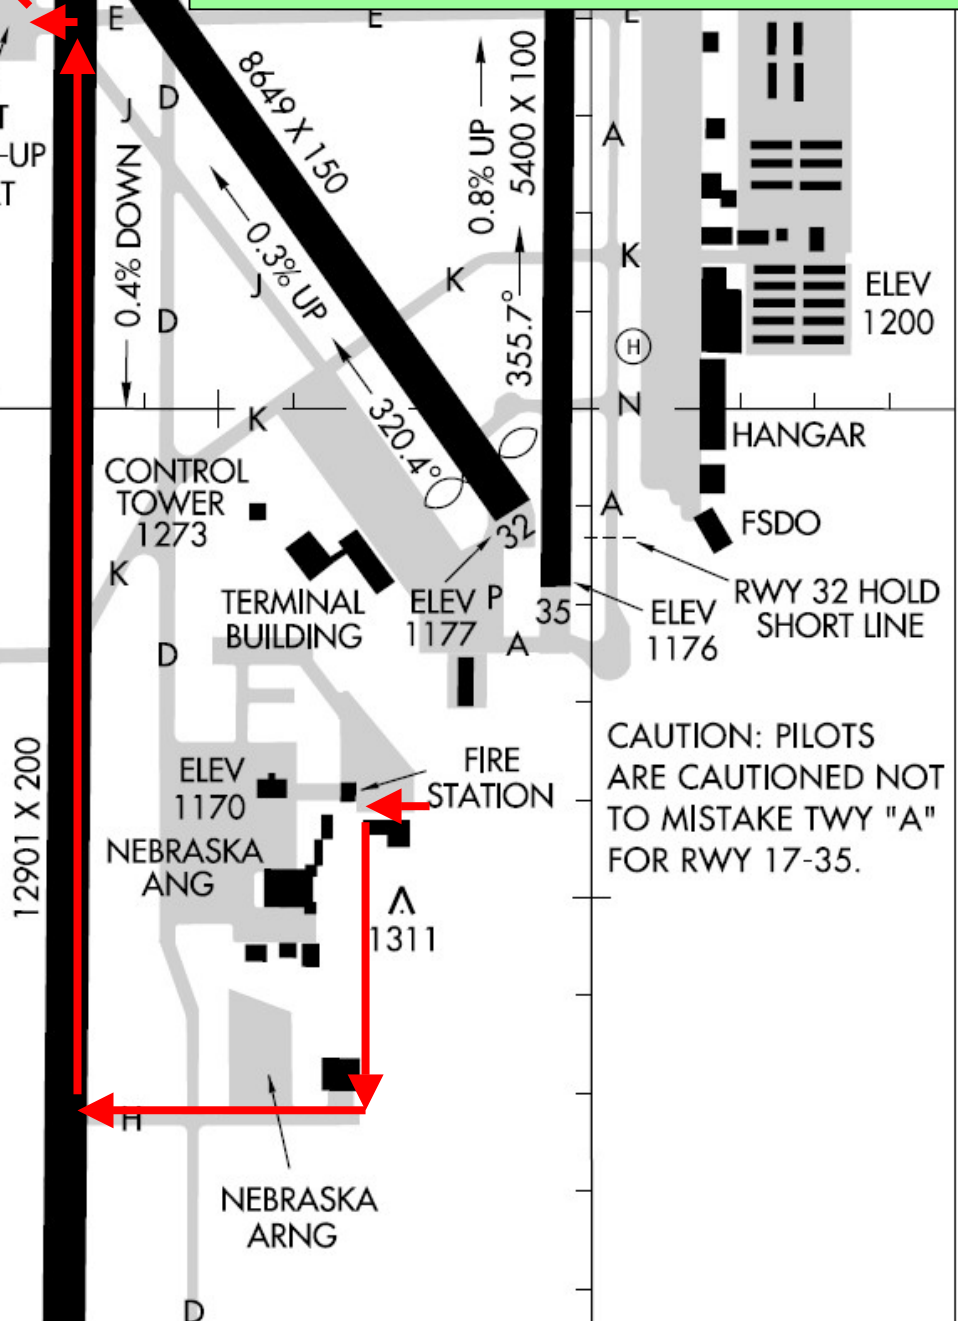
A bicyclist entered the AOA through the ANG main gate. The gate guard yelled at the bicyclist to stop but he was wearing earphones and didn't hear. The bicyclist continued west and south through the ANG area, west on Hotel, north on Rwy 36. ATCT spotted the bicyclist northbound on Rwy 36. The bicyclist exited Rwy 36 westbound on Taxiway Echo and was apprehended by the Airport Police on Twy Juliet. The bicyclist was looking for a way to a church on the west side of the airport.
