PROJECT COMPLETION REPORT

End Creek-Rice Fish Habitat & Wetland Restoration Project

Oregon Watershed Enhancement Board Project No. 204-434

January 2007

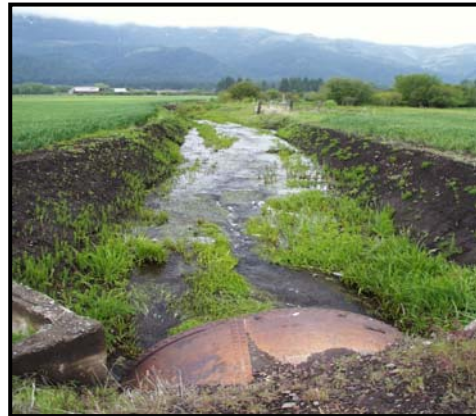
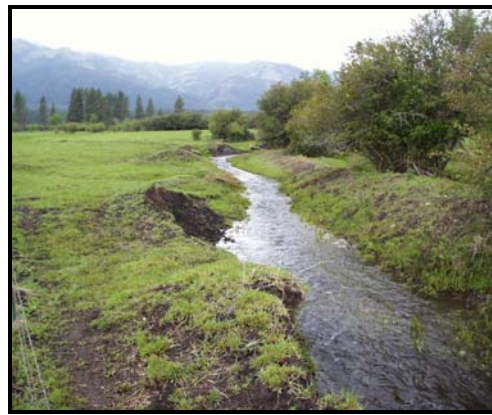
June 2003 Photos illustrate lower channelized End Creek. Extensive channelization in project area created unstable stream channels, excessive erosion, elevated water temperatures, loss of riparian and wetland vegetation, and poor fish habitat.

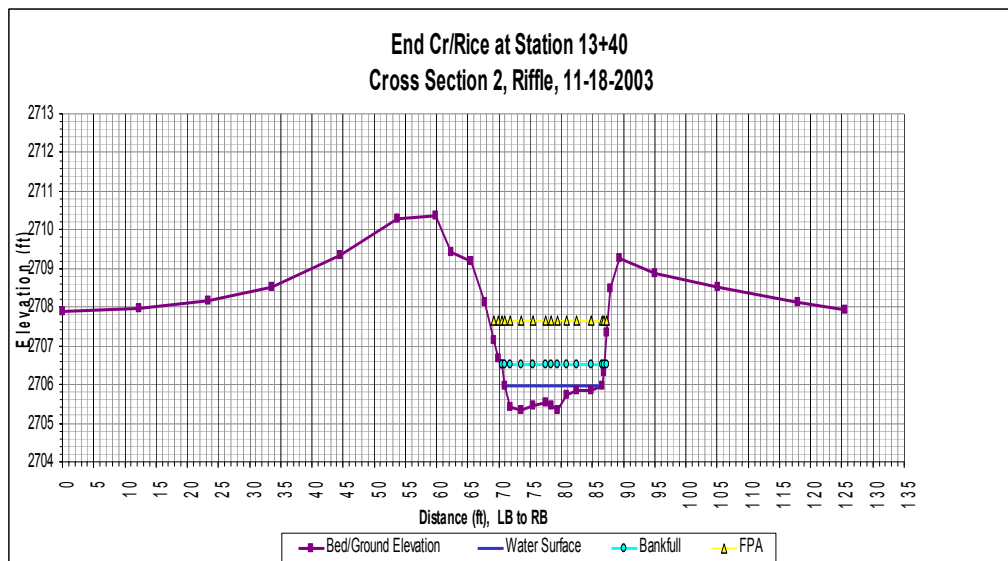
Figure 6 Riffle Cross Section of Existing End Creek Reach

The following figure depicts a typical riffle cross section generated from survey data collected at Station 13+40 along lower End Creek. The cross section clearly illustrates the extent of channel incision and lack of floodplain connectivity. Flood conveyance capacity of the channel is significant which contributes to unstable stream banks shown in the above photos. Note that both the bankfull discharge and floodprone area are contained entirely within the existing channel, limiting connectivity to the floodplain.

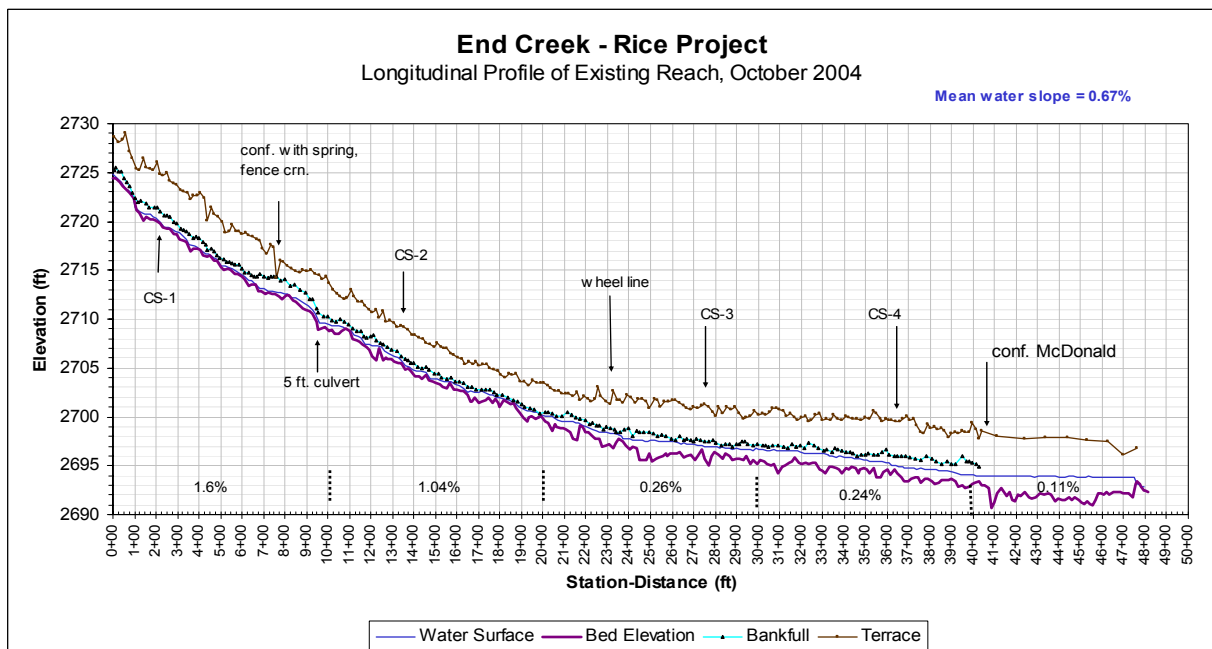
Figure 7 Longitudinal Profile of Lower End Creek

Figure 7 illustrates the profile of lower End Creek. Note the relation of the channel thalweg in comparison to adjacent terraces which illustrates extensive channel entrenchment, confinement, and high water slopes (mean of 0.67%). Also of note in the profile is the lack of large pool habitat. In the current condition, End Creek is severely unstable and lacks stable morphology necessary to develop high quality fish habitat.

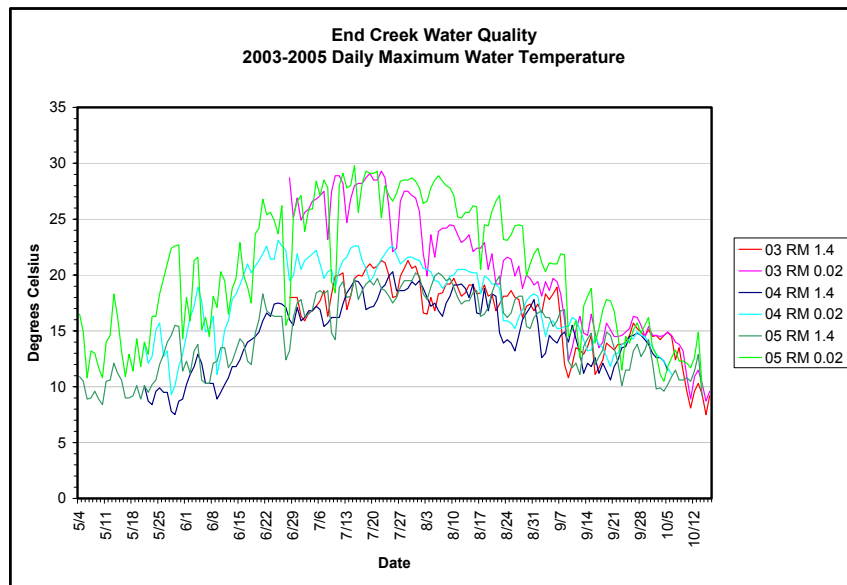
Figure 8 End Creek Daily Maximum Water Temperatures 2003-2005

Water temperatures recorded at the upper monitoring site have been observed to be consistently cooler than the lower site during 2003 through 2005 with a consistent heating trend detected through the lower channelized project reach. Observed maximum temperatures indicate that summer salmonid distribution in lower End Creek is limited by high summer water temperatures. Figure 8 illustrates data collected during 2003 through 2005.

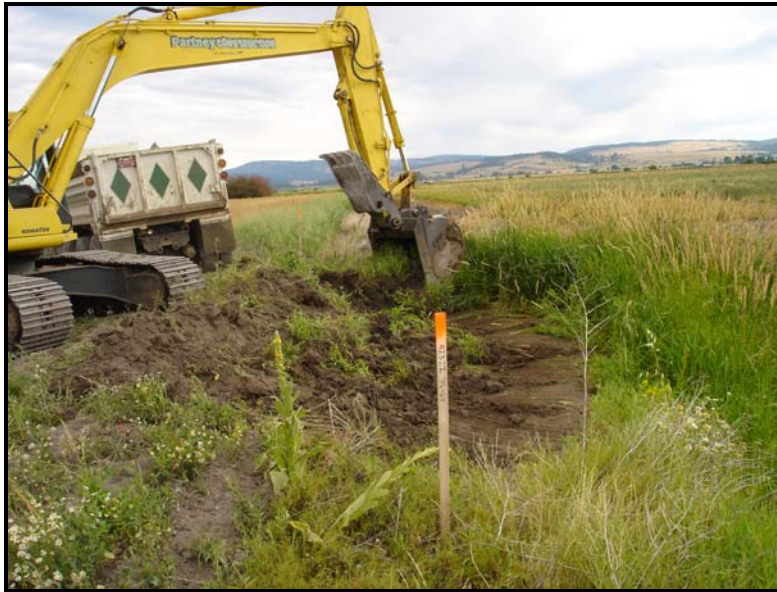
Initiation of End Creek restoration channel construction. July 2006

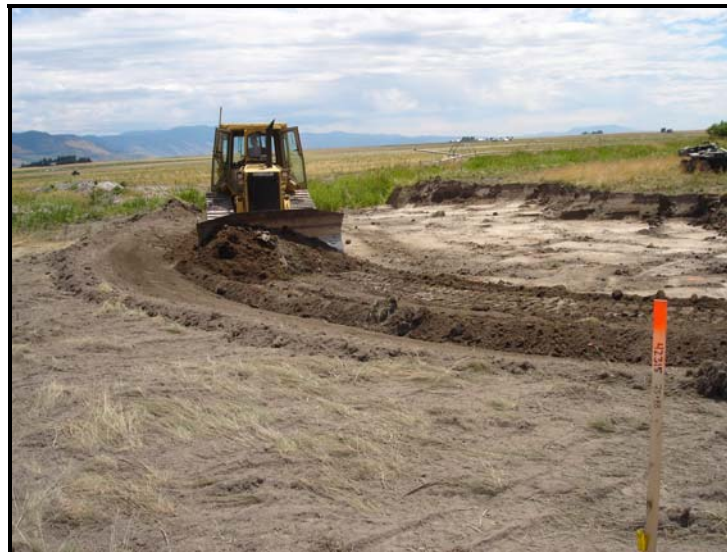
D5 Dozer grading material from floodplain in preparation for bankfull channel excavation by track-hoe. July 2006

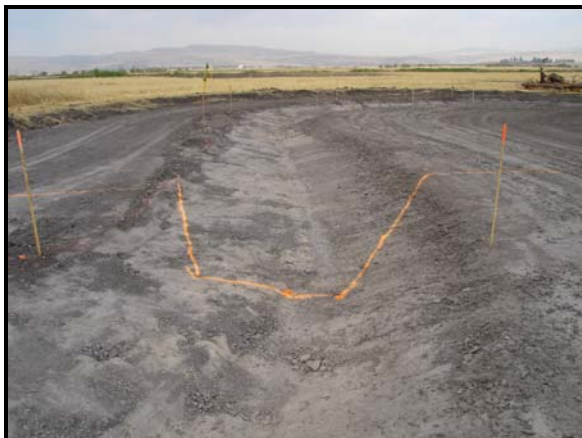
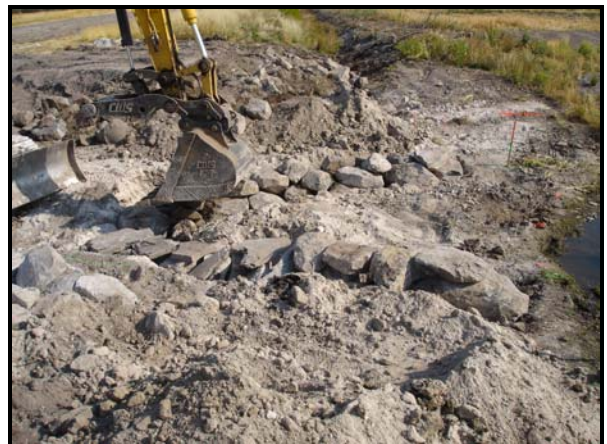
Photos below illustrate structure layout in the constructed restoration channel and an installed structure prior to backfill. Note that the elevation (invert) of the structure is the same as the bottom (thalweg) of the channel. August 2006.

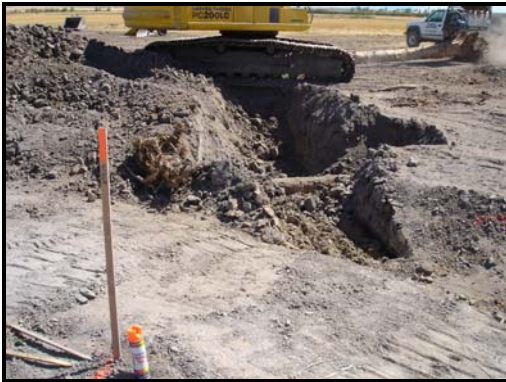
Rootwad revetment installation. Photo illustrates installed footer log and keyway for rootwad and tree bole installation. August 2006

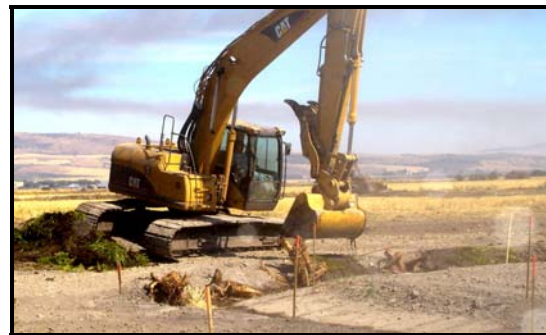
September 2006 photo illustrating rootwad revetment and installation of sedge/rush mats.

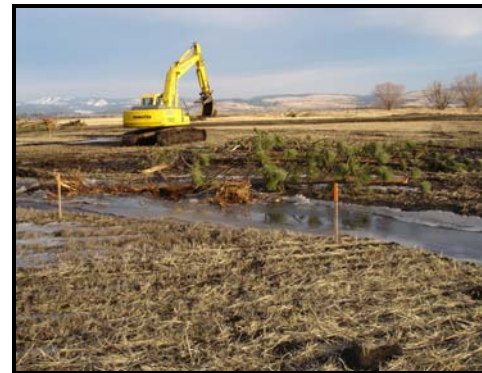
November 2006 photo illustrating wood placement along South Fork Willow restoration channel.

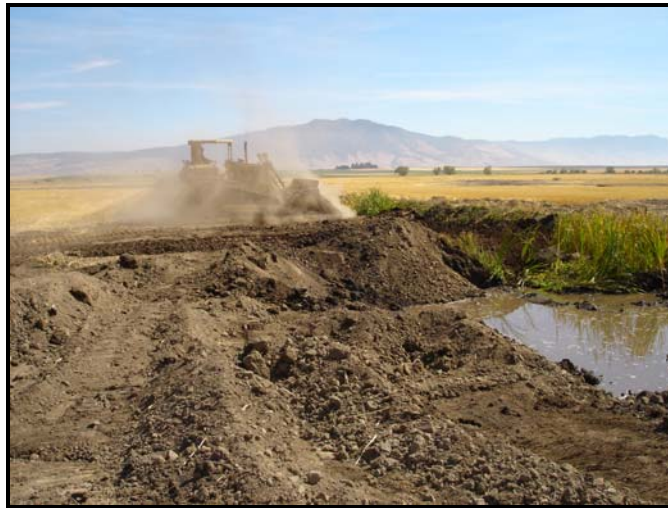
Reclamation of channelized End Creek following activation of restoration channel. August 2006.

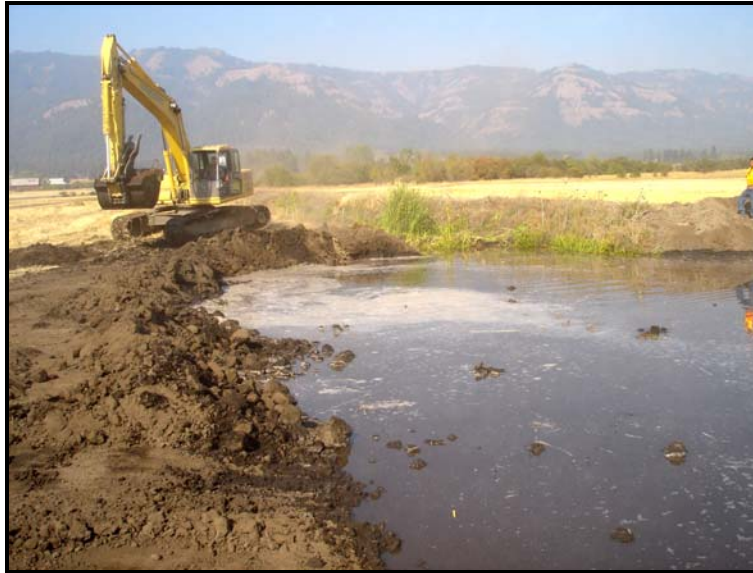
Floodplain pond construction. August 2006.

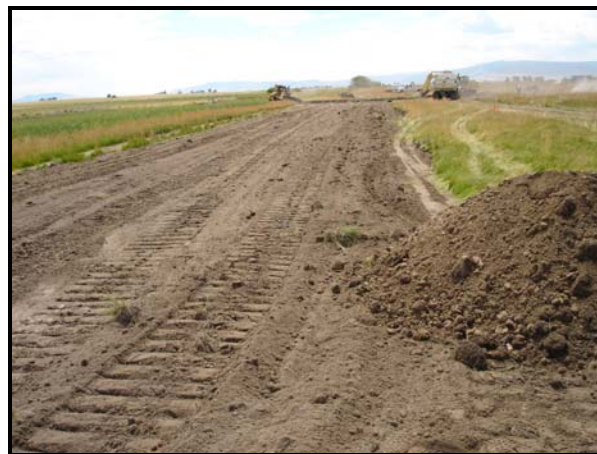
Earthen terrace constructed along eastern project boundary to minimize potential for flooding on adjacent private land. July 2006

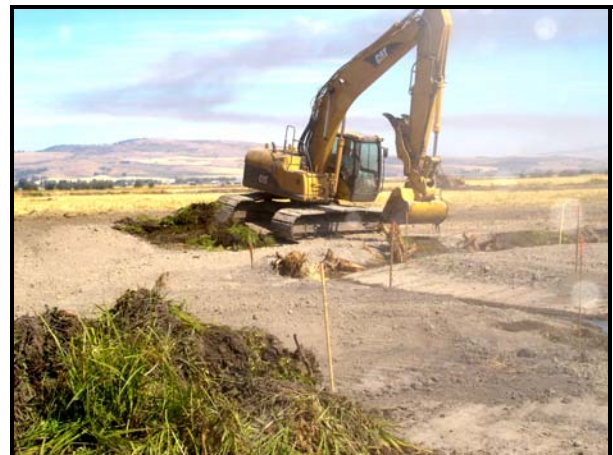
*Excavator installing sedge/rush mats along outside stream meander on rootwad revetment.
September 2006*

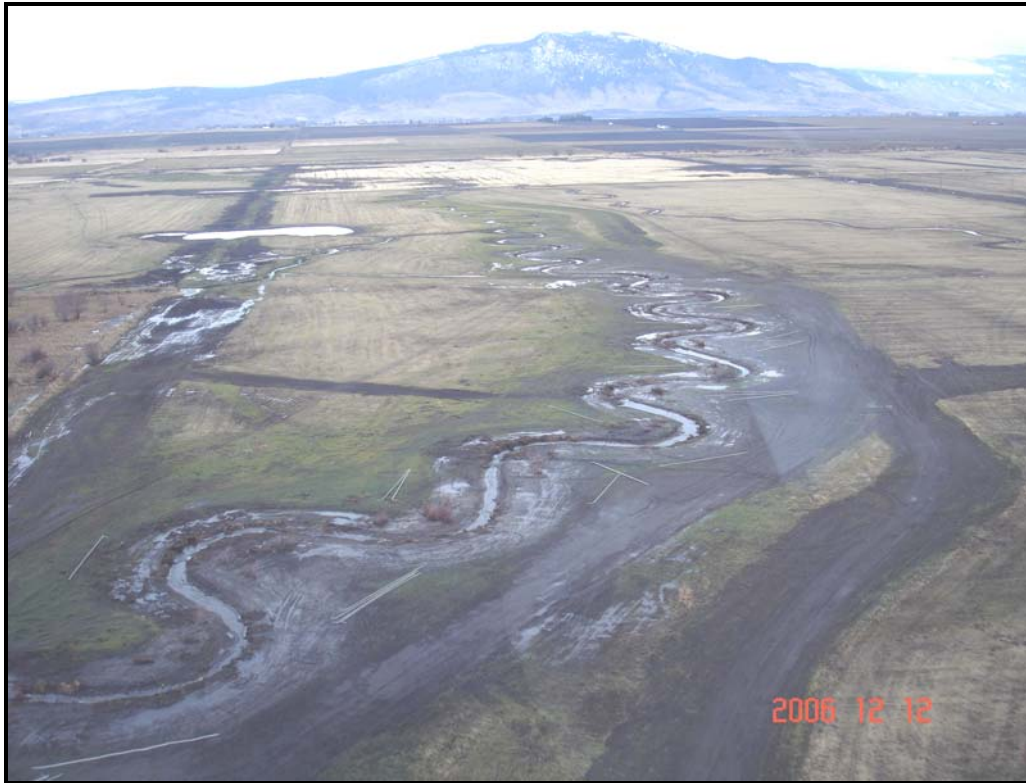
Upstream reach of End Creek (Rice) Restoration Channel, viewing east (downstream) towards South Fork Willow Creek confluence. Note reclaimed channelized reach in left corner of photo and floodplain ponds incorporated into reclamation plan. December 2006

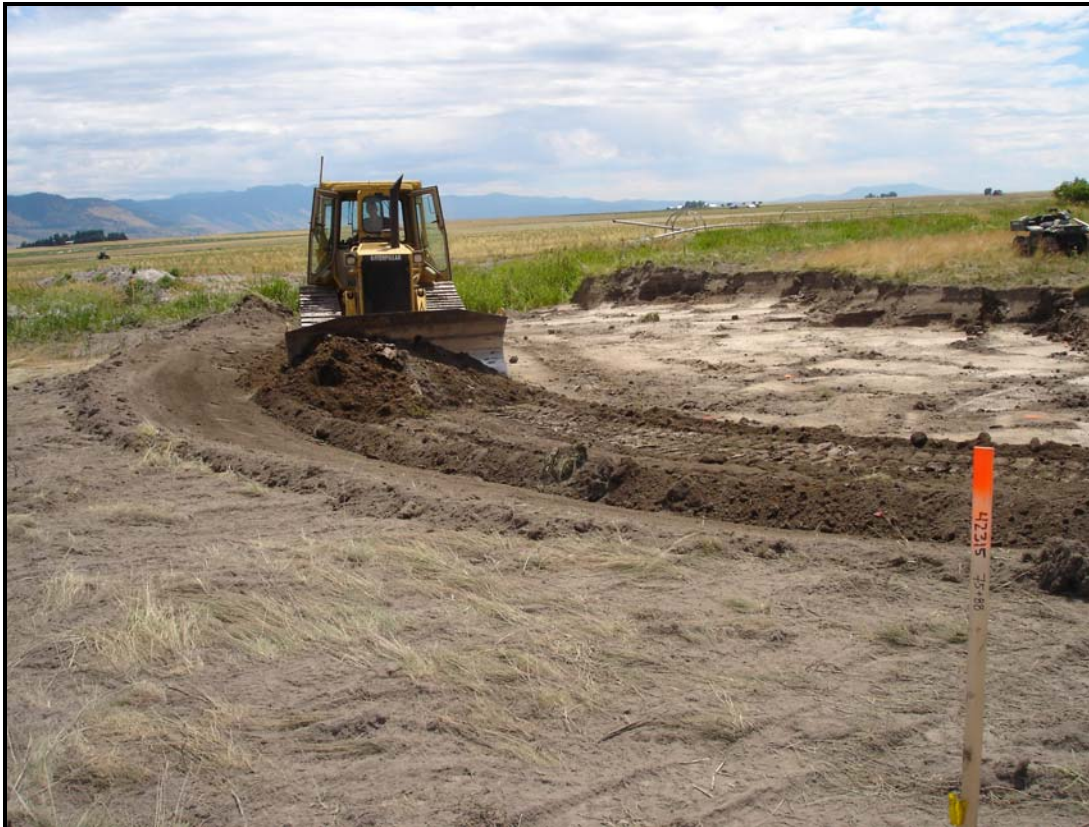
Initiation of channel construction on lower End Creek. December 2006

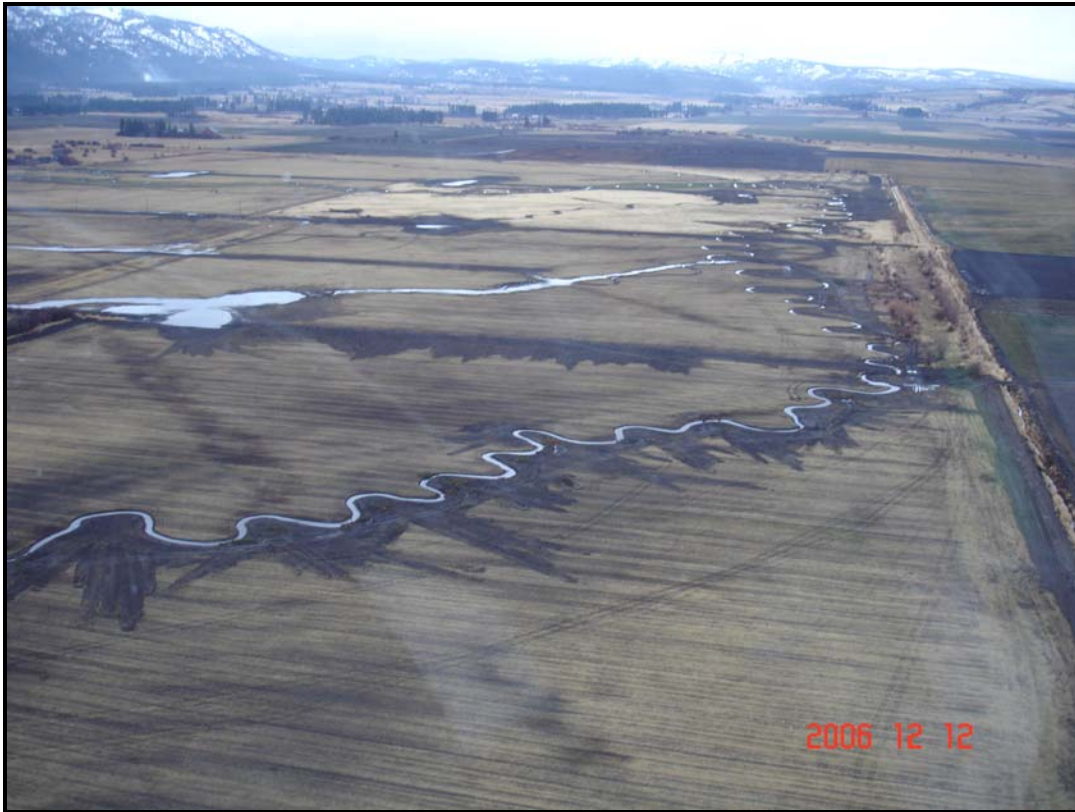
Upper reach of South Fork Willow Creek restoration channel viewing downstream towards confluence with End Creek restoration channel. Note large woody debris placement in channel and floodplain. December 2006
