Appendix 2. Pre- and post-test documentation

Turtle #1 – Pre-test documentation
 MXH20060301-01

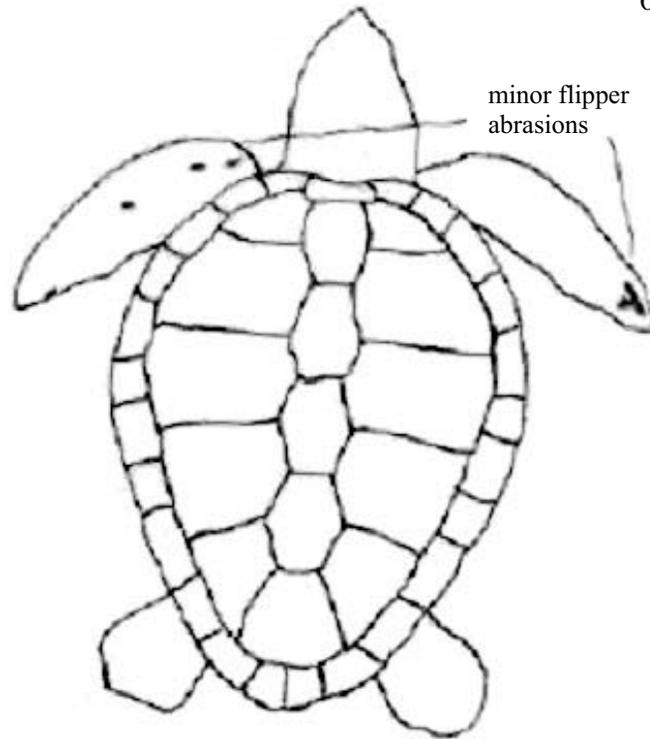
Tow #3

Turtle went around end of dredge, minimal impact. Carcass examined, no visible injuries, minor abrasions on front flippers.

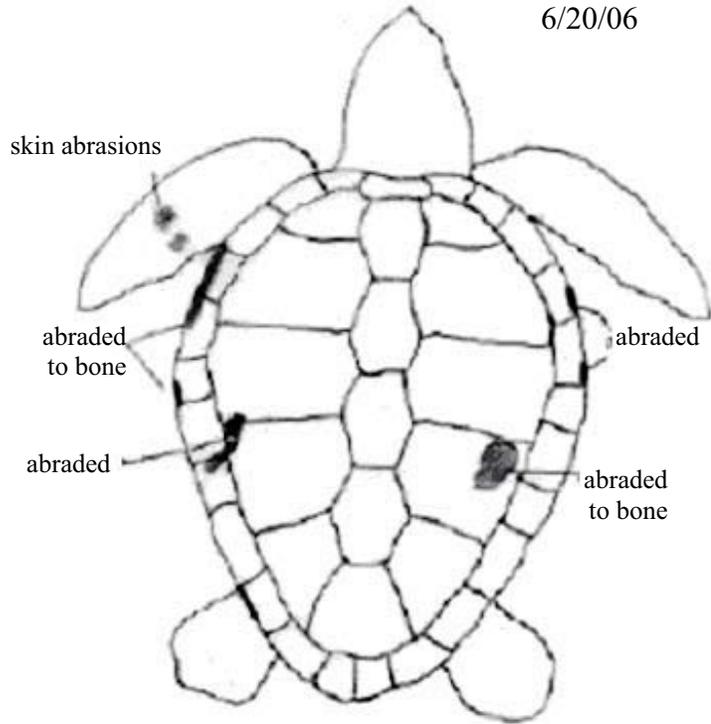
Tow #6 (see diagrams):
Abrasions on L & R side marginals,
both dorsal and ventral. Crack in
bone in left side marginals, only
visible ventral. Abraded to bone
on RC #4.

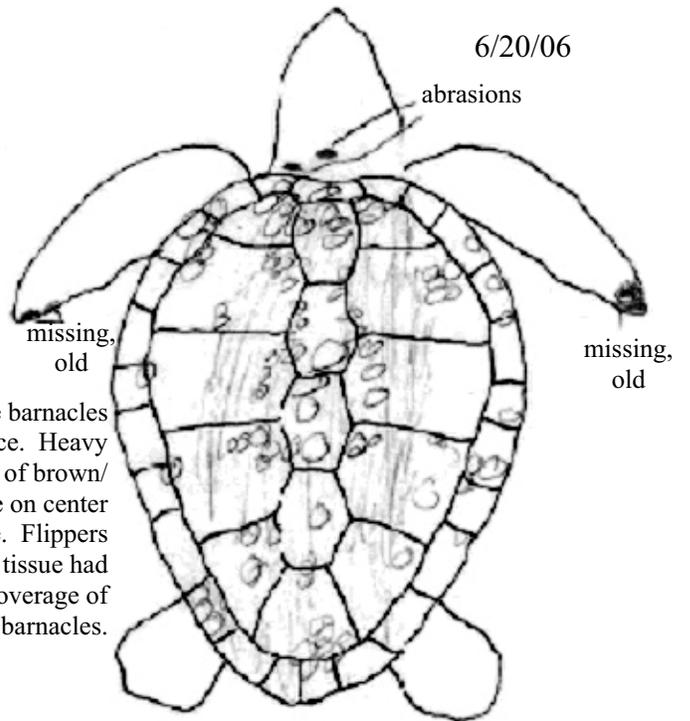
Many large barnacles on carapace. Heavy coverage of brown/red algae on center carapace. Flippers and soft tissue had heavy coverage of small barnacles.

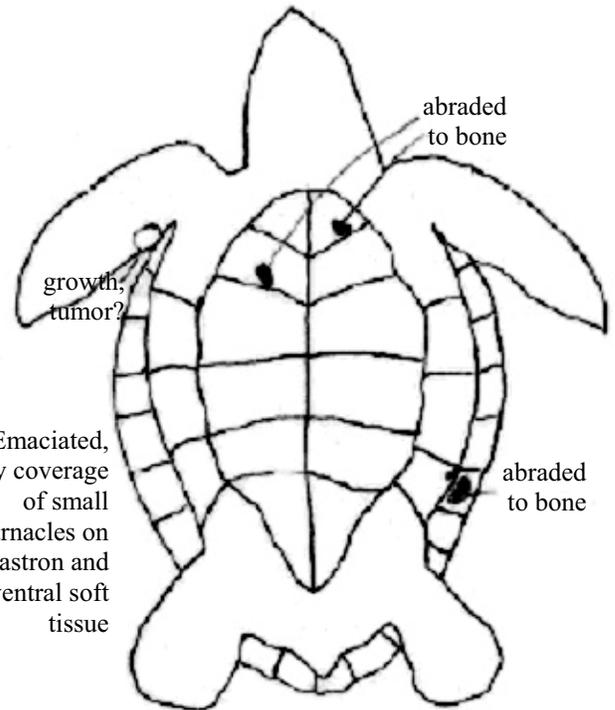
Emaciated, heavy coverage of small barnacles on plastron and ventral soft tissue

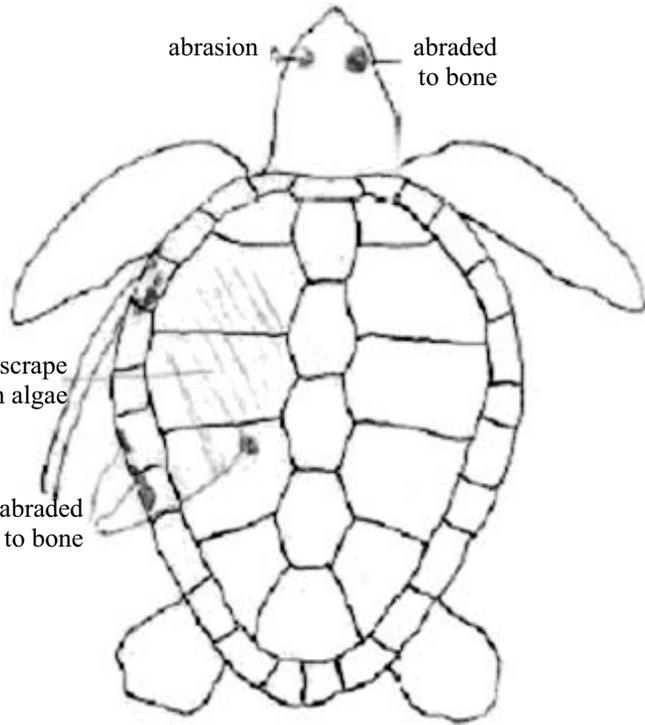
Turtle #3 Post-test documentation
Tow #8

Some barnacles (~5-10%)
knocked off center carapace

Superficial scrape
marks in algae

abraded
to bone

abrasion

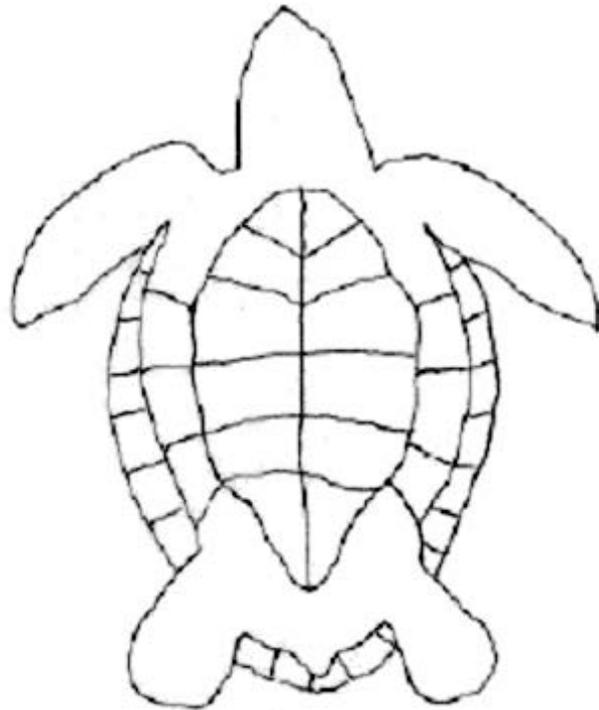
No additional ventral
injuries seen

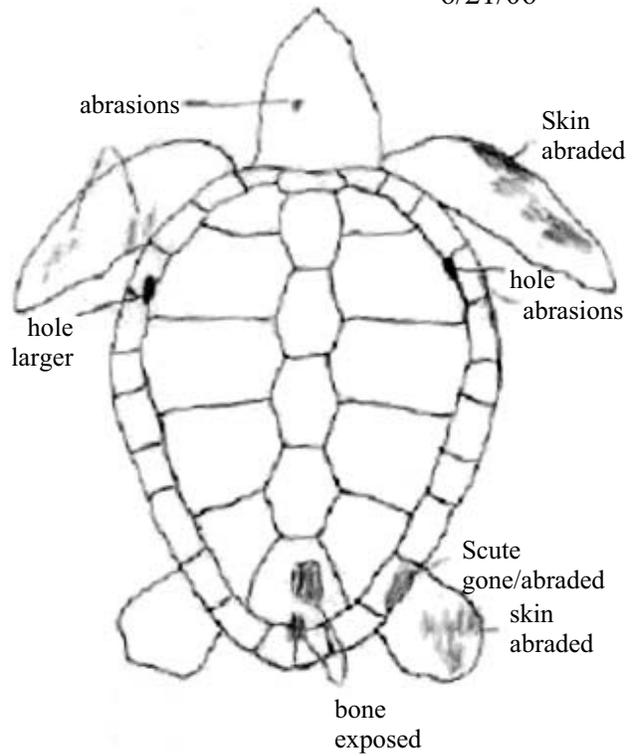
Tow #10

Scutes abraded from dorsal surfaces of both front flippers and R rear flipper.

Separation/hole larger between L marginals and LC #2. Hole between R marginals. RC #2 scute gone/abraded on R posterior marginal and minor on R side marginals. Bone exposed (skin abraded) on posterior carapace where scute was missing previously.

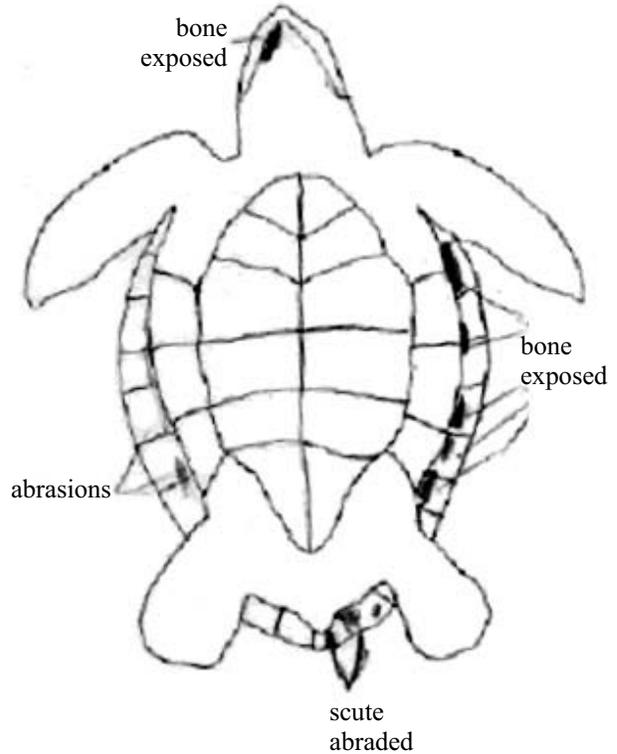
Bone exposed on right side of jaw bone.

Bone exposed along left side of plastron where marginals meet plastron – more abraded and over larger area than pre-test documentation.

Scutes abraded on ventral posterior marginals.

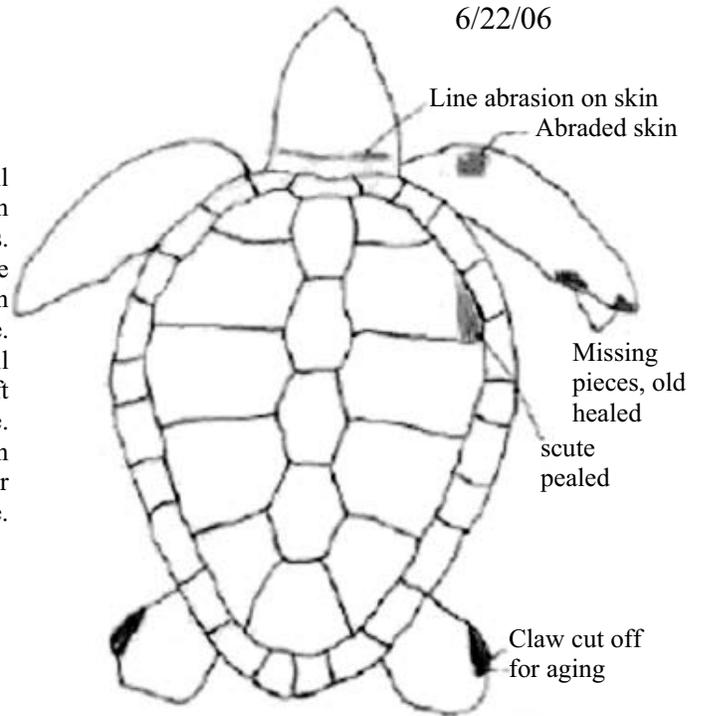
Few small barnacles on flippers.
 Several large barnacles on carapace.
 Some small barnacles on left side of carapace.
 Green algae on posterior carapace.

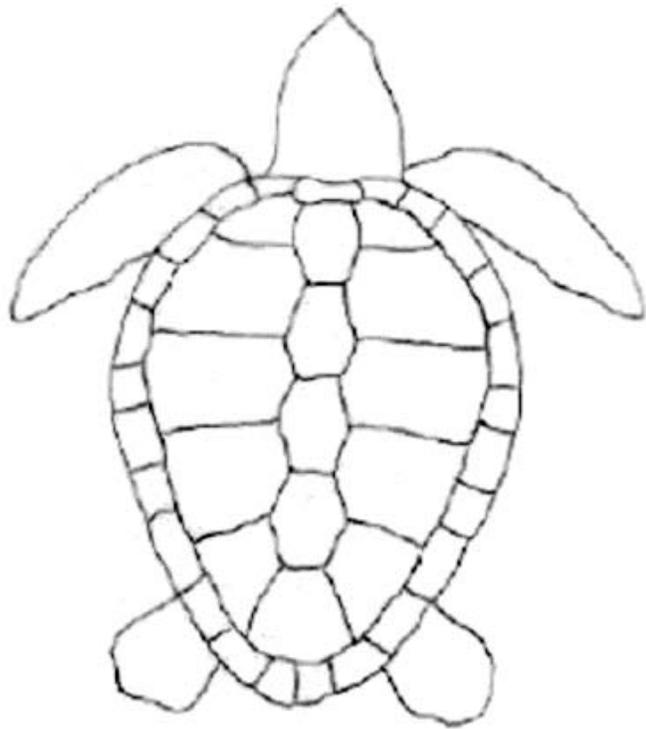
Tow #14

Carcass examined from a small boat while carcass still in water.

No additional damage seen relative to pre-test documentation.
