RULEMAKING ISSUE
(Notation Vote)

SECY-04-0194

SUBJECT: DENIAL OF PETITION FOR RULEMAKING (PRM-40-28) - DONALD A.
BARBOUR, PHILOTECHNICS

**Report: Repair and Refurbishment of Aircraft
Counterweights**

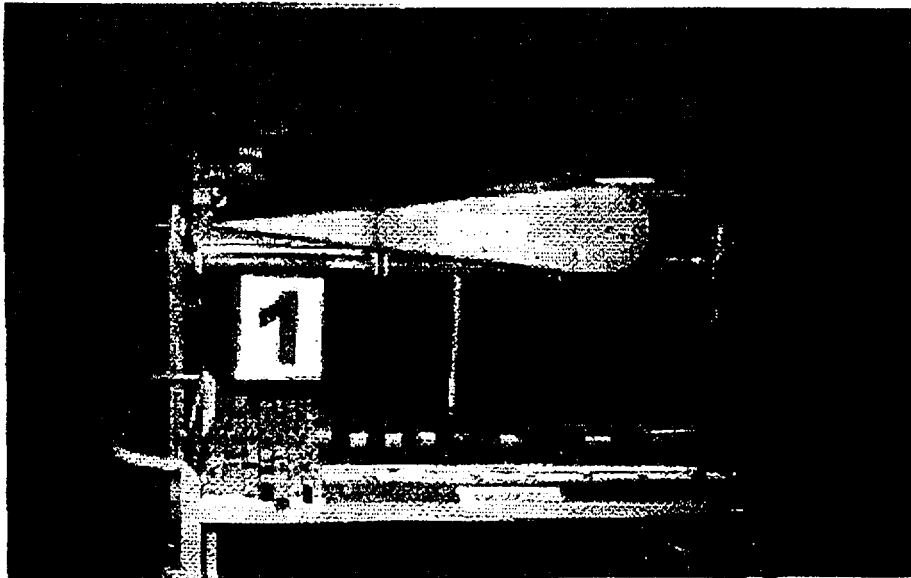
Figure 3, Counterweights Removed From Elevator 1

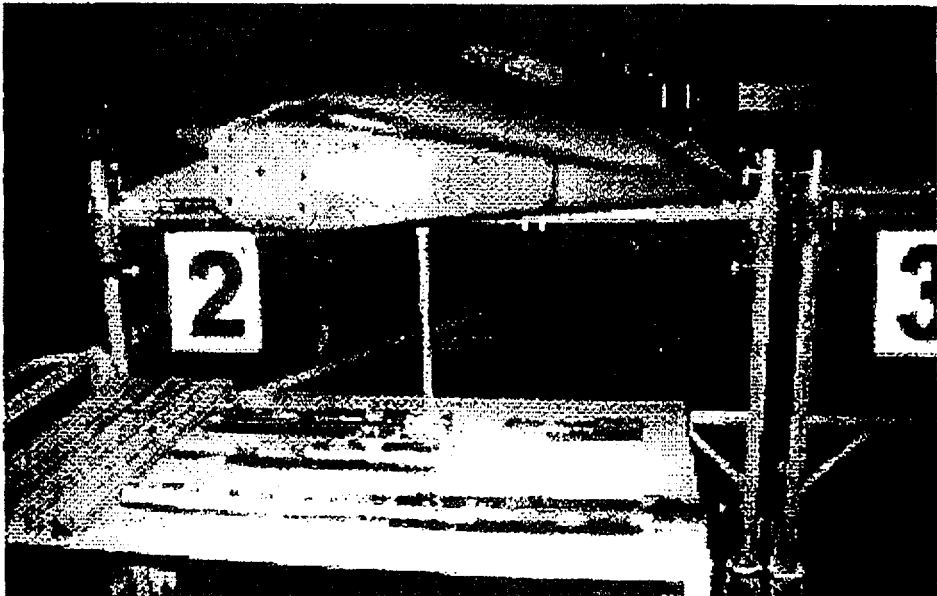
Figure 4, Counterweights Removed From Elevator 2

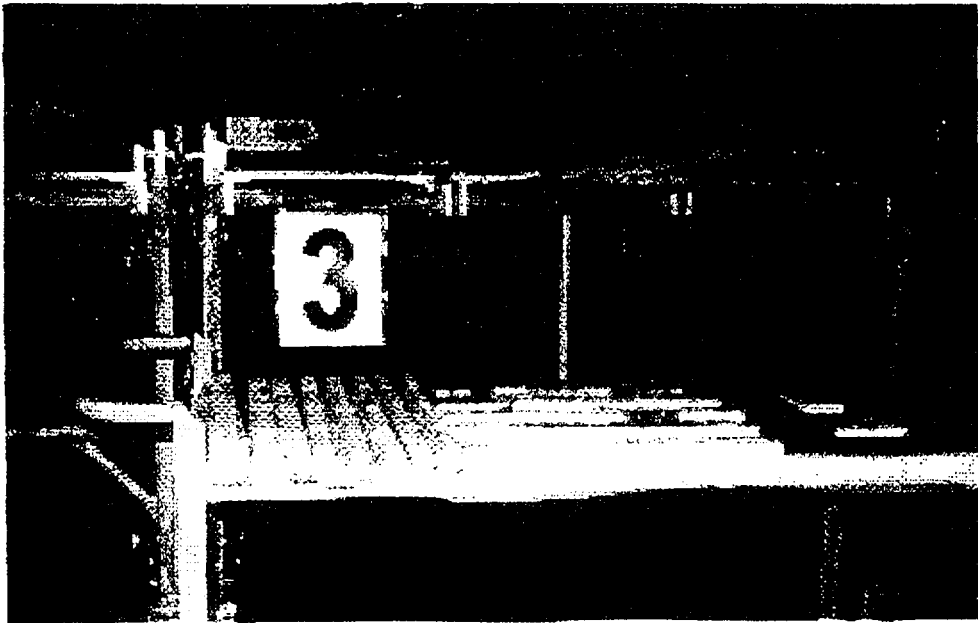
Figure 5, Counterweights Removed From Elevator 3

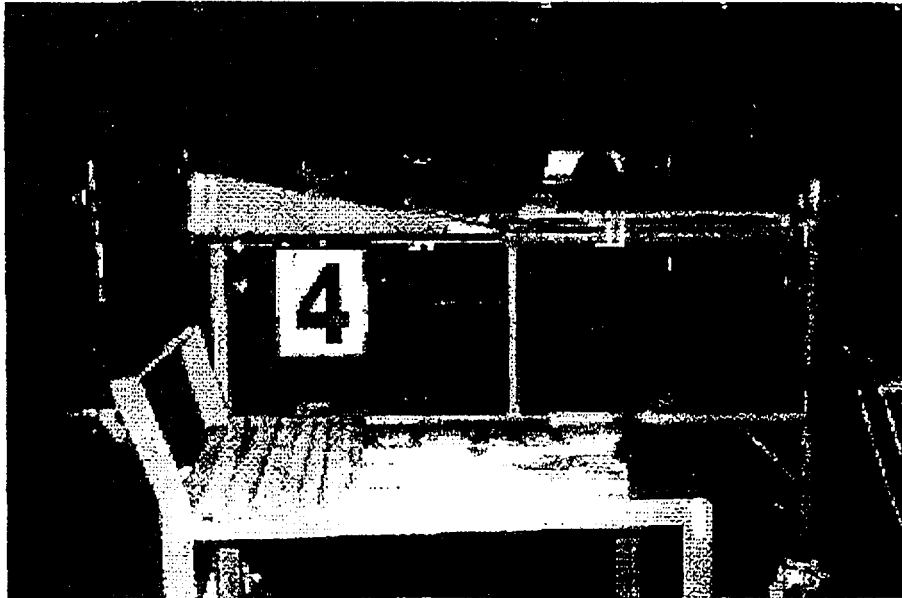
Figure 6, Counterweights Removed From Elevator 4
