Northeast Fisheries Science Center Reference Document 07-07

Evaluation of a Modified Scallop Dredge's Ability to Reduce the Likelihood of Damage to Loggerhead Sea Turtle Carcasses

April 2007

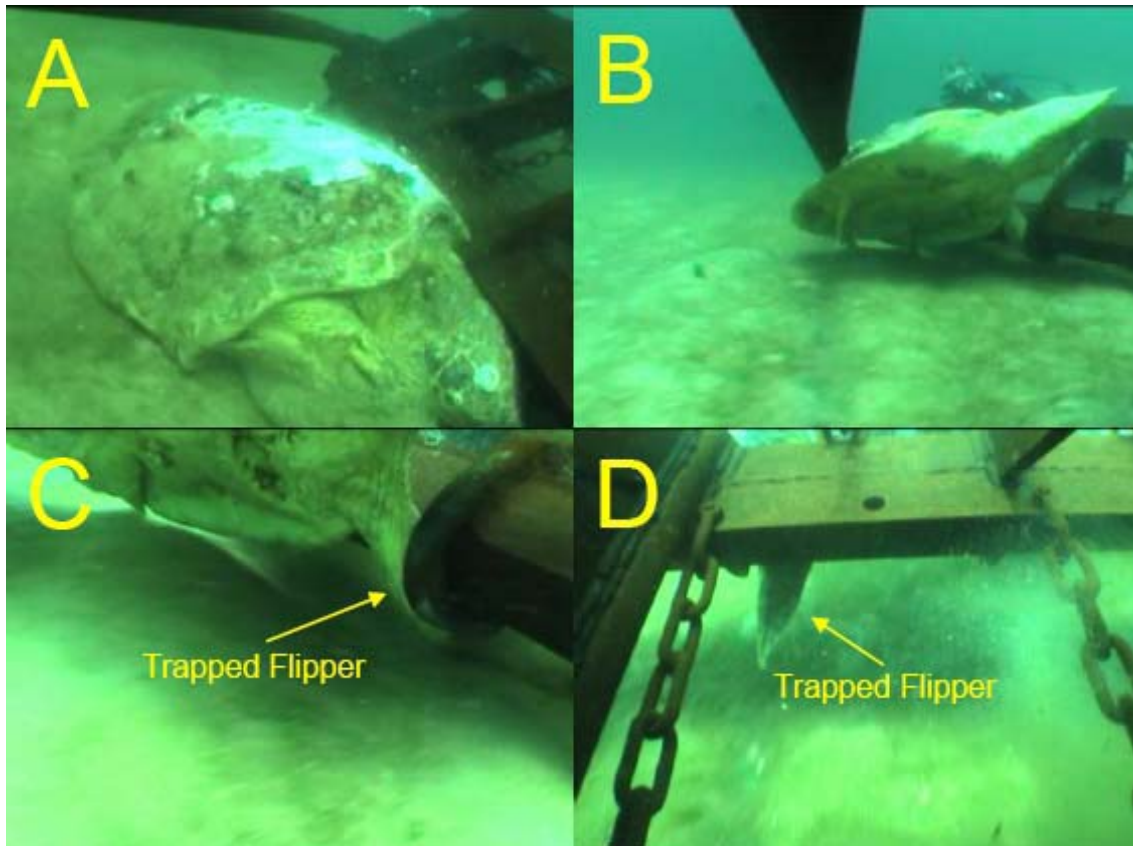
Comments: The carcass was placed under the starboard side of the dredge bale and made contact with the cutting bar in the center of the starboard side of the dredge approximately 3 feet from the edge (Figure 2A). The carcass was facing the dredge and turned slightly to the right, with the left front flipper trapped under the cutting bar by water pressure and the posterior edge of the shell held down by the bale (Figure 2B). The carcass was held in this position for approximately 4 minutes before divers removed it. The front flipper was trapped under the cutting bar and against a vertical piece of round stock that was added to the front edge of the cutting bar and pressure plate (Figure 2C and D).

Figure 2. Photos taken from video collected during tow #6 of modified scallop dredge testing June 20, 2006. (A) Initial impact with the dredge; (B) carcass caught under bale; (C) flipper under cutting bar and against round stock modification; (D) rear view of flipper.

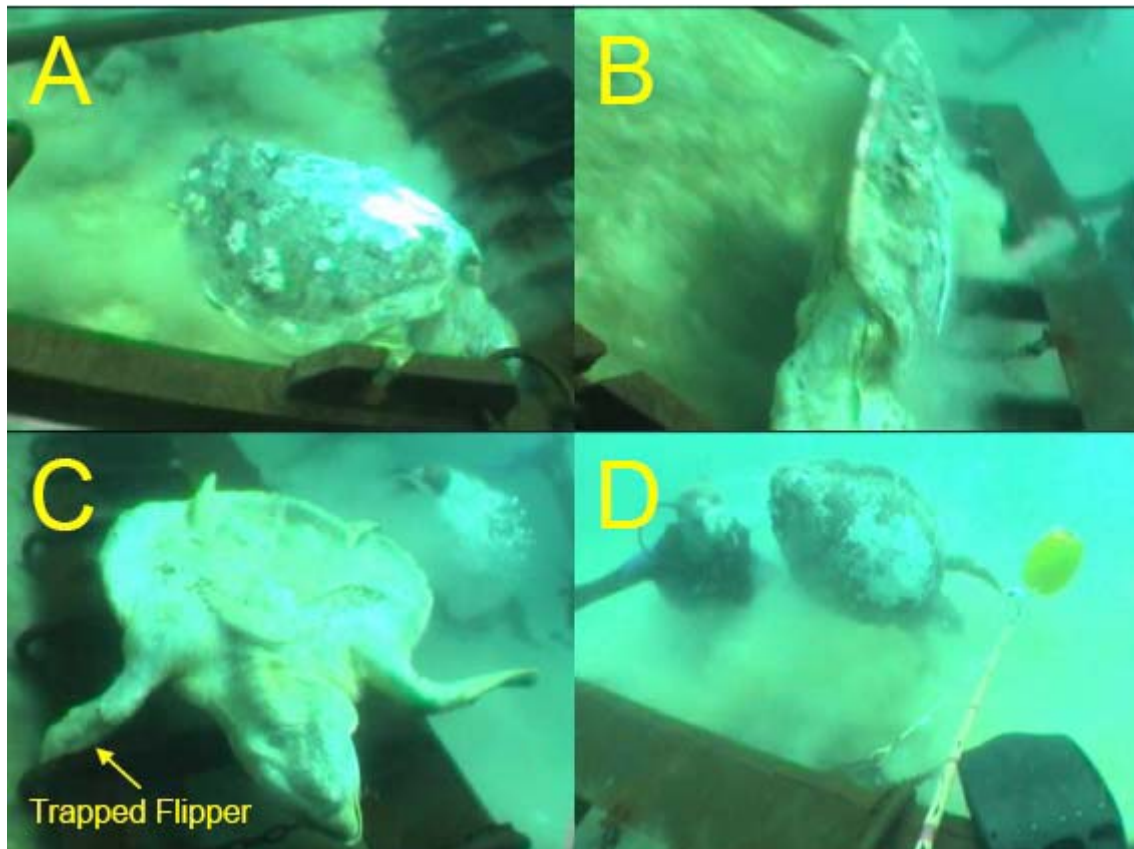
Comments: The carcass was placed under the starboard side of the dredge bale and made contact with the cutting bar just to the starboard side of the center bar approximately 6 feet from the edge of the frame (Figure 3A). The carcass was facing the dredge and turned slightly to the right with the front left flipper and head making initial contact. The carcass then flipped up onto the front of the dredge (Figure 3B and C). The right front flipper was momentarily trapped under the cutting bar before releasing and allowing the carcass to flip up and over the dredge (Figure 3C and D).

Figure 3. Photos taken from video collected during tow #7 of modified scallop dredge testing June 20, 2006. (A) Initial impact with the dredge; (B) carcass beginning to flip up; (C) carcass flipping onto dredge with flipper momentarily trapped; (D) carcass going over dredge.

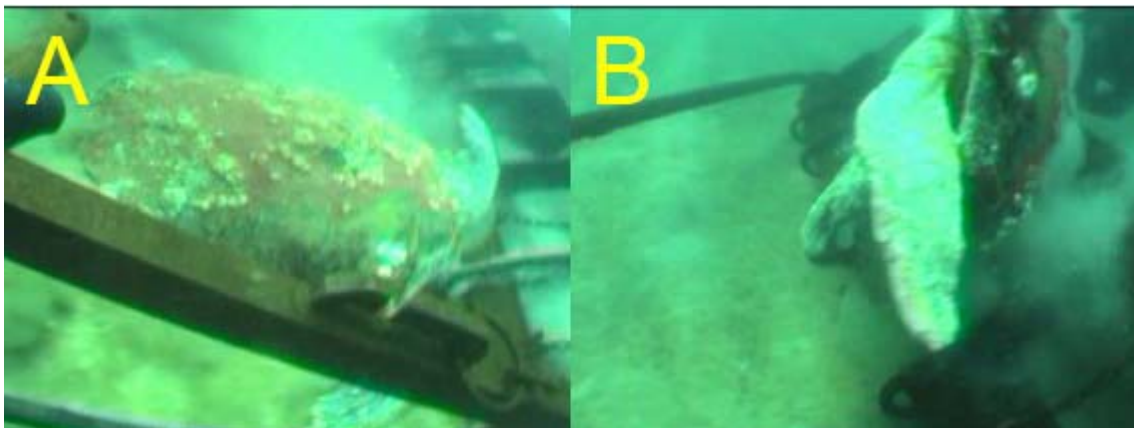
Comments: The carcass was placed under the starboard side of the dredge bale and made contact with the cutting bar just to the starboard side of the center bar approximately 6 feet from the edge of the frame (Figure 4A). The carcass was facing the dredge and made contact head first. The carcasses stayed in position for a few seconds and proceeded to flip up and over the pressure plate where it was recovered by divers (Figure 4B).

Figure 4. Photos taken from video collected during tow #8 of modified scallop dredge testing June 20, 2006. (A) Initial impact with the dredge; (B) carcass flipping up and over the dredge.

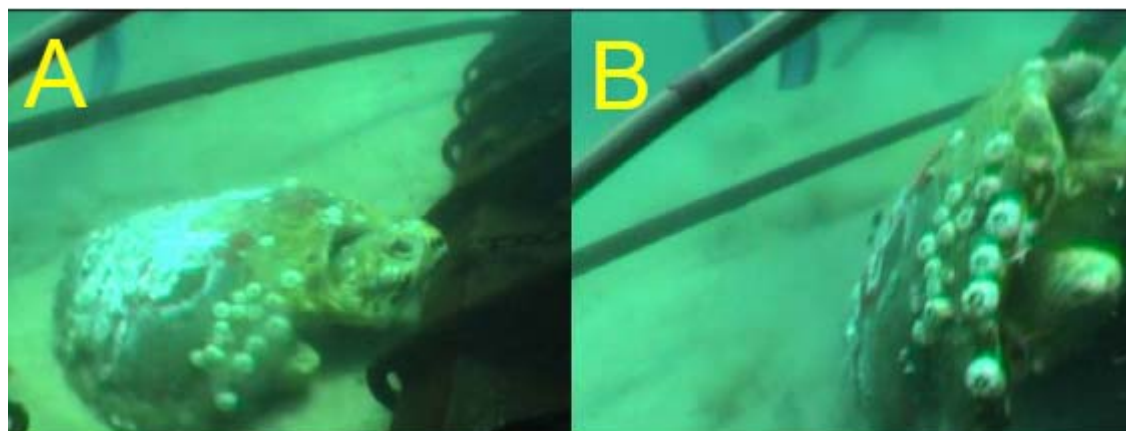
Comments: The carcass was placed under the starboard side of the dredge bale and made contact with the cutting bar near the middle of the starboard side of the dredge approximately 4 feet from the edge of the frame (Figure 5A). The carcass was facing the dredge and made contact head first. The carcass slid up the face of the dredge immediately after impact and proceeded to go over the pressure plate (Figure 5B).

Figure 5. Photos taken from video collected during tow #10 of modified scallop dredge testing June 21, 2006. (A) Initial impact with the dredge; (B) carcass sliding up and over the dredge.

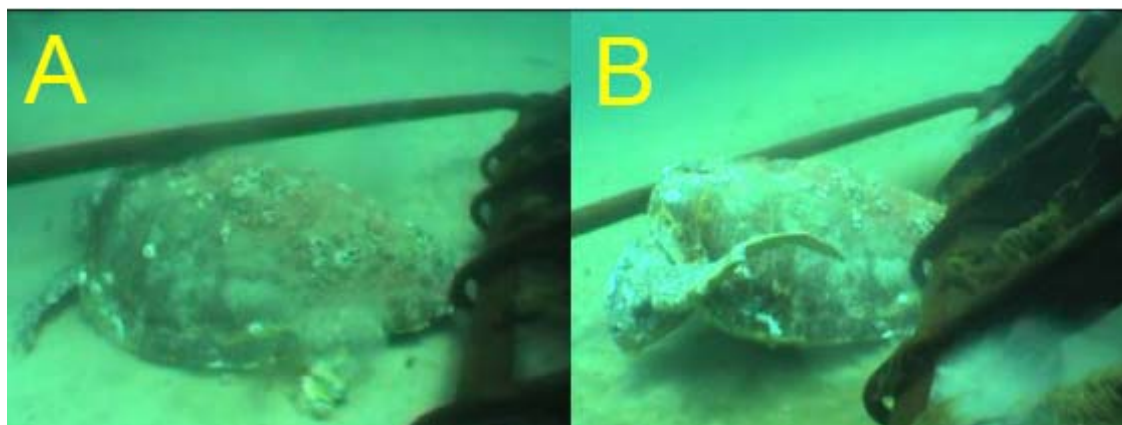
Comments: The carcass was placed under the starboard side of the dredge bale and made contact with the cutting bar near the edge of the starboard side of the dredge approximately 3 feet from the edge of the frame (Figure 6A). The carcass encountered the dredge tail first. The posterior edge of the carapace was caught under the cutting bar while the anterior portion of the carapace was held down by the dredge bale, which prevented the carcass from flipping up and over the dredge frame (Figure 6B).

Figure 6. Photos taken from video collected during tow #11 of modified scallop dredge testing June 21, 2006. (A) Initial impact with the dredge; (B) carcass caught under bale and cutting bar.

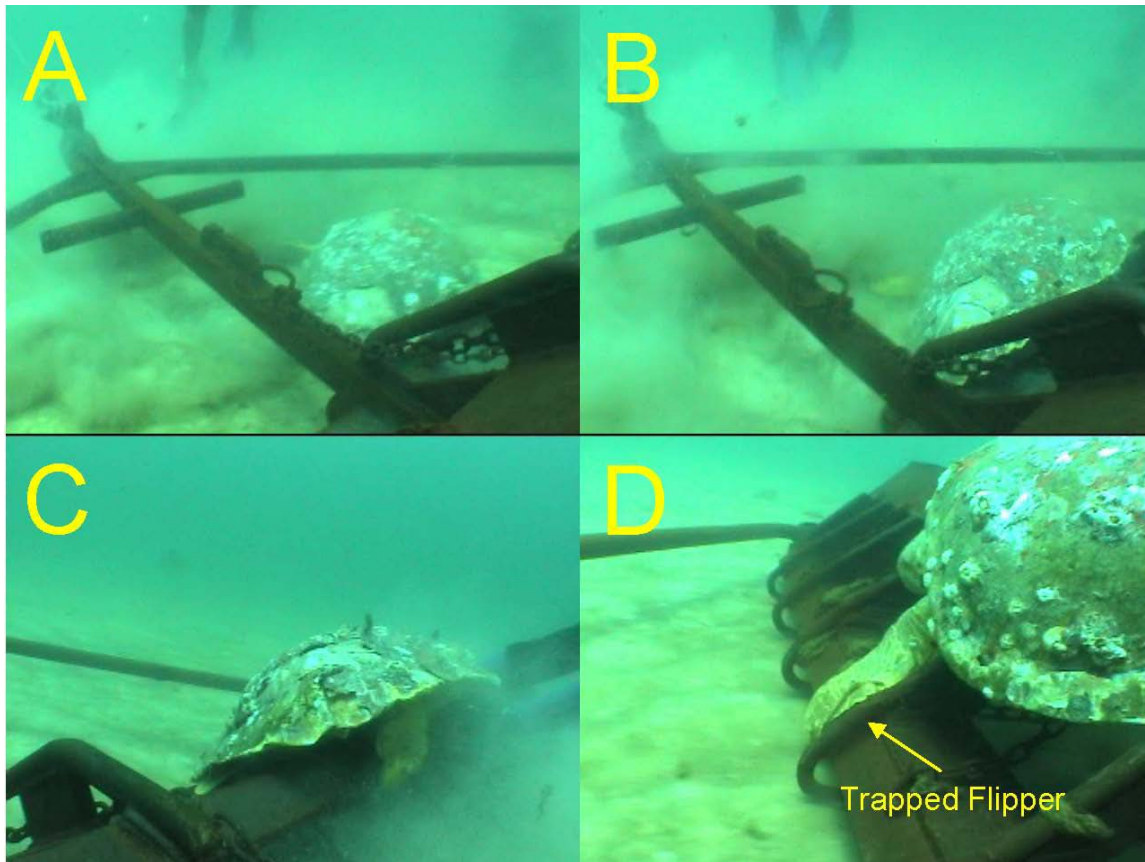
Comments: The carcass was placed under the starboard side of the dredge bale and made contact with the cutting bar near the center of the dredge just on the starboard side of the center brace bar approximately 6 feet from the edge of the frame (Figure 7A). The carcass encountered the dredge tail first and was angled to the right. Upon impact the carcass slid up the face of the dredge and stalled on the pressure plate (Figure 7B and C). The carcass's front left flipper was trapped under the cutting bar and against a vertical piece of round stock (Figure 7D). The carcass was held in this position for approximately one minute before it moved the rest of the way over the dredge.

Figure 7. Photos taken from video collected during tow #12 of modified scallop dredge testing June 21, 2006. (A) Initial impact with the dredge; (B) carcass sliding up face of the dredge; (C) carcass stopping on the pressure plate; (D) flipper which may have temporarily held carcass in place.

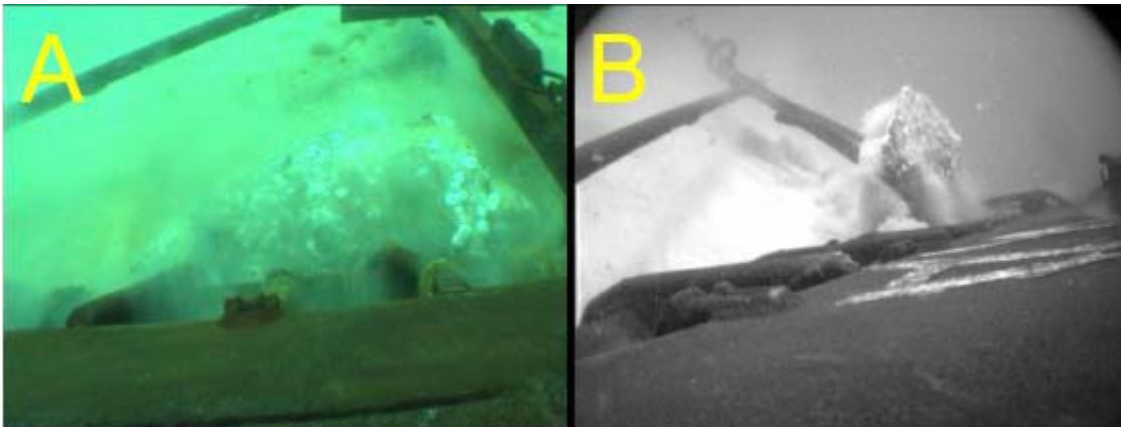
Comments: The carcass was placed under the port side of the dredge bale and made contact with the cutting bar near the center of the dredge just on the port side of the center brace bar approximately 5 feet from the edge of the frame (Figure 8A). The carcass was facing to the right and encountered the dredge along its entire right side. Upon impact the carcass flipped up and over the dredge (Figure 8B).

Figure 8. Photos taken from video collected during tow #13 of modified scallop dredge testing June 21, 2006. (A) Initial impact with the dredge; (B) carcass flipping up and over the dredge.

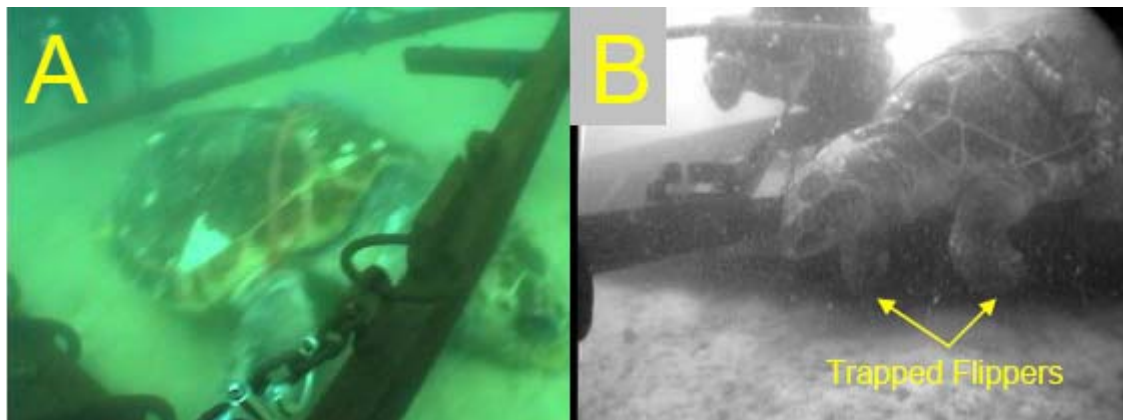
Comments: The carcass was large and bloated and required the addition of thirty pounds of weight to sink. The carcass was placed under the port side of the dredge bale and made contact with the cutting bar just to the port side of the center brace bar approximately 5 feet from the edge of the frame (Figure 9A). The carcass was facing to the right and encountered the dredge along its entire right side. Upon impact the carcass slid up the face of the dredge and stopped (Figure 9B). The attached weights may have hung on the face of the dredge preventing it from sliding completely over the dredge. In addition, both front flippers were under the cutting bar which may have also prevented the carcass from sliding any further up the face of the dredge (Figure 9B).

Figure 9. Photos taken from video collected during tow #14 of modified scallop dredge testing June 22, 2006. (A) Initial impact with the dredge; (B) carcass sliding up the face of the dredge.

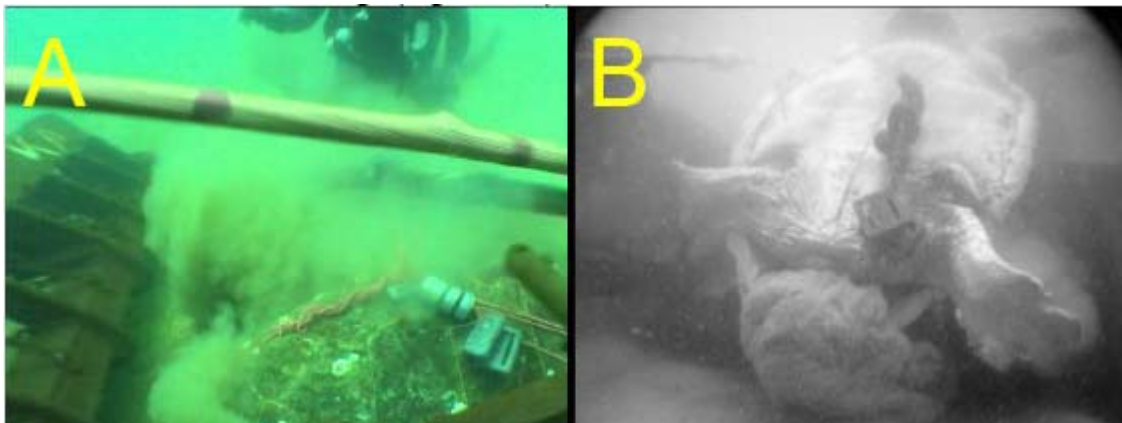
Comments: This was the same carcass used on the previous tow and required the addition of weights to sink. The carcass was placed under the port side of the dredge bale and made contact with the cutting bar on the port side of the center brace bar about 5 feet from the edge of the frame (Figure 10A). The carcass encountered the dredge tail first. Upon impact the carcass flipped up and over the face of the dredge (Figure 10B).

Figure 10. Photos taken from video collected during tow #15 of modified scallop dredge testing June 22, 2006. (A) Initial impact with the dredge; (B) carcass flipping up and over the dredge.

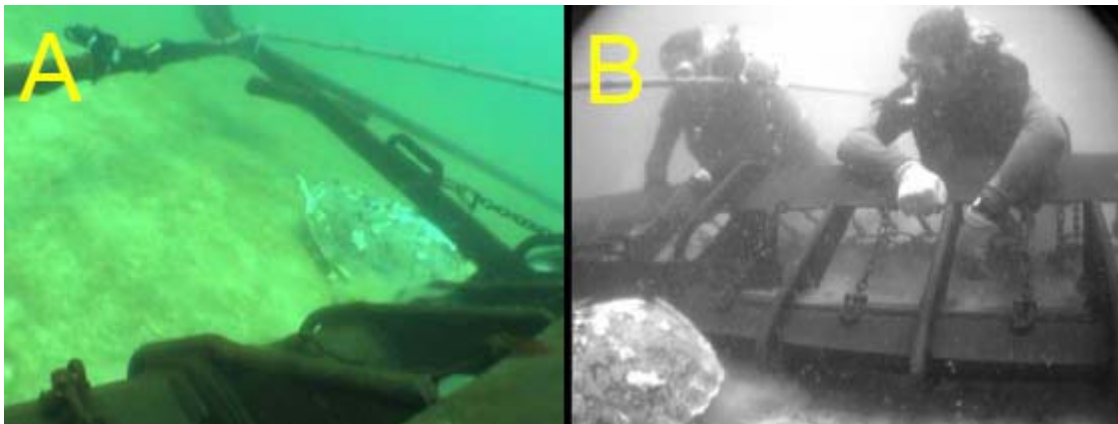
Comments: The carcass was placed directly under the center brace bar (Figure 11A). The carcass encountered the dredge head first and was held under the center brace bar until divers removed it (Figure 11B).

Figure 11. Photos taken from video collected during tow #16 of modified scallop dredge testing June 22, 2006. (A) Initial impact with the dredge; (B) divers preparing to remove carcass from under the center brace bar.

The 2006 Panama City gear trials showed that moving the cutting bar forward and adding round stock to the dredge frame was successful in creating a ramp that caused turtle carcasses to go over the dredge. Further work will incorporate the same frame design with modifications to the bale to reduce the likelihood of entrapping turtles under these bars.

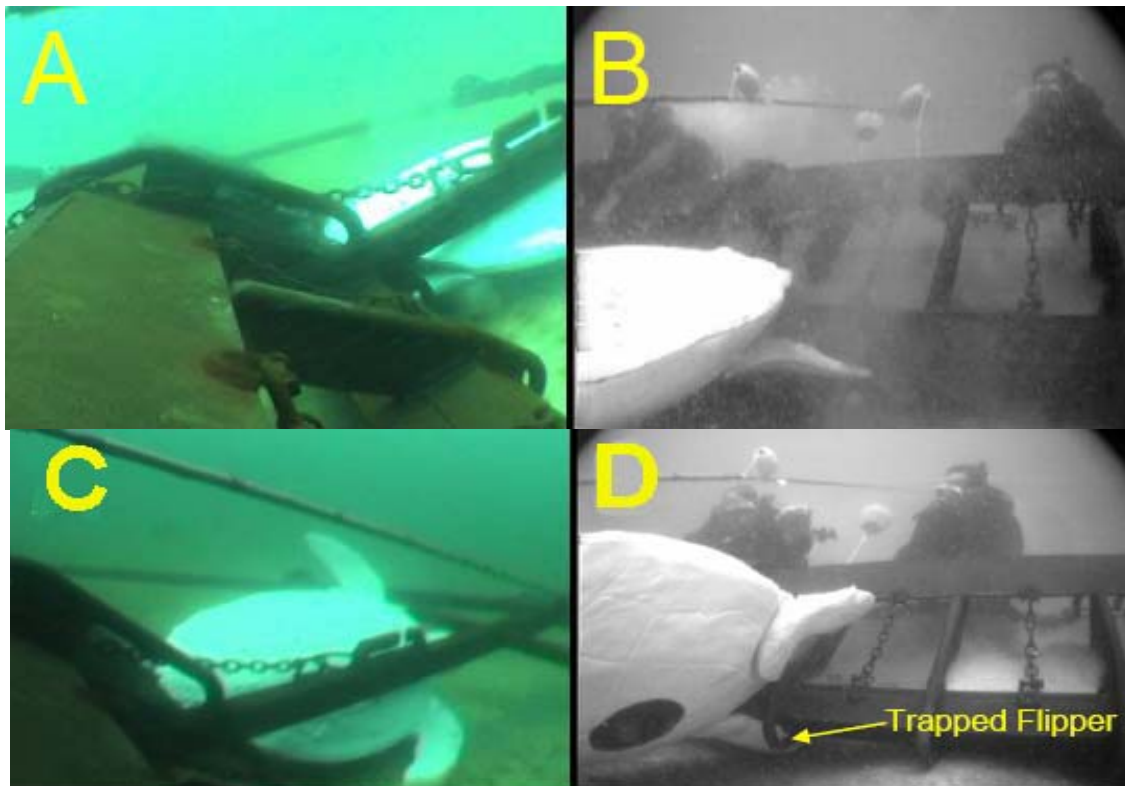
Comments: The model was placed under the port side of the dredge bale and made contact with the cutting bar near the center of the dredge just on the port side of the center brace bar 5 feet from the edge of the frame (Figure 12A and B). The model encountered the dredge tail first. Upon impact the model started to flip up but the head caught under a cross bar where wheels had been previously mounted on the center bar. This prevented the model from flipping up and over the dredge (Figure 12C). In addition, the right rear flipper was trapped under the cutting bar (Figure 12D).

Figure 12. Photos taken from video collected during tow #17 of modified scallop dredge testing June 22, 2006. (A) Initial impact with the dredge; (B) initial impact with the dredge; (C) turtle model caught with head under crossbar (D) rear flipper of model shown under cutting bar.

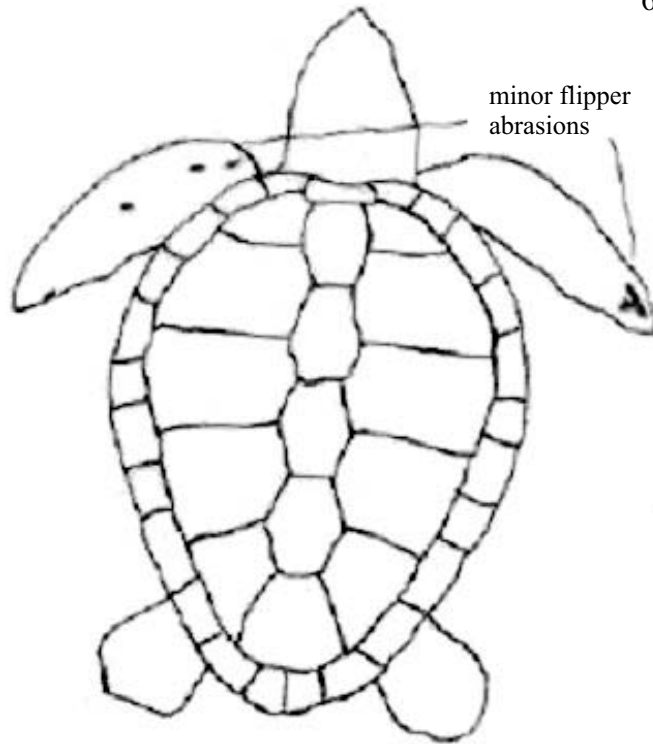
Tow #3

Turtle went around end of dredge, minimal impact. Carcass examined, no visible injuries, minor abrasions on front flippers.

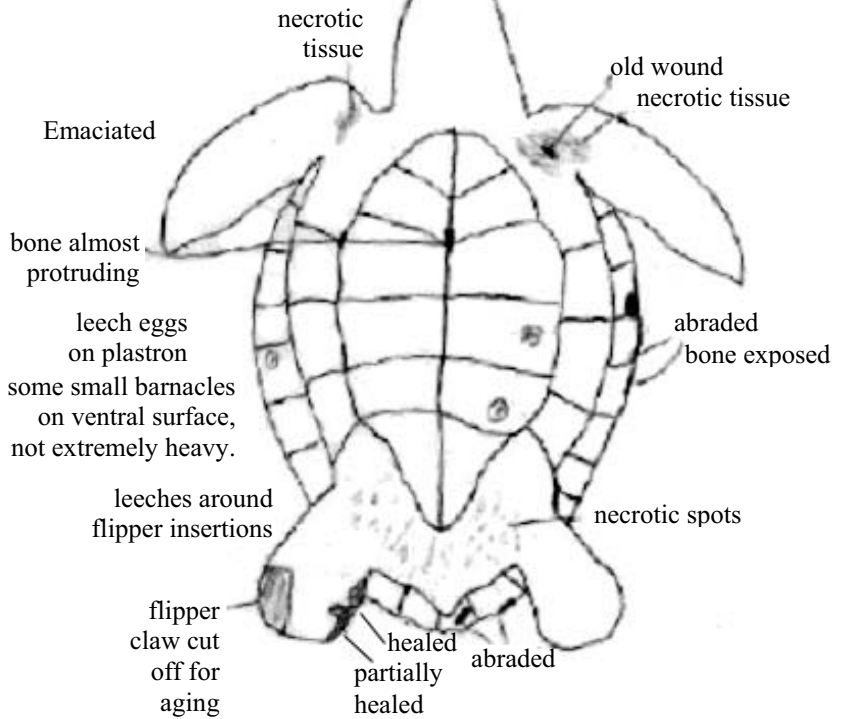
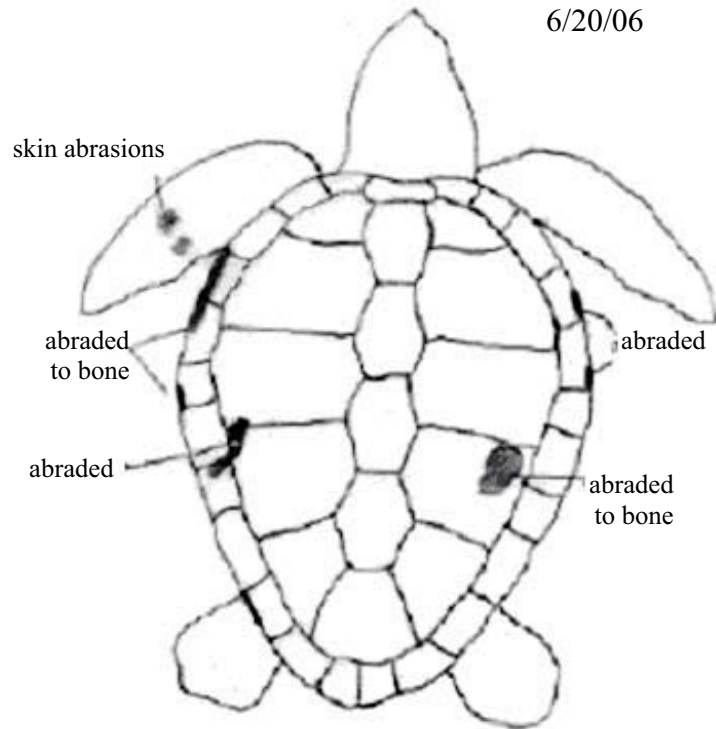
Tow #6 (see diagrams):
Abrasions on L & R side marginals,
both dorsal and ventral. Crack in
bone in left side marginals, only
visible ventral. Abraded to bone
on RC #4.

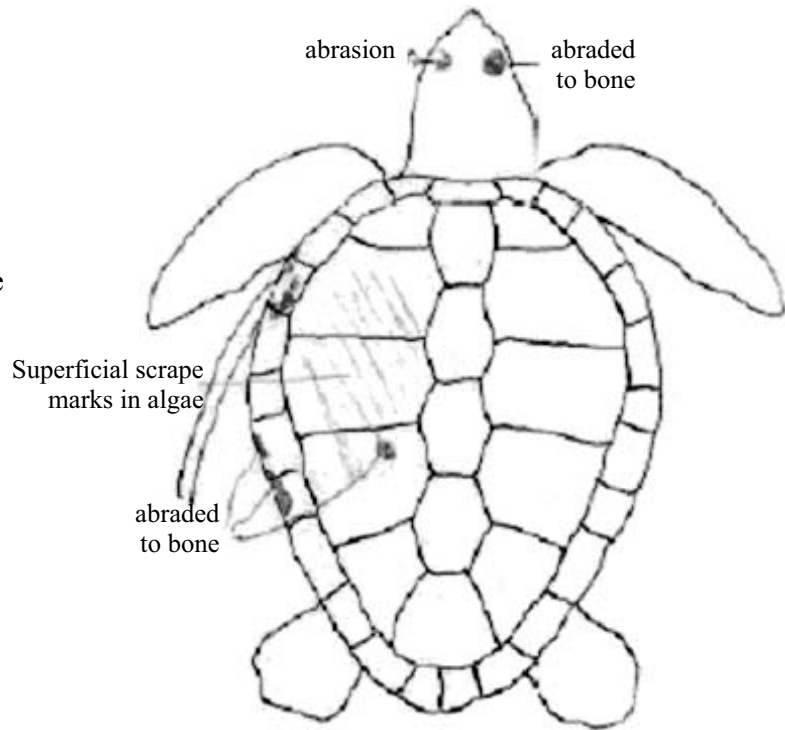
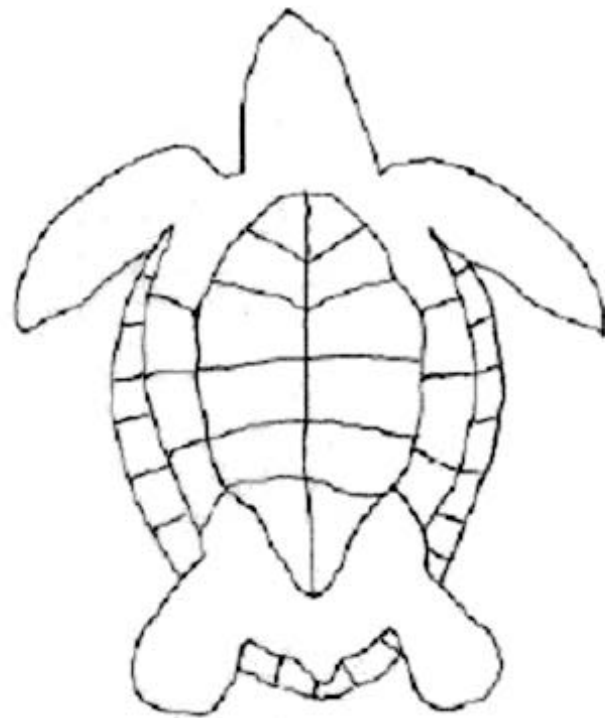
Turtle #3 Post-test documentation
Tow #8

Some barnacles (~5-10%)
knocked off center carapace

No additional ventral
injuries seen

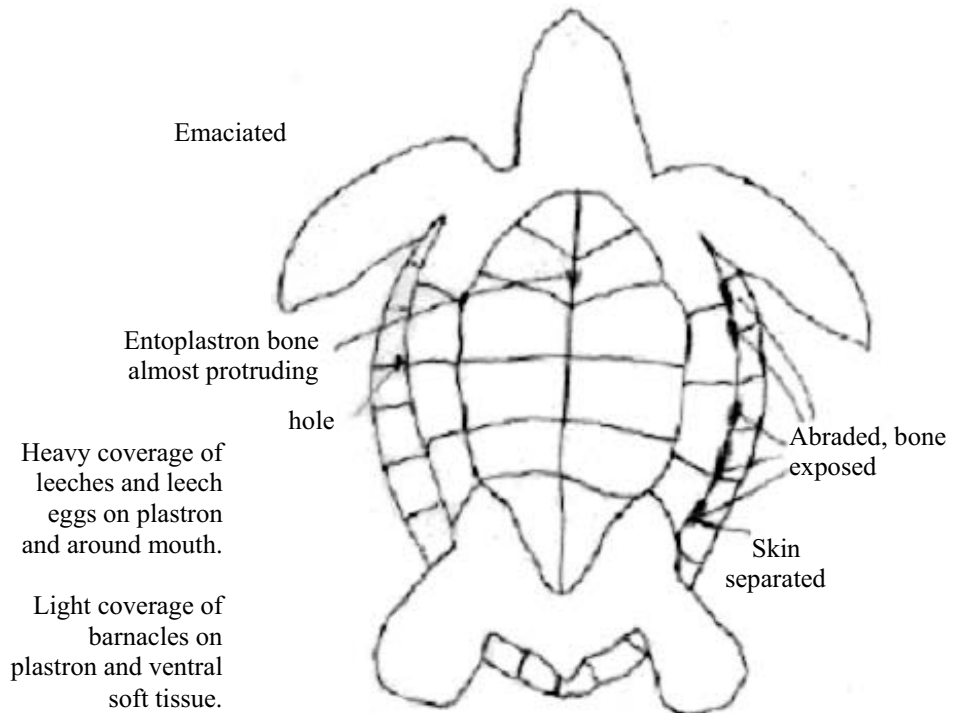
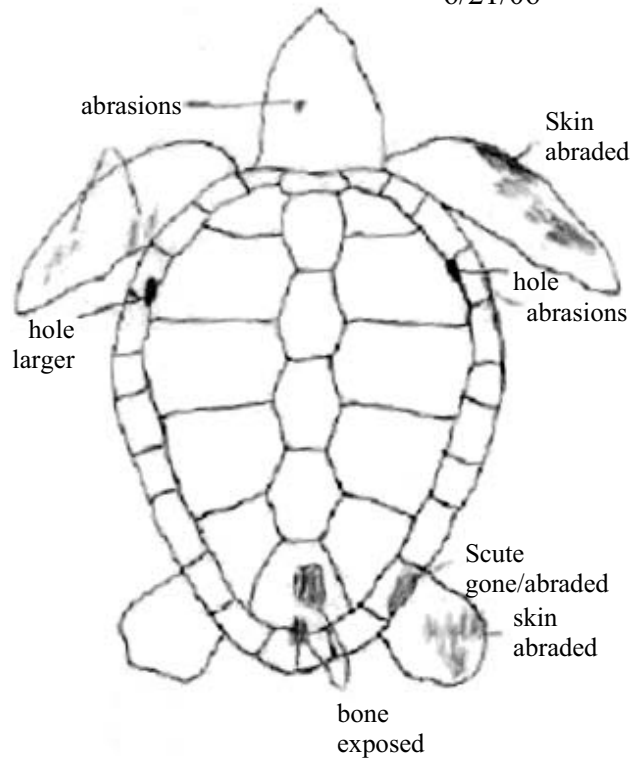
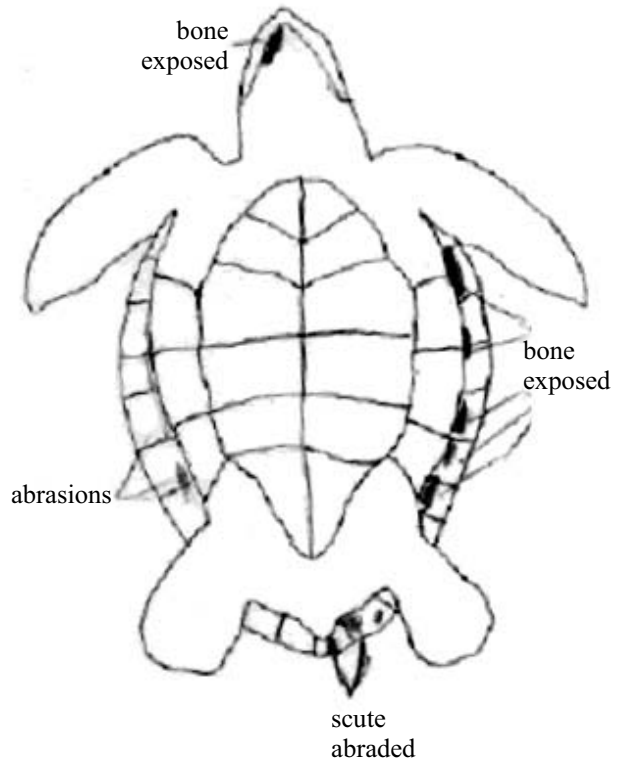
Tow #10

Scutes abraded from dorsal surfaces of both front flippers and R rear flipper.

Separation/hole larger between L marginals and LC #2. Hole between R marginals. RC #2 scute gone/abraded on R posterior marginal and minor on R side marginals. Bone exposed (skin abraded) on posterior carapace where scute was missing previously.

Bone exposed on right side of jaw bone.

Bone exposed along left side of plastron where marginals meet plastron – more abraded and over larger area than pre-test documentation.

Scutes abraded on ventral posterior marginals.

Tow #12 – no additional damage
 Tow #13 – carapace bone broken. RC#3 and adjacent marginals; crack in posterior carapace.

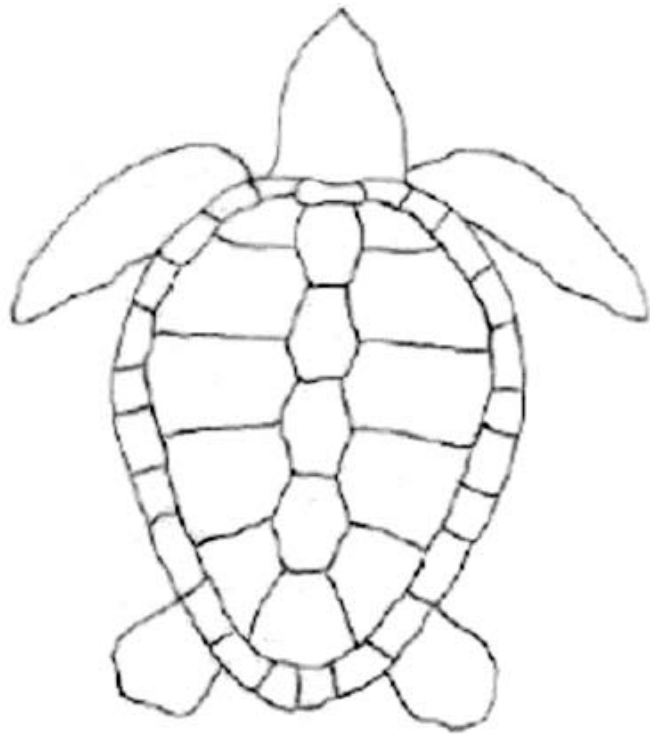
Tow #14

Carcass examined from a small boat while carcass still in water.

No additional damage seen relative to pre-test documentation.
