U.S. Department of Agriculture
Office of Inspector General
Western Region
Audit Report

Rural Development
Lender Servicing of
Business and Industry
Guaranteed Loans - State of Arizona
Lender B

Report No.
34601-4-SF
September 2001

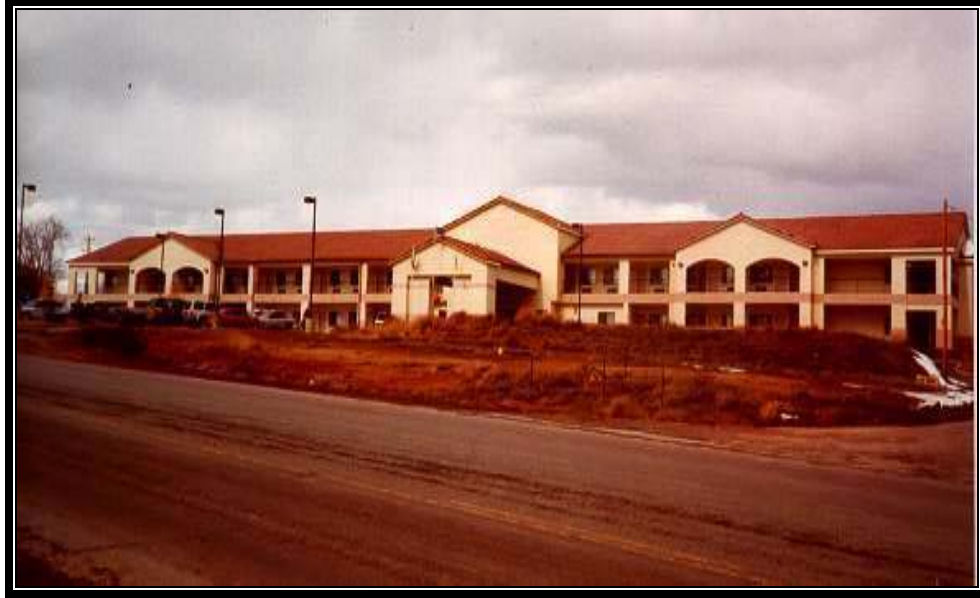
OIG Photo

The architect’s consulting engineer completed a report on September 14, 1998 (see Exhibit B), subsequent to the completion of the structure, and noted 44 deficiencies that affected the structural integrity of the building. These deficiencies resulted from the contractor’s deviations from the original plans and specifications. The engineer indicated that these deficiencies “must be repaired to improve the structural integrity of the building as intended by our original structural design and drawings.” To support the assertion that deviations had occurred, the engineer referred in his report to an affidavit from a subcontractor that stated, “throughout the building, support footing for beam supports were all deleted.”
