Appendix D2

ESEM and SEM/EDS Data for Test #2, Day-30 Fiberglass in High- and Low-Flow Zones

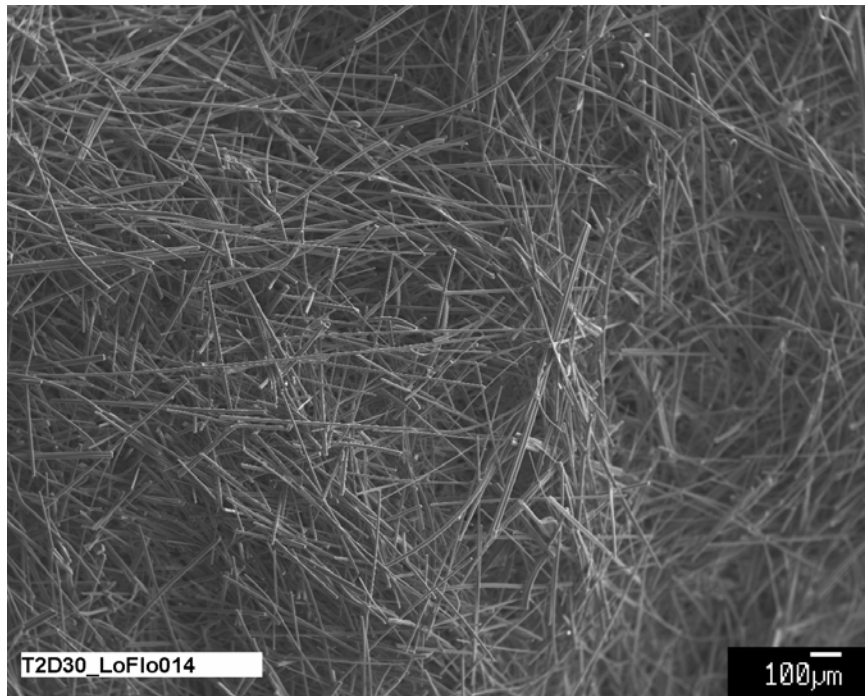
Figure D2-1. SEM image for a Test #2, Day-30 low-flow exterior fiberglass sample. (T2D30_LoFlo014)

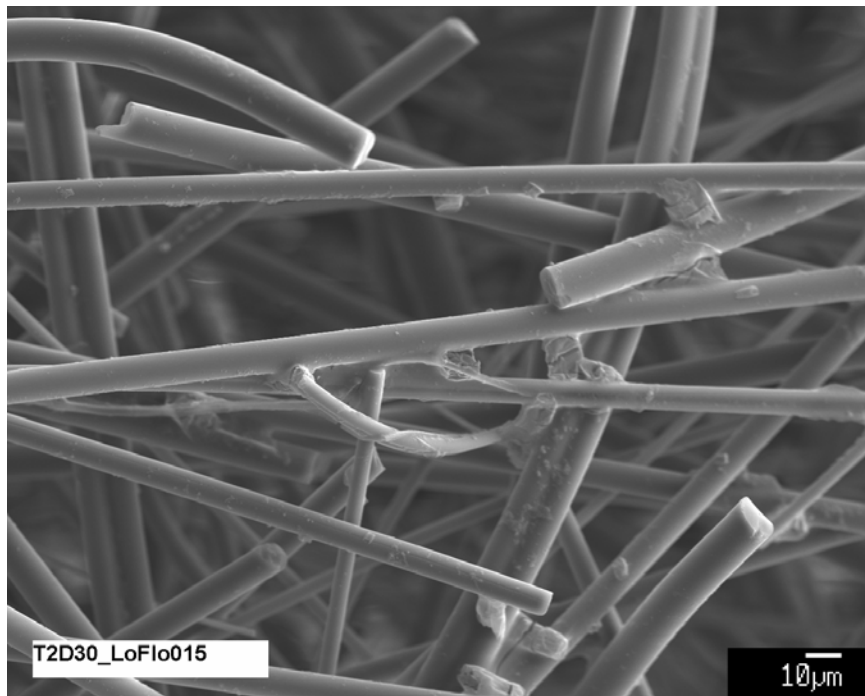
Figure D2-2. SEM image of a higher magnification for a Test #2, Day-30 low-flow exterior fiberglass sample. (T2D30_LoFlo015)

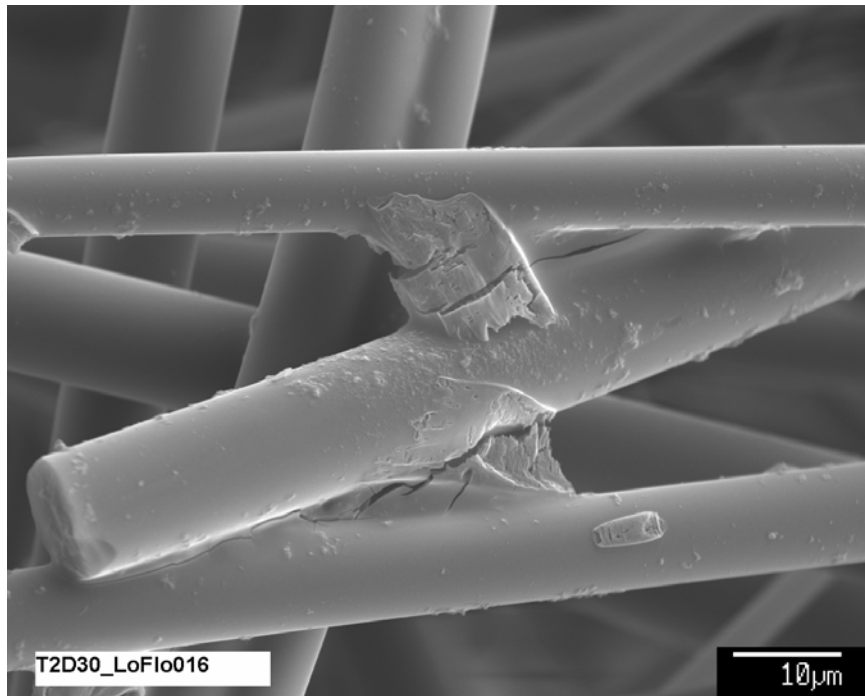
Figure D2-3. SEM image of a higher magnification for a Test #2, Day-30 low-flow exterior fiberglass sample. (T2D30_LoFlo016)

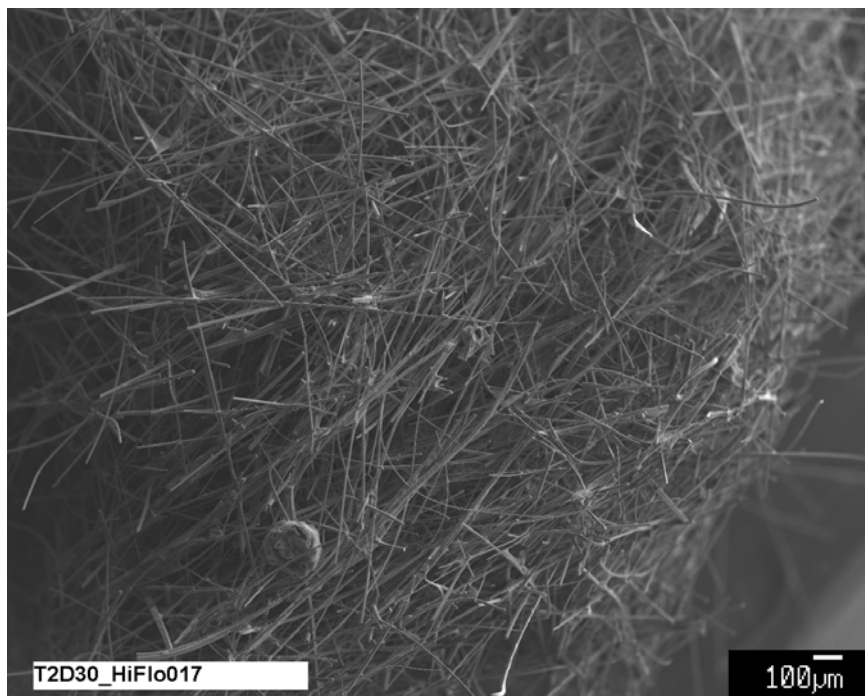
Figure D2-4. SEM image for a Test #2, Day-30 high-flow exterior fiberglass sample. (T2D30_HiFlo017)

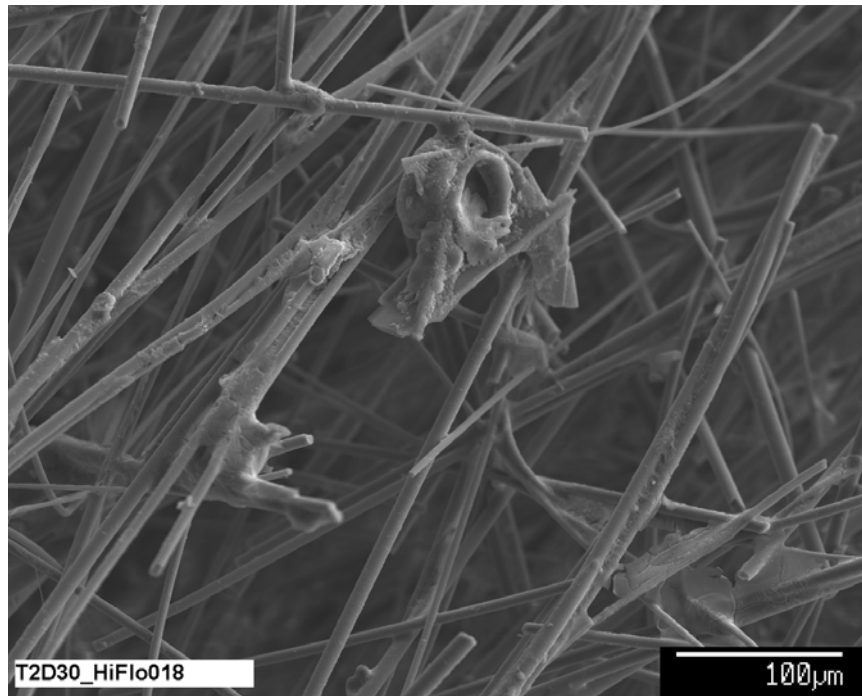
Figure D2-5. SEM image for a Test #2, Day-30 high-flow exterior fiberglass sample. (T2D30_HiFlo018)

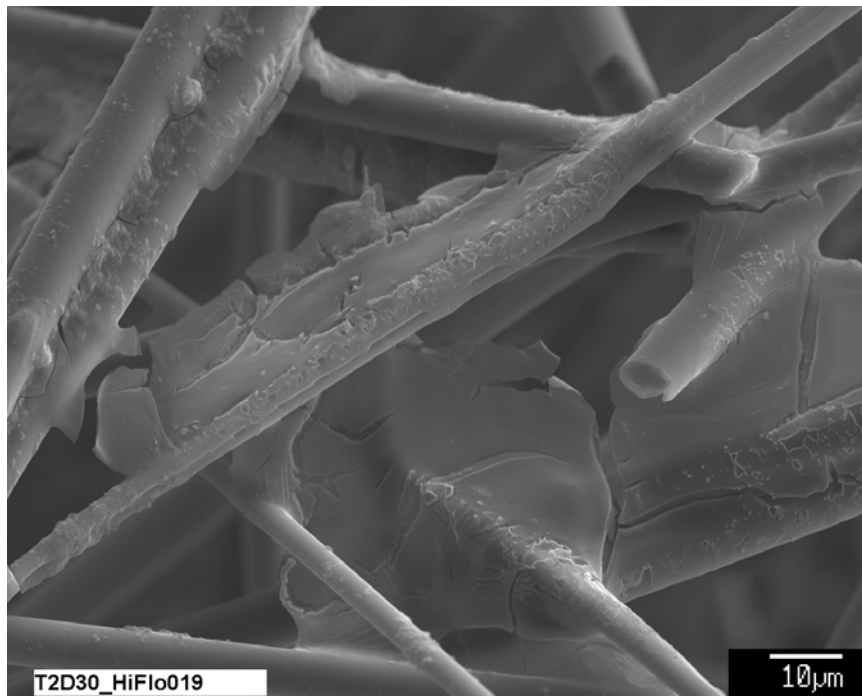
Figure D2-6. SEM image of a higher magnification for a Test #2, Day-30 high-flow exterior fiberglass sample. (T2D30_HiFlo019)

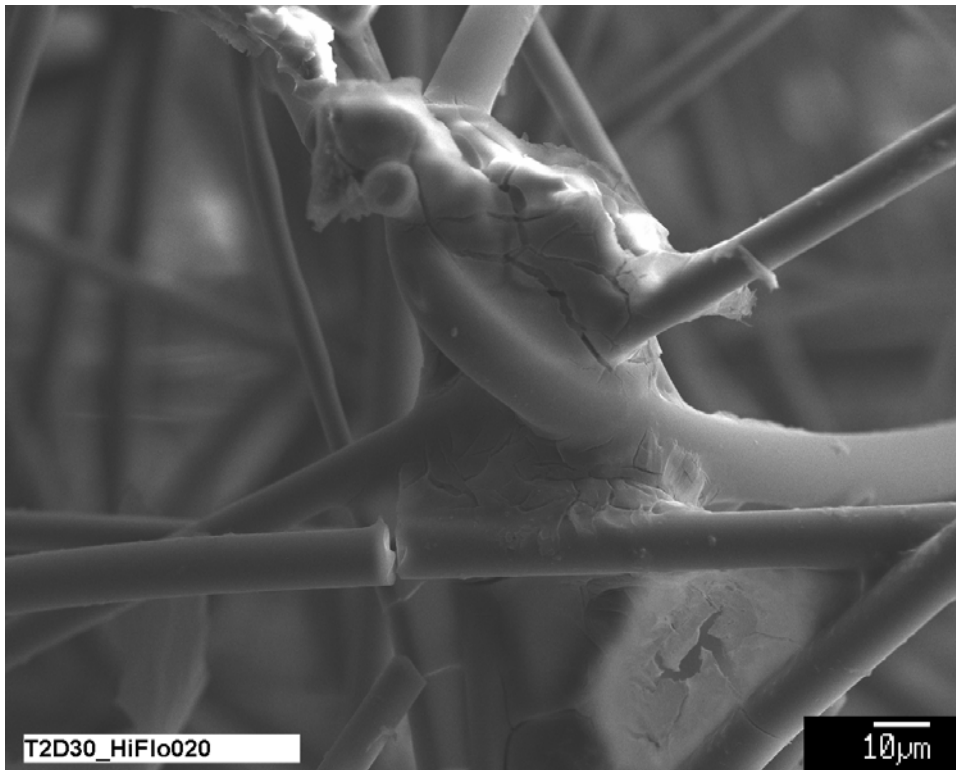
Figure D2-7. SEM image of a higher magnification for a Test #2, Day-30 high-flow exterior fiberglass sample. (T2D30_HiFlo020)

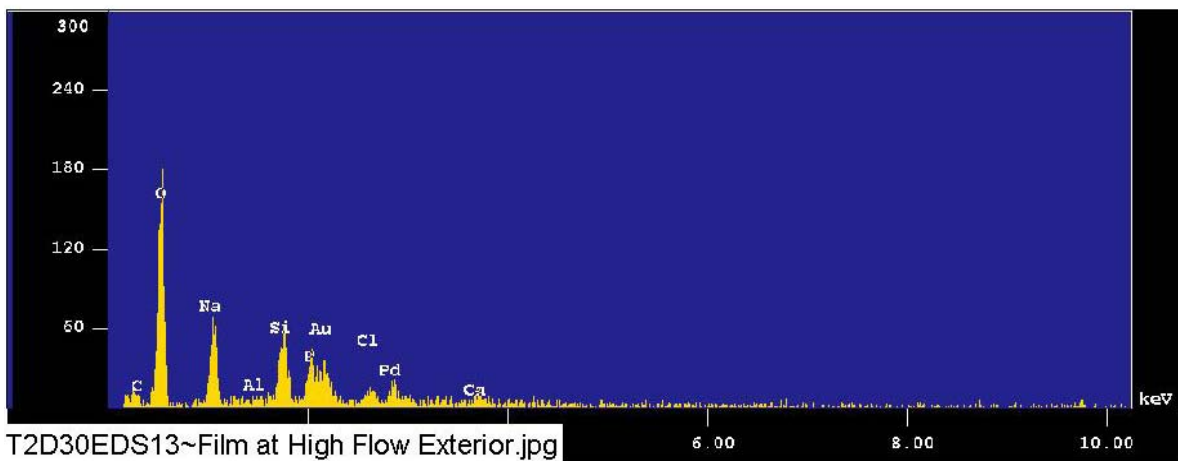
Figure D2-8. EDS counting spectrum for the film deposits or growth on fiberglass, as shown in Figure D2-7. (T2D30EDS13~Film at High Flow Exterior)

The results from the chemical composition analysis for T2D30EDS13 are given in Table D2-1.

Element	Mass%	Atomic%	ZAF	Z	A	F
C	0.000	0.0000	6.0057	1.0404	5.7730	0.9999
O	68.212	77.9670	0.7076	0.9928	0.7128	1.0000
Na	15.750	12.5283	1.5604	1.0448	1.4934	1.0001
Si	7.284	4.7427	1.3779	0.9953	1.3873	0.9980
P	4.750	2.8046	0.8298	1.1782	0.7048	0.9993
Cl	2.197	1.1335	1.1025	1.0478	1.0529	0.9993
Ca	1.806	0.8239	1.0120	1.0156	0.9965	1.0000

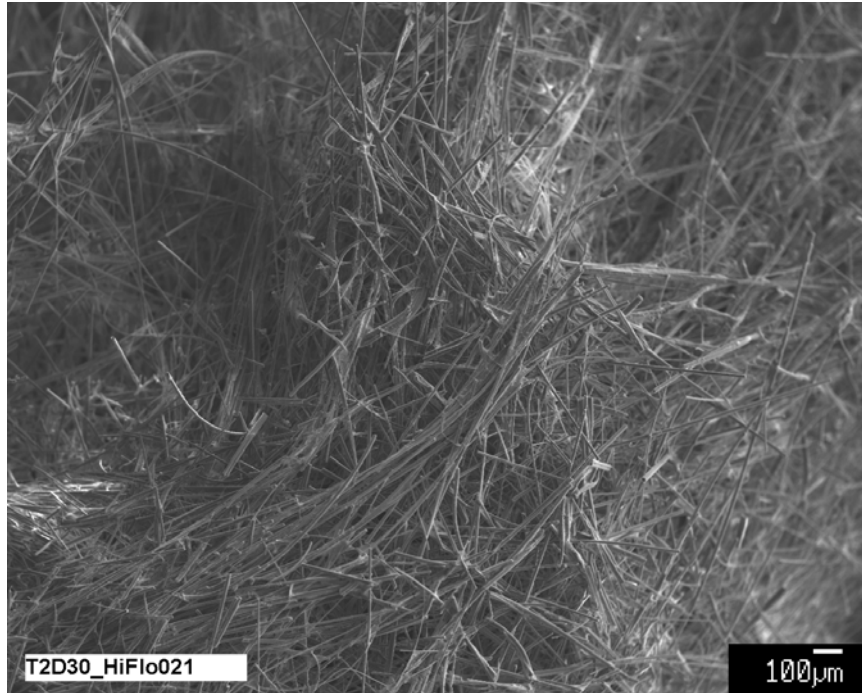
Figure D2-9. SEM image for a Test #2, Day-30 high-flow interior fiberglass sample. (T2D30_HiFlo021)

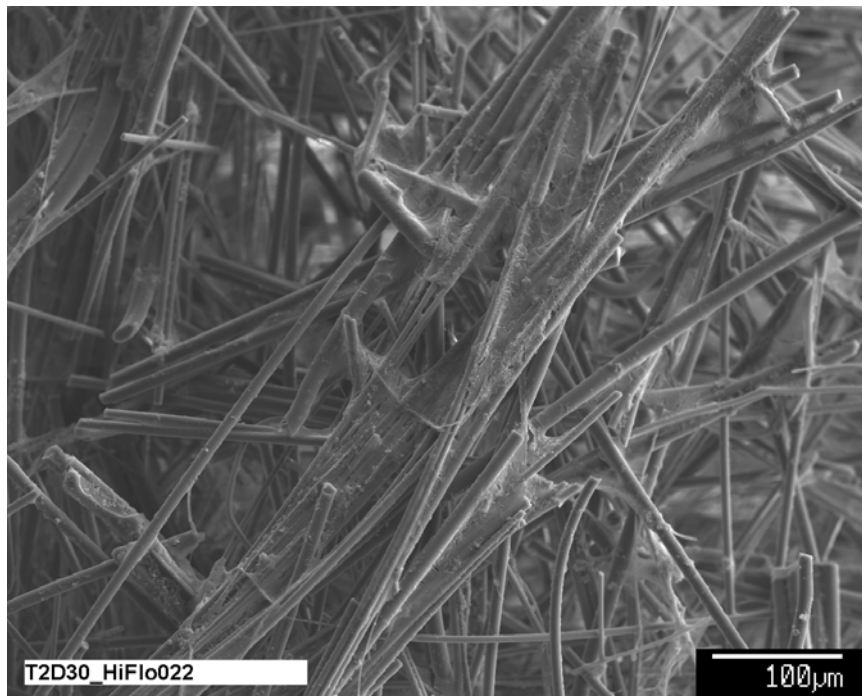
Figure D2-10. SEM image for a Test #2, Day-30 high-flow interior fiberglass sample. (T2D30_HiFlo022)

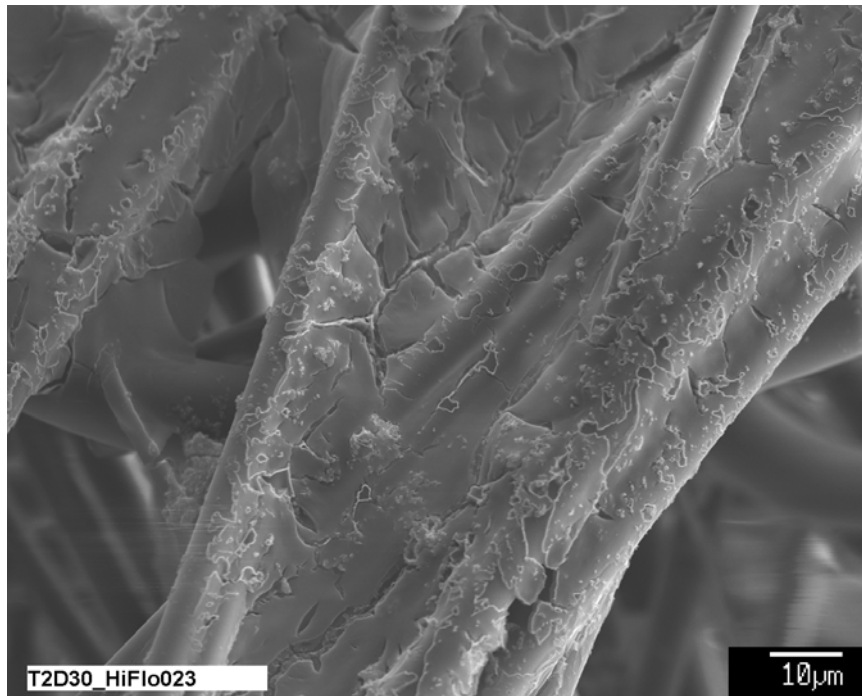
Figure D2-11. SEM image at 1000× magnification for a Test #2, Day-30 high-flow interior fiberglass sample. (T2D30_HiFlo023)

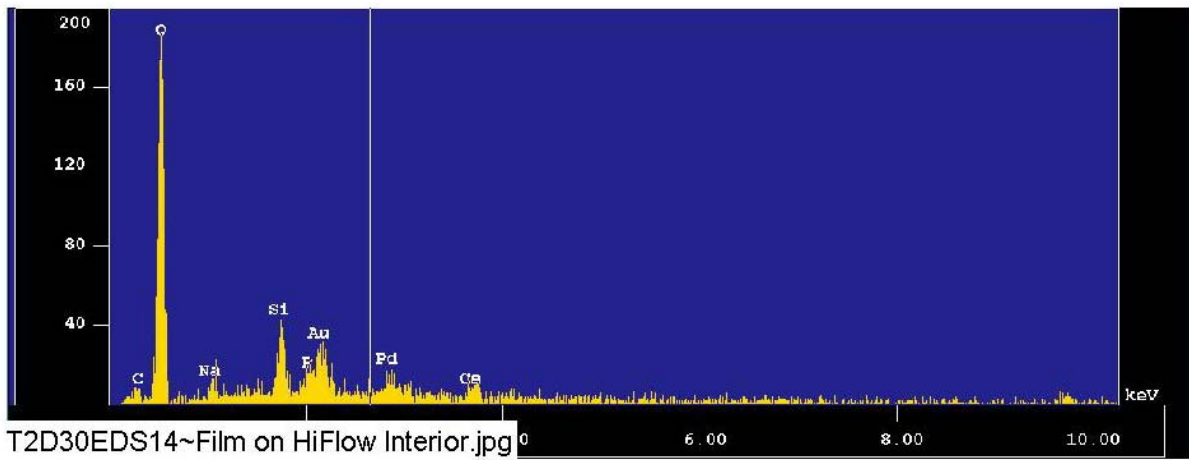
Figure D2-12. EDS counting spectrum for the film deposits or growth on fiberglass, as shown in Figure D2-11. (T2D30EDS14~Film on HiFlow Interior)

The results from the chemical composition analysis for T2D30EDS14 are given in Table D2-2.

Element	Mass%	Atomic%	ZAF	Z	A	F
C	0.000	0.0000	3.8510	1.0451	3.6851	0.9999
O	85.150	90.8939	0.5770	0.9974	0.5785	1.0000
Na	4.620	3.4320	1.8017	1.0498	1.7160	1.0002
Si	6.368	3.8722	1.3235	1.0003	1.3239	0.9994
P	1.246	0.6870	0.7999	1.1842	0.6756	0.9999
Ca	2.616	1.1148	0.9886	1.0213	0.9680	1.0000

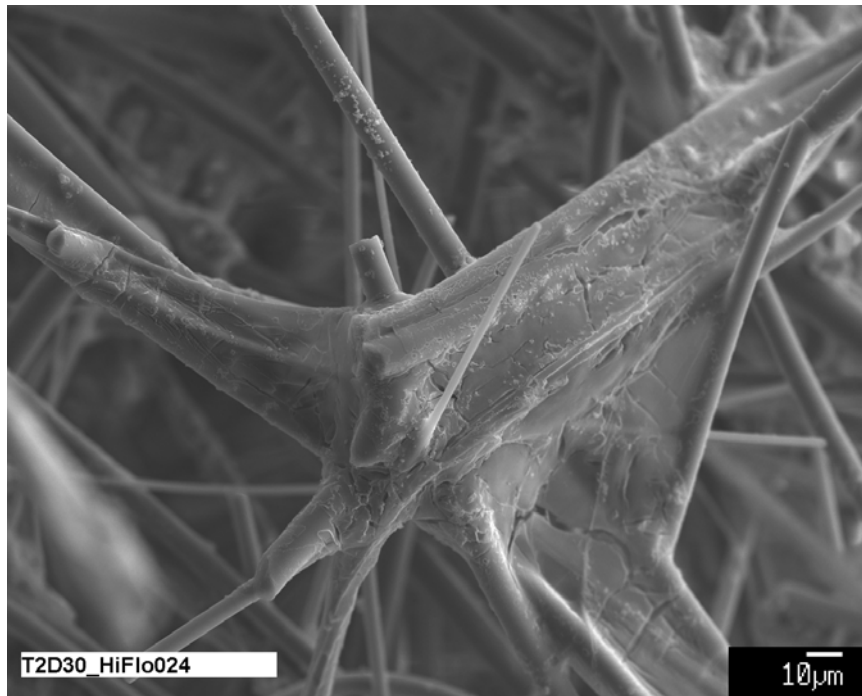
Figure D2-13. SEM image of a higher magnification for a Test #2, Day-30 high-flow interior fiberglass sample. (T2D30_HiFlo024)

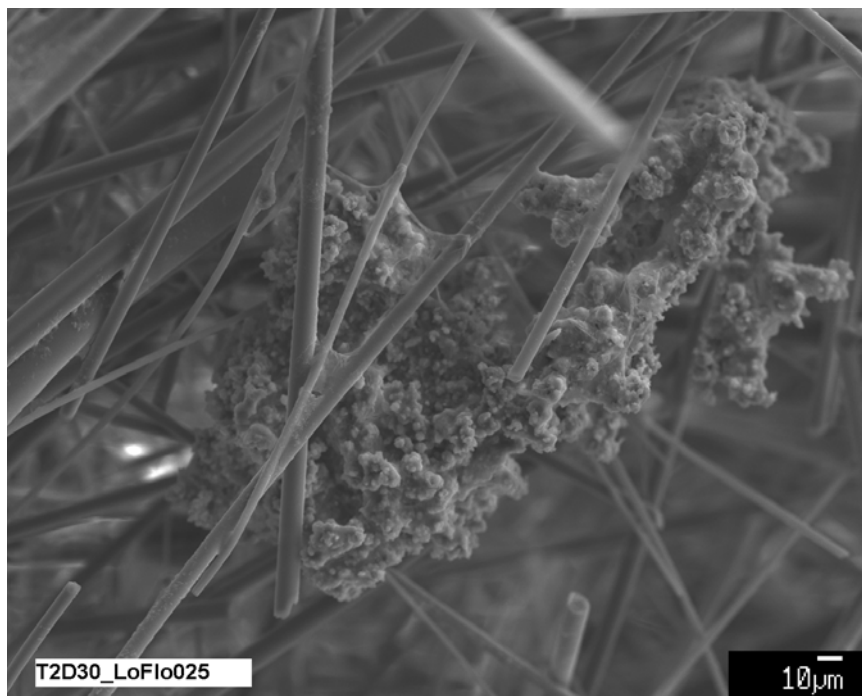
Image:	T2D30_LoFlo025	350 ×	On possible bacteria or Ca Phosphate	Figure D2-14
EDS:	T2D30EDS15		Globular cluster from image 025	Figure D2-15
Image:	T2D30_LoFlo026	800 ×	Different area	Figure D2-16

Figure D2-14. SEM image for a Test #2, Day-30 low-flow interior fiberglass sample. (T2D30_LoFlo025)

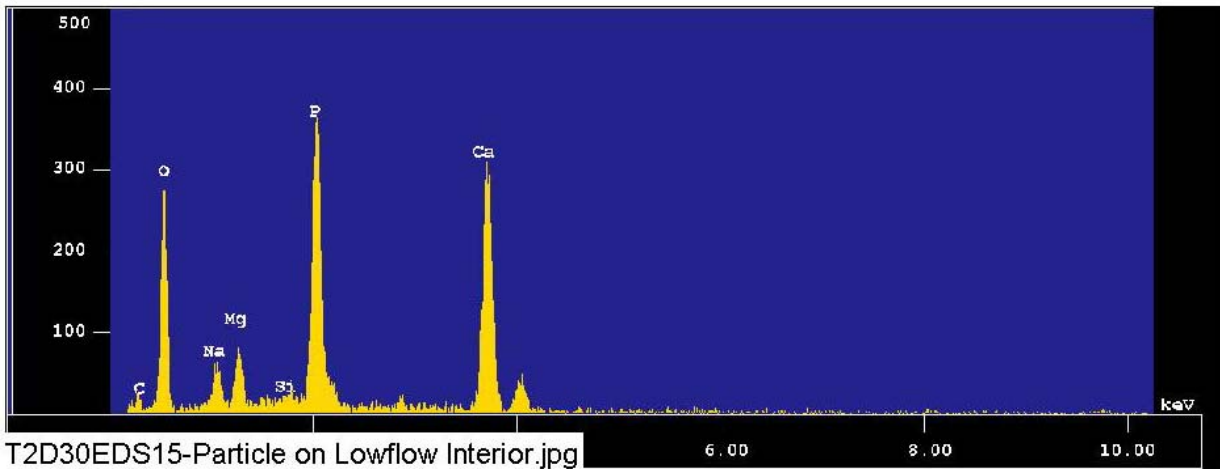
Figure D2-15. EDS counting spectrum for the particulate deposits or growth on fiberglass, as shown in Figure D2-14. (T2D30EDS15-Particle on Lowflow Interior)

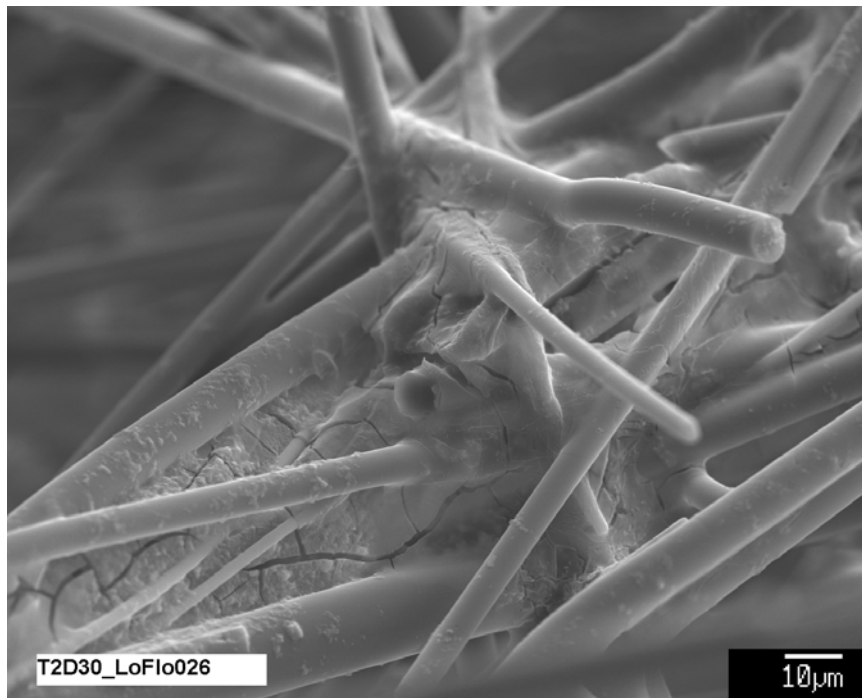
Figure D2-16. SEM image of a higher magnification for a Test #2, Day-30 low-flow interior fiberglass sample. (T2D30_LoFlo026)

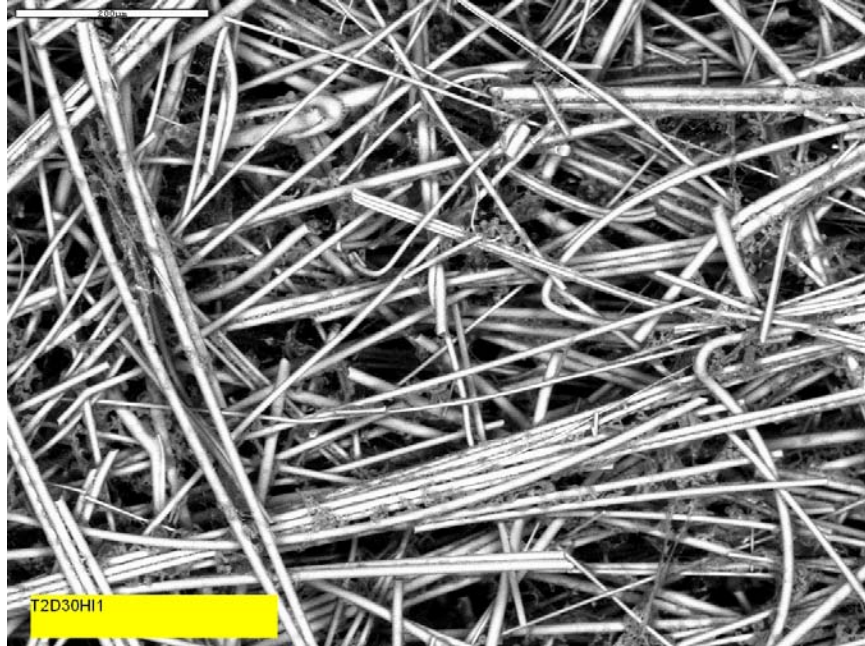
Figure D2-17. ESEM image for a Test #2, Day-30 high-flow interior fiberglass sample. It seems the interior fiberglass is cleaner than exterior fiberglass. (T2D30HI1)

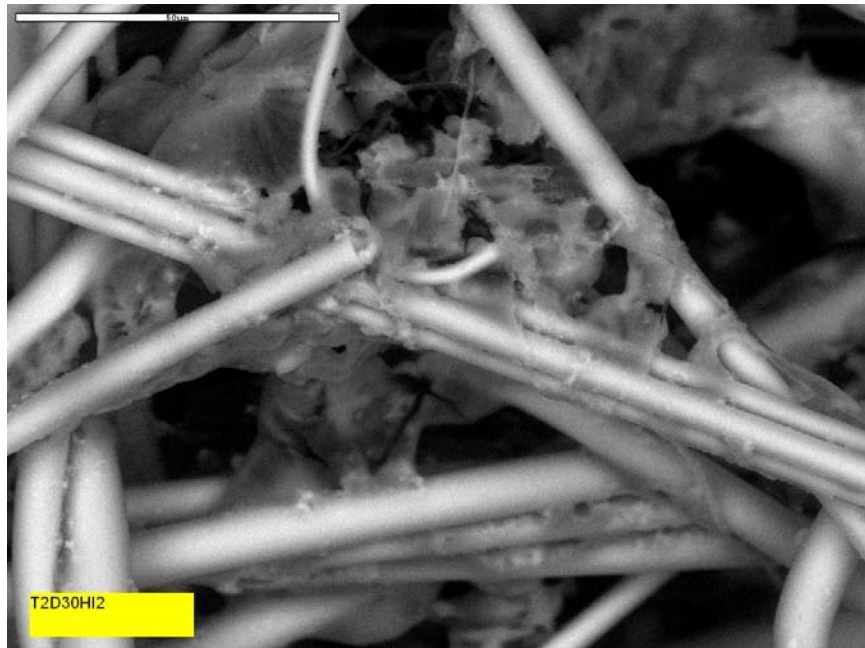
Figure D2-18. ESEM image of a higher magnification for a Test #2, Day-30 high-flow interior fiberglass sample. (T2D30HI2)

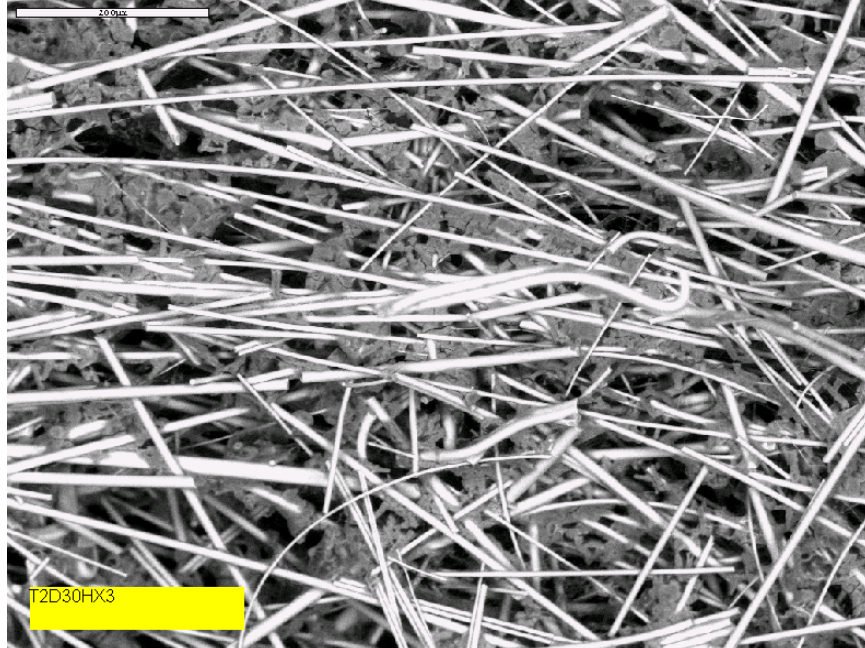
Figure D2-19. ESEM image for a Test #2, Day-30 high-flow exterior fiberglass sample. (T2D30HX3)

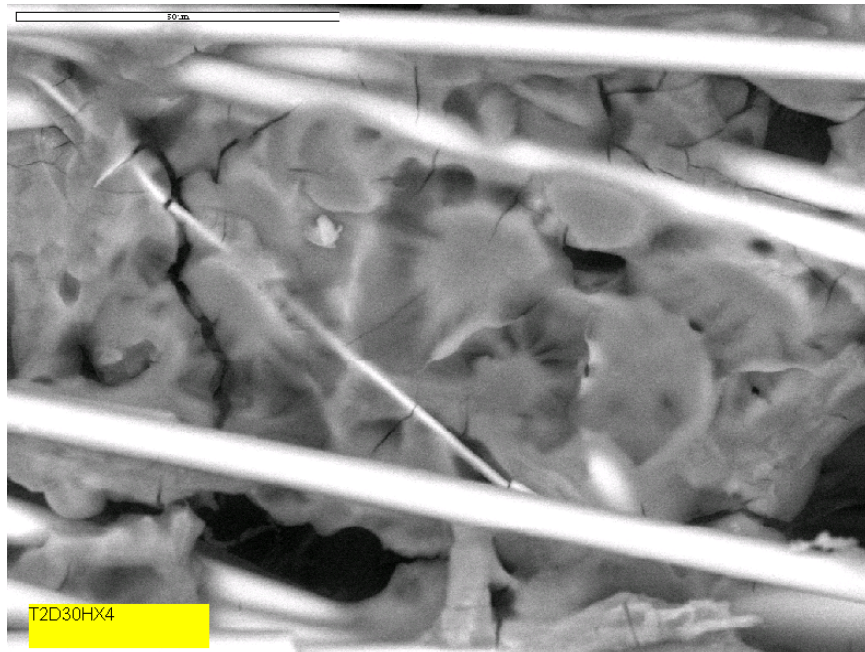
Figure D2-20. ESEM image of a higher magnification for a Test #2, Day-30 high-flow exterior fiberglass sample. (T2D30HX4)

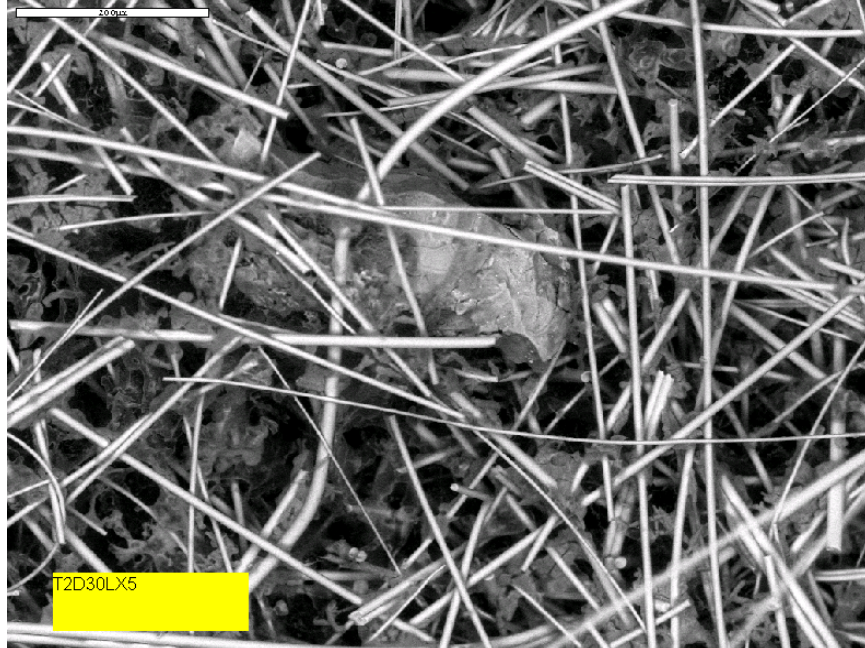
Figure D2-21. ESEM image for a Test #2, Day-30 low-flow exterior fiberglass sample. (T2D30LX5)

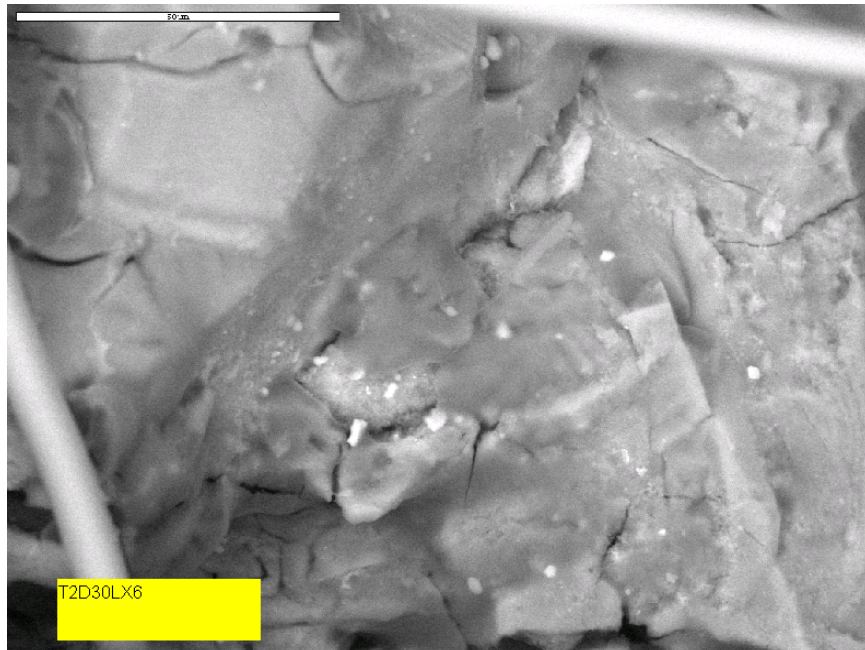
Figure D2-22. ESEM image of a higher magnification for a Test #2, Day-30 low-flow exterior fiberglass sample. (T2D30LX6)

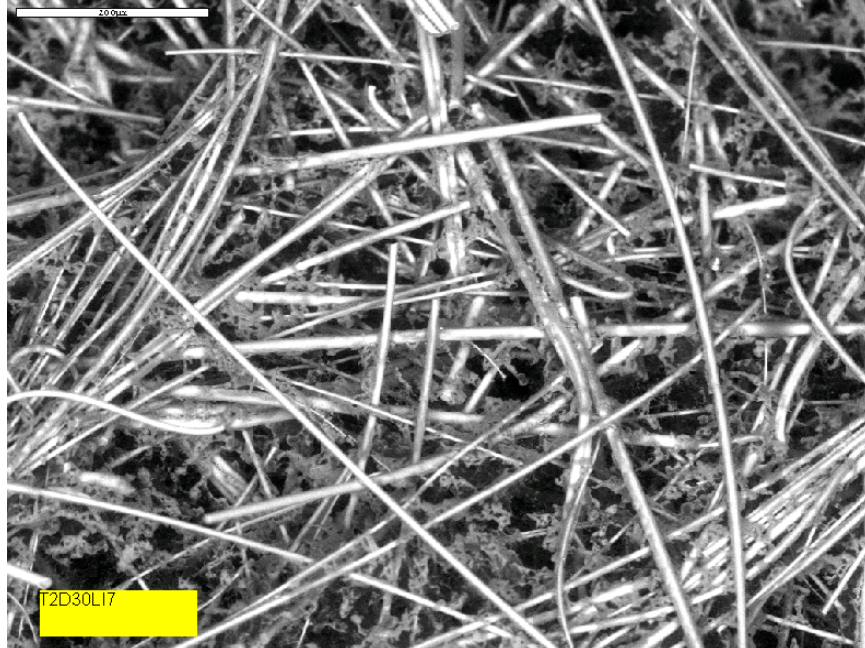
Figure D2-23. ESEM image for a Test #2, Day-30 low-flow interior fiberglass sample. (T2D30LI7)

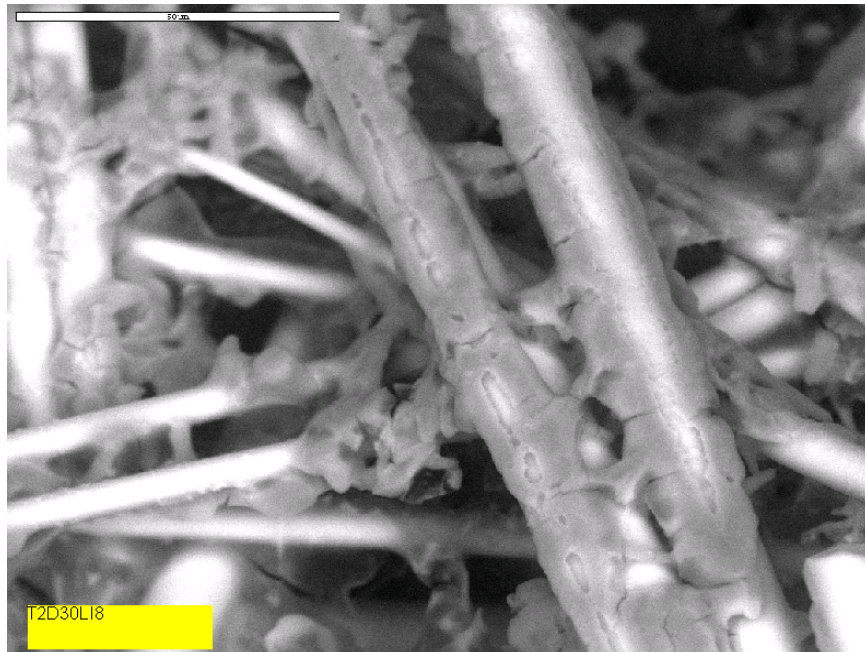
Figure D2-24. ESEM image of a higher magnification for a Test #2, Day-30 low-flow interior fiberglass sample. (T2D30LI8)
