## Appendix D3

# ESEM and SEM/EDS Data for Test #2, Day-30 Drain Collar Fiberglass

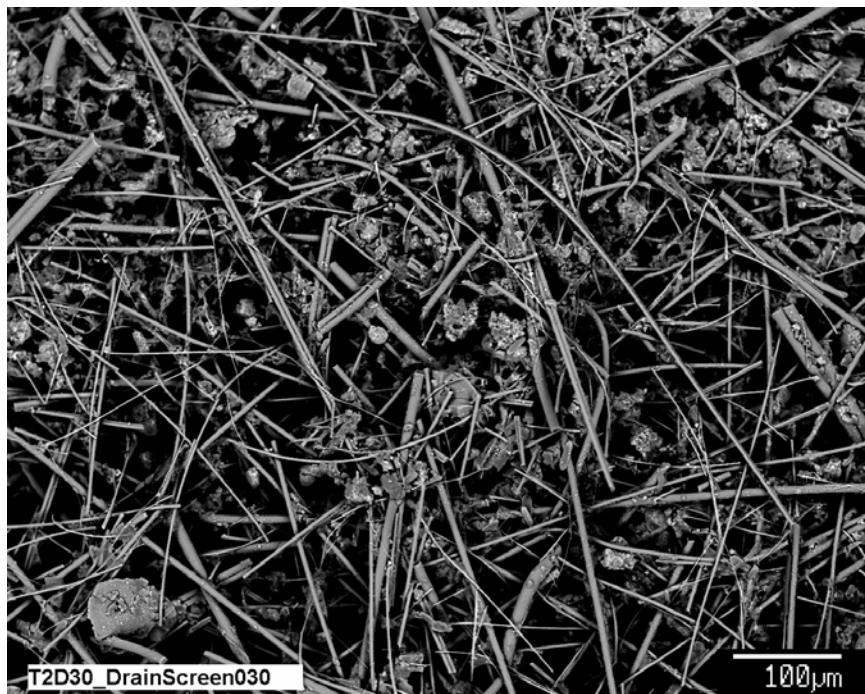
Figure D3-2. Backscattered SEM image for a Test #2, Day-30 fiberglass sample on the drain collar next to the drain screen, illustrating that deposits have a similar atomic number to fiberglass. (T2D30\_DrainScreen030)

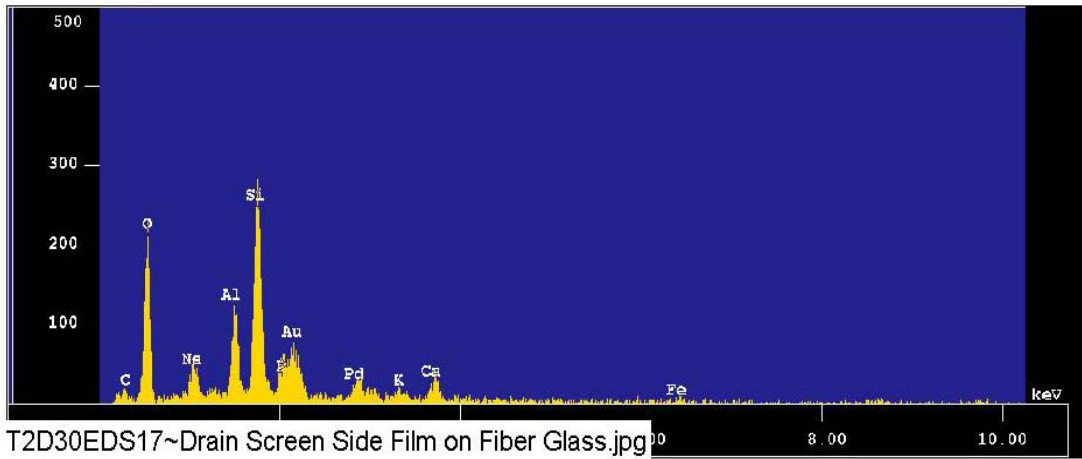
**Figure D3-6.** EDS counting spectrum for the film between fibers shown in Figure D3-4. The film is rich in silicon, oxygen, aluminum, sodium, and calcium. (T2D30EDS17~Drain Screen Side Film on Fiber Glass)

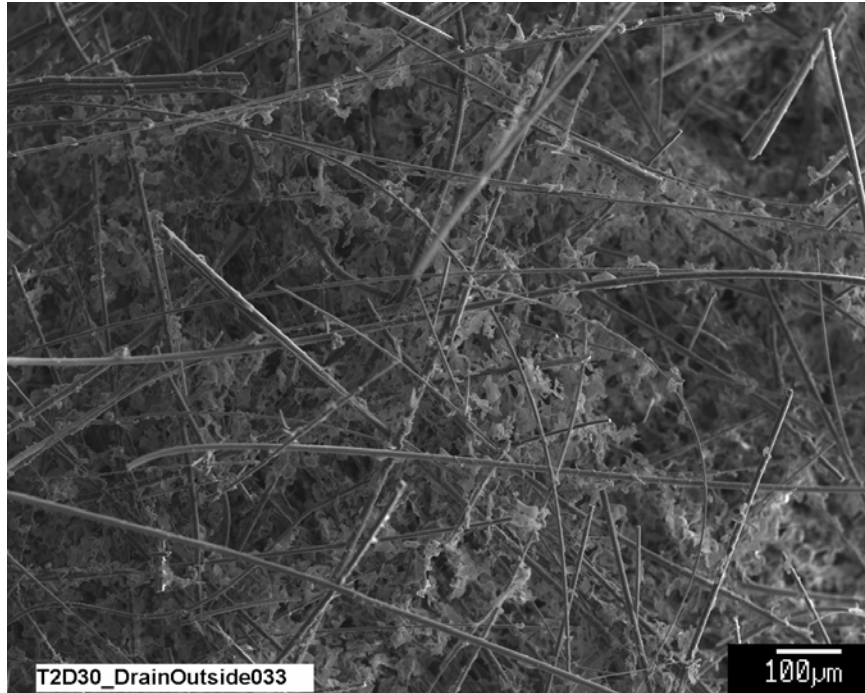
Figure D3-7. SEM image for a Test #2, Day-30 exterior fiberglass sample on the drain collar (away from the drain screen) showing deposits or growth on fiberglass. (T2D30\_DrainOutside033)

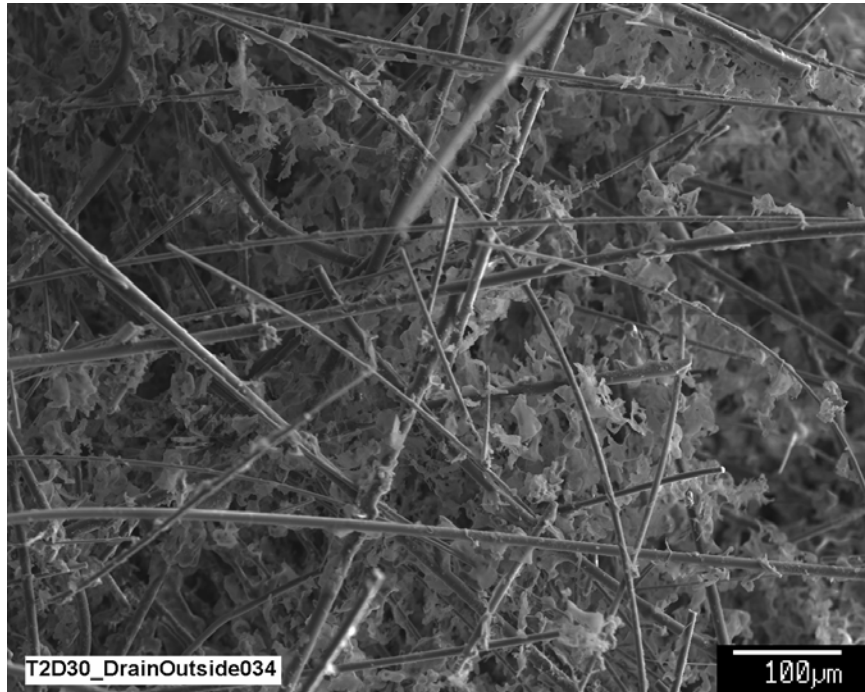
Figure D3-8. SEM image for a Test #2, Day-30 exterior fiberglass sample on the drain collar showing deposits or growth on fiberglass. (T2D30\_DrainOutside034)

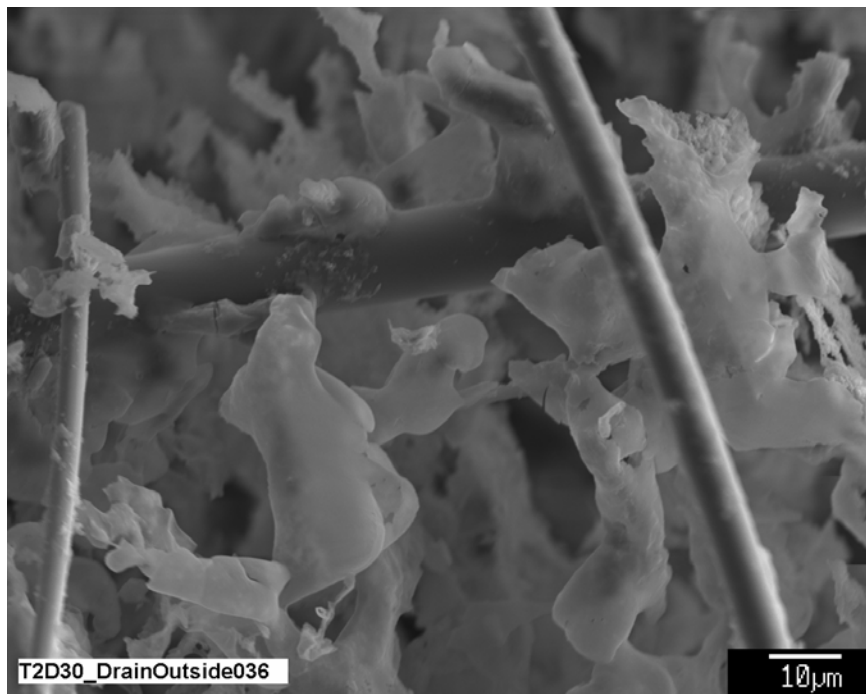
Figure D3-10. SEM image at a higher magnification for a Test #2, Day-30 exterior fiberglass sample on the drain collar showing deposits or growth on fiberglass. (T2D30\_DrainOutside 036)

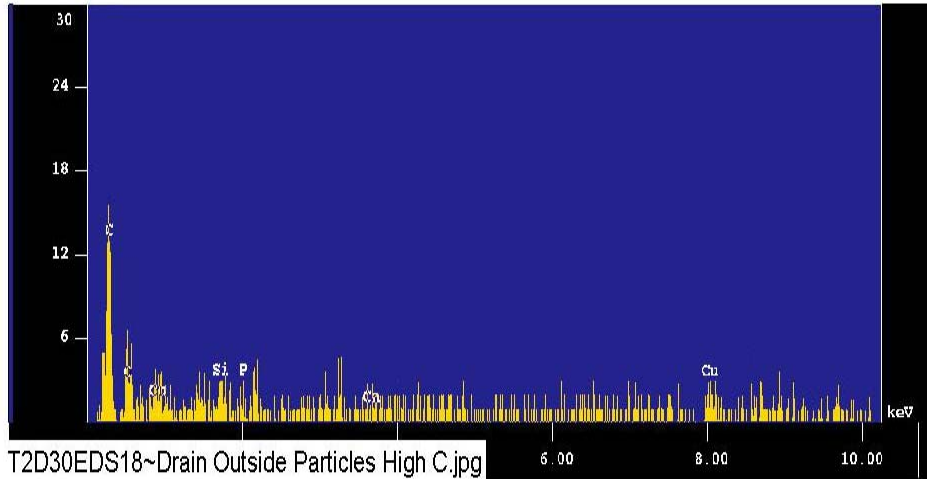
Note: \*Very difficult to get EDS spectrum of particles. The particles are very thin and react under the beam. EDS18 and EDS19 are simply replicates at slightly different sample locations.

**Figure D3-11. EDS counting spectrum for deposits or growth on fiberglass. The deposits contain a significant amount of carbon. (T2D30EDS18~Drain Outside Particles High C)**

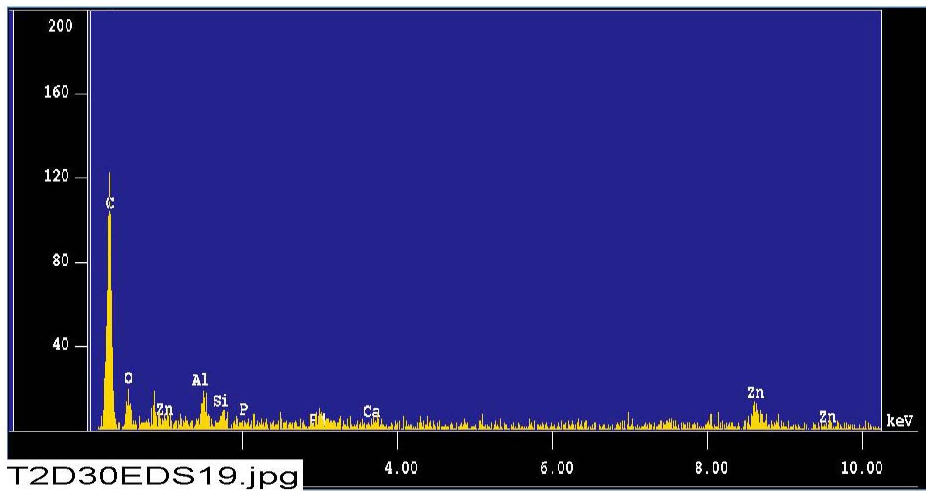
**Figure D3-12. EDS counting spectrum for a deposit or growth on fiberglass. The deposit contains a significant amount of carbon. (T2D30EDS19)**

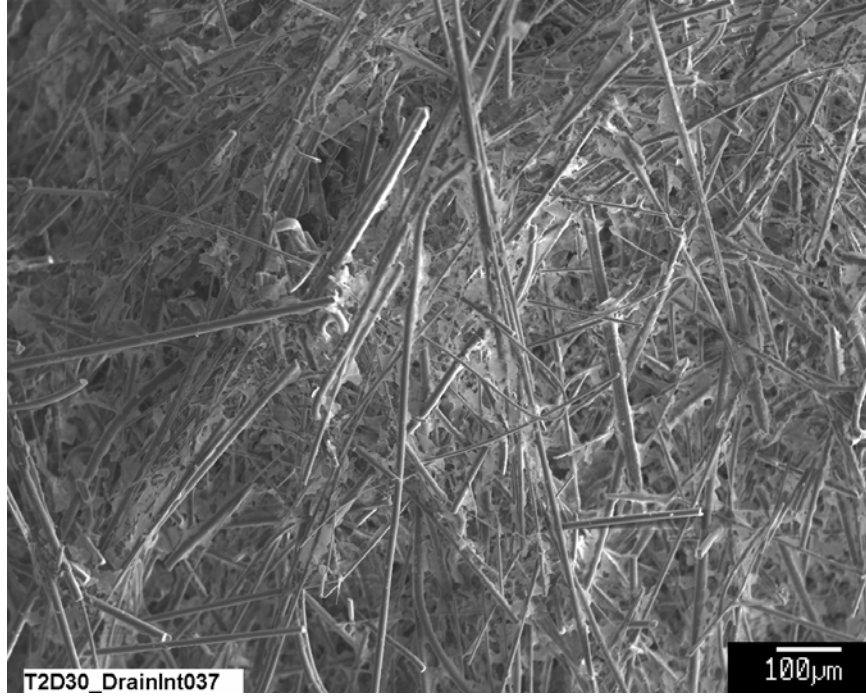
Figure D3-13. SEM image for a Test #2, Day-30 interior fiberglass sample on the drain collar. Image shows deposits or growth on fiberglass. (T2D30\_DrainInt037)

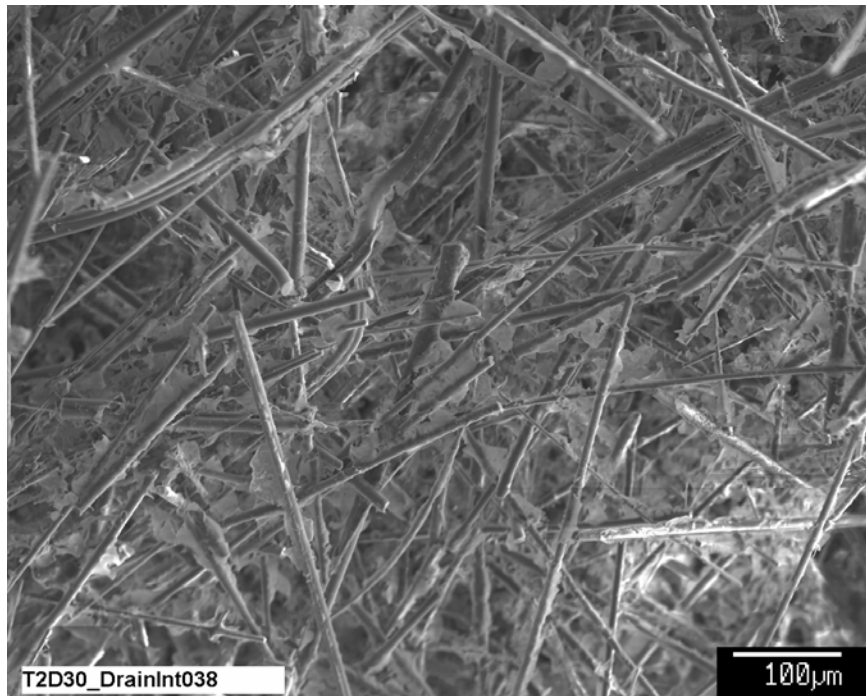
Figure D3-14. SEM image for a Test #2, Day-30 interior fiberglass sample on the drain collar. Image shows deposits or growth on fiberglass. (T2D30\_DrainInt038)

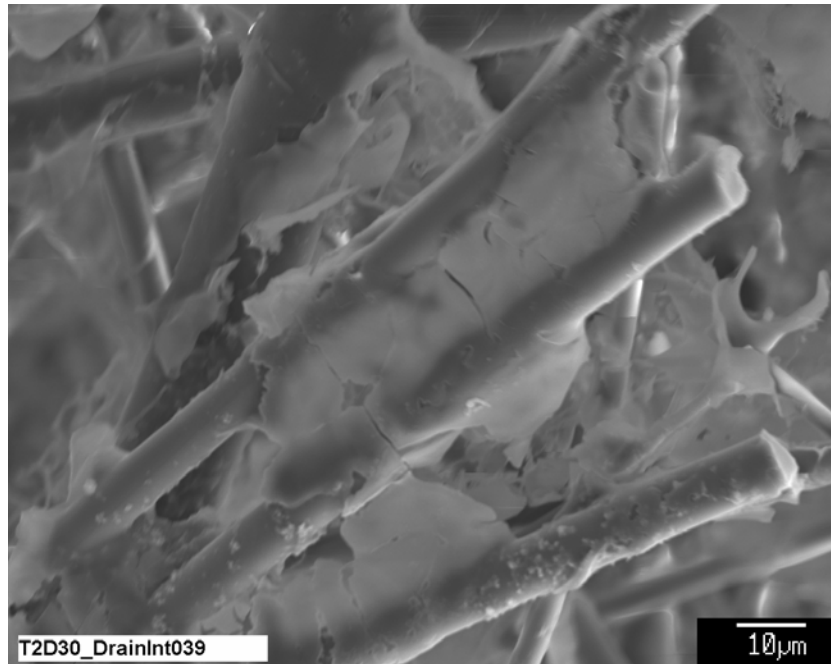
Figure D3-15. SEM image of a higher magnification for a Test #2, Day-30 interior fiberglass sample on the drain collar. The image shows deposits or growth on fiberglass. (T2D30\_DrainInt039)

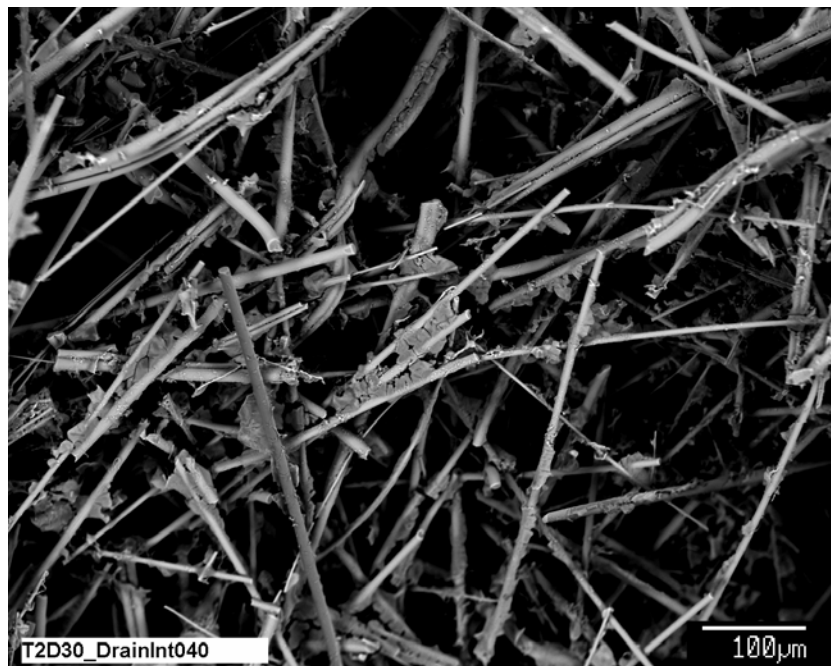
Figure D3-16. Backscattered SEM image for a Test #2, Day-30 interior fiberglass sample on the drain collar. Deposits appear to have a similar or lower atomic number as compared with fiberglass. (T2D30\_DrainInt040)

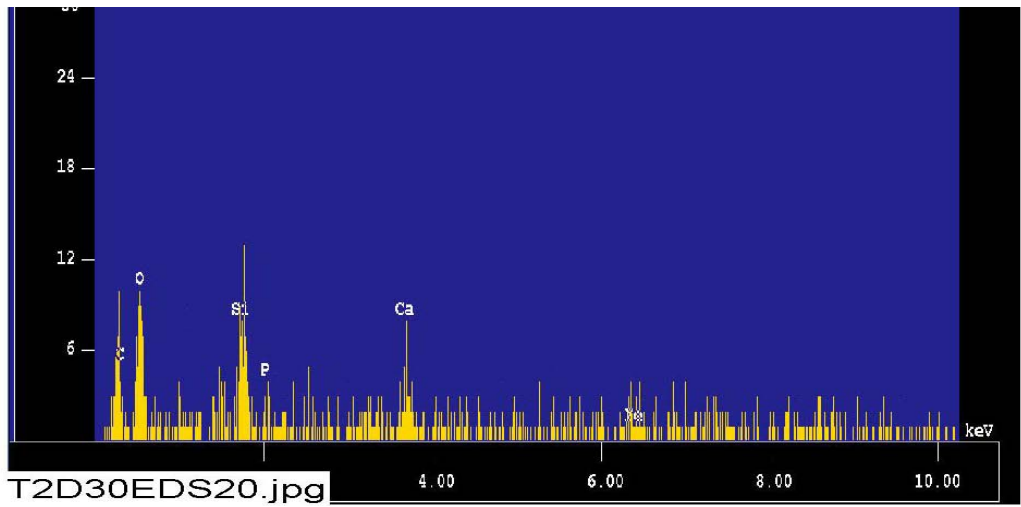
**Figure D3-17. EDS counting spectrum for the deposits or growth on fiberglass. The deposits are rich in silicon, carbon, oxygen, and calcium. The deposits are very thin, and thus it was difficult to obtain high-quality EDS spectra. (T2D30EDS20)**

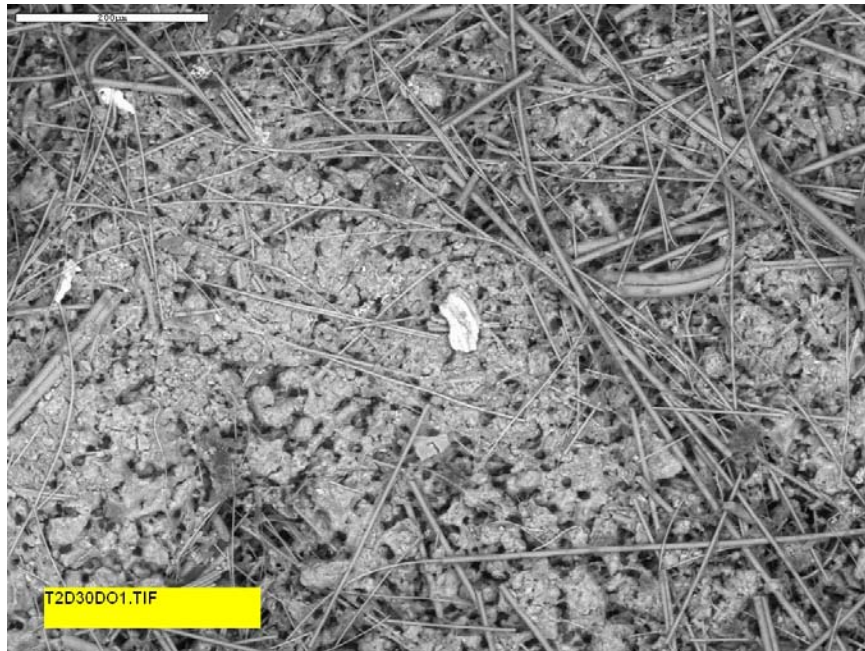
**Figure D3-18. ESEM image for a Test #2, Day-30 exterior fiberglass sample on the drain collar. Image shows particulate deposits or growth on fiberglass. (T2D30DO1)**

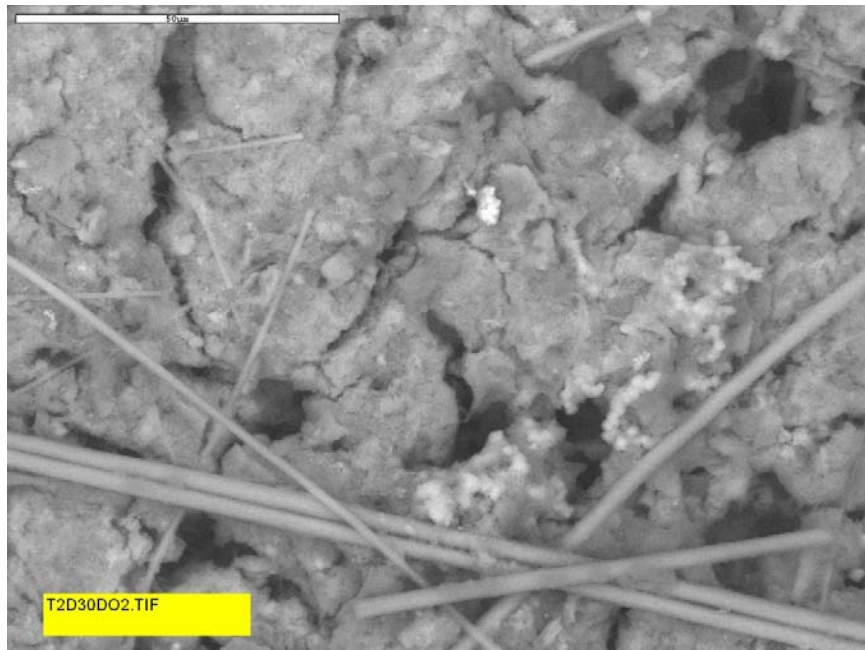
**Figure D3-19. ESEM image of a higher magnification for a Test #2, Day-30 exterior fiberglass sample on the drain collar. The image shows particulate deposits or growth on fiberglass. (T2D30DO2)**

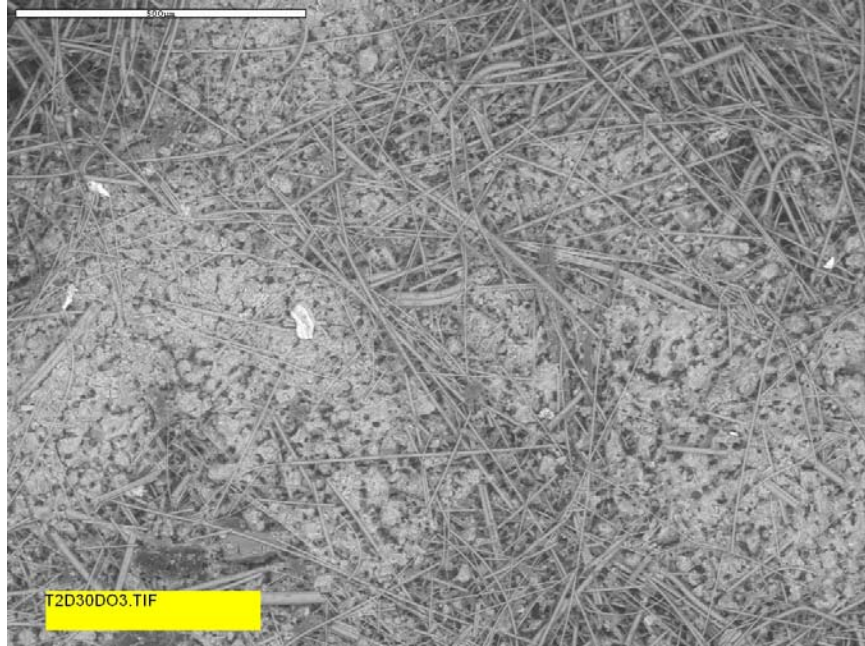
**Figure D3-20. ESEM image for a Test #2, Day-30 exterior fiberglass sample on the drain collar. Image shows particulate deposits or growth on fiberglass. (T2D30DO3)**

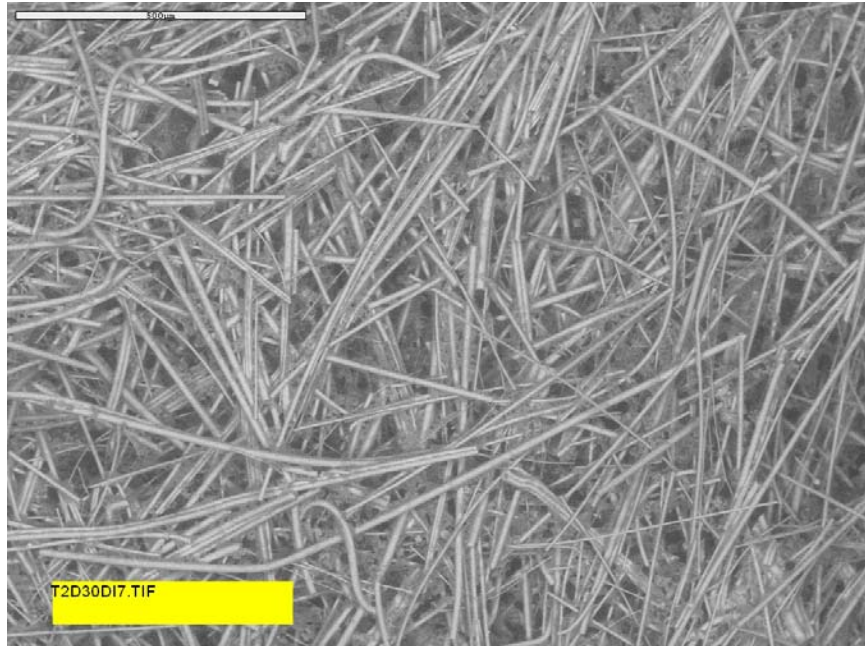
**Figure D3-24. ESEM image for a Test #2, Day-30 interior fiberglass sample on the drain collar. Image suggests that interior fiberglass was relatively clean as compared with exterior. (T2D30DI7)**

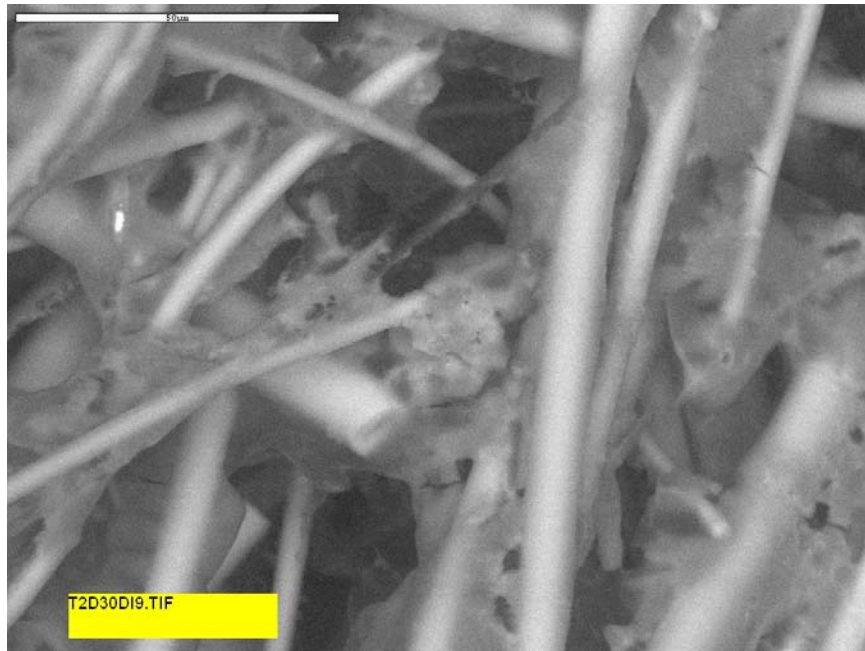
**Figure D3-26. ESEM image of a higher magnification for a Test #2, Day-30 interior fiberglass sample on the drain collar. The image shows deposits or growth on the interior fiberglass, although the quantity was less than for exterior samples. (T2D30DI9)**
