[Docket No. 2002-SW-25-AD; Amendment 39-13217; AD 2003-13-15]

Airworthiness Directives; Schweizer Aircraft Corporation Model 269A, 269A-1, 269B, 269C, and TH-55A Helicopters

2003-13-15 Schweizer Aircraft

Federal Aviation Administration

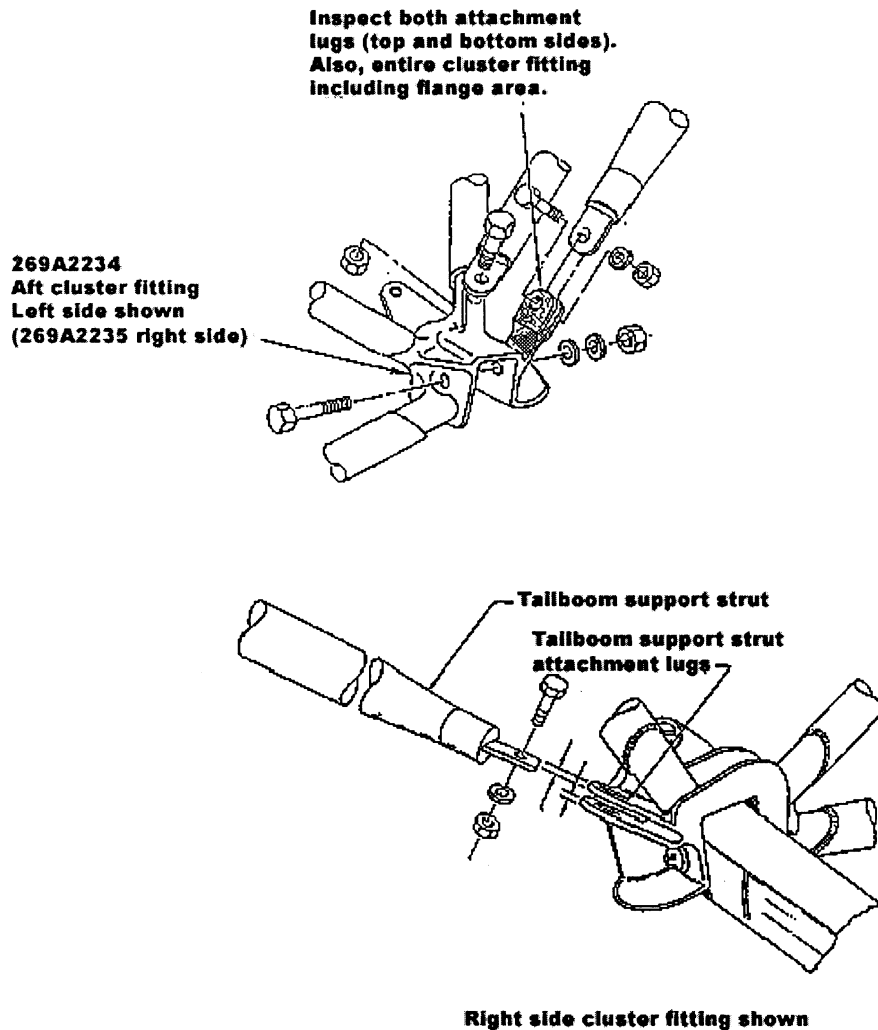
Figure 1

(2) Dye-penetrant inspect the lugs on each cluster fitting. See the following Figure 1:

(3) If a crack is found, before further flight, replace the cracked cluster fitting with an airworthy cluster fitting.
