[Docket No. FAA-2006-25105; Directorate Identifier 2006-CE-33-AD; Amendment 39-14982; AD 2007-06-01]

Airworthiness Directives; Raytheon Aircraft Company Beech Models 45 (YT-34), A45 (T-34A, B-45), and D45 (T-34B) Airplanes

ACTION: Final rule.

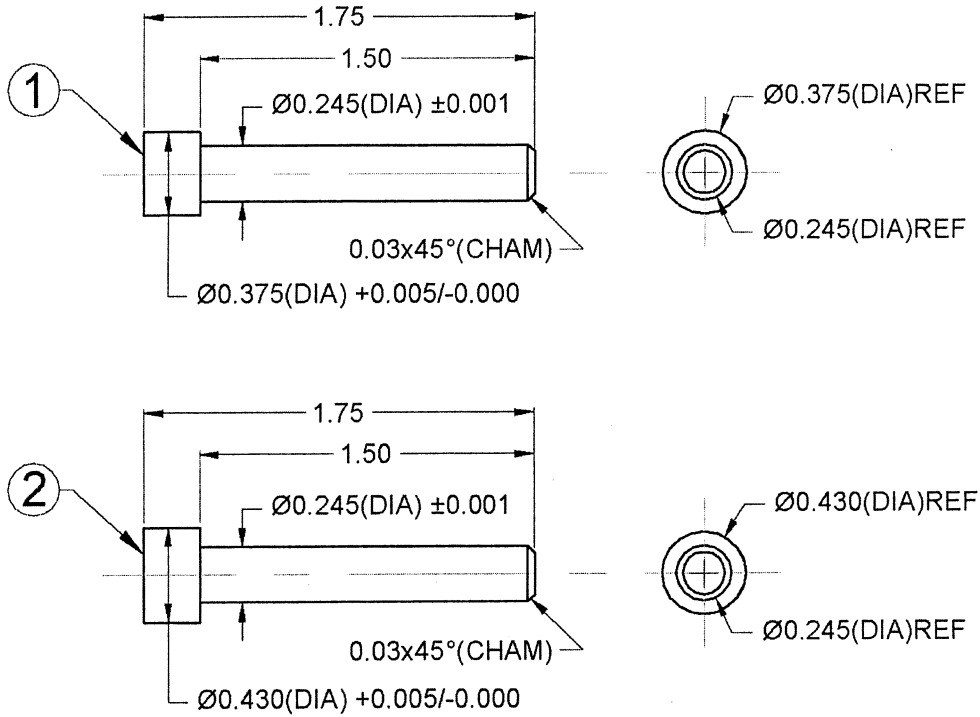
Figure 1

KEY	PART NO.	DESCRIPTION	SIZE	MATERIAL SPEC.	HEAT TREAT	NOTES
2	45-127-2	BUSHING TOOL	Ø0.44(DIA) x1.75	ALUMINUM		BREAK ALL SHARP EDGES
1	45-127-1	BUSHING TOOL	Ø0.38(DIA) x1.75	ALUMINUM		BREAK ALL SHARP EDGES

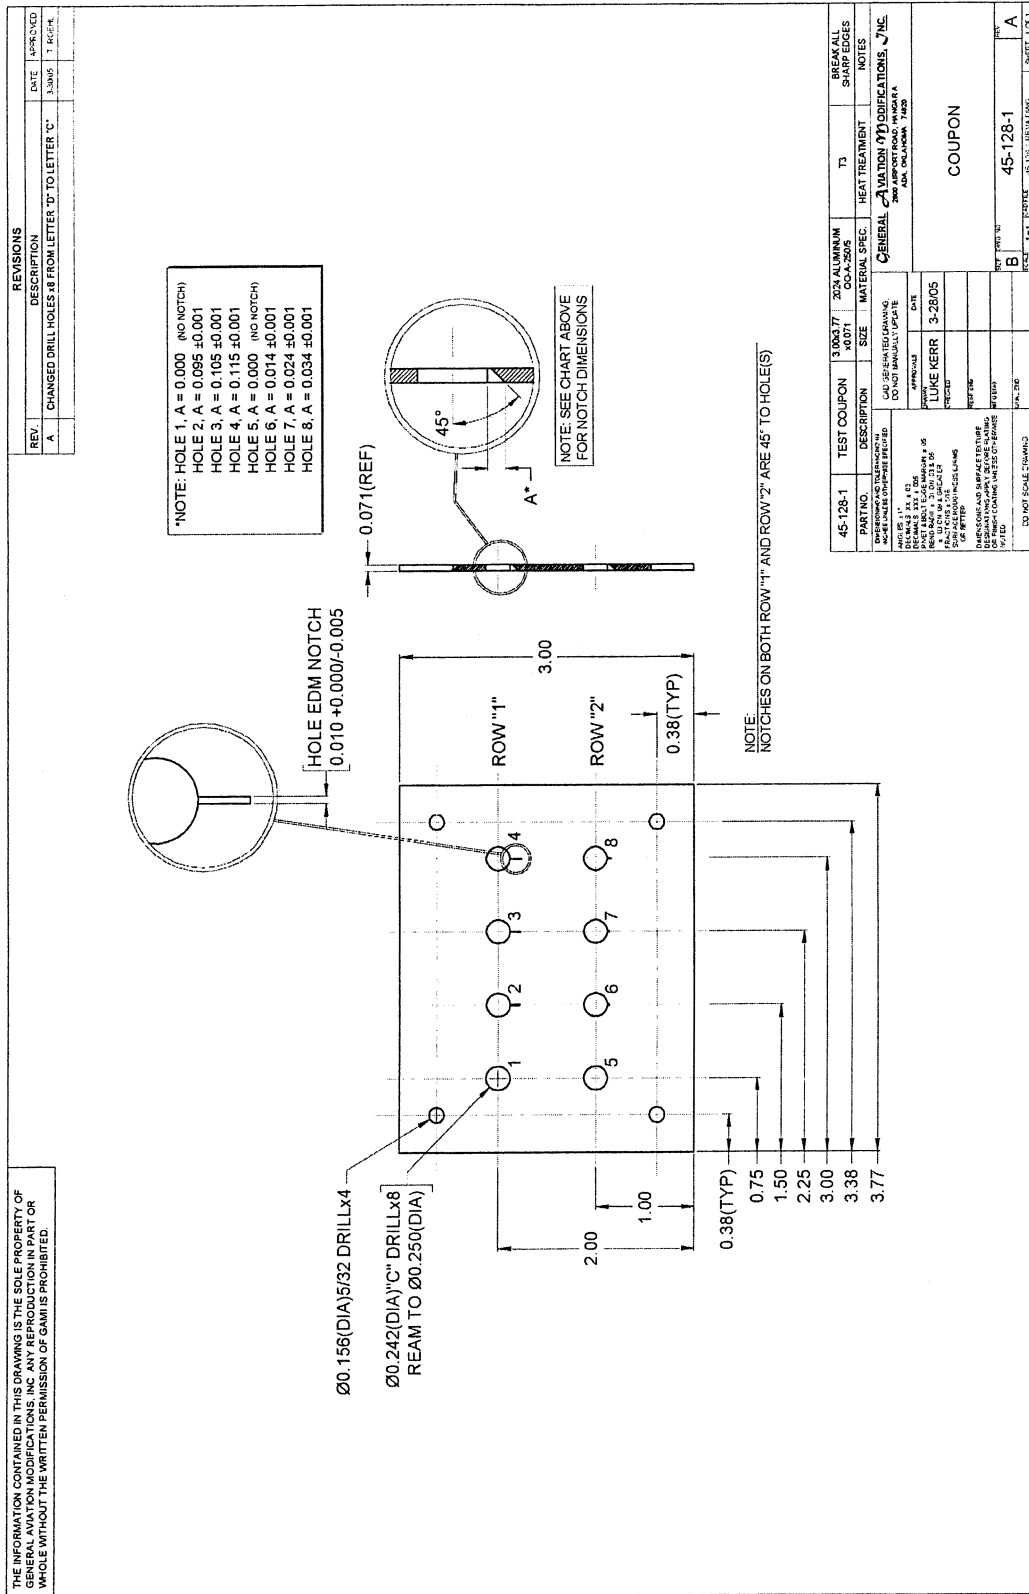
Figure 2

PART NO.	TEST COUPON	3.00x3.77	2024 ALUMINUM	DOA-2505	T3	HEAT TREATMENT	NOTES
45-128-1	TEST COUPON	3.00x3.77	2024 ALUMINUM	DOA-2505	T3	HEAT TREATMENT	NOTES
