[Docket No. FAA-2006-25105; Directorate Identifier 2006-CE-33-AD; Amendment 39-15016; AD 2007-06-01 R1]

#### Airworthiness Directives; Raytheon Aircraft Company Beech Models 45 (YT-34), A45 (T-34A, B-45), and D45 (T-34B) Airplanes

**ACTION:** Final rule; correction.

**Appendix to AD 2007-06-01 R1—Surface Eddy Current Inspection Procedure**

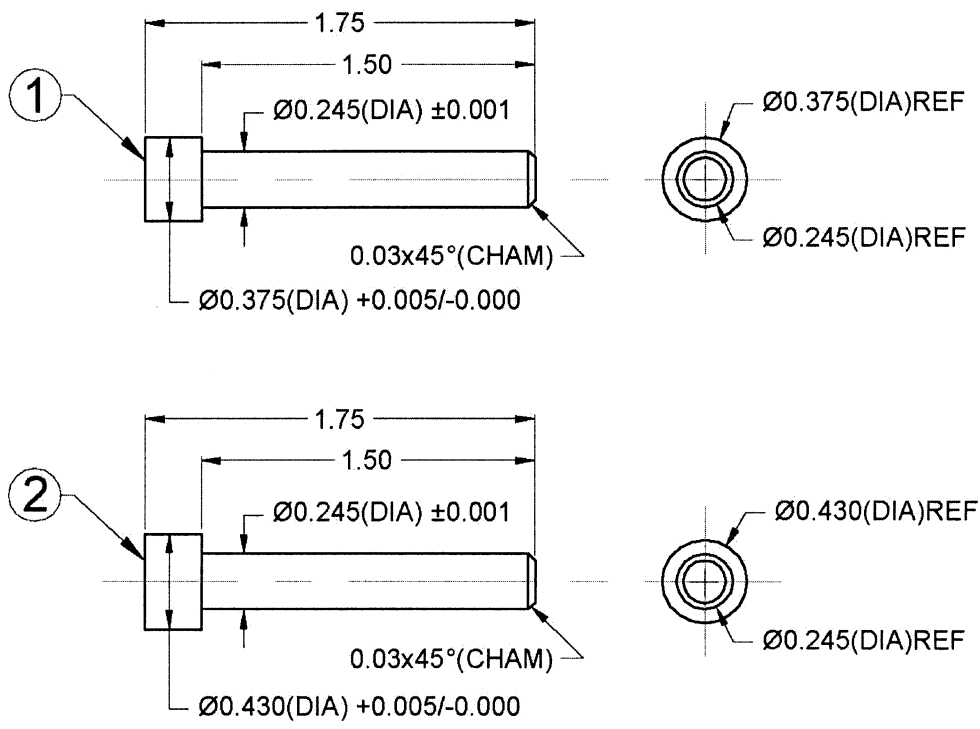
Figure 1

is flush with the edge of the bushing. Using the pin (see the attached Figures) as a guide, circle the area surrounding the steel bushing with the probe and adjacent area (approximately 1/4") to inspect for cracks. Inspect forward and aft surfaces surrounding bushings of each spar.

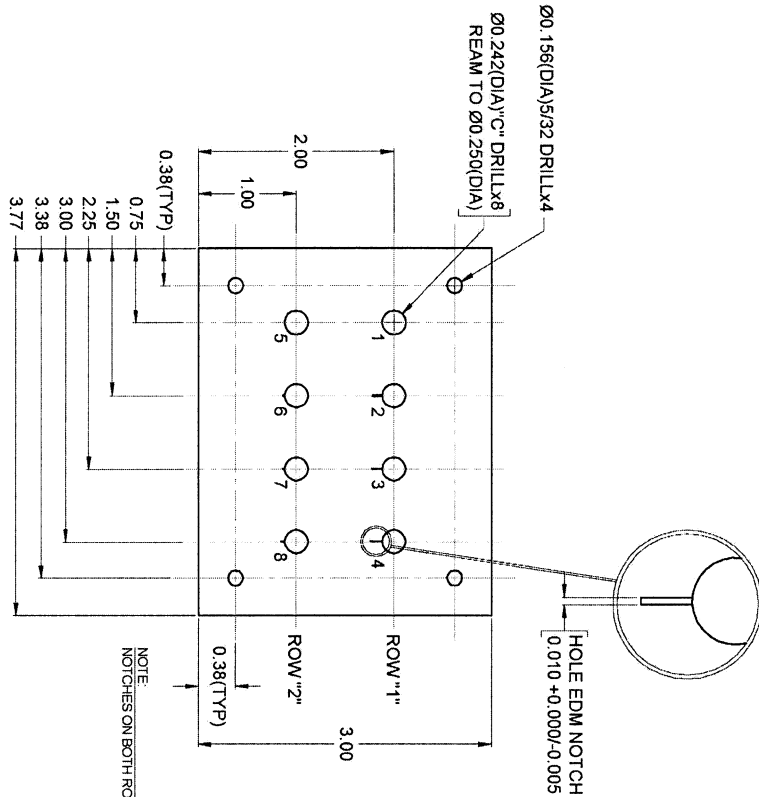
Figure 2

\*NOTE: HOLE 1, A = 0.000 (NO NOTCH)  
 HOLE 2, A = 0.095 ±0.001  
 HOLE 3, A = 0.105 ±0.001  
 HOLE 4, A = 0.115 ±0.001  
 HOLE 5, A = 0.000 (NO NOTCH)  
 HOLE 6, A = 0.014 ±0.001  
 HOLE 7, A = 0.024 ±0.001  
 HOLE 8, A = 0.034 ±0.001
