# **Stream Channel & Bank Restoration with Fish Passage**

By: **Ron A. Reisdorf, P.E., P.L.S**

By: **Lance A. Clark, P.E.**

# PERHAM CREEK

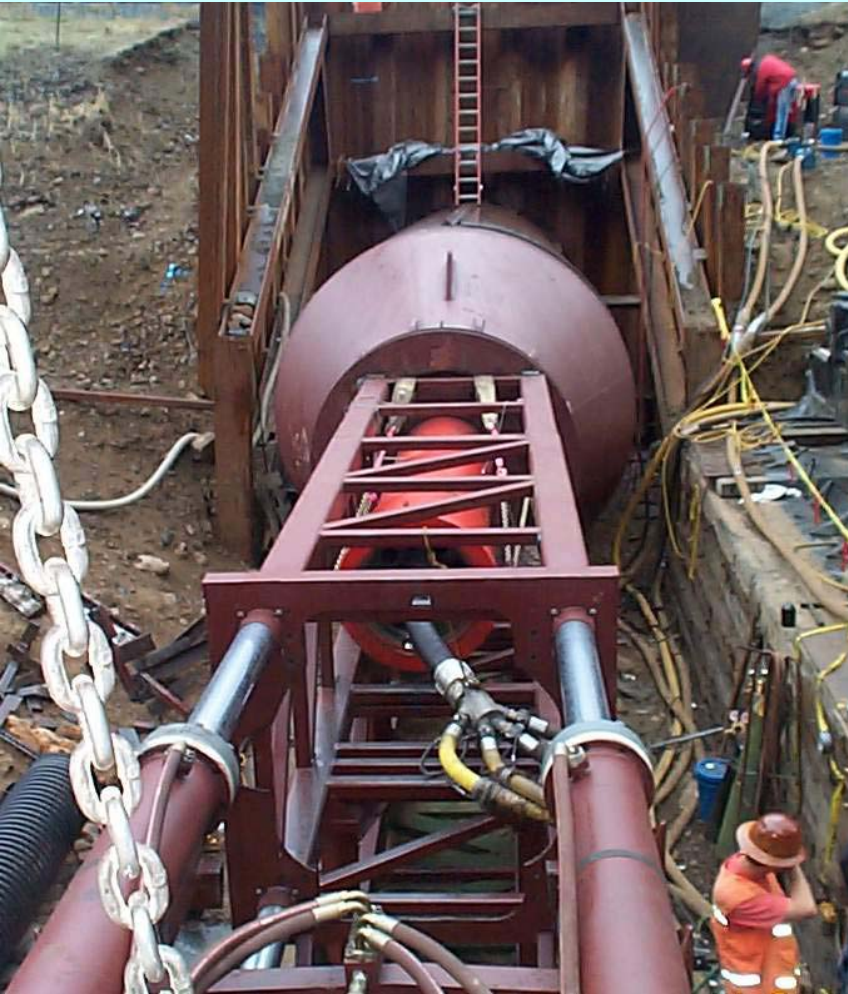
The initial ram was not large enough and stalled part way through.

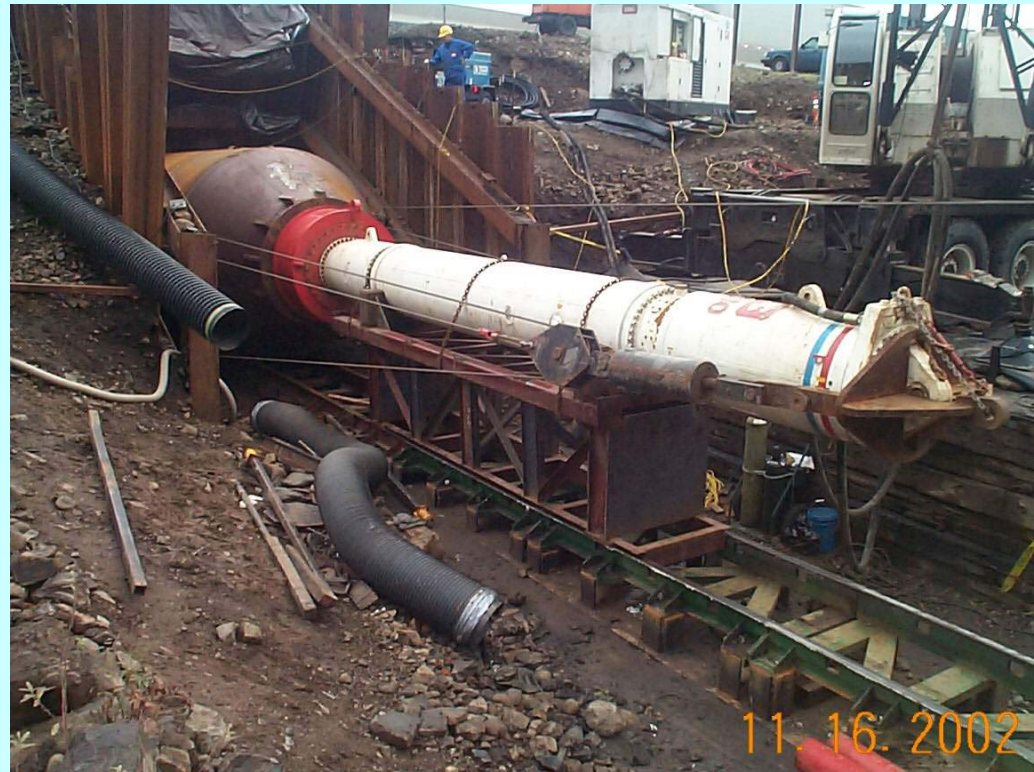
Larger ram was brought in to finish the ramming operation.

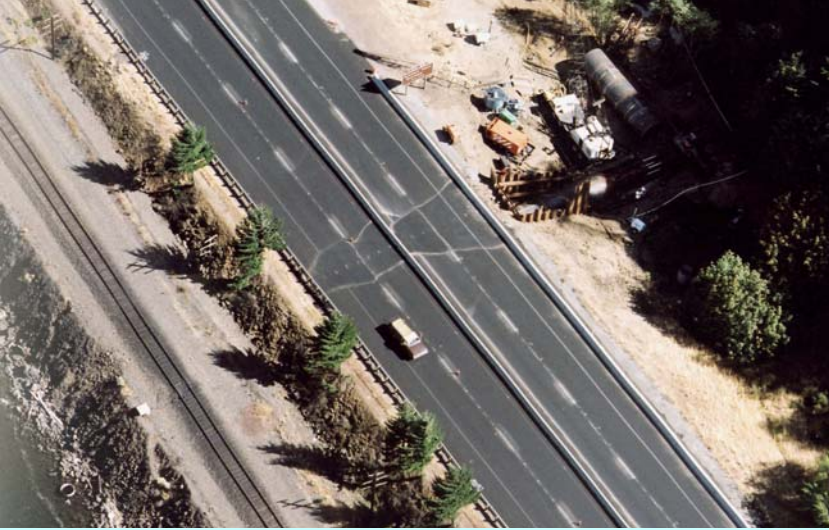
Notice the settlement of the freeway from the vibration of the ram.

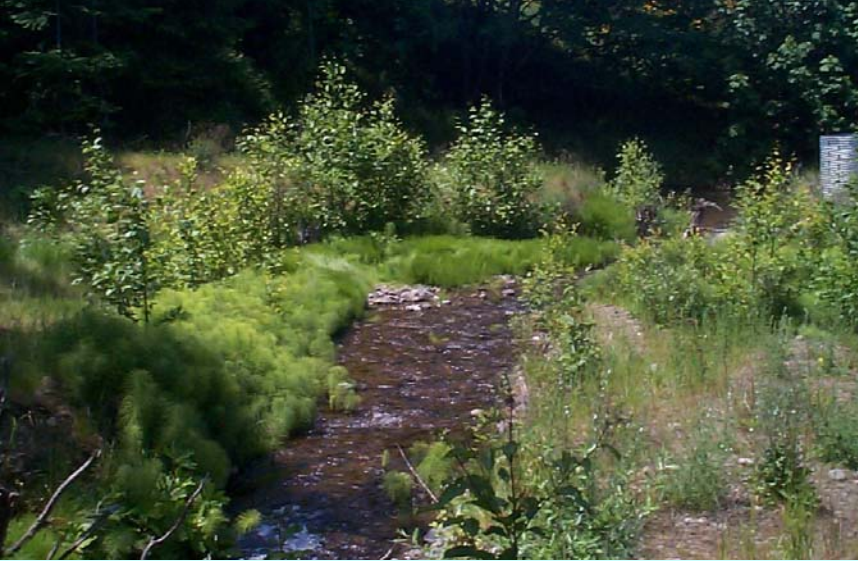
Stream channel prior to construction.  
notice the standpipe in the upper right.

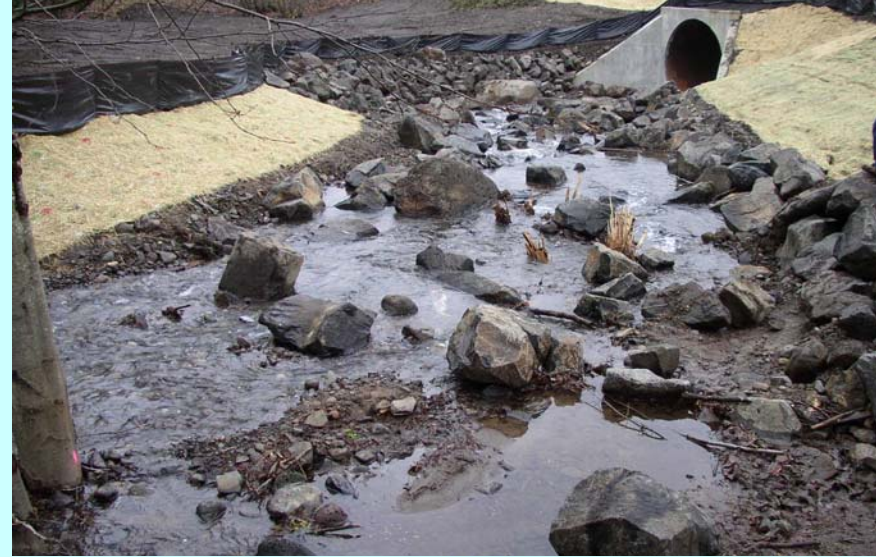
New channel after construction with  
bank slopes are seeded with matting.

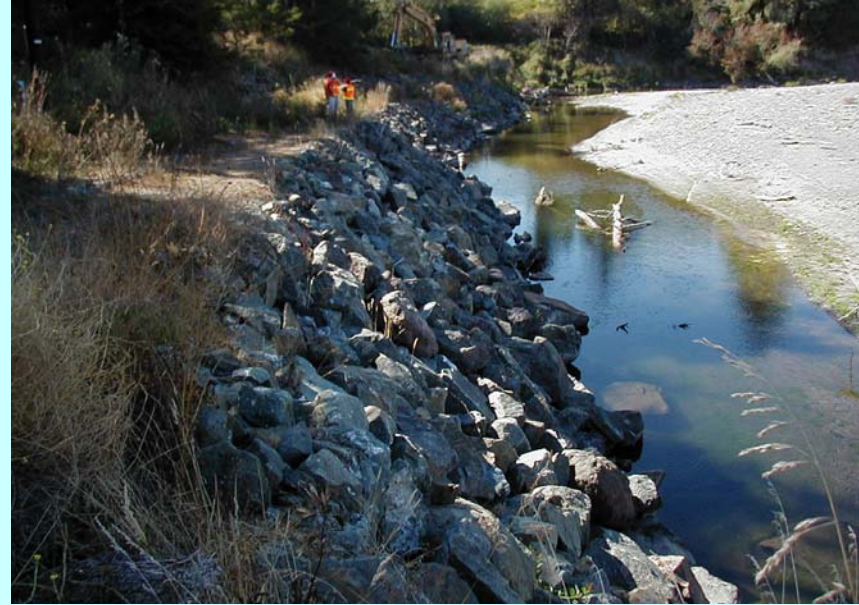
Bank Prior to installation of wood.

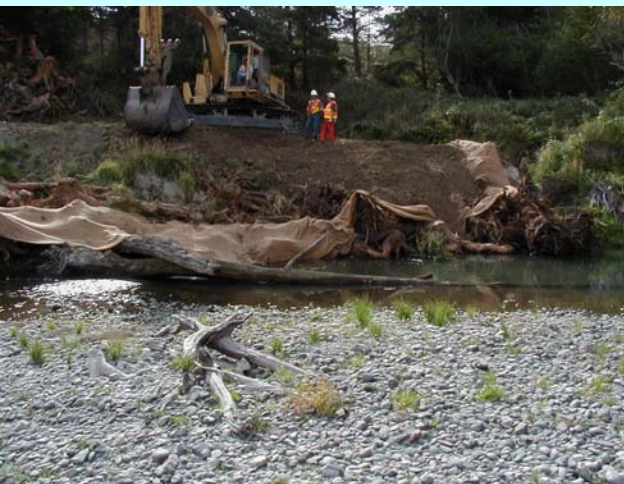
Re-sloping bank to 2:1 for stability.

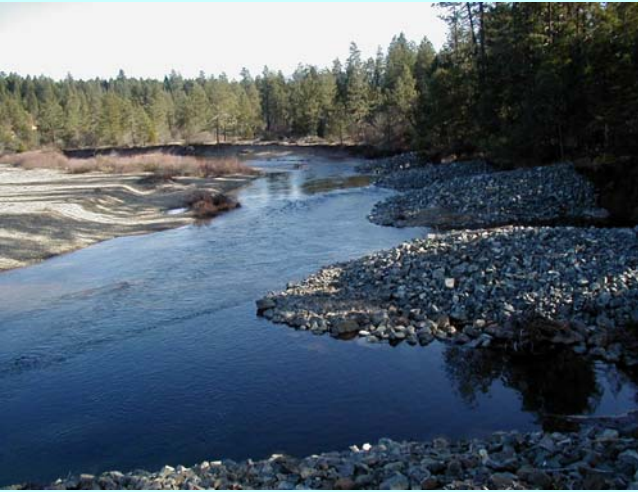
First winter flows, thalweg is moving back to the North.

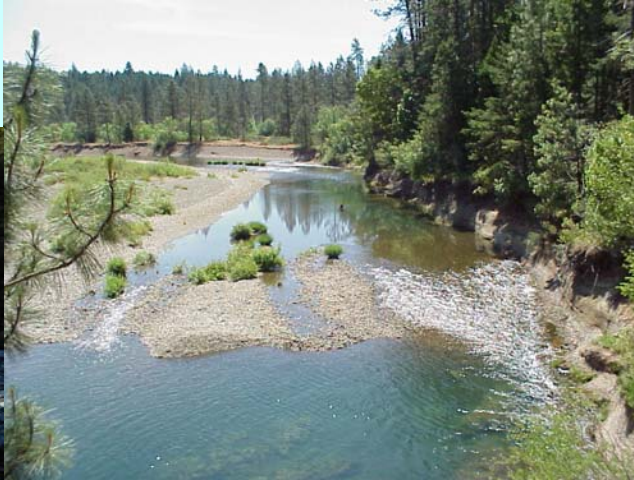
Prior to installation of Rock Barbs the river was moving to the south.

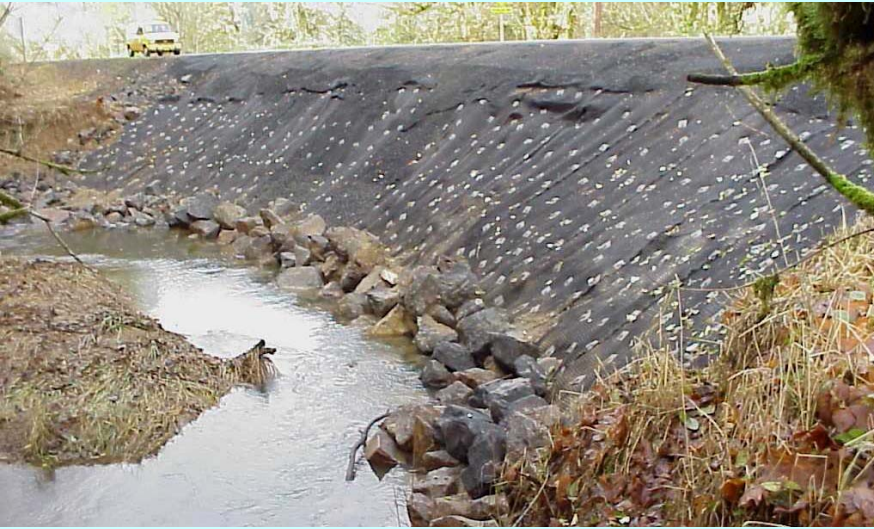
Urgency repair by ODOT Maintenance in November, using Pyramat. Photo was taken November 30th, 1999.

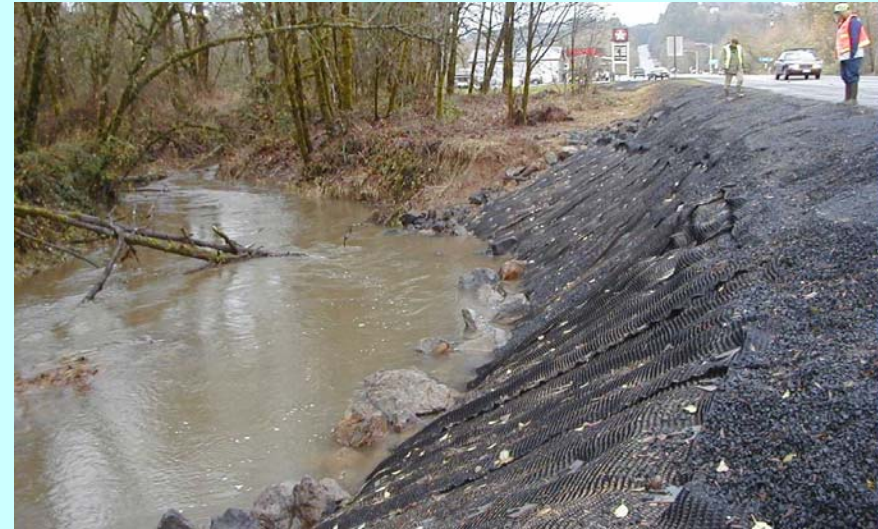
December 6th, 1999, Pyramat and riprap holding well.
