## Overview

## **Emergency Dam Break Analyses Following the Cerro Grande Fire near Los Alamos, New Mexico** Rodney J. Wittler, Blair P. Greimann, Tony L. Wahl **U.S. Bureau of Reclamation, Technical Service Center – Denver, CO**

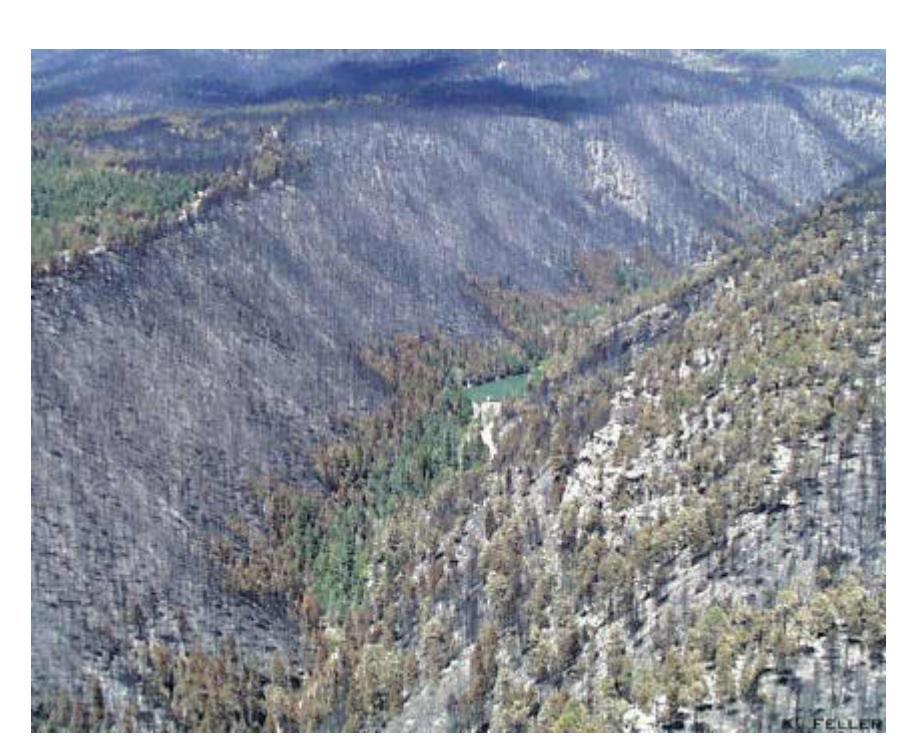
Los Alamos Reservoir and burned watershed

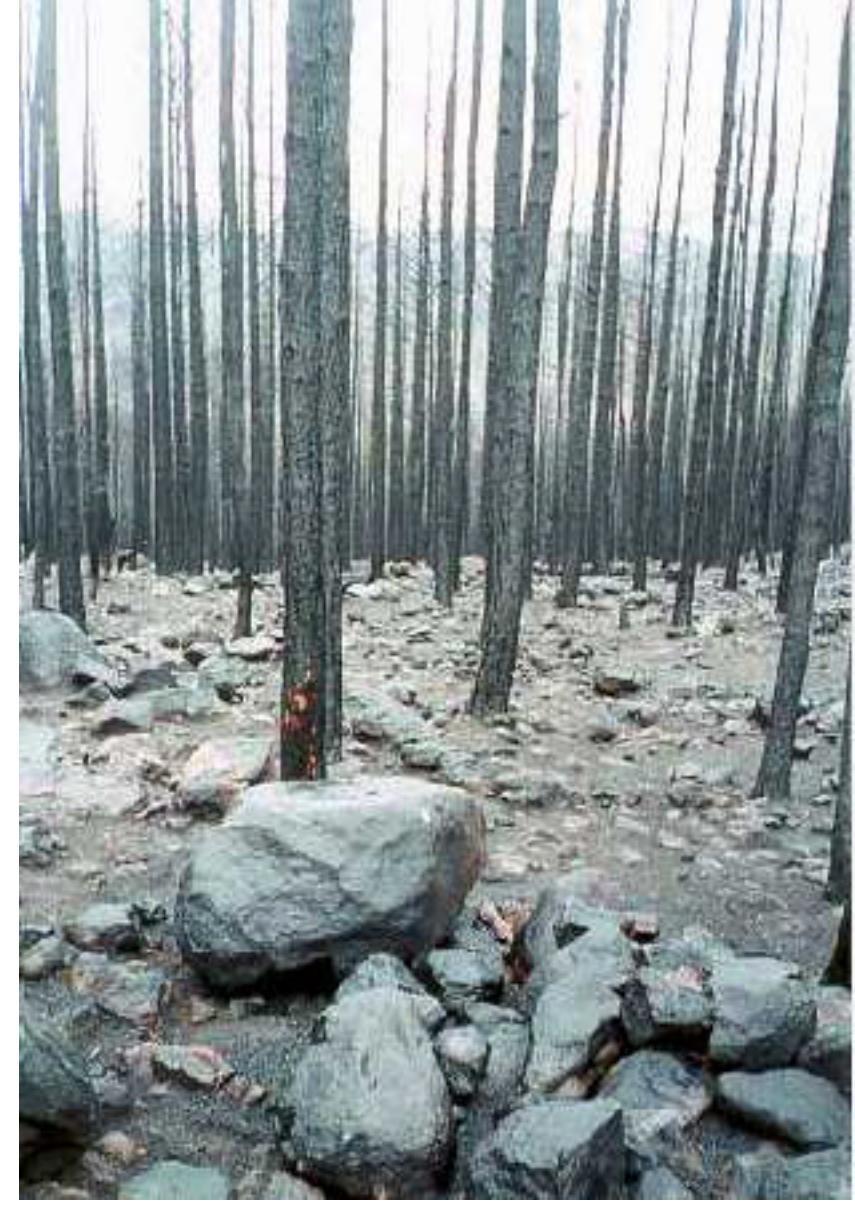
Several watersheds experienced moderate to high burn intensities over 80-90 percent of their area

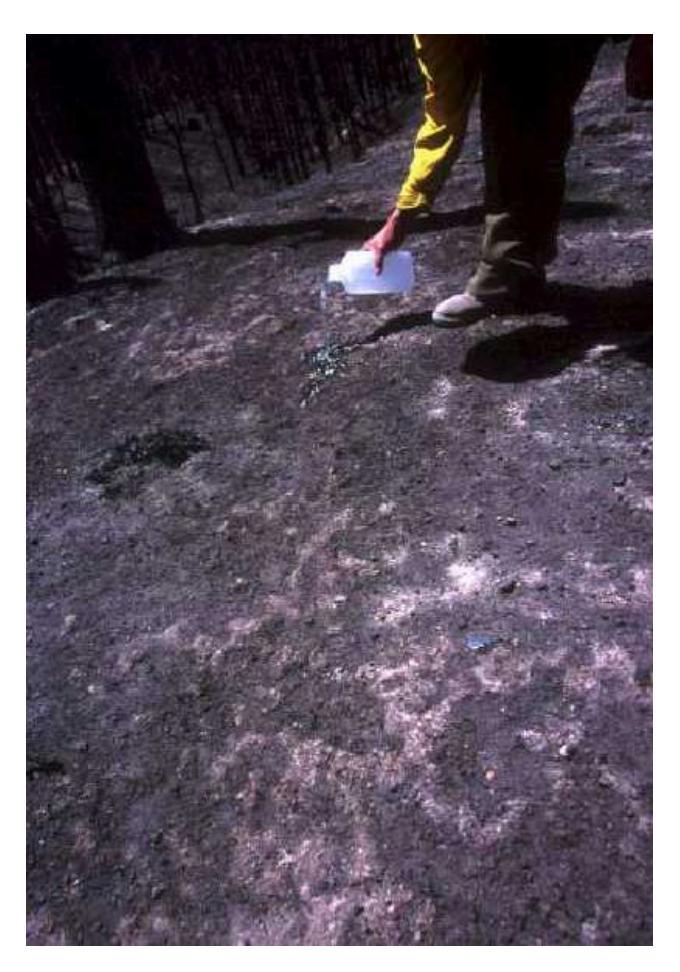
Intense heat produces hydrophobic soils, which yield nearly 100 percent runoff

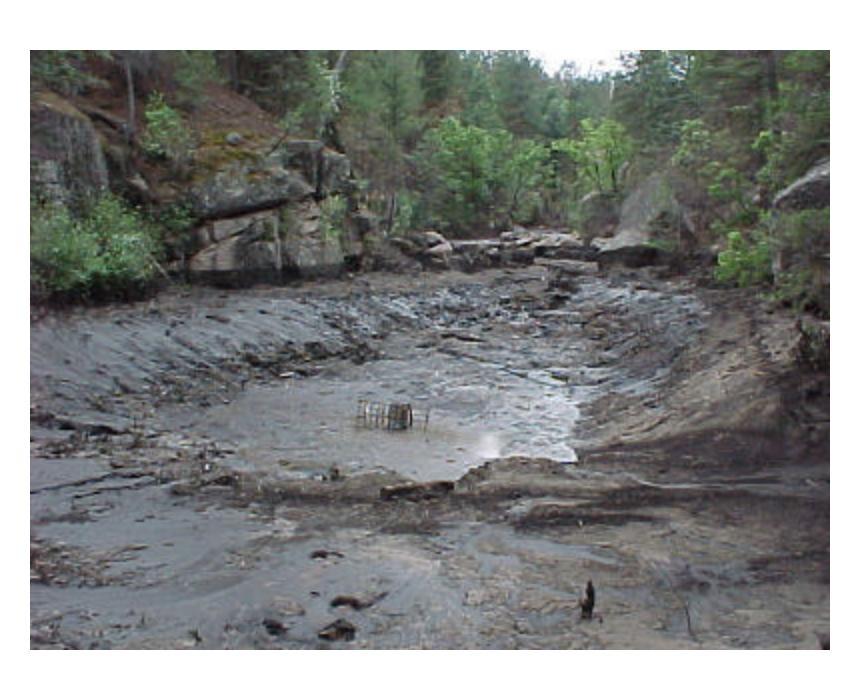
Upstream side of Diamond Ave. roadfill – existing 18-inch culvert after June 2, 2000 storm
