[Docket No. 2003-SW-23-AD; Amendment 39-13966; AD 2005-03-10]

Airworthiness Directives; Bell Helicopter Textron, A Division of Textron Canada Model 222, 222B, 222U and 230 Helicopters

ACTION: Final rule.

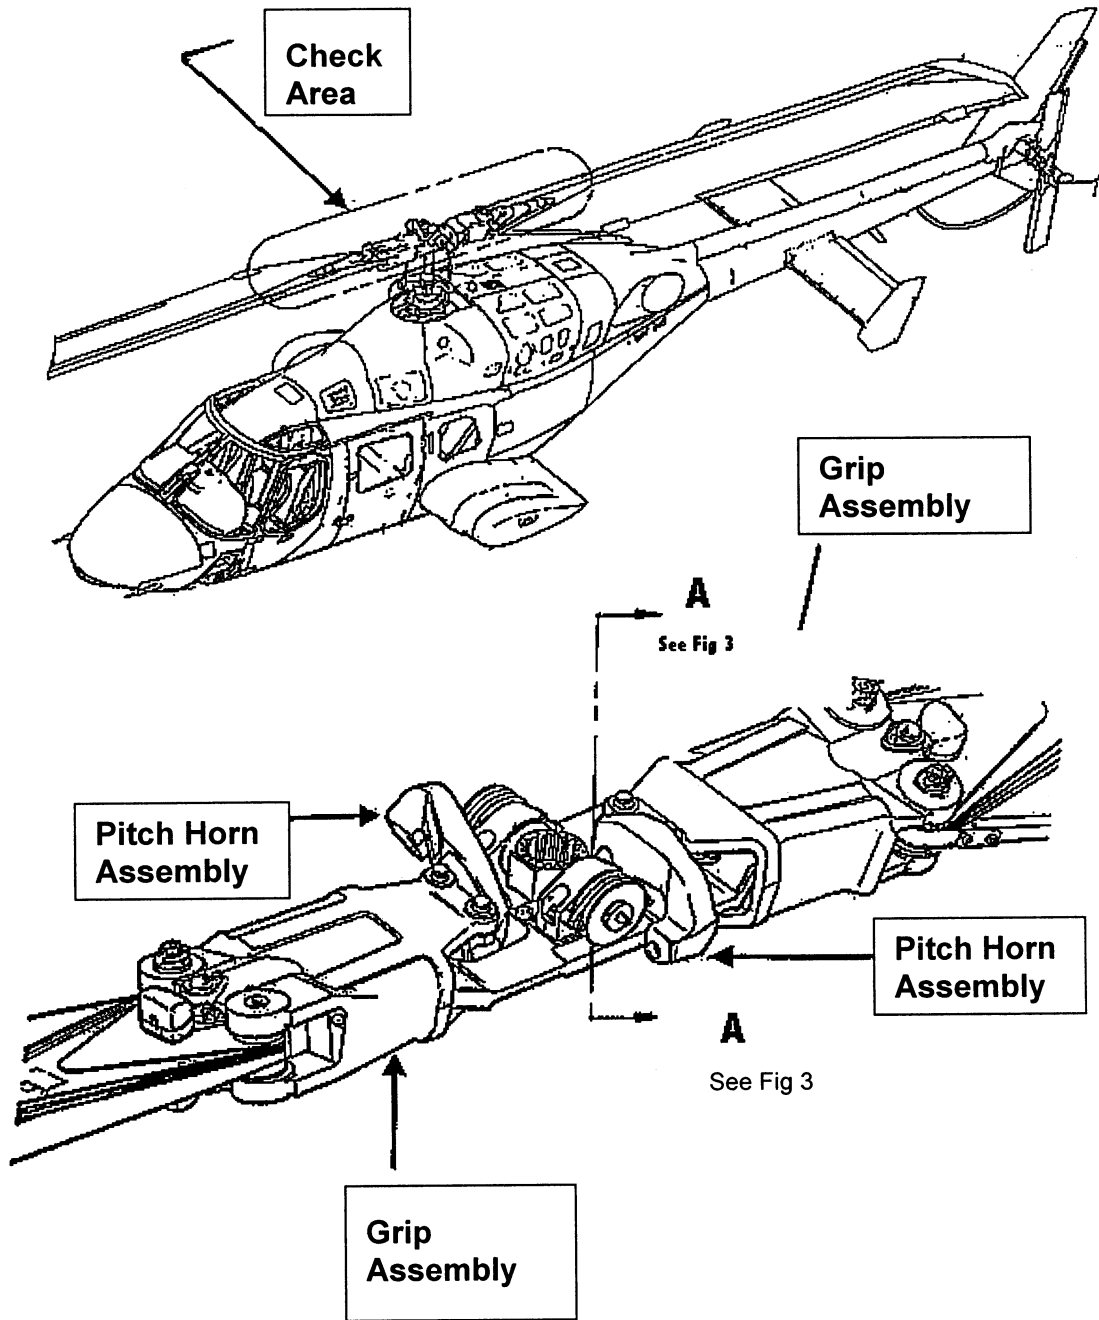
(1) Wipe clean the main rotor grip and pitch horn surfaces to remove grease and dirt in the check area as shown in Figure 1 of this AD:

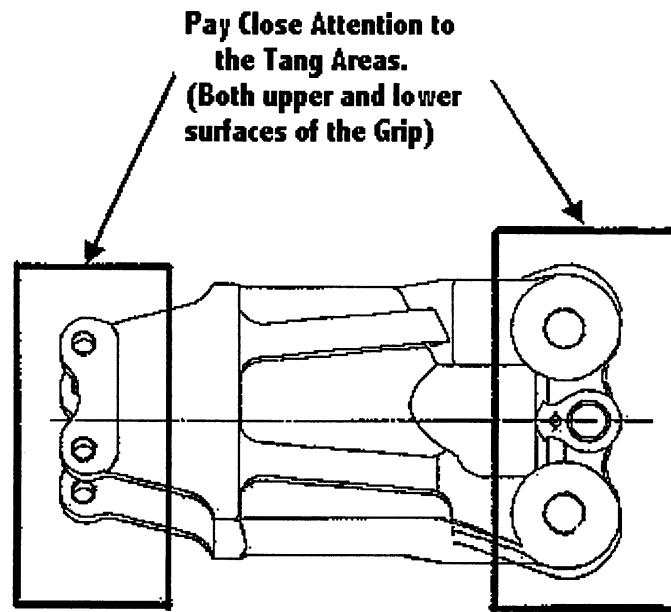
(2) Visually check both main rotor grips for a crack. Pay particular attention to the inboard and outboard tangs portions of the

grip, which are in direct contact with the pitch horns and the main rotor blades and check the area to at least 3 inches beyond the

grip to pitch and grip to blade contact areas as shown in Figure 2 of this AD:

Entire surface of the grip must be checked

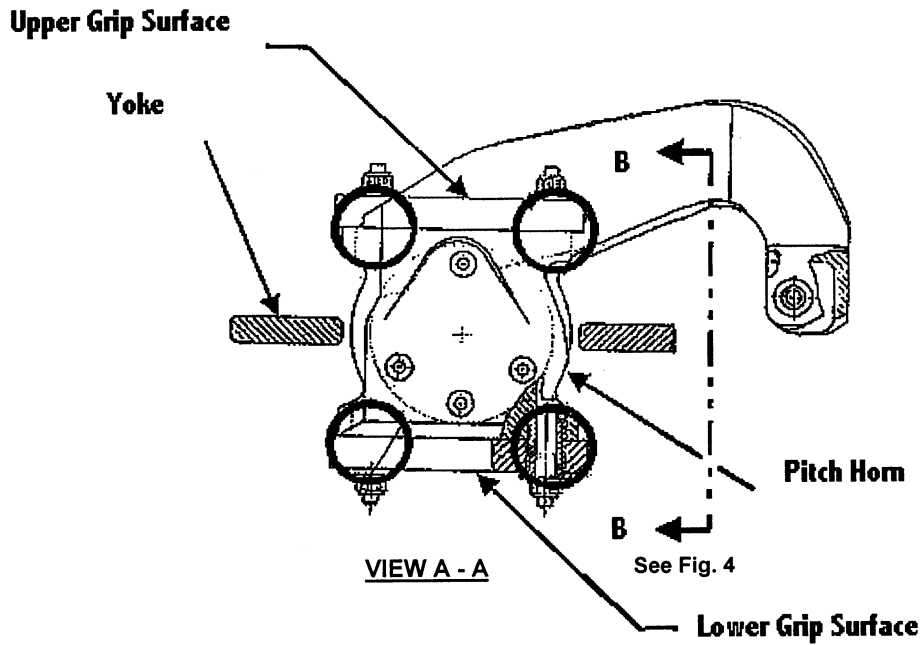
(3) Visually check all visible portions of each pitch horn for a crack. Pay particular attention to the attachment lugs of the pitch

horns, which are in direct contact with the inboard tangs of the main rotor grips, as shown in Figure 3 of this AD, and the four

**All visible portions of the pitch horn must be checked.
Pay particular attention to the circled areas shown above and View B-B, Fig. 4.**

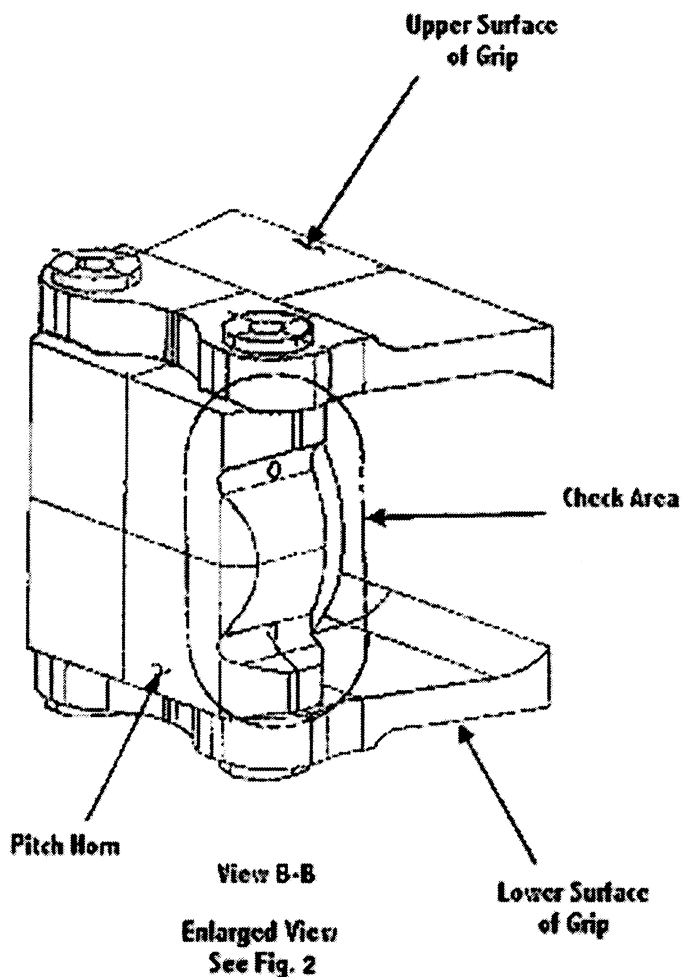
large bolt cutouts, as shown in Figure 4 of this AD:
