[Docket No. FAA–2004–18850; Directorate Identifier 2004–SW–19–AD; Amendment 39–14694; AD 2004–16–15 R1]

#### **Airworthiness Directives; Eurocopter France Model AS–365N2, AS 365 N3, EC 155B, EC155B1, SA–365N, N1, and SA–366G1 Helicopters**

**2004–16–15 R1 Eurocopter France:**

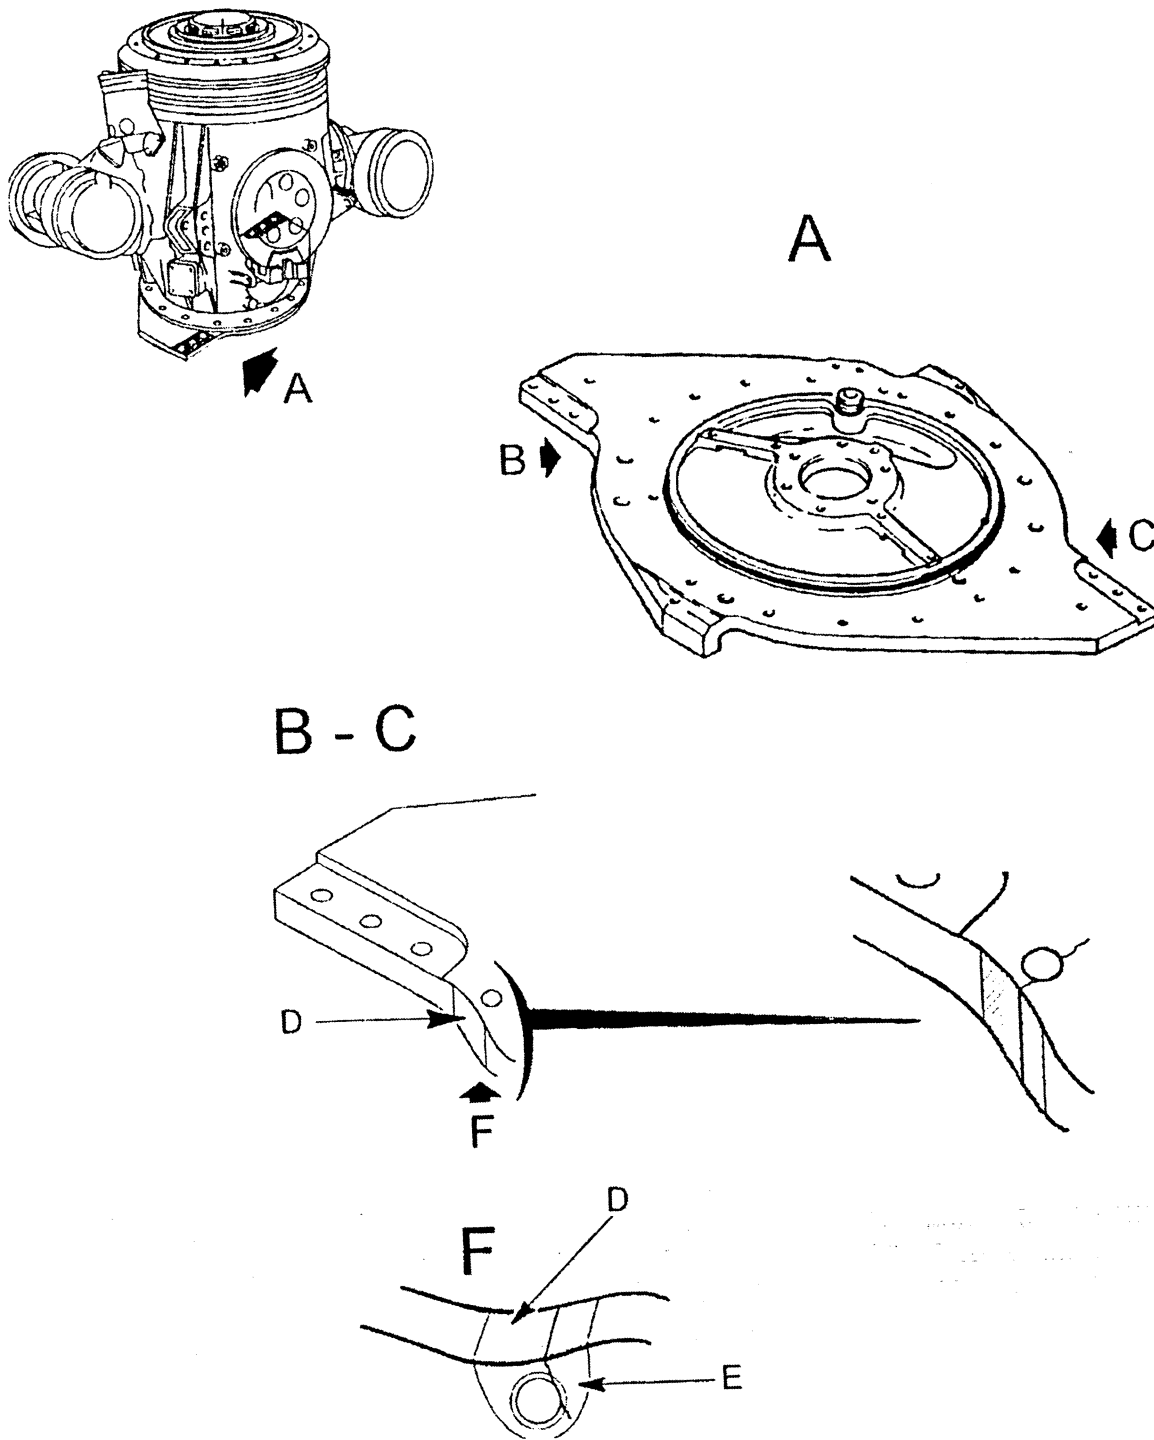
**Figure 1**

To detect a crack in the MGB base plate and prevent failure of a MGB attachment point to the frame, which could result in severe vibration and subsequent loss of

strip the paint from area “D” on both sides (“B” and “C”) of the MGB base plate as depicted in Figure 1 of this AD.

(b) At the times indicated in the compliance table, inspect area "D" of the MGB base plate for a crack using a 10x or higher magnifying glass. Area "D" to be inspected is depicted in Figure 1 of this AD.

(c) If a crack is found in a MGB base plate, remove and replace the MGB with an airworthy MGB before further flight.
