EPA/600/R-07/025
March 2007

Demonstration Evaluation of Biodegradable Degreaser

Battelle
Columbus, Ohio 43201

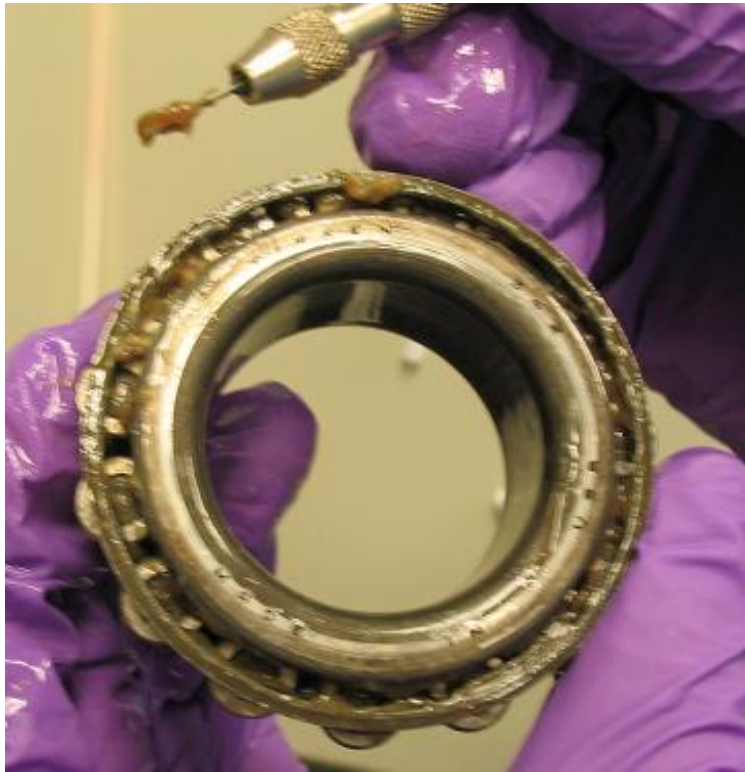
Three contaminated wheel bearings (two ~3 inches in diameter and one ~2.5 inches in diameter) were obtained. One was placed in a beaker and submersed in Eagle Kleen™ for approximately 25 minutes. During that time there was little change to the solution color. Some grease may have been loosened in the inner bearings, but no apparent degreasing was observed (see Figure 1).

Figure 1. Bearing Inspection after Initial Immersion

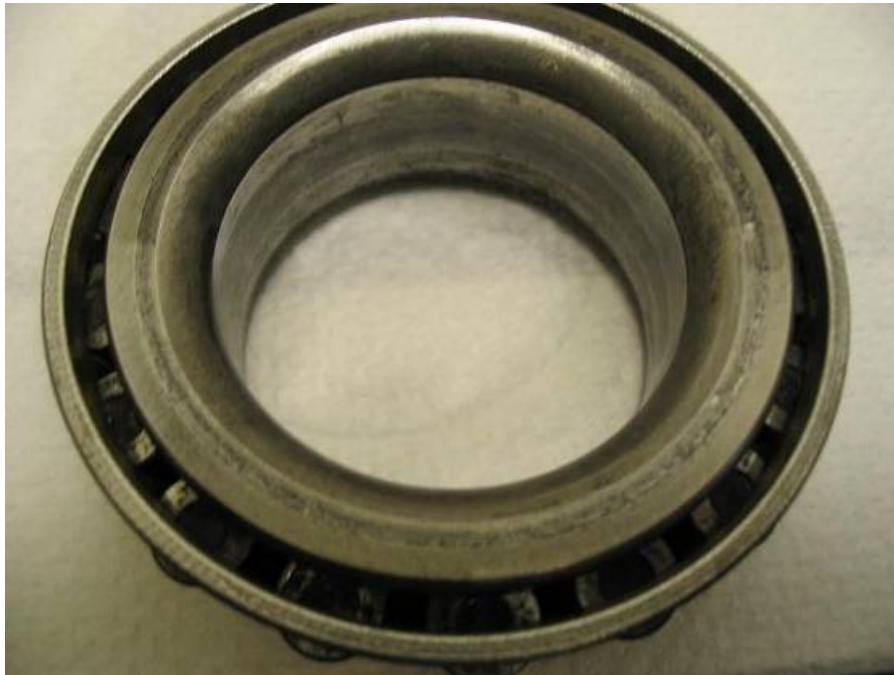
Figure 2. Bearing after Final Cleaning

At this stage, it appeared that Eagle Kleen™ would degrease a part effectively enough for a mechanic to determine if it had a major defect that would require replacement. It also appeared that the part would be clean enough for repacking with grease for reinstallation. It was determined that this cleaning ability was suitable for site testing to commence at Robins AFB, but because spot rusting was observed, the demonstration was delayed until corrosion data were obtained.

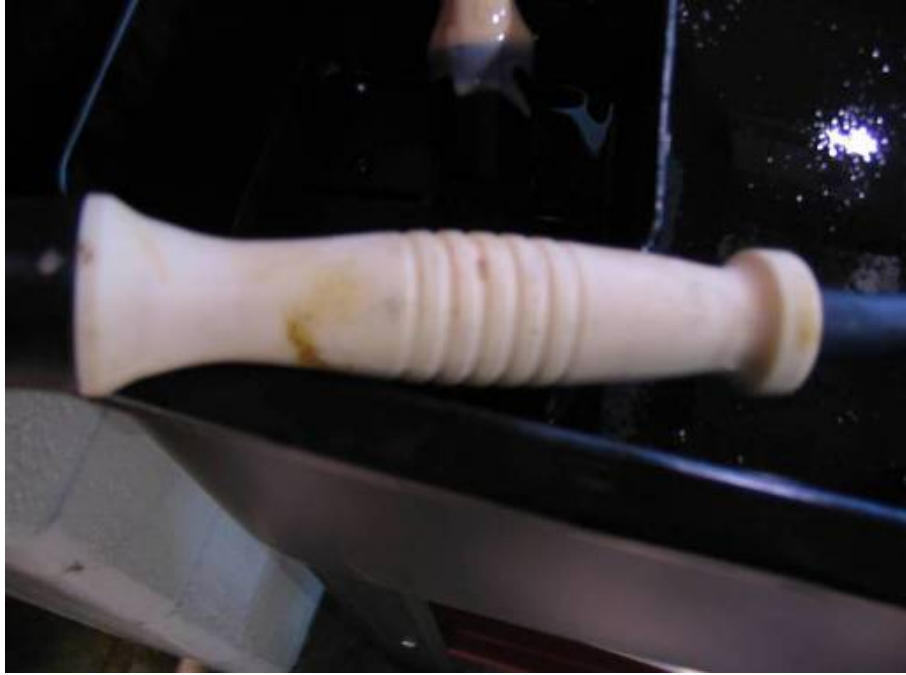
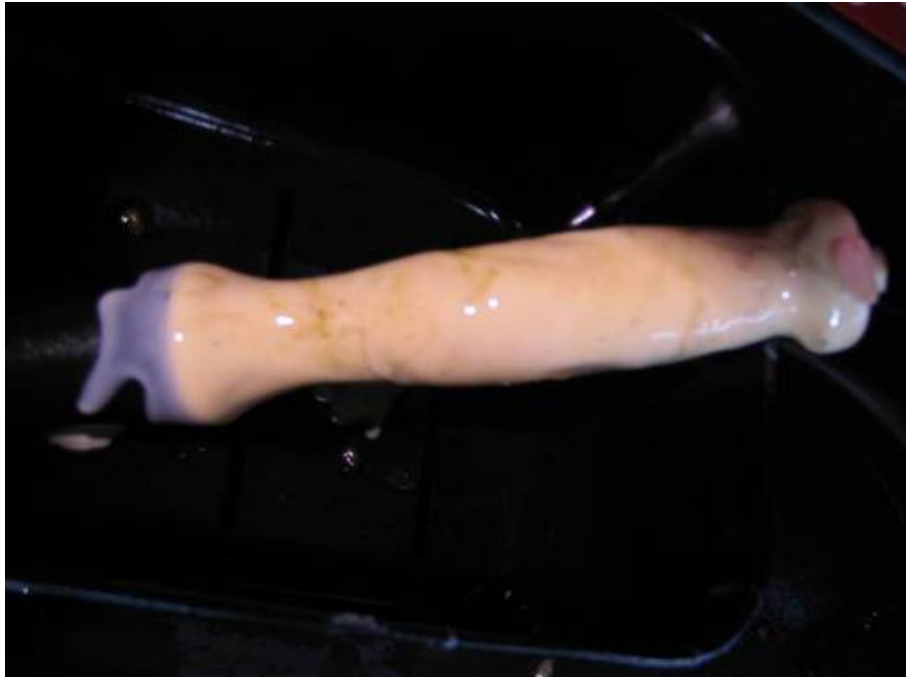
While conducting the Robins AFB demonstration, it was determined that Eagle Kleen™ is not suitable for use with or on certain types of polymers. A scrub brush used during the hand cleaning at the Vehicle shop was left to lay in approximately ½-inch of Eagle Kleen III degreaser over the weekend. Upon return to the shop the following week, employees found that the scrub brush had “melted” (see Figure 3 for the “before” photograph and Figure 4 for the “after” photograph).

Figure 3. Handle Before Exposure to Eagle Kleen III

Figure 4. Handle After Exposure to Eagle Kleen III

After reviewing this study, it became apparent that if Eagle Kleen™ were to be used in a large-scale setting, care would need to be taken to ensure the materials of construction for the equipment used in conjunction with the fluid were compatible with Eagle Kleen™. In addition, the facility would need to stress the importance of using the appropriate PPE for this task and set up a stringent replacement schedule of said PPE. However, from the preliminary compatibility testing performed, it appears that acceptable alternatives, such as neoprene gloves, Viton or Teflon gaskets and seals, and high-density polyethylene (HDPE) tanks and containers are readily available.

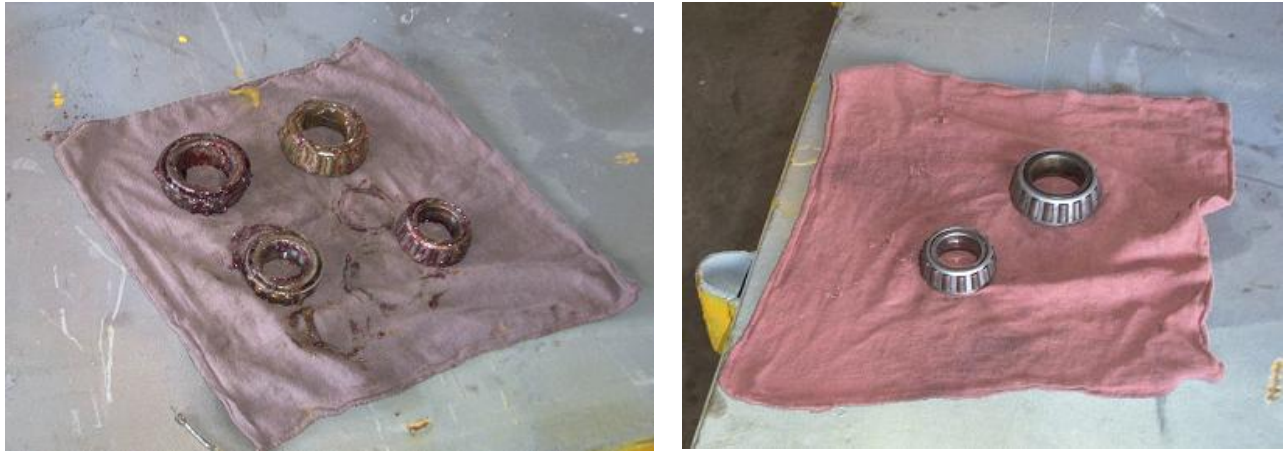
Figure 7. Wheel Bearings Before (left) and After (right) Degreasing with Eagle Kleen™

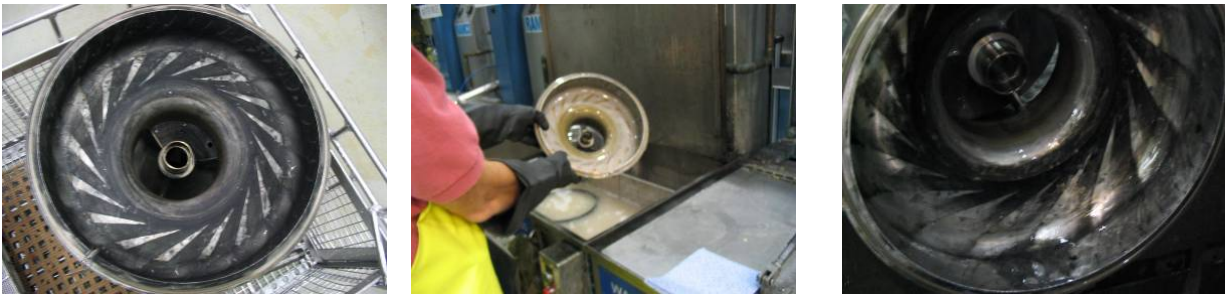
Figure 12. Example of Air Inlet Housing Prior to Cleaning (left), After Degreasing with Turco 6849 (center), and After Degreasing with Eagle Kleen™ (right)

- Removal of oil and grease tended to be equal to or slightly inferior to Turco 6849 degreaser for lightly soiled parts.
- Eagle Kleen™ was not effective at cleaning carbon-contaminated parts.
- Parts cleaned using Eagle Kleen™ required more manual cleaning than Turco 6849 after the 30-minute degreasing step for all types of contamination.
- The strong odor of Eagle Kleen™ was objectionable to the operators. Operation without a ventilation system caused some operators to complain of headaches, irritation of mucous membranes, and light headedness.

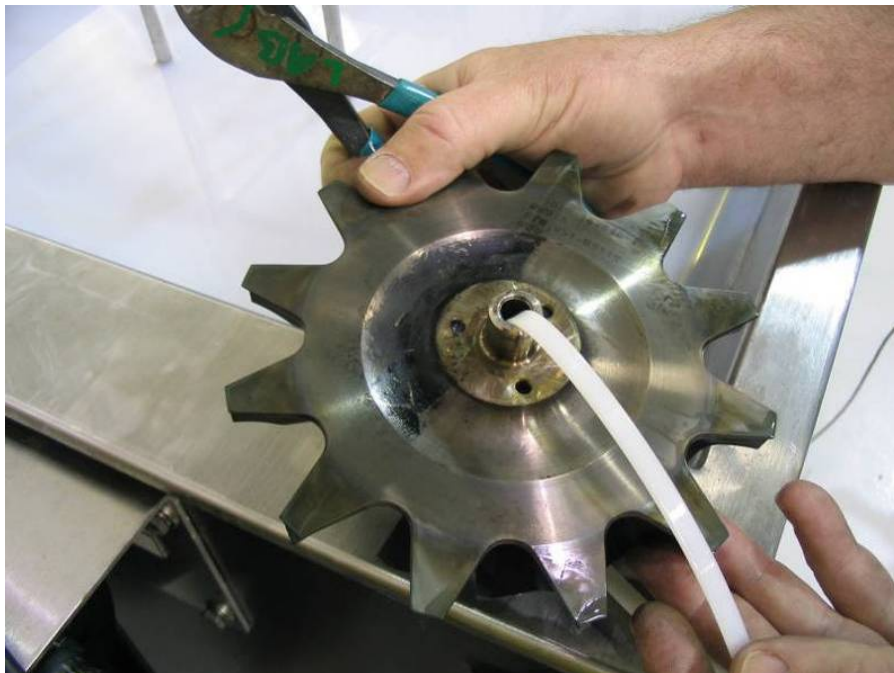
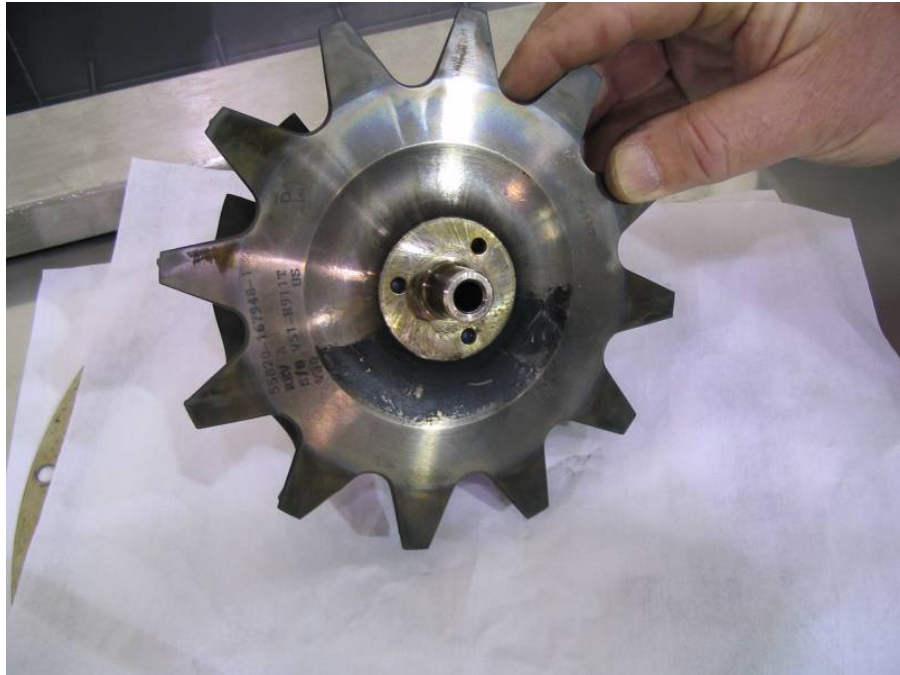
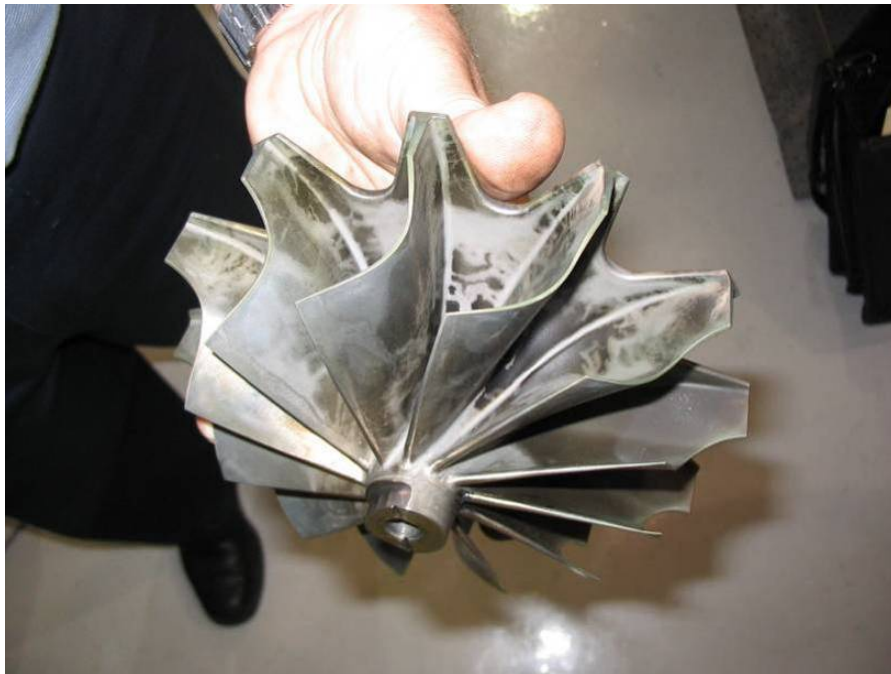
In an attempt to allow a better evaluation of the effectiveness of Eagle Kleen™ a fan assembly along with a different part (some type of housing) were submerged and suspended over the solution (see Figure 17). The fan assembly after 15 minutes showed a dramatic removal of the black coating. On the front, there is a clear demarcation of where the fan was immersed in the cleaner, and in this area the surface looks very clean (see Figure 18). The area cleaned is free of the black deposit. Another view, showing the dramatic cleaning achieved, is shown in Figure 19. On the rear side, where the fins are observed, it shows the surface substantially cleaned, but not totally (see Figure 20). This photo also shows an area that was not submerged, and is still completely covered with the dark brown/black substance.

Figure 18. Top View of Fan Assembly After Cleaning

Figure 19. Front View of Fan Assembly after Cleaning

Figure 20. Rear View of Fan Assembly
