OFFICE OF INSPECTOR GENERAL

Audit of the Post-Project Condition of Roads and Bridges Constructed in Honduras Under the Emergency Reconstruction of Roads and Bridges Activity

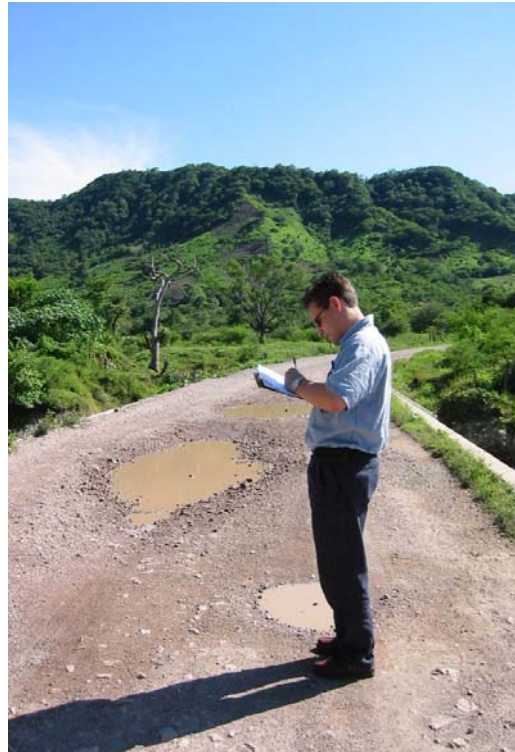
Figure 1 - Photograph of auditor assessing road condition on Road #210, Choluteca, Honduras, September 2003

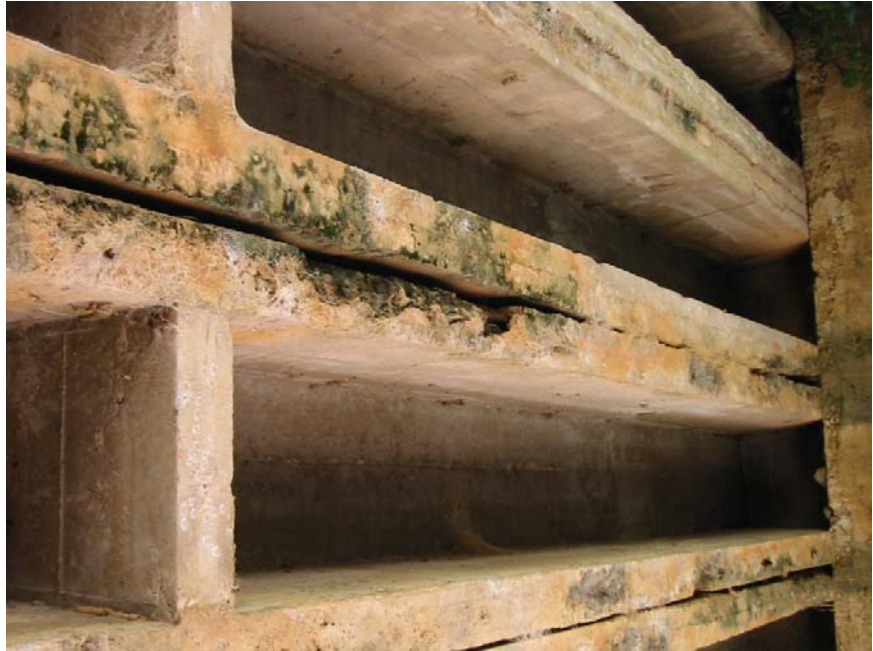
Figure 2 – Photograph of concrete beams with corroded steel strands and filtered-down moisture below Los Achiotes bridge in Olancho, Honduras, September 2003

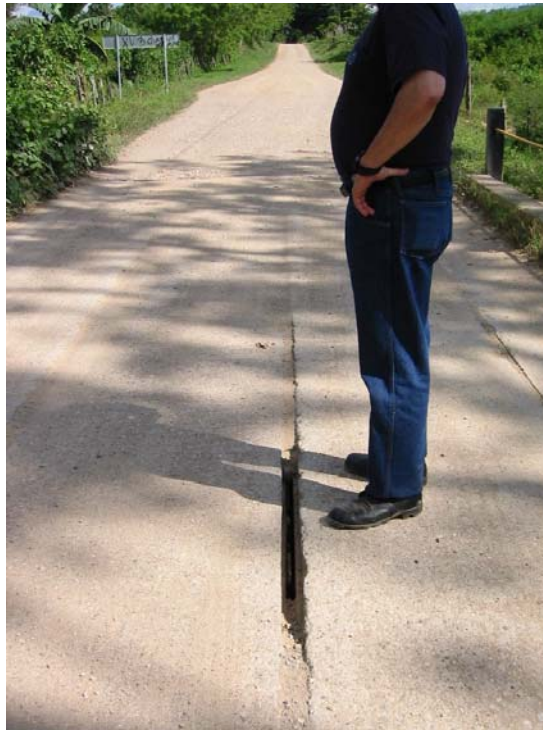
Figure 3 - Photograph of separated concrete slabs on the deck of Zopilote bridge in Olancho, Honduras, September 2003
