# NASA Technical Memorandum 87636

EARTH RADIATION BUDGET EXPERIMENT (ERBE) SCANNER INSTRUMENT ANOMALY INVESTIGATION

N. D. WATSON, J. B. MILLER, L. V. TAYLOR, J. B. LOVELL, J. W. Cox, J. C. Fedors, L. P. Kopia, R. M. Holloway, and O. H. Bradley

OCTOBER 1985

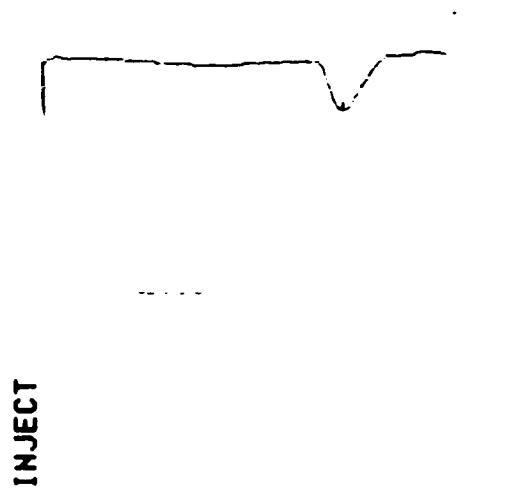
Fig. 2- HPLC chromatogram of the phenolic retainer extract

The HPLC analysis revealed that the freon solvent was able to extract the fluorinated polyether lubricant from the phenolic retainer, figure, 3 and that no "detectable" amount of the lubricant was found on the ball bearings, figure 4. The word "detectable" is used because if the lubricant was present on the ball bearings the amount extracted was too small to be detected by the refractive index detector. Comparison of the FTIR spectra (both identical) also showed no detectable amount of the lubricant was extracted.

The evidence indicates ineffective transfer of the liquid lubricant from the phenolic retainer to the ball bearings. Any lubrication between the ball bearings and the races may be due to the TCP treatment. In the high vacuum conditions of outer space, once the metal oxide or phosphate film wear away there is no oxygen or water vapor to react with the nascent metal surfaces to reform a protective film.

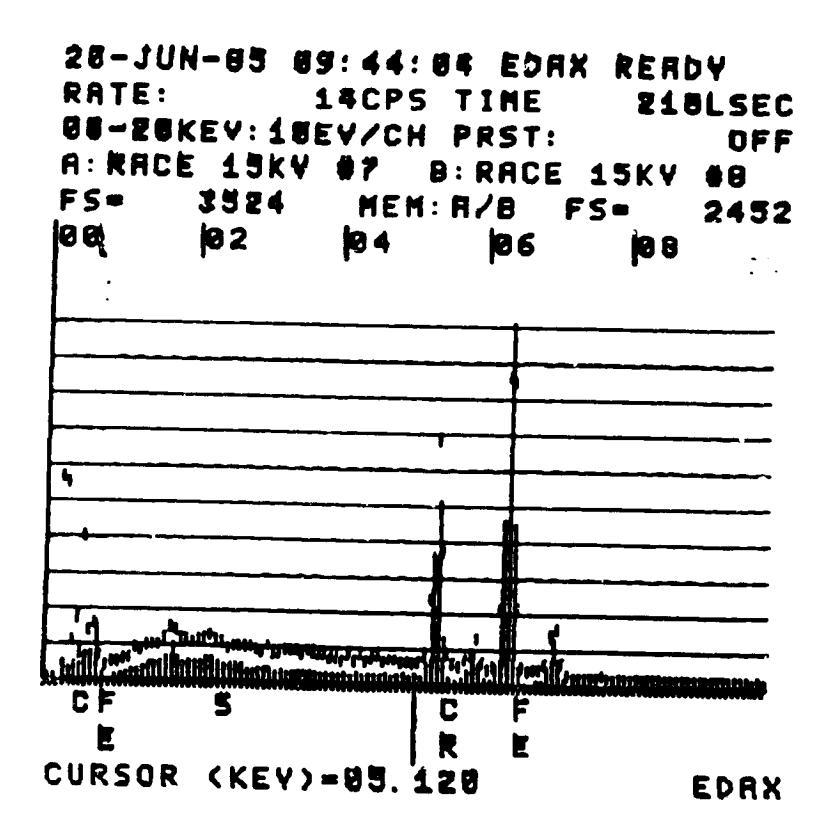
Fig. 6- EDX analysis of outer race

In light of the low vacuum  $(10^{-3}$ Torr) used in the scanner life test, it is possible that the deposit found on the outer race could have resulted from a oxygen reaction at the wearing surfaces.
