QM-8 Field Joint Protection System Final Report Volume 7

June 1989

TWR-17591 VOL. VII QM-8 FIELD JOINT PROTECTION SYSTEM FINAL REPORT VOLUME 7 FINAL REPORT

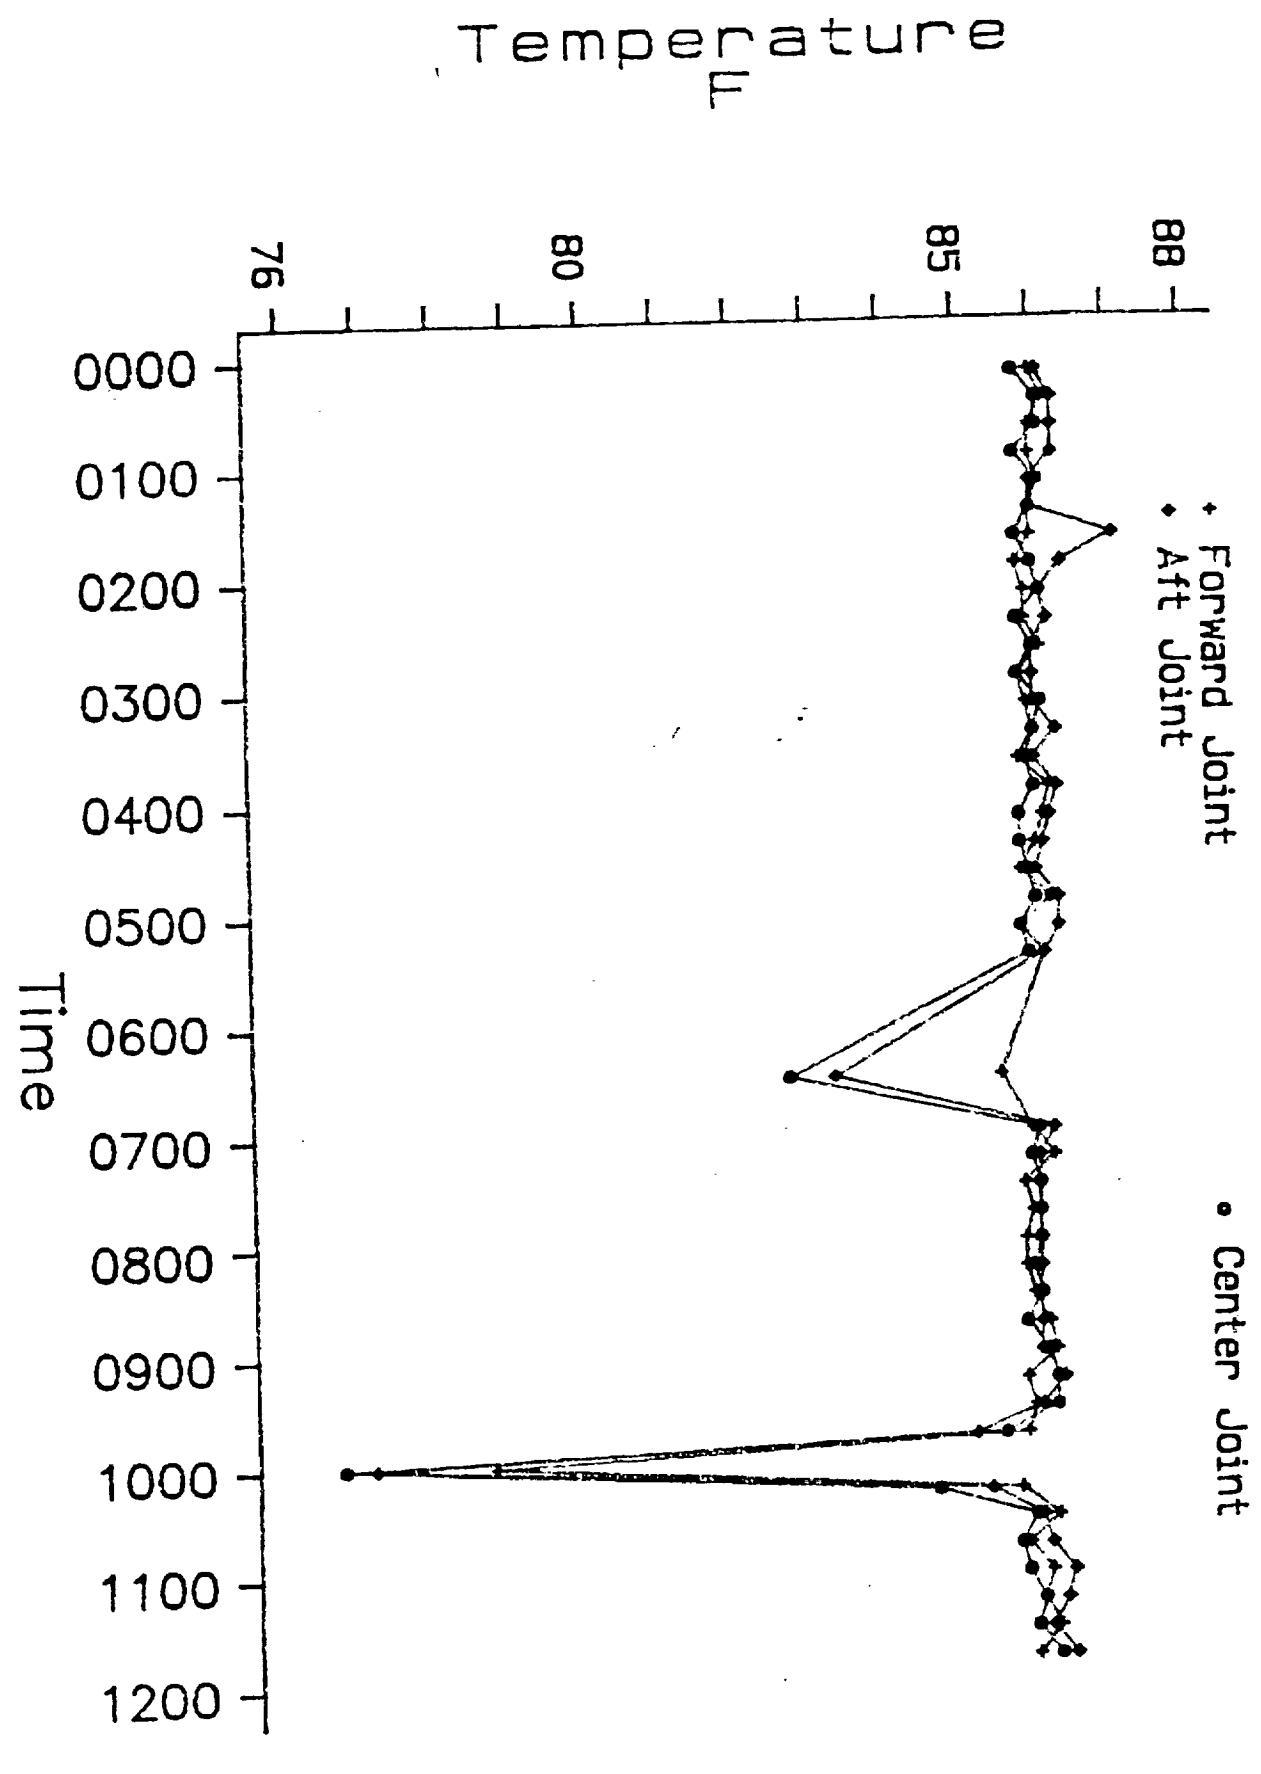
RTD at 86° with a maximum deviation of -0.6° to +0.5°. The four temperature sensors at each field joint were continuously monitored and the coldest sensor was manually selected for temperature control. Figure 2 is a plot of the temperature of the controlling RTD of the three field joints. The drop in temperature at 0600 and 1000 hours was due to heater power shut off.
