ATTACHMENT 1

PROPOSED:	REEF RESTORATION
AT:	KEY WEST, FLORIDA
COUNTY OF:	MONROE
APPLICATION BY:	ECM/Hudson Maritime Services, LLC

ATTACHMENT 2

Re Request for modification of permit application #1997-03492 (LP-VA)
Contship Houston rubble removal/disposal

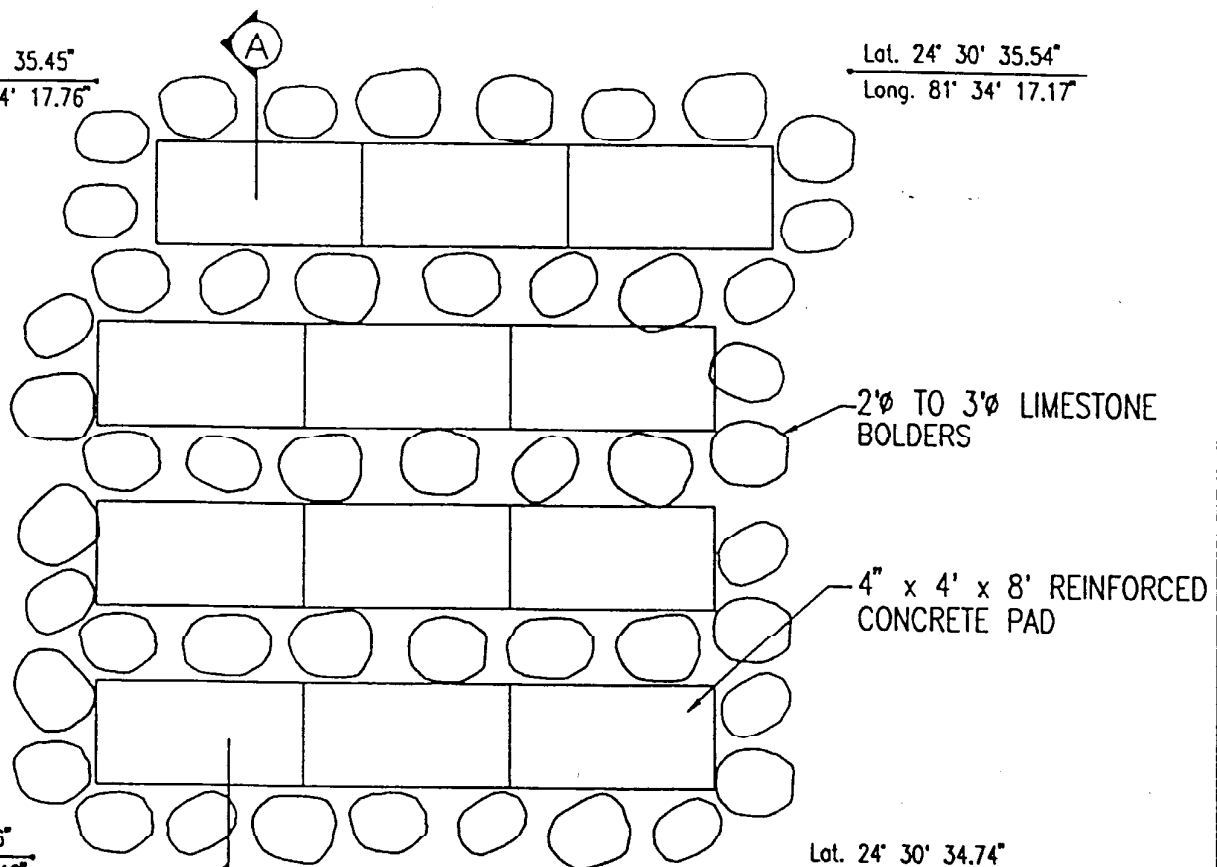
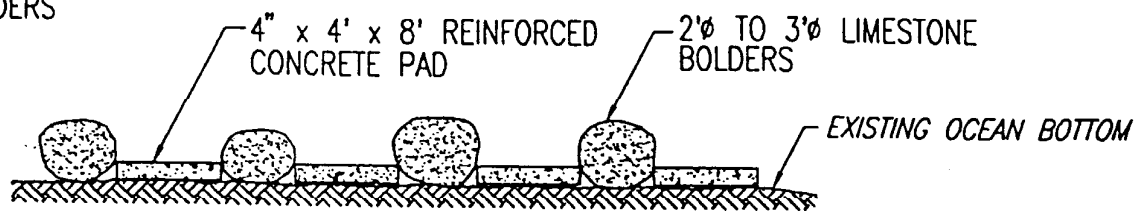
PLAN OF PL-1
SCALE: NONE

4,425 SQ. FT. DAMAGED AREA
216 TONS BOULDERS
25 MATS

Several factors determined the design (i.e., selection/placement of concrete mats and/or limestone boulders) for each of the four primary restoration areas. Of major concern was the amount of unconsolidated material that was present. Relatively large open, flat expanses (e.g., PL-1) uniformly characterized by this erosion-prone sediment were deemed to require the greatest need for stabilization via concrete mats. Of equal importance, any areas of existing reef habitat relief or areas where any emergency coral reattachment/relocation occurred were unsuitable surfaces for installing concrete mats. Areas not spatially defined by either of these criteria were most suitable to receive limestone. To the extent that it could be reasonably accommodated, there was also interest in slightly varying the design among the primary restoration areas to facilitate post-construction comparisons.

At PL-1, concrete mats were used extensively because the area was flat and uniformly composed of the unconsolidated material. Approximately 216 tons (97 cubic yards) of limestone boulders were added to provide some additional relief. At RP-1, concrete mats were used wherever relatively broad expanses of unconsolidated material was present, but existing reef structures and biota prevented it from being covered as seamlessly as achieved in PL-1. The limestone was used to provide relief and to add structural stability to relatively smaller mat segments. Approximately 125 tons (56 cubic yards) of limestone were used at RP-1.

At both RP-1 and PL-1, there were a few spots where the mats had to be cut so that it did not drape over any pre-existing or reattached coral. A total of approximately 6,350 square feet of concrete armorflex mats was used (at RP-1 and PL-1), of which approximately 4,675 square feet was applied at PL-1 and approximately 1,675 square feet was applied at RP-1.

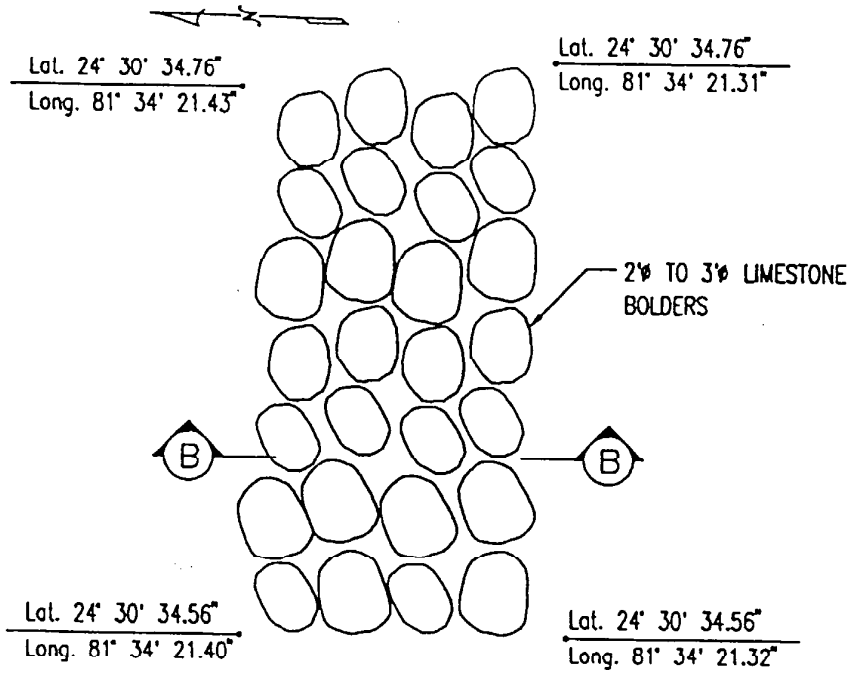
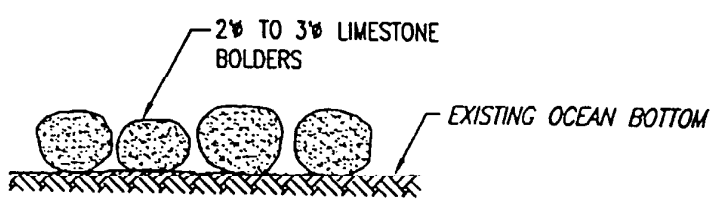
PLAN OF PL-4
SCALE: NONE

210 SQ. FT. DAMAGED AREA
25 TONS BOULDERS
0 MATS

PL-4 was blanketed with approximately 25 tons (11 cubic yards) of limestone because it was too small an area for effective deployment of concrete mats. Density and height of boulder placement was greater than used in the other primary restoration areas so as to additionally provide an opportunity for developing some meaningful post-construction comparisons.

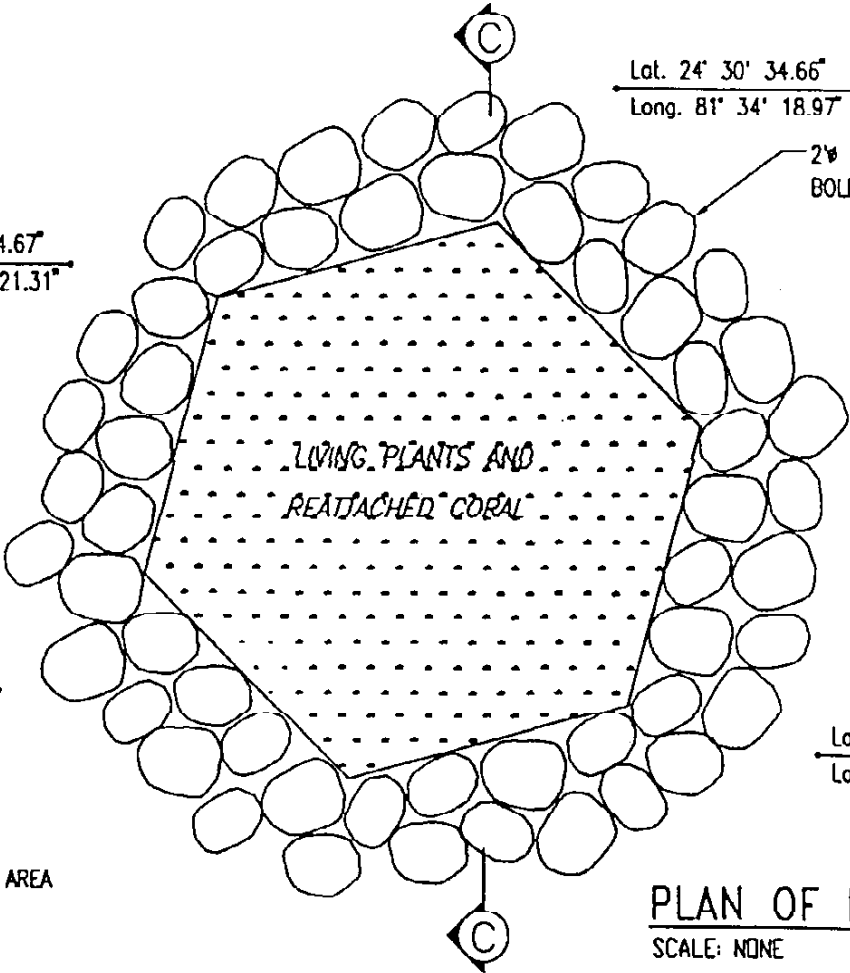
PLAN OF RP-2
SCALE: NONE

763 SQ. FT. DAMAGED AREA
85 TONS BOLDERS
0 MATS

At RP-2, the extent of (emergency) re-attached coral locations and uninjured biota was deemed too significant to permit safe placement of either armorflex mats or limestone. Nevertheless, the underlying reef spur had been injured. It was decided to stack approximately 85 tons (38 cubic yards) of limestone boulders in a narrow band around the periphery of RP-2 that was not the focus of coral reattachment effort nor was a highly successfully colonized reef area. By stacking the limestone boulders on the periphery, it was postulated that erosional forces within RP-2 could be most effectively minimized.

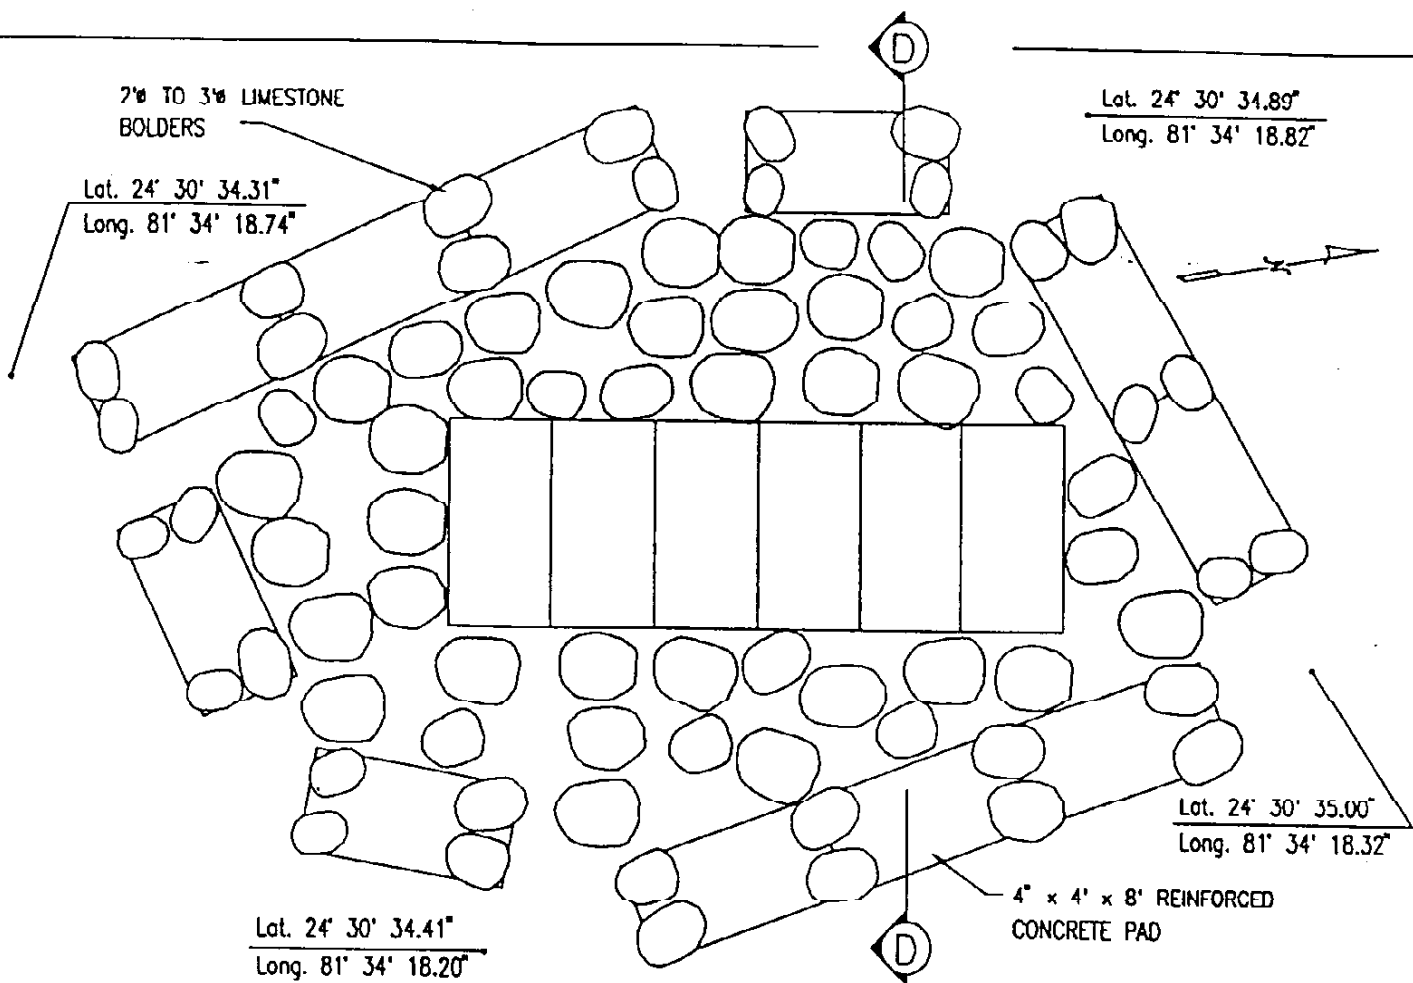
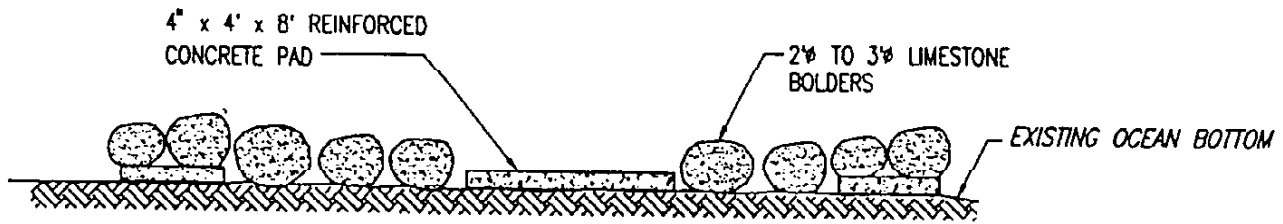
PLAN OF RP-1
SCALE: NONE

3,225 SQ. FT. DAMAGED AREA
125 TONS BOLDERS
15 MATS

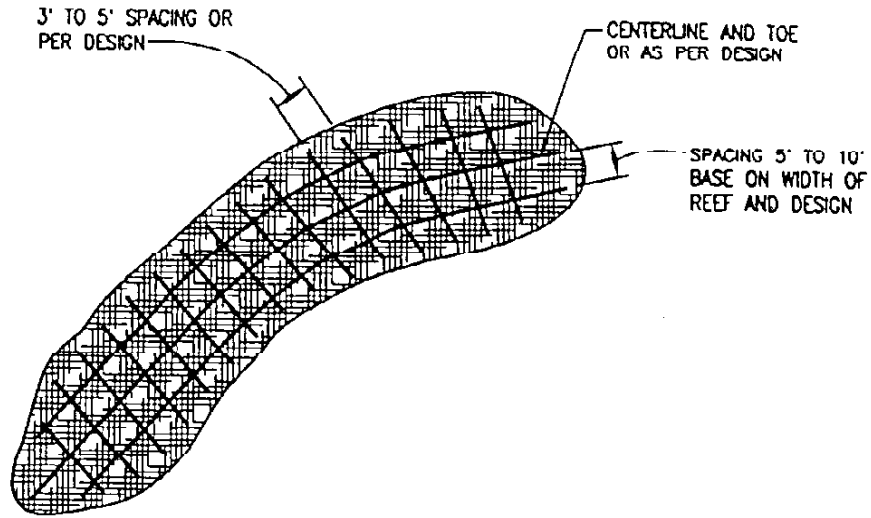
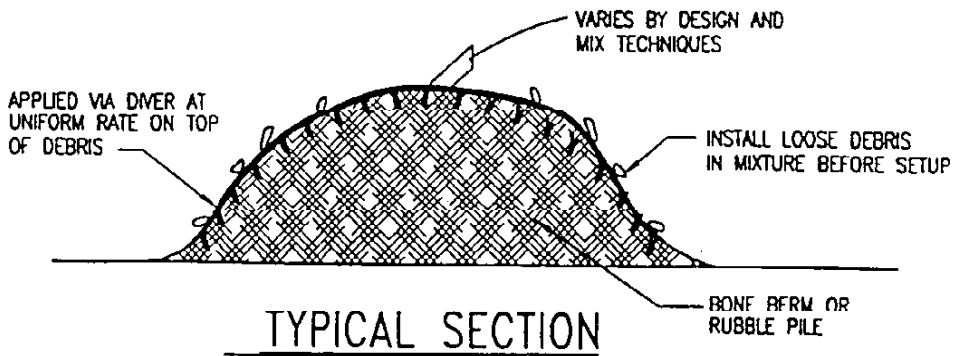
TYPICAL CORAL REEF PLAN
SCALE: NONE

TYPICAL FOR BB-1, BB-2, BB-3 & BB-4

1. EPOXY TO BE APPLIED BY DIVERS IN CONTROLLED MANNER TO MINIMIZE TURBIDITY, AND MONITOR FLOW RATES.
2. TYPICAL EPOXY BAND WIDTHS 10 TO 12 INCHES.
3. MINIMIZE COLD JOINTS AND MAINTAIN BUCKET CONTACT WITH BERM.

The berm rubble was then epoxied using a delivery system that mixed the adhesive components at the nozzle. There was no discernible cloud of material as it was applied to the berms and one could thus reasonably infer that no adverse water quality impacts resulted. Approximately 570 product gallons of epoxy were used. Field operations for epoxy stabilization of these berms occurred from 31 July to 14 August 1997. The engineering calculations projecting the bonding strength of the material was provided to and subsequently approved by NOAA. Smaller rubble pieces not assembled into the berms and not found within the primary restoration areas (see below) were evenly distributed into on-site grooves or other natural formations.
