Abraham Lincoln Birthplace National Historic Site

Boyhood Home Unit

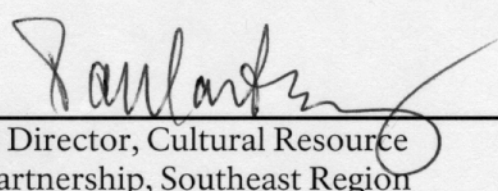
6-19-06
Associate Regional Director, Cultural Resource Date
Stewardship and Partnership, Southeast Region

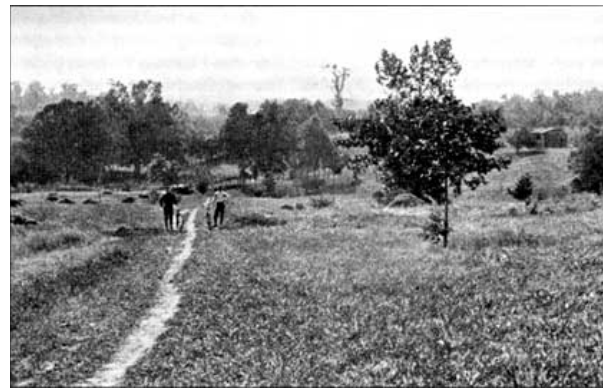
*Figure A-2 Sinking Spring Farm, 1895
(National Park Service)*

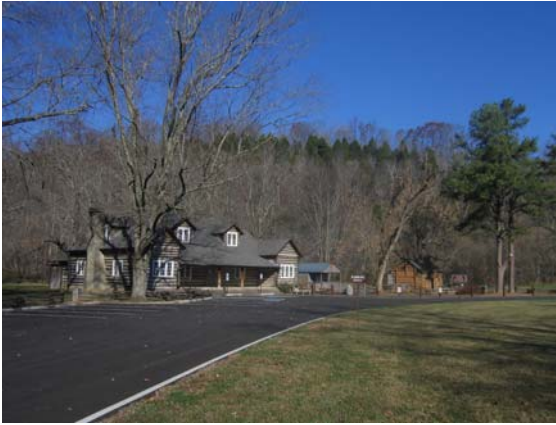
Figure A-11 Boyhood Home site, December 2005

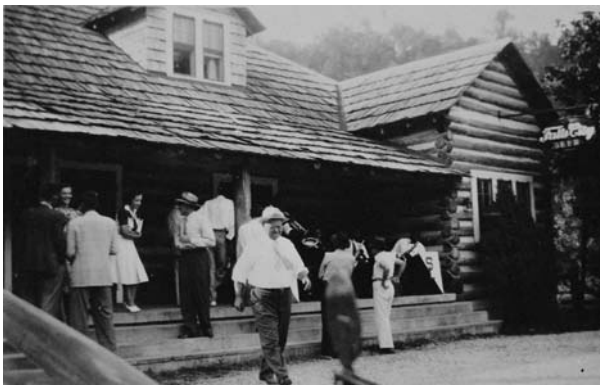
*Figure B-5 East elevation of tavern, undated
(courtesy of Mary Brooks Howard)*

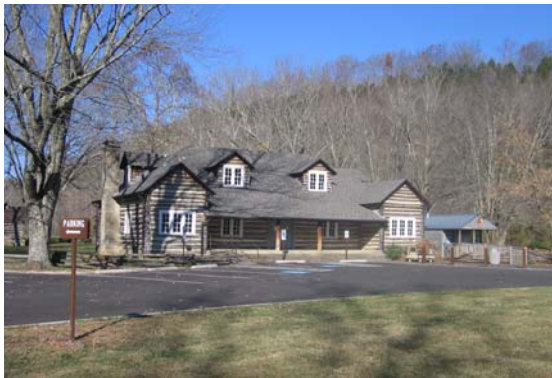
Figure C-1 Tavern from the southeast

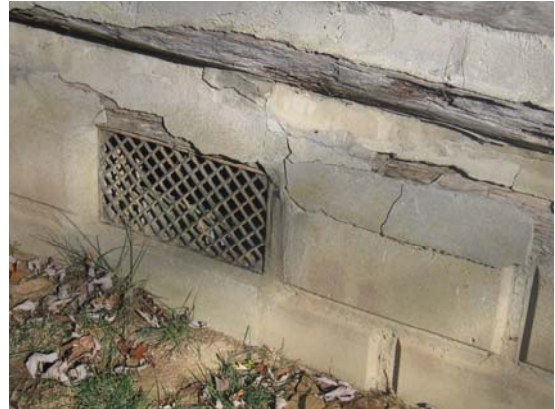
Figure C-3 Concrete masonry units and vent

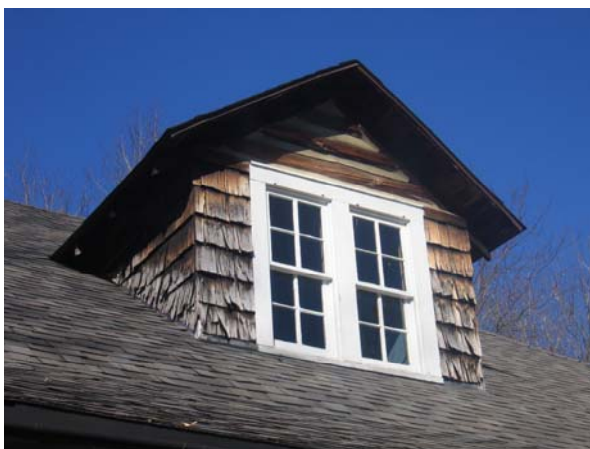
Figure C-6 East-facing dormer

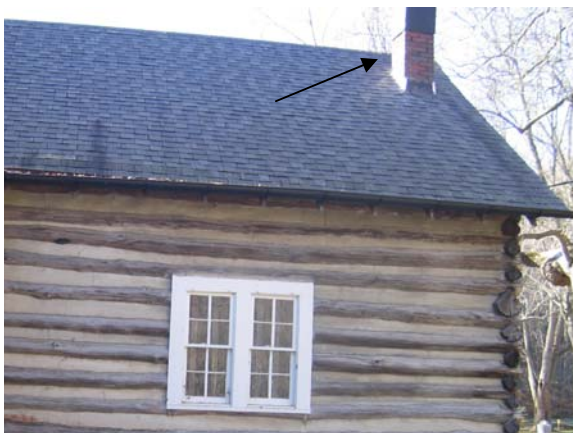
Figure C-12 Brick chimney at kitchen

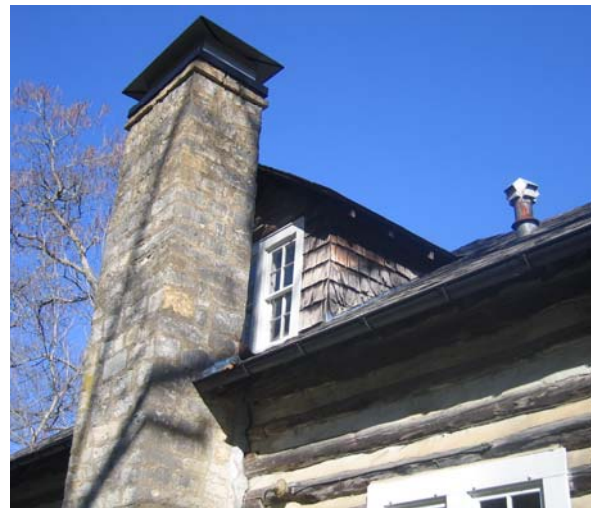
Figure C-13 Limestone chimney on south wall

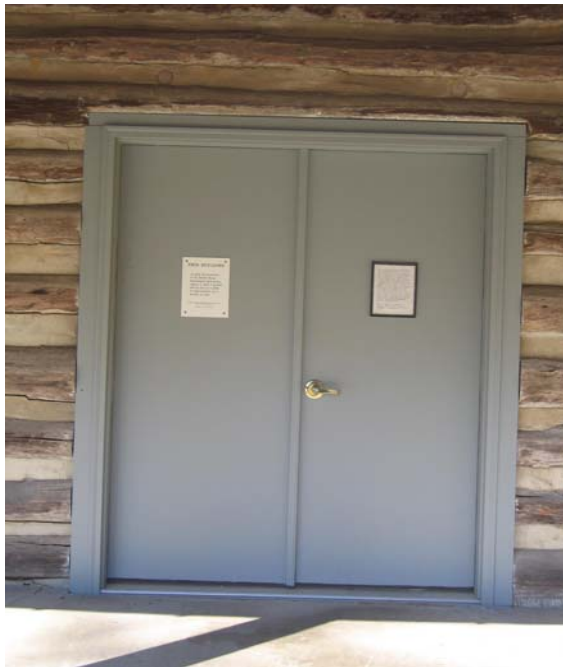
Figure C-14 Modern front doors

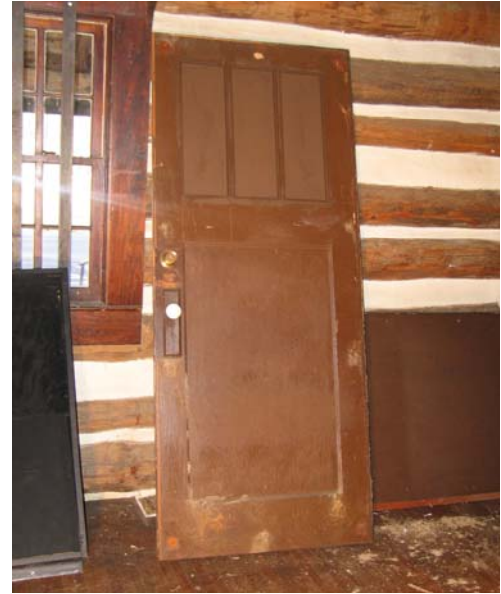
Figure C-15 Original front door, stored in the hall

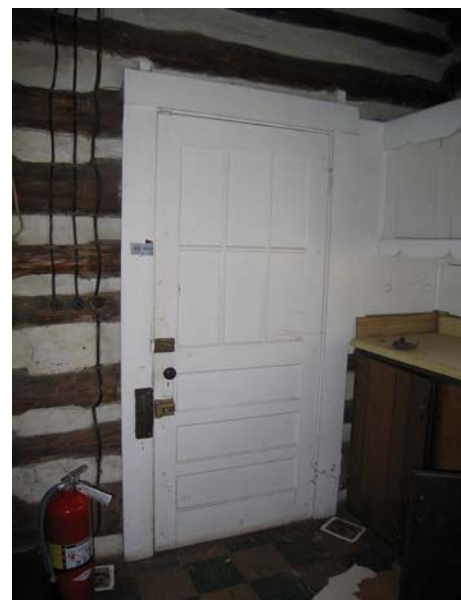
Figure C-16 Original rear doorway in kitchen

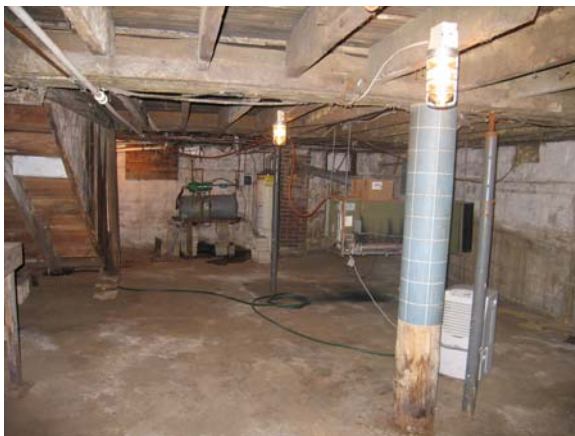
Figure C-23 Room 001, looking northwest

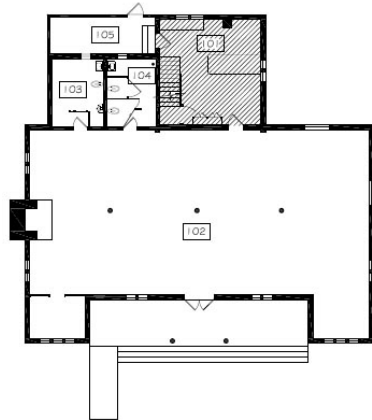
Figure C-25 First floor plan with Room 101 shaded

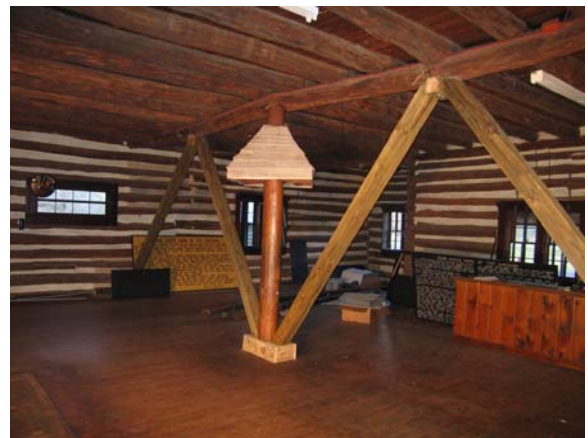
Figure C-33 Room 102, looking northeast

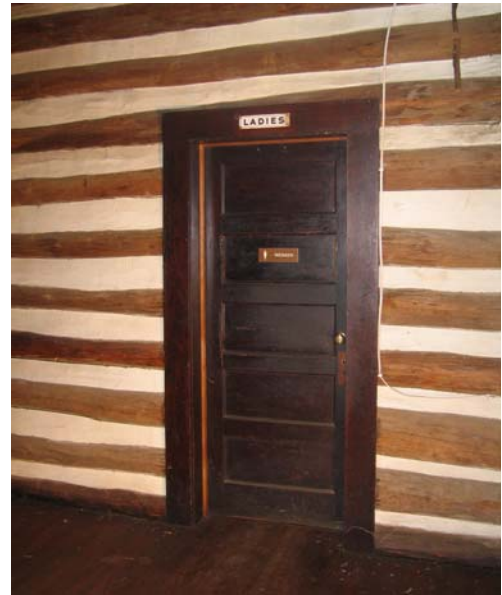
Figure C-36 Door to women's restroom, Room 104

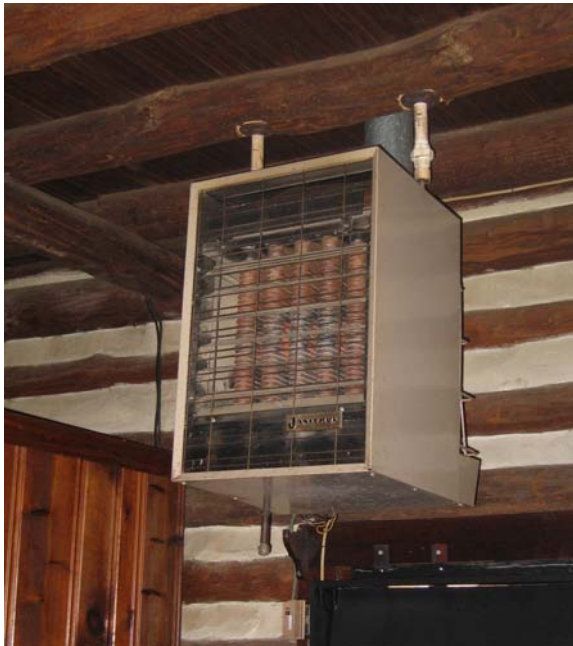
Figure C-38 Unit heater in Room 102

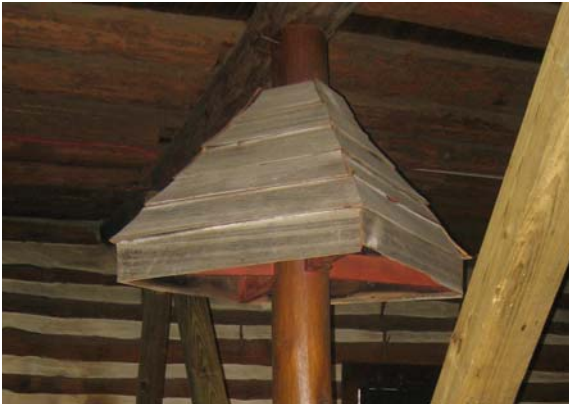
Figure C-40 Display canopy in Room 102

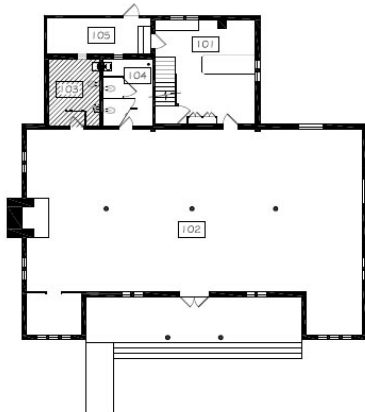
Figure C-41 First floor plan with Room 103 shaded

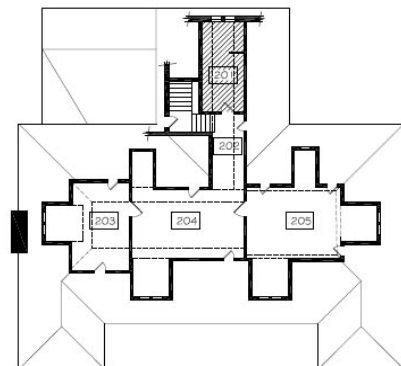
Figure C-49 Second floor plan with Room 201 shaded

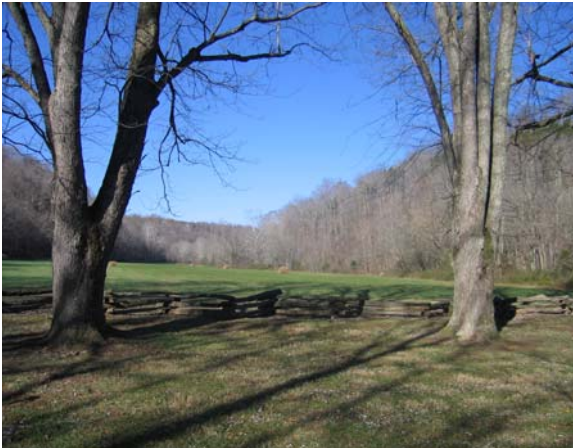
Figure B-1 View to fields west of tavern

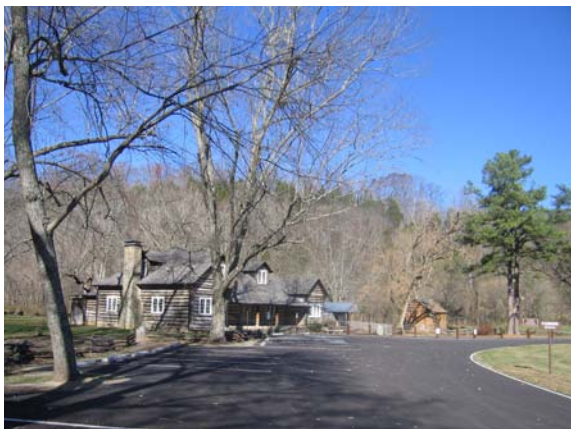
Figure E-1 Current setting of tavern and cabin, 2005

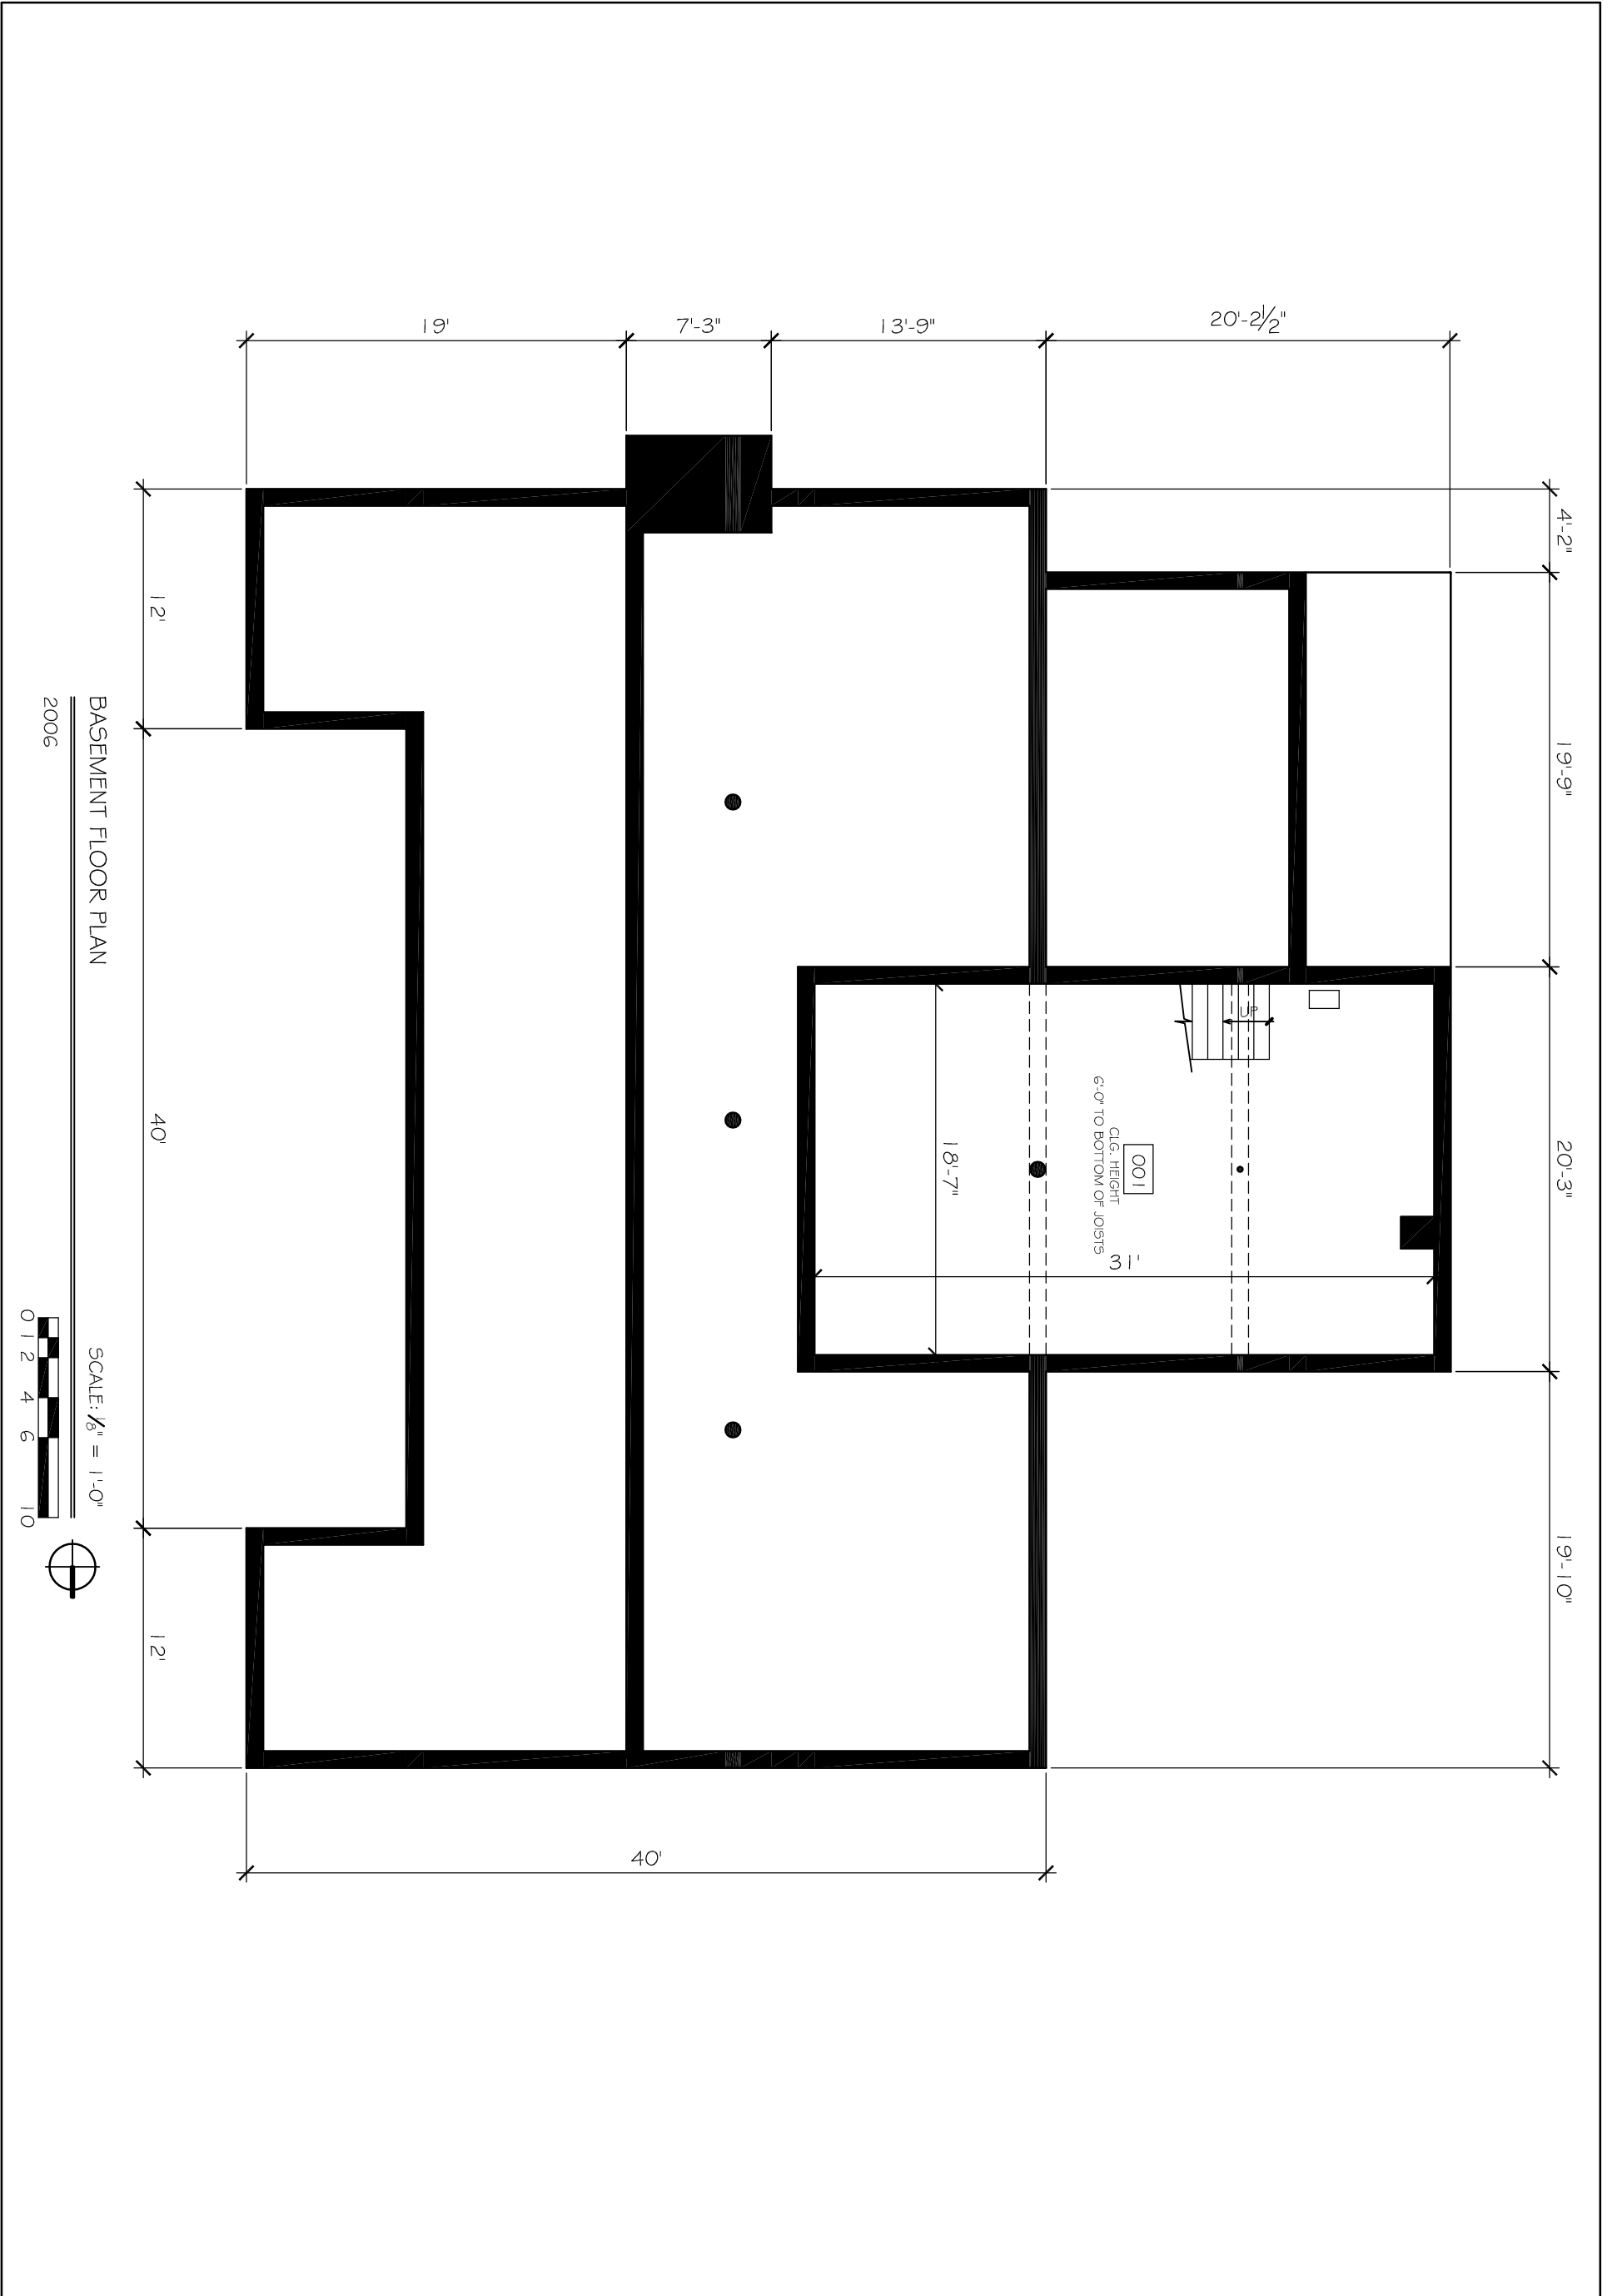
JOB #:	0506
DATE:	04-01-2006
DRAWN BY:	JLP/v
REVISIONS:	
SHEET #:	1

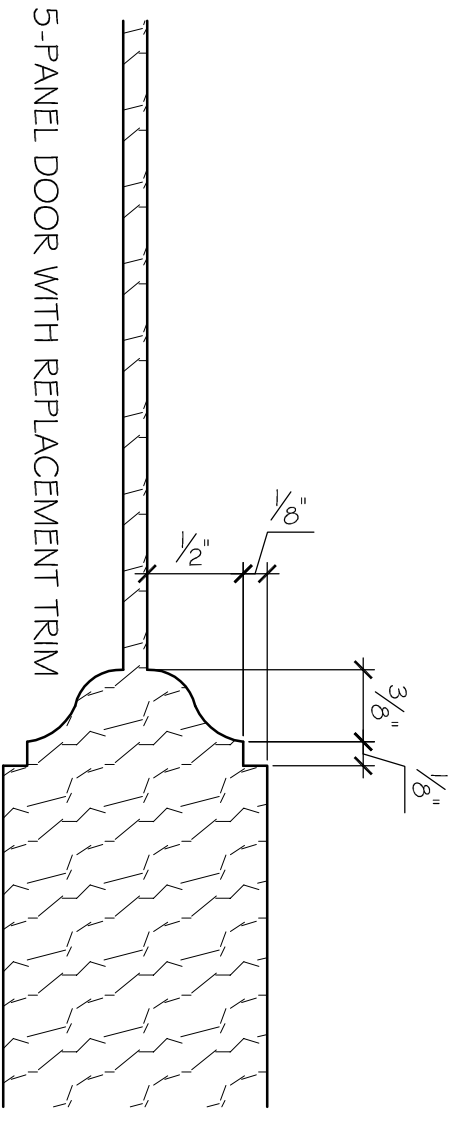
5-PANEL DOOR WITH REPLACEMENT TRIM

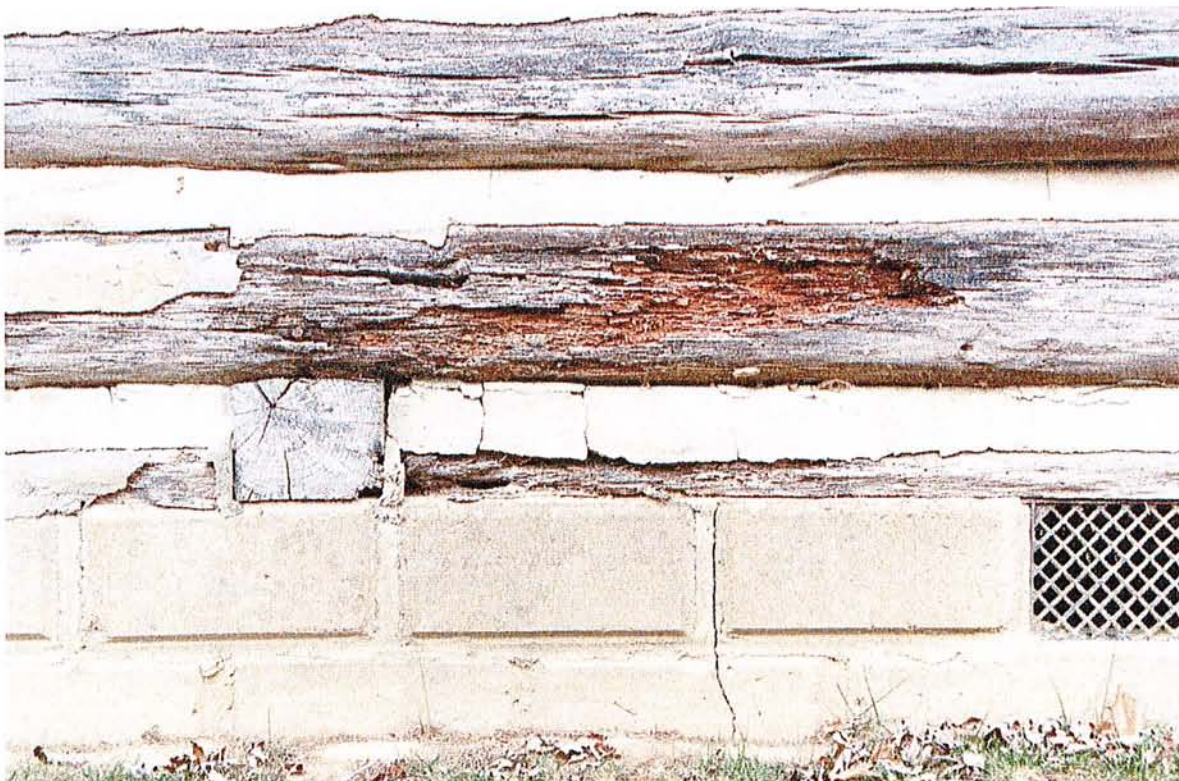
Figure 4 Many of the lower logs are badly deteriorated. Resistance drilling can be used to quantify the amount of material to be replaced.

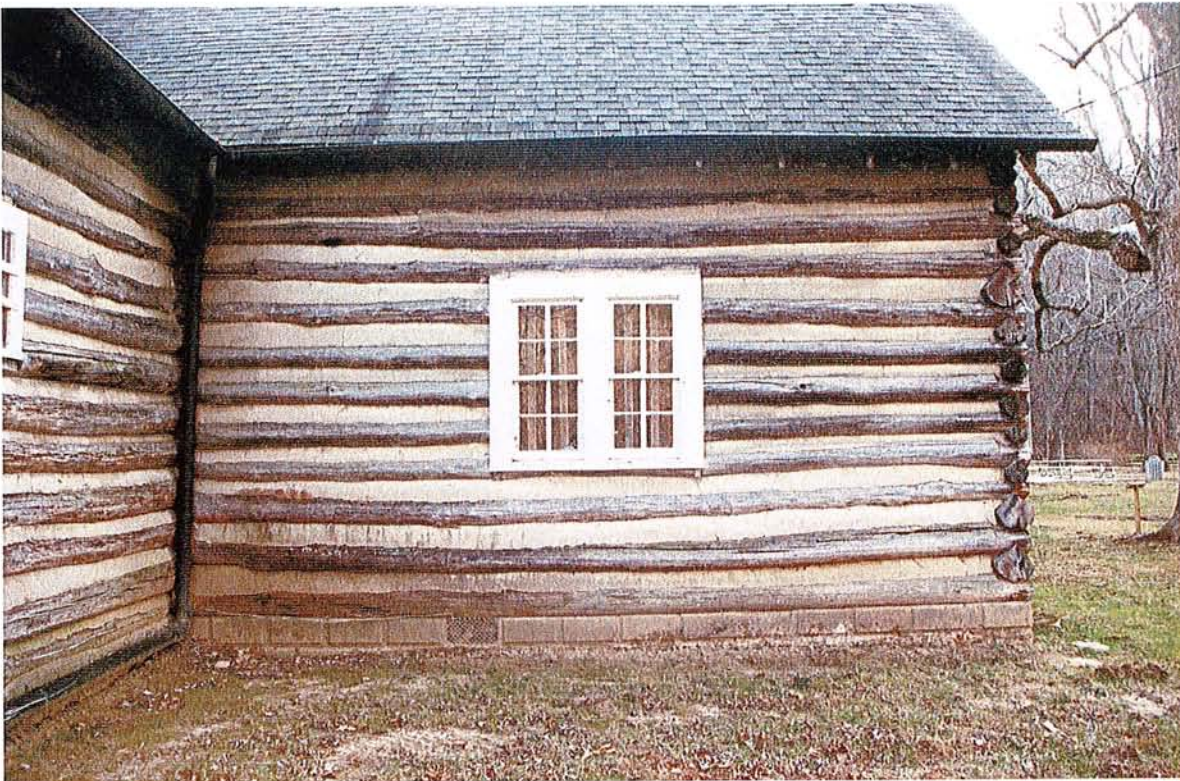
Figure 5 The bow in the bottom logs and the wide band of chinking indicates that severe deterioration is present at the base of this wall.

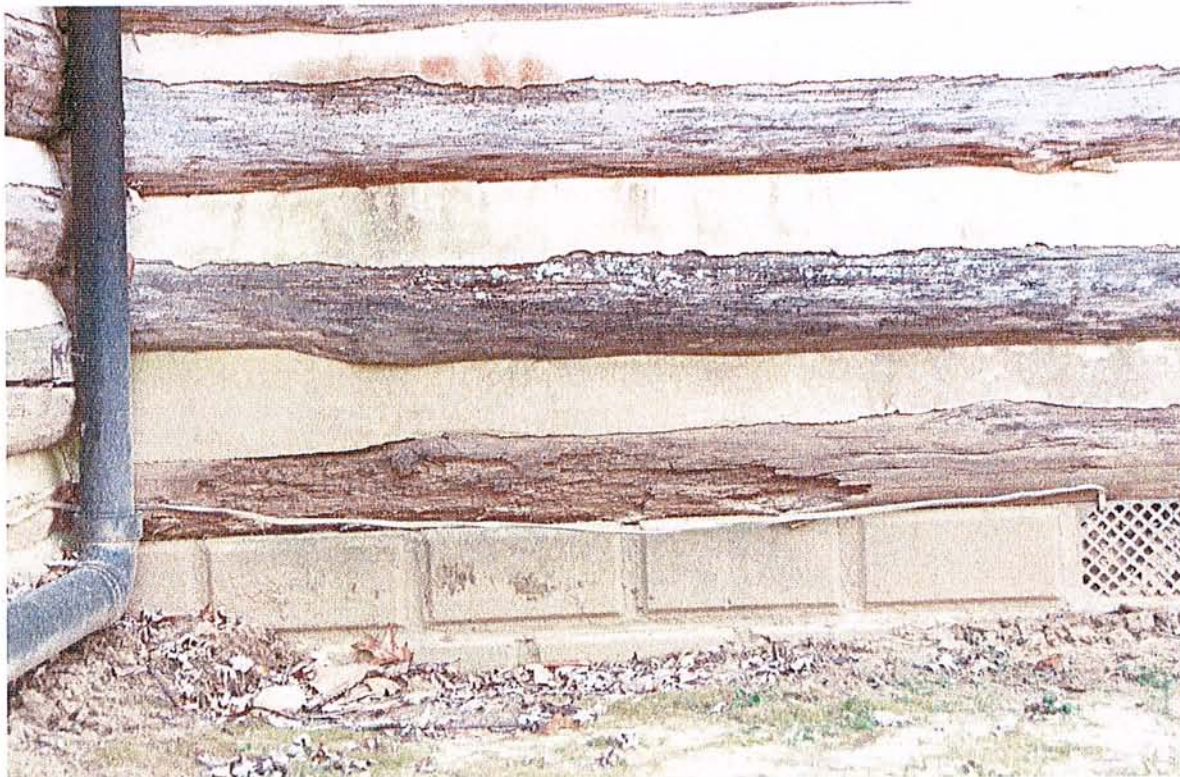
Figure 6 Stains and cracks in the chinking are clues to possible wood deterioration.

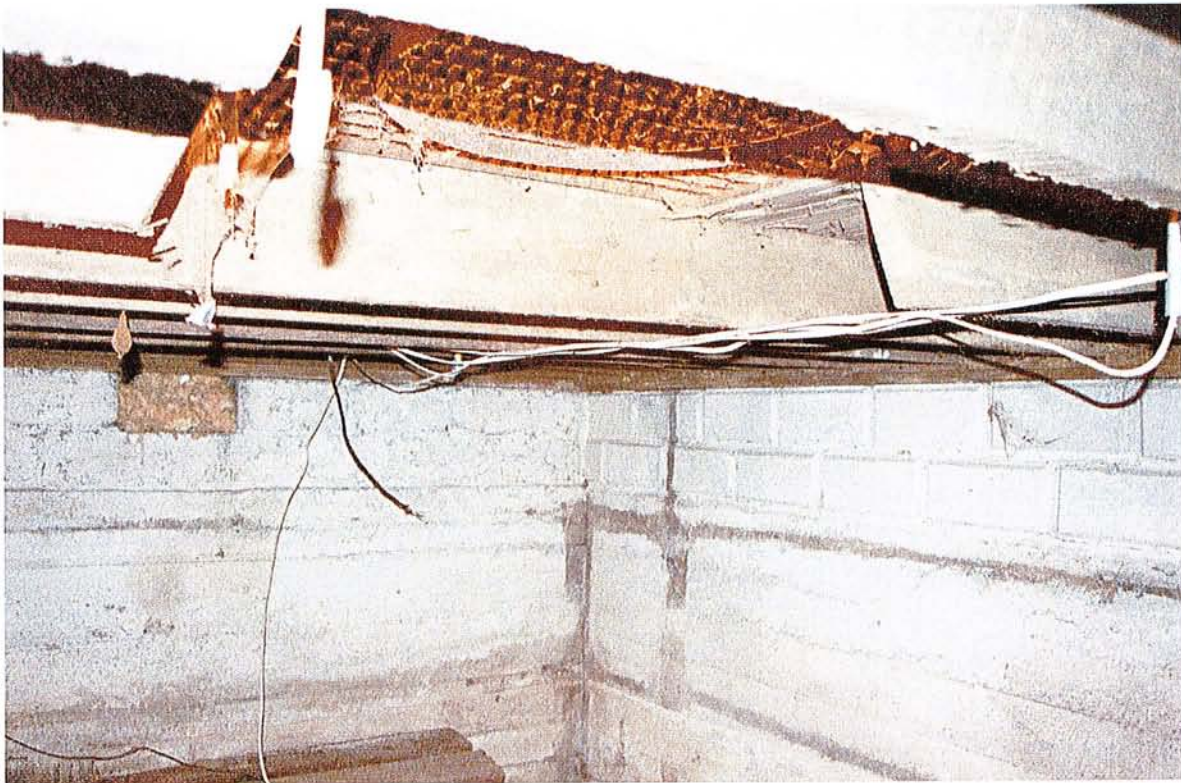
Figure 7 This vent was added without a header provided where the floor joists were cut.
